National Register of Historic Places Inventory—Nomination Form

historic The Free Church

and/or common The Powers Church

HISTORIC AMERICAN
BUILDINGS SURVEY
SHEET 1 OF 4 SHEETS

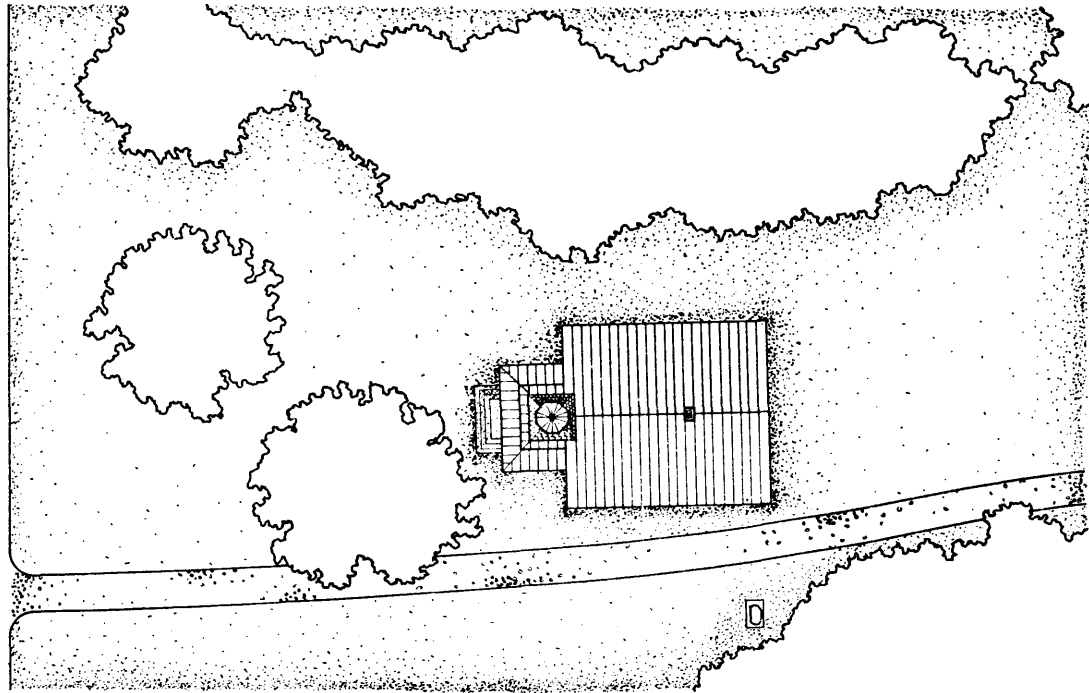
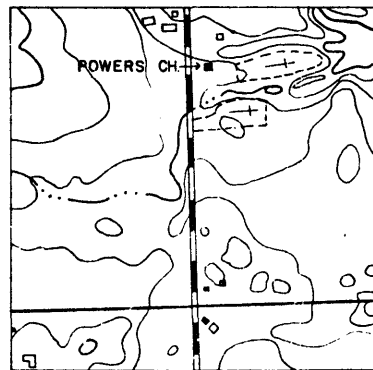
POWER'S CHURCH

THE POWER'S CHURCH, BUILT IN 1876, IS A FINE EXAMPLE OF EARLY NORTHERN INDIANA COLONIAL REVIVAL ARCHITECTURE. ONCE PART OF A PIONEER SETTLEMENT IN STEUBEN COUNTY, IT STANDS ALONE, SURROUNDED BY A WOODED LOT AND A CEMETERY, WHICH ALSO DATES BACK TO THE 1870'S. ESPECIALLY NOTABLE, ON THE STRUCTURE, IS THE OCTAGONAL WOOD SPIRE, WITH SCALLOPPED TRIM. THE ENTIRE STRUCTURE IS IN EXCELLENT CONDITION.

The Free Church is located in a rural setting on Old Road 1 North, near Angola in Steuben County, Indiana. Built in 1876, it is a frame structure covered with 4" wide clapboard siding and rests on a fieldstone foundation. The building is basically rectangular in plan; a three-story, square tower topped with a spire presents the sole deviation to this plan as it projects out to the west. The building has a simple gable roof that was originally covered with shingles; the current standing-seam metal roof was installed sometime in the 1940s. A brick chimney with a concrete cap appears on the ridge of the roof near the center of the building.
