KENTUCKY HISTORIC RESOURCES INVENTORY

Site No. Sc 334

1. Historic Name(s) <u>(Matthew Henry) house</u>		22. ADD/County <u>Bluegrass 1 Sect</u> 105	
Original Owner <u>Matthew Henry</u>		23. U.S.G.S. Quadrant (15'/75') <u>Centerville v. c.</u> 047

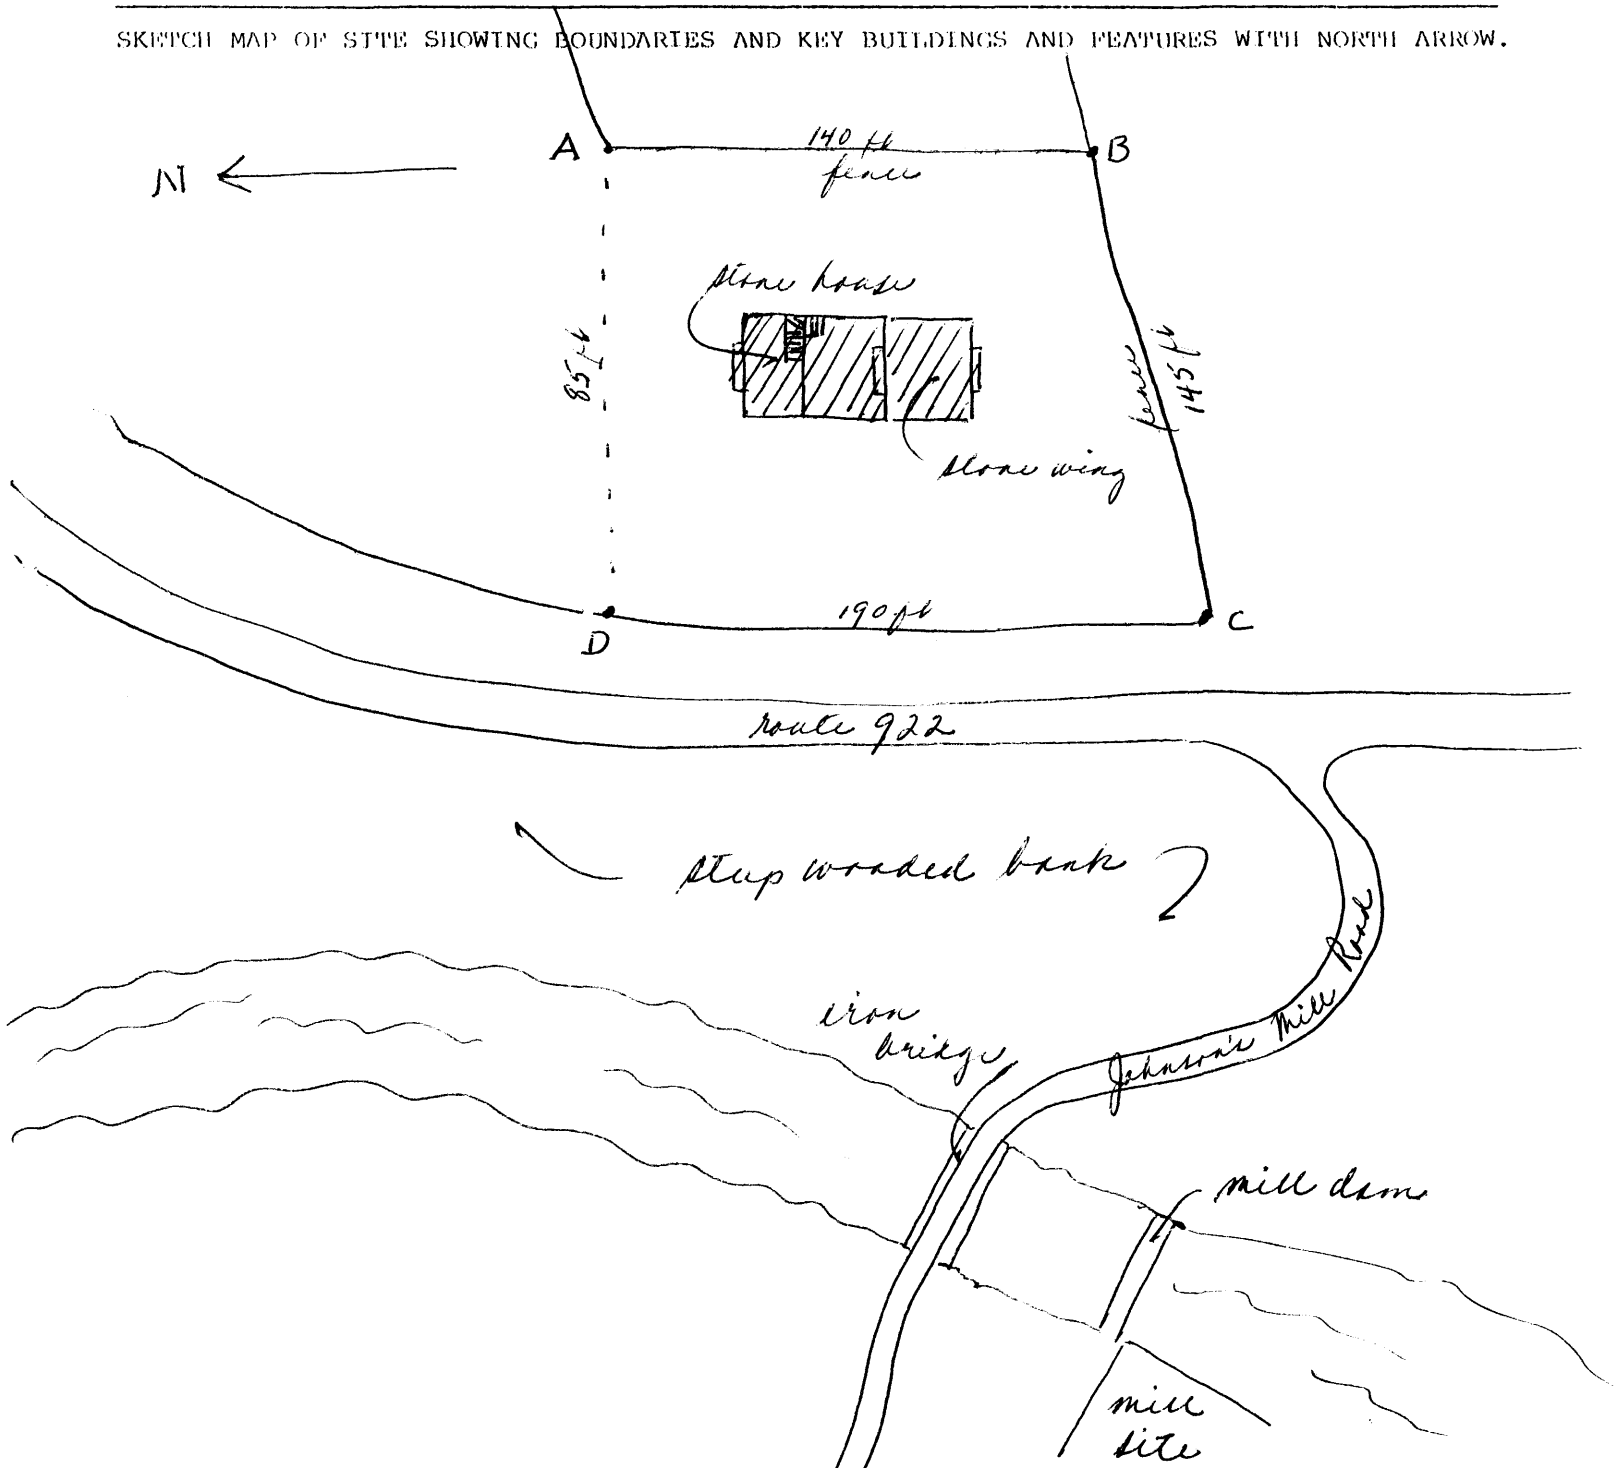
SKETCH MAP OF SITE SHOWING BOUNDARIES AND KEY BUILDINGS AND FEATURES WITH NORTH ARROW.

Beginning at A at a fence corner NE of the house, thence with fence S 140 ft to another corner B, thence W with fence 145 ft to road C, thence with road 190 ft to D, thence leaving road 85 ft E to the beginning enclosing the stone house and about 1/2 acre. No other significant buildings at site.
