Resource	#_	BK-9
BRACKEN		County

<u>1.</u>	Name of Resource:	16.	Date:	
	Mordecai Chalfant House		Original Building early 19th Cen	itur∳ 8
2.	Original Owner:		Addition	, cur y o
	Mordecai Chalfant	17.	Style: Federal

•		•		
					<i></i>
45.	Description and House Plan:				<u> </u>

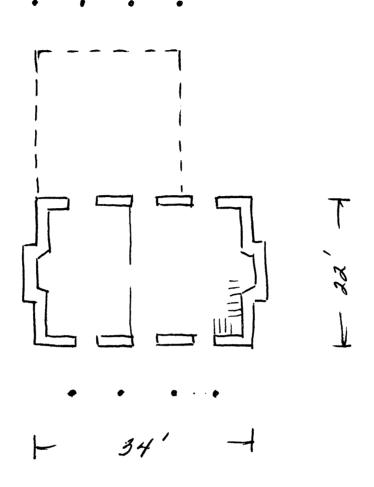
Bhg 1.393

One and one-half story, three-bay, hall-parlor, dry-stone house. Stones tooled and coursed. Upper Ordovician limestone, Kope Formation. Exterior chimneys, each end, flanked by square attic windows. No voussoirs, frames not pegged, ovolo trim.

Interior refinished with wood sheathing which covers fireplaces. Original woodwork replaced except window frames, which have beaded corners (larger than usual) and ovolo trim. Open corner stair rebuilt. All changes around turn of the century.

A late 19th century frame ell was added to rear, with one side of roof at different pitch to cover a side porch (now enclosed). The shed porch on the front of the house is the same period as the rear ell. The shed porch on rear of ell was added when the side porch was enclosed in the early 20th century. These additions do not destroy the unity and form of the original house.

The house is located in a flat valley bordering the Ohio River and Chalfant Creek which was named for the owner of the house.

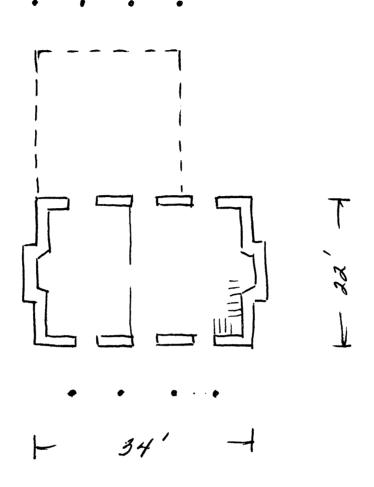
Bhg 1.393

One and one-half story, three-bay, hall-parlor, dry-stone house. Stones tooled and coursed. Upper Ordovician limestone, Kope Formation. Exterior chimneys, each end, flanked by square attic windows. No voussoirs, frames not pegged, ovolo trim.

Interior refinished with wood sheathing which covers fireplaces. Original woodwork replaced except window frames, which have beaded corners (larger than usual) and ovolo trim. Open corner stair rebuilt. All changes around turn of the century.

A late 19th century frame ell was added to rear, with one side of roof at different pitch to cover a side porch (now enclosed). The shed porch on the front of the house is the same period as the rear ell. The shed porch on rear of ell was added when the side porch was enclosed in the early 20th century. These additions do not destroy the unity and form of the original house.

The house is located in a flat valley bordering the Ohio River and Chalfant Creek which was named for the owner of the house.
