National Register of Historic Places  
Registration Form

historic name Fitch-Hoose House

street & number 6 Gulf Road not for publication

city or town Dalton vicinity

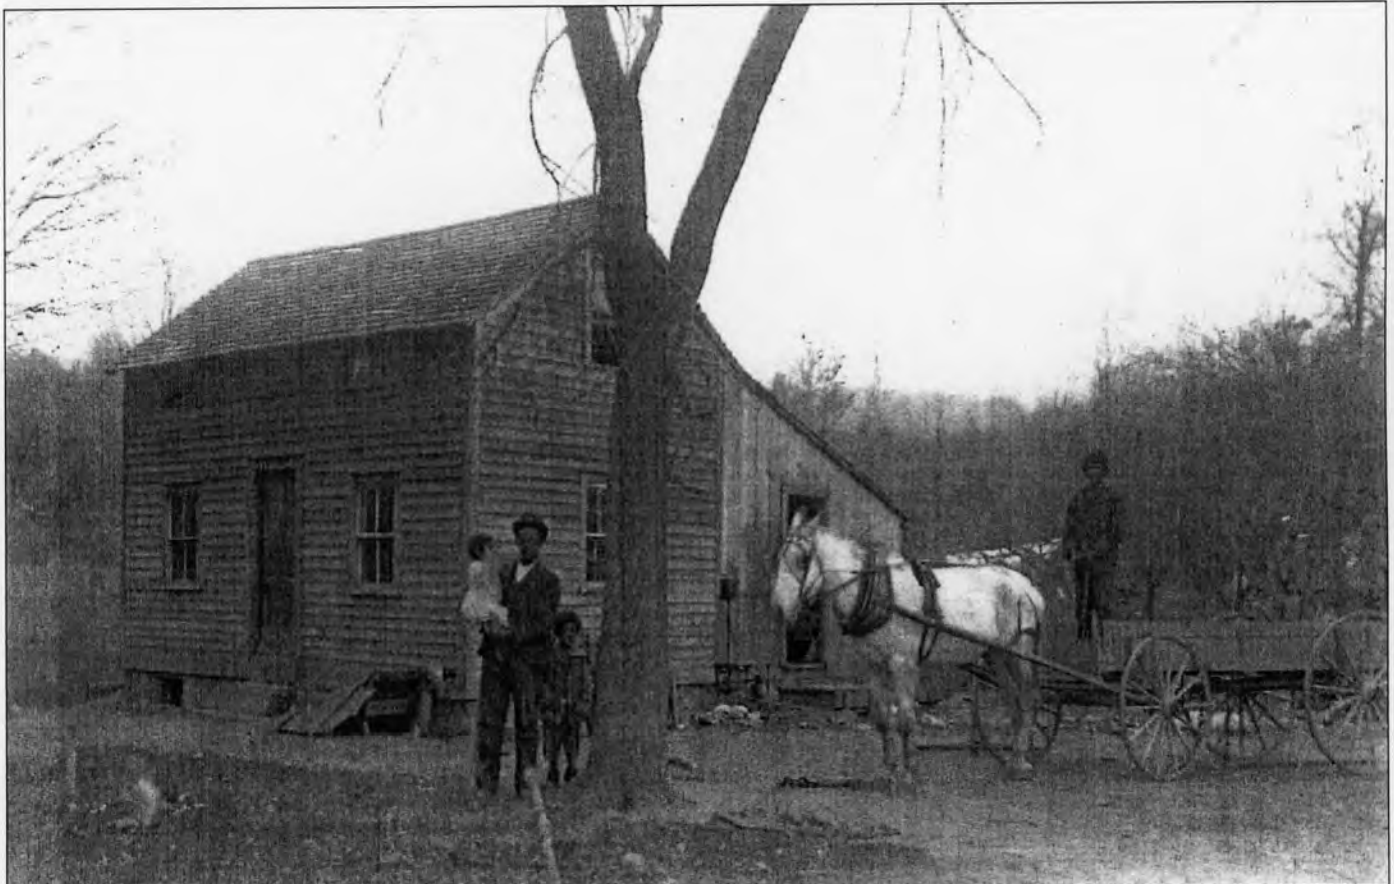
Fig.1: View of Fitch-Hoose House from southeast, c. 1900. Source: Ashfield Historical Society Photograph Collection.

The front (south) façade contains an off-center entrance flanked by windows (Figs. 2 & 3 and photos 1 & 3). Two attic-story windows that appear in the historic photograph and are still visible on the interior have been covered by the current wall siding (Fig.1). The original door and frame are intact (glazing has been added to the upper section of the door), and a metal storm door has been added to the exterior. Window openings and frames are intact, but the historic sash have been removed and replaced with metal framed sash with insulated glass. In the historic photograph, the windows contained 2/2 wood sash.

Only the rear wall of the extension is visible on the north side of the house (photo 2). It contains four windows, with a brick chimney located on the eastern side of the façade. The division between the two sections is clearly evident in the differing size of windows east and west, the contrasting foundation materials, and the failing connection between the two parts of the roof. The chimney was built on a concrete base, and it also was elongated vertically with the addition of flue tile. The present chimneys date to the 20<sup>th</sup> century. It appears there was no heat in the house originally, or at least no masonry chimney; possibly, a cook stove and earlier chimney or pipe existed in the rear section of the house that is not visible in the historic photo (Fig. 1).

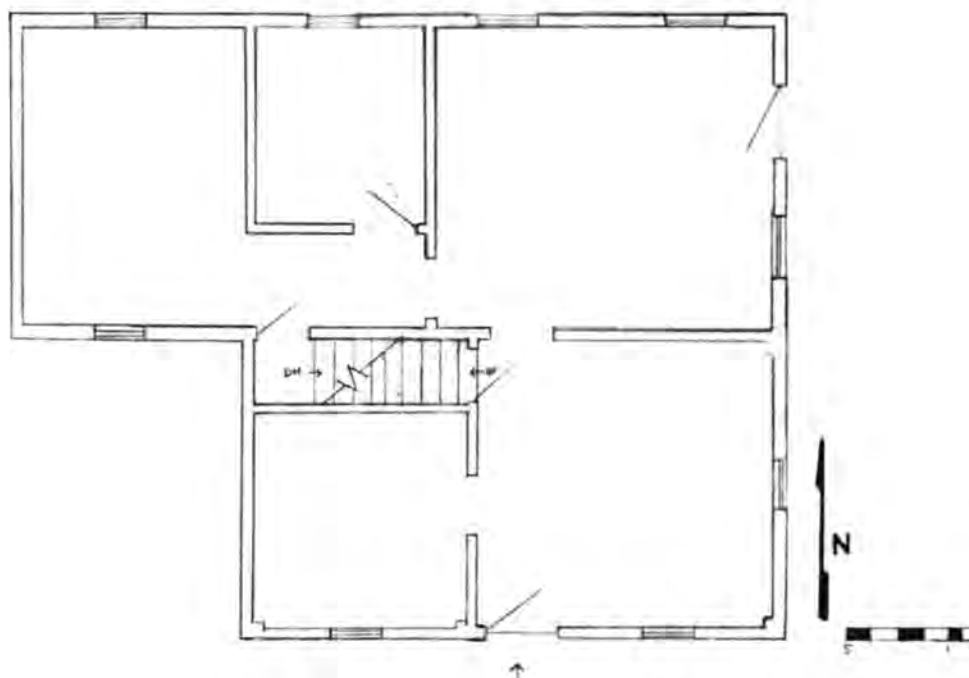
Fig.2: Floor Plan, first floor. Drawing by Larson Fisher Associates, 2007.

The interior of the main section of the house is divided into two rooms (Figs. 2 & 3). The principal living room is located on the east side and measures about 11 feet square with a door and a window on the south wall and a window centered in the east wall (photo 4). The corner posts in the northeast and southeast corners protrude into the room, with the casing of the lower half stepped out from that on the upper half. There is a doorway in the east end of the north wall, which connects with the kitchen in the rear; there are two doorways on the west wall, one leading to the bed chamber and one opening on the enclosure containing the attic stairs (photo 5). Walls and ceiling retain their original lath and plaster under a later application of gypsum board. Window and door openings are framed with four-inch board surrounds. Original doors remain in the doorways to the exterior and the attic; the other two doors have been removed. Historic 6/6 (east) and 2/2 (south) wood window sash have been replaced with metal 1/1 sash containing insulated glass. (The 2/2 sash were late 19<sup>th</sup>-century upgrades.) A narrow-gauge (2½ inch wide) hardwood floor has been applied over the original wide pine boards. A smaller bed chamber measuring roughly 8½ feet across the front (south) and eight feet deep occupies the southwest corner of the main section (IMAGE 6). The enclosure containing the stair to the attic is located behind the smaller chamber, filling out the northwest corner of the plan. A window is centered in the south wall of the bed chamber, and a doorway to the living room is centered in the east wall. There does not appear to have been a window in the blank west wall. The historic 2/2 wood sash have been replaced with 1/1 metal sash containing insulated glass. Original lath and plaster walls are covered with gypsum board, and hardwood flooring has been added. The stairs to the attic are steep, with seven-inch treads and nine-inch risers. Original plaster finish is exposed on the walls.

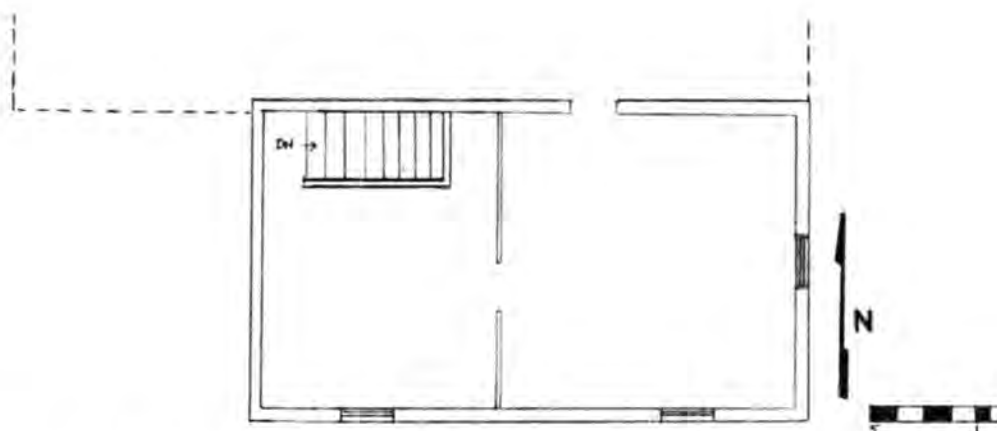
Fig.3: Floor Plan, second floor. Drawing by Larson Fisher Associates, 2007.

The two attic rooms are roughly the same dimension as those below them, except there is no partition dividing the stairs from the west room. A recent wood-stud partition divides the space about one foot east of the girt at the east end of the stair hole. It probably replaces a board wall in the same general location. Any evidence of an earlier wall is concealed under later cellulose boards covering the walls and ceiling. Whitewash visible on rafters and the underside of the roof, as well as on wall studs and sheathing, indicates that the interior surfaces of the wall and roof framing were not covered until the early 20<sup>th</sup> century (photo 7). There are single windows centered in the gable ends, now containing replacement sash. Two window openings in the kneewall on the front (south) side of the house are still in place, even though they have been sided over on the exterior. No window sashes remain in the openings, however.

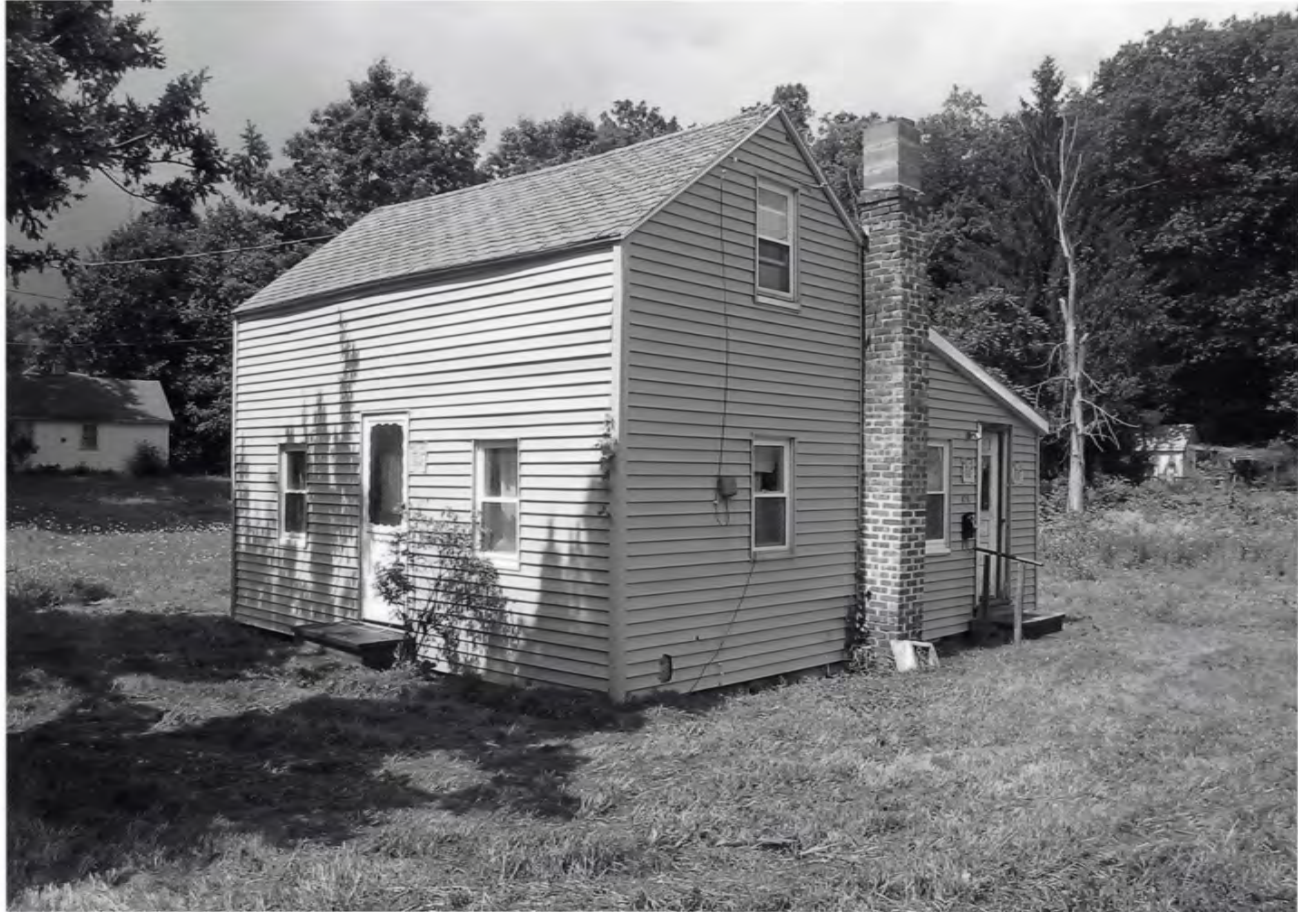
PHOTO 1: View from southeast

The main section of the 1½-story house measures roughly 20 feet by 12 feet, with a one-story extension measuring 28 feet by 12 feet on the rear (photos 1-3). The rear edge of the gable roof of the main section terminates slightly above the flatter shed roof on the extension. A historic photograph (ca.1900) suggests that the eastern portion of this extension was added to the house at an early date (Fig.1). Its roof had a steeper pitch than the existing roof and was contiguous with the main roof. It was originally about 14 feet in length. This section has been enlarged with a recent addition doubling its size and extending it about eight feet past the west wall of the main section; the pitch and connection of the roof was evidently altered at this time (photo 2). The walls of the entire house have been covered with a green vinyl clapboard siding, and the roofing material is now light gray asphalt shingles on the main section, and asphalt sheets on the extension. There is a full stone basement under the main section with brick courses at the top for a more finished exterior appearance. The extension was constructed over a crawl space, with a stone foundation visible under the older section and a concrete block foundation under the addition.

The east facade of the house contains windows centered in the ground and attic stories (photo 1). The original openings and frames are intact, but the sashes have been replaced. A square brick chimney is attached to the exterior wall near the northeast corner where the main section joins the extension. Its height has been increased by the addition of three concrete chimney blocks on top of the brick. The east end of the extension contains a door and a window, which are later additions, as the historic view shows only a door centrally placed in the wall (Fig. 1). The wood door has a plate-glass window in its upper half, and a metal storm door has been added to the exterior. The window sash has been replaced more recently. A louvered vent is located in the upper south corner.

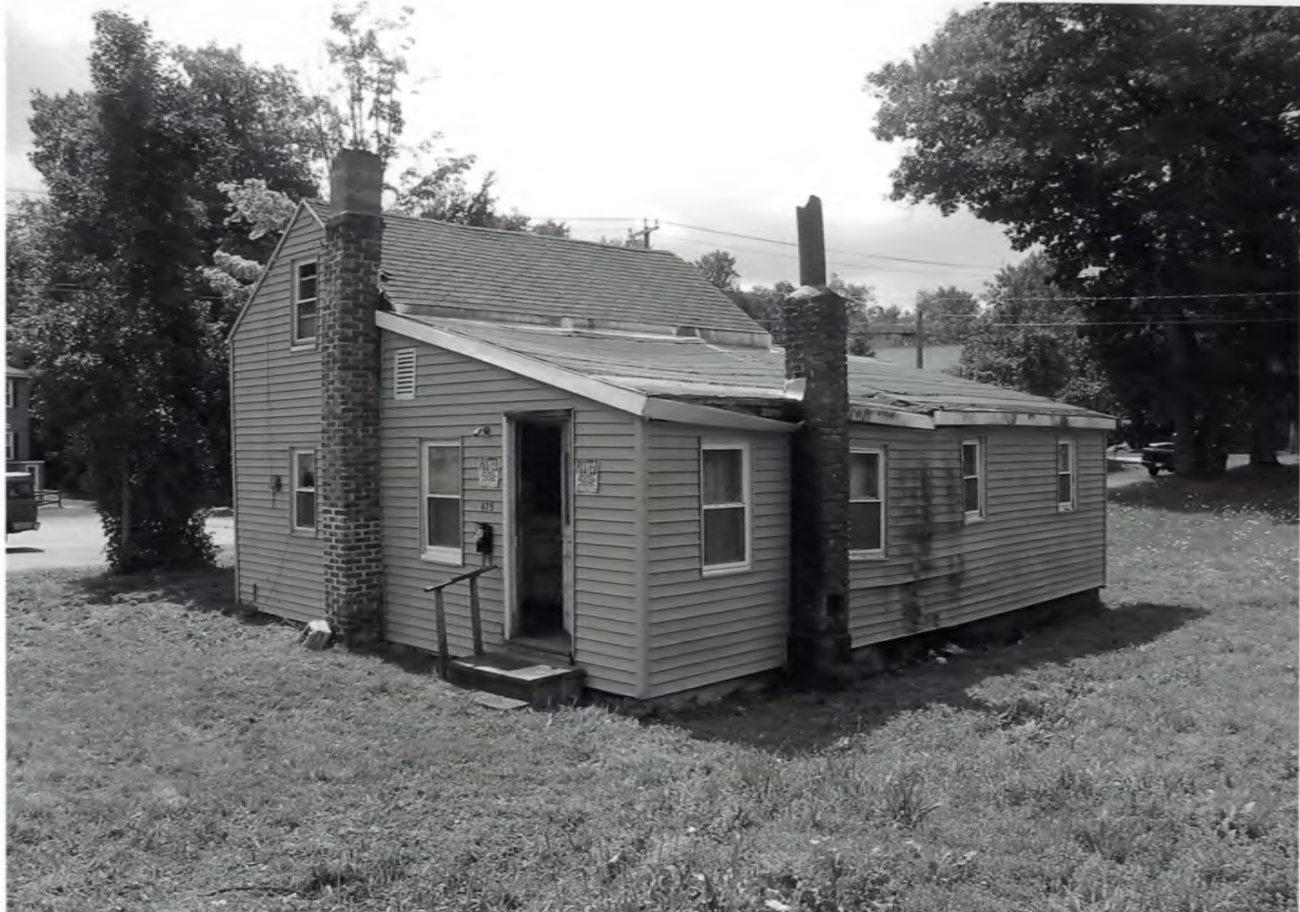
PHOTO 2: View from northeast

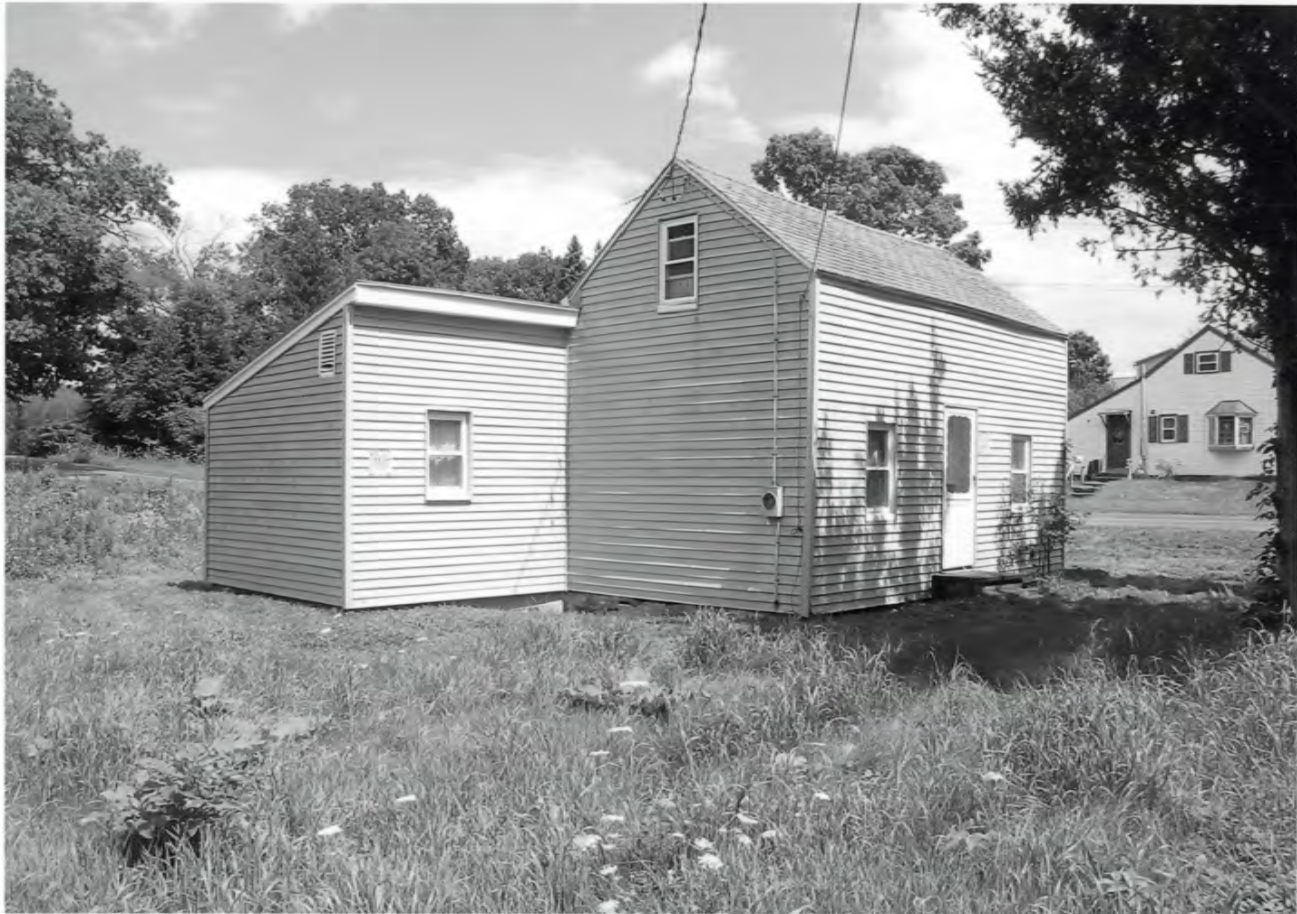
PHOTO 3: View from southwest

The west end has an irregular façade due to the presence of the projecting addition of the rear extension (photo 3). The wall of the main section has but a single window centered in the attic. There is no window on the main level, and there is no particular evidence that one located there originally would have been walled over. The west wall of the shed-roof extension is also blank except for a louvered vent in the uppermost location. A window is centered in the north wall of the part of the extension protruding beyond the main section. All windows contain replacement sash. Electric and telephone service are attached to the front edge of the main section.

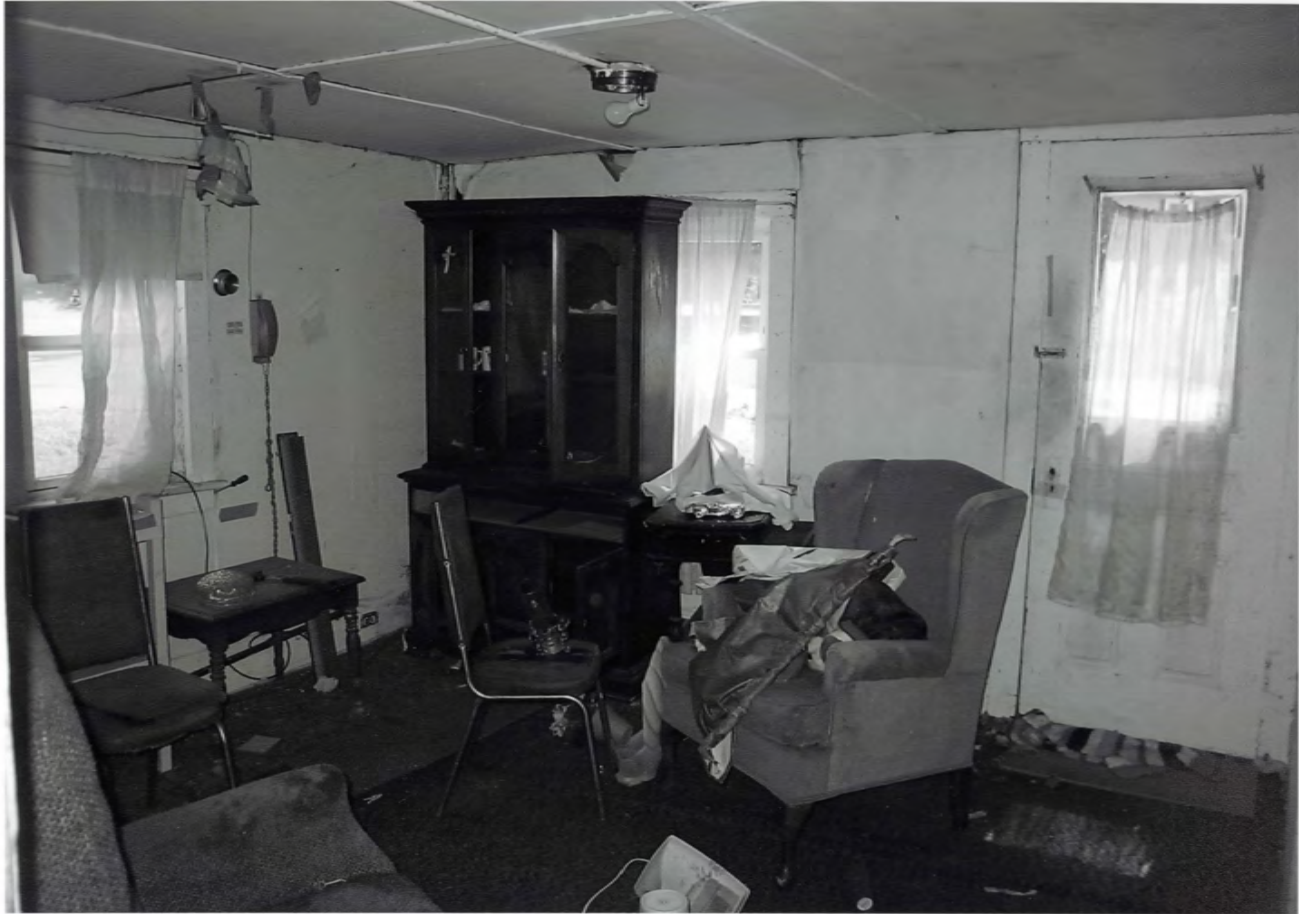
PHOTO 4: View of parlor from north, front entrance  
on right.

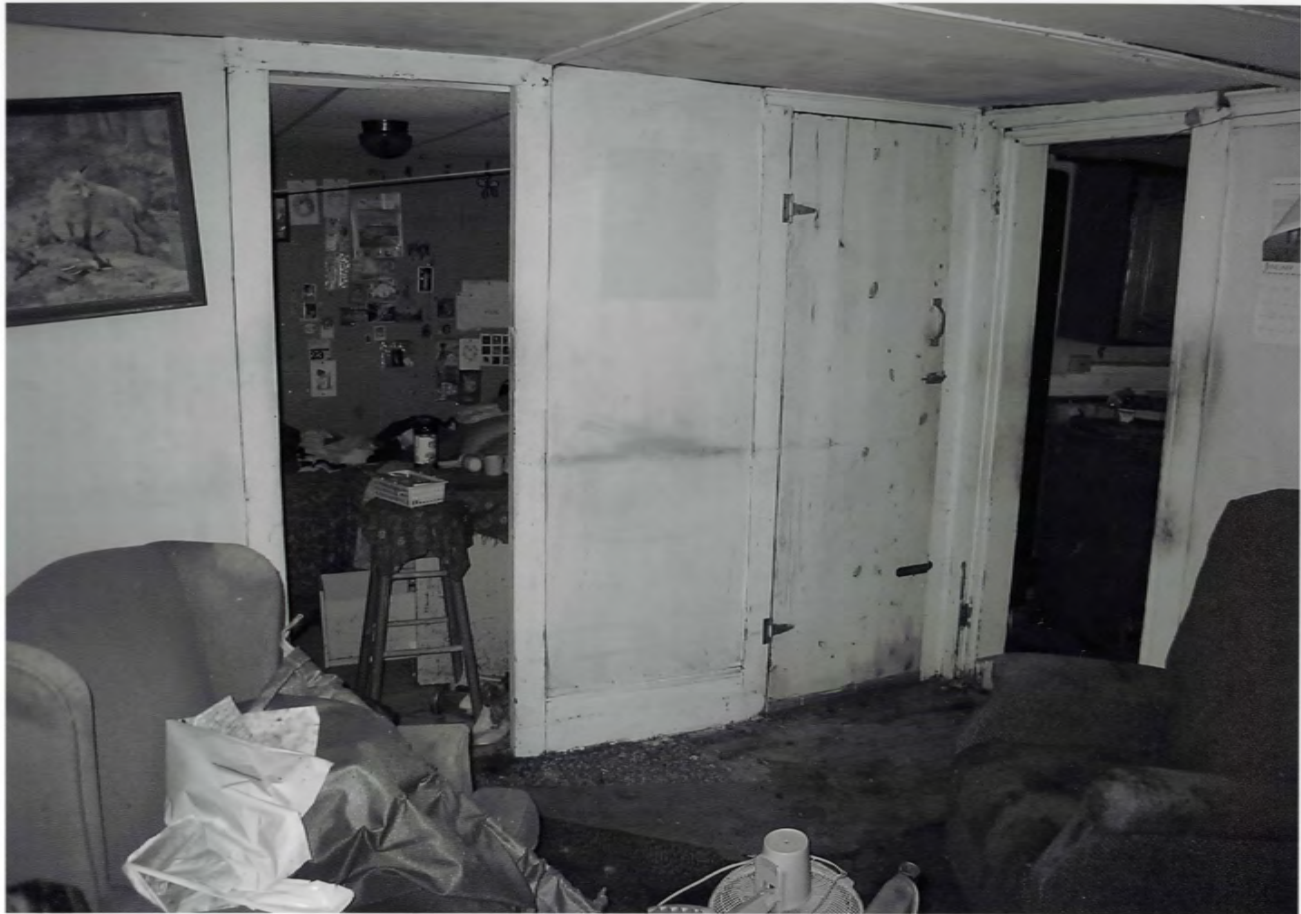
PHOTO 5: View of partition between parlor & chamber  
from east, doorway to stairs on right

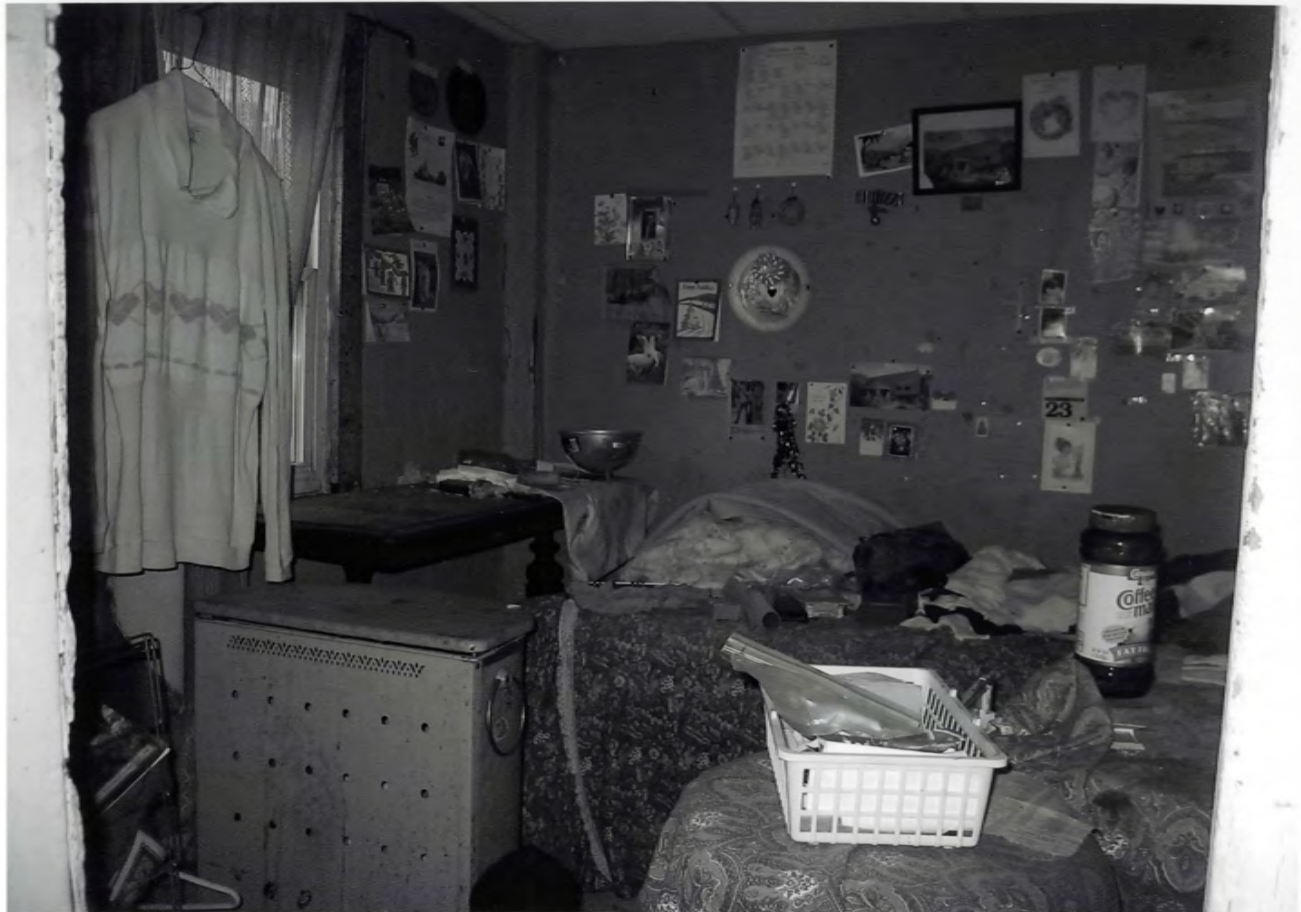
PHOTO 6: View of chamber from east

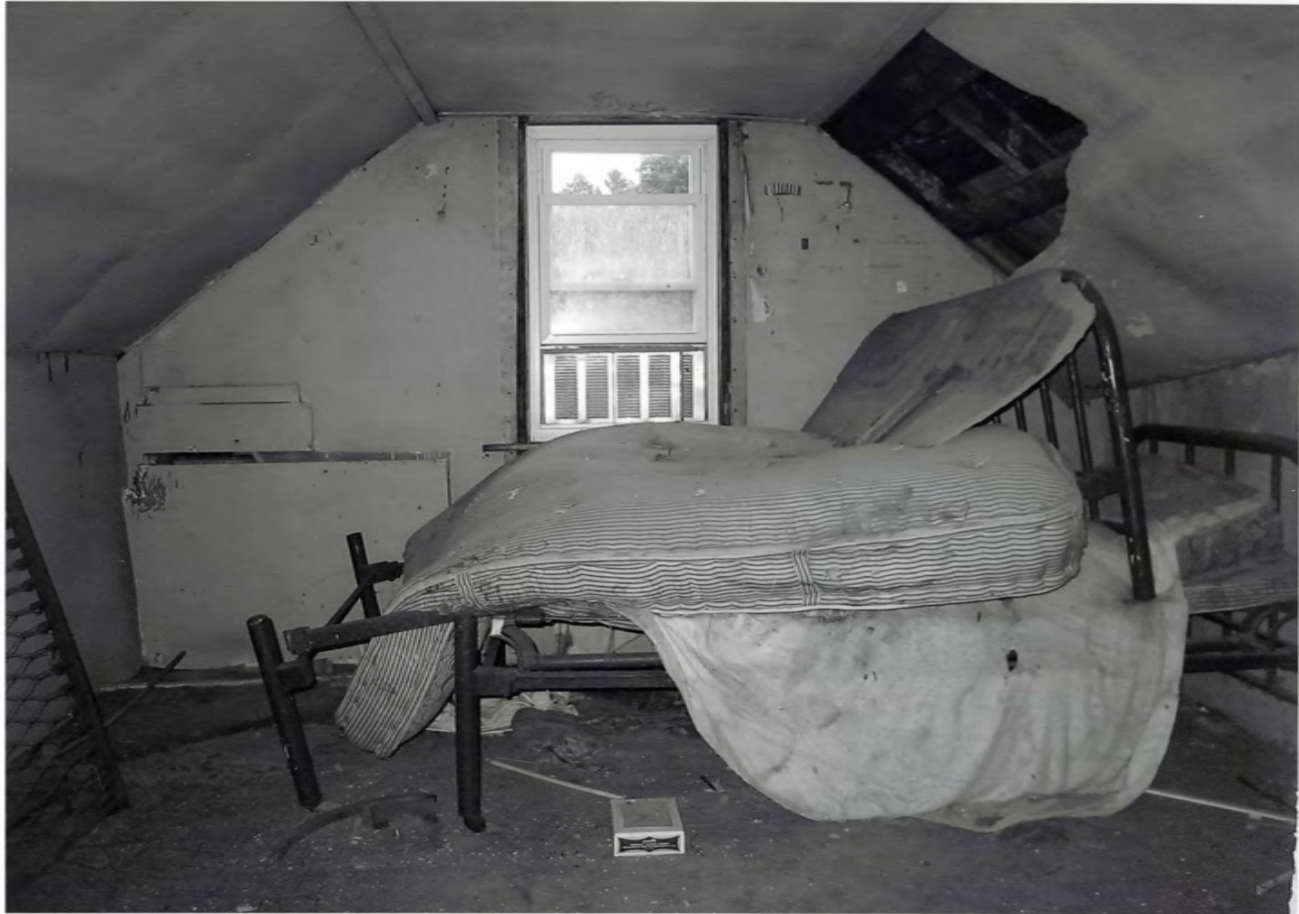
PHOTO 7: View of east attic room from west.

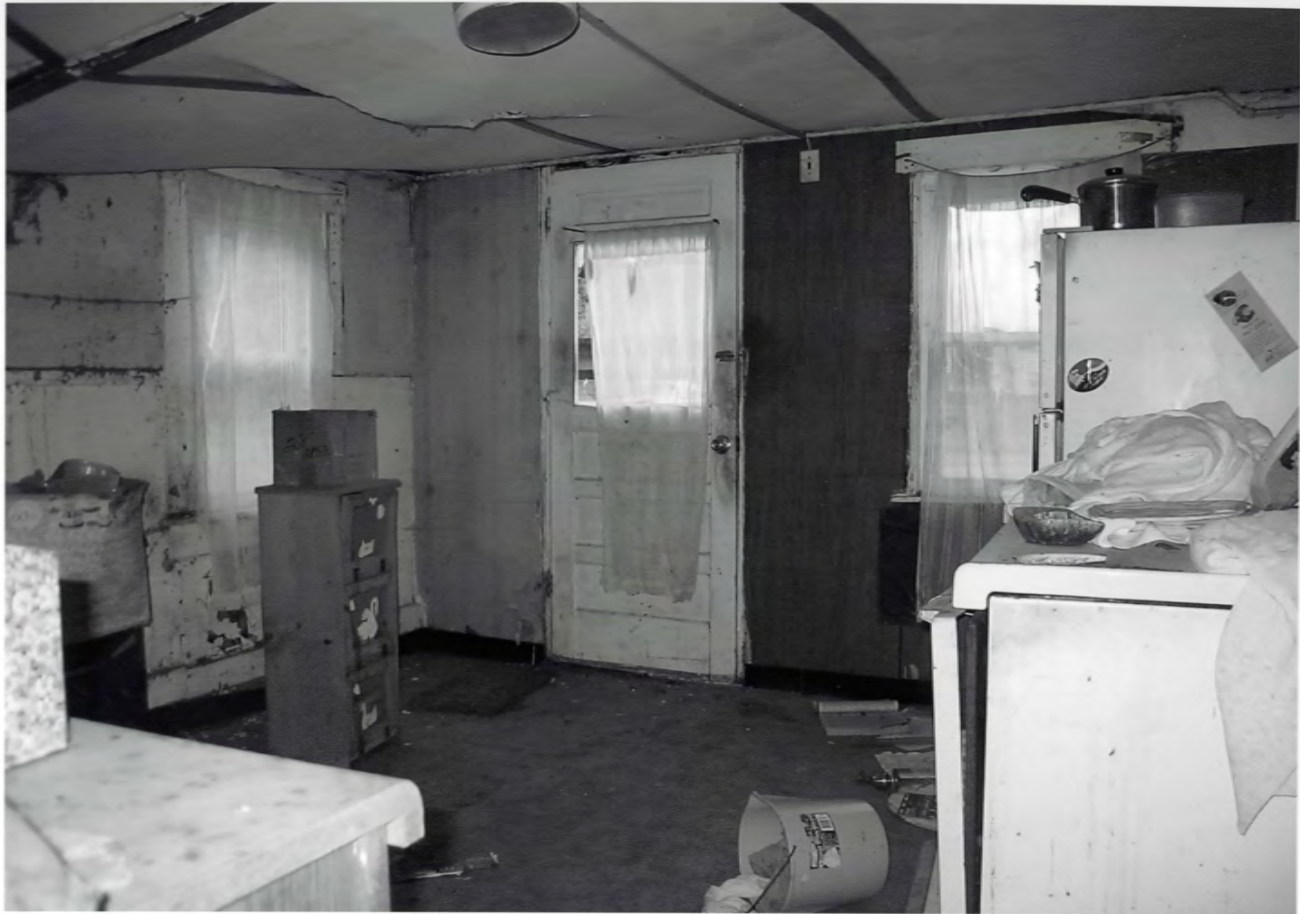
PHOTO 8: View of kitchen from west
