**National Register of Historic Places
Inventory—Nomination Form**

historic White Horse Pike Residential District

city, town Haddon Heights _____ vicinity of

state New Jersey code 034 county Camden code 007

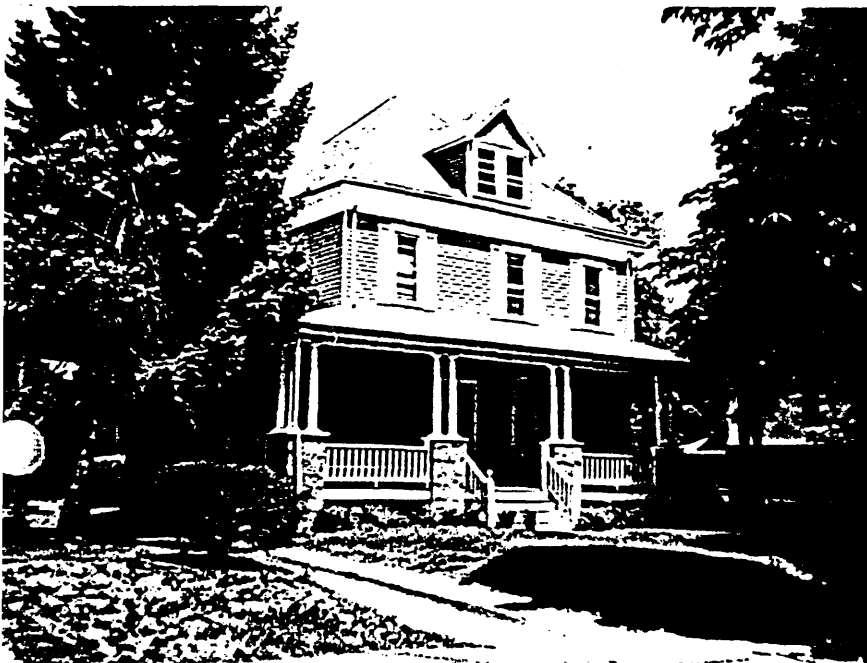
Negative File No. A-28 (E)

Construction Date: ca. 1907
 Architect:
 Style: Colonial Revival
 Number of Stories: 2.5
 Foundation: 36"; stone
 Exterior Wall Fabric: 1st floor- uncoursed stone; 2nd floor- synthetic siding
 Fenestration: 4 Bay; 1/1
 Roof/Chimneys: Cross gabled; slate/ rear chimney

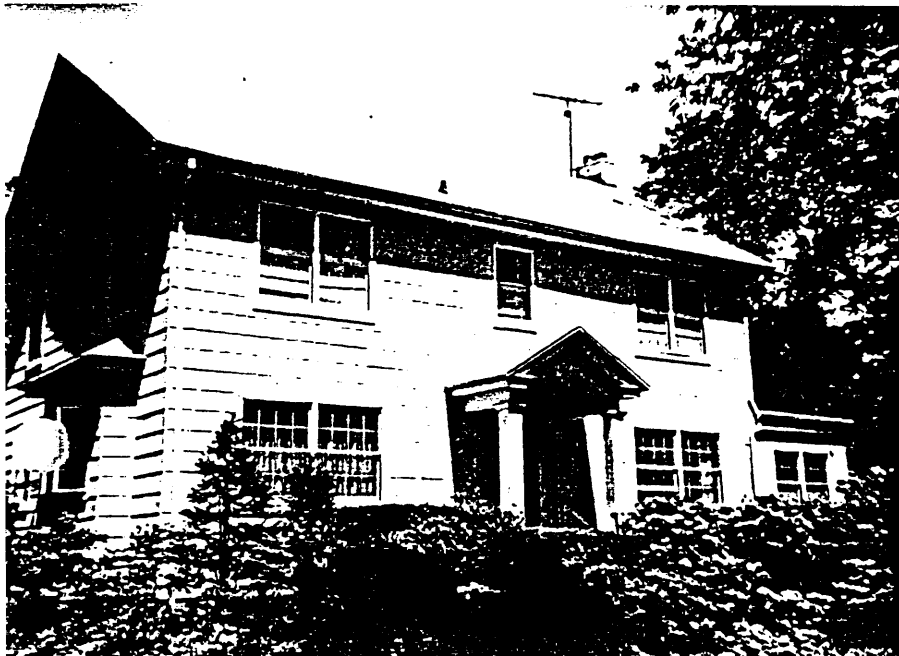
Negative File No. A30/e

Construction Date: 1922
 Architect:
 Style: Colonial Revival
 Number of Stories: 2
 Foundation: Concrete; 24"
 Exterior Wall Fabric: Synthetic siding
 Fenestration: 3 Bay; 8/8 (new)
 Roof/Chimneys: Gable; synthetic roof/ outside end chimney

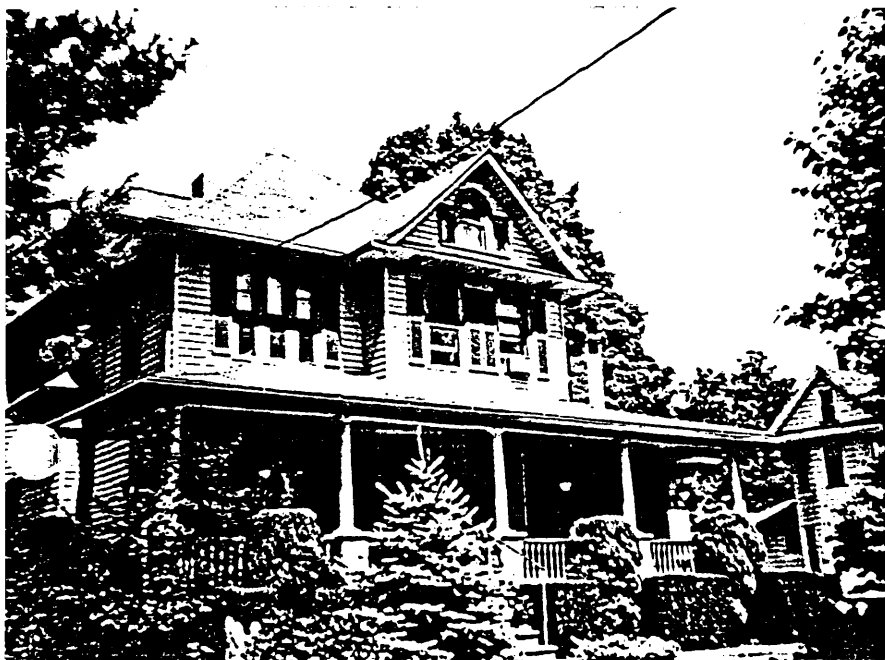
Negative File No. A-32 (E)

- Wraparound porch with Roman Doric columns on stone piers
- Classical doorway with stained glass lights
- Triple, narrow windows in 2nd floor side-roof dormers
- Palladian window on roof pediment
- Oriel window and stained glass windows in 1st floor bay of side and rear additions

2 track cement driveway to large wooden shed (shed may be original)
Stone wall on front of property

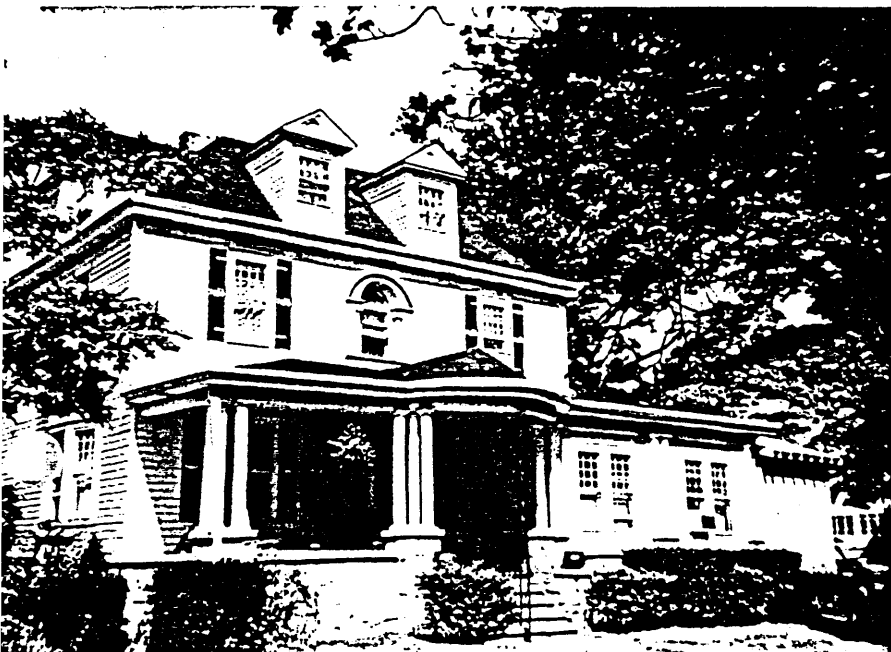
PHOTO Negative File No. A-34 (E)

Construction Date: ca. 1907
 Architect:
 Style: Colonial Revival
 Number of Stories: 2.5
 Foundation: Stone; 30"
 Exterior Wall Fabric: Synthetic siding
 Fenestration: 3 Bay; B/1
 Roof/Chimneys: Hipped; synthetic/ central chimney

Front porch with triple Roman Doric columns, partially enclosed
 Projecting circular portico with conical roof
 Recessed arched window on 2nd floor with elaborate trim
 Twin dormers on four sides of roof including columns
 Rear and side additions

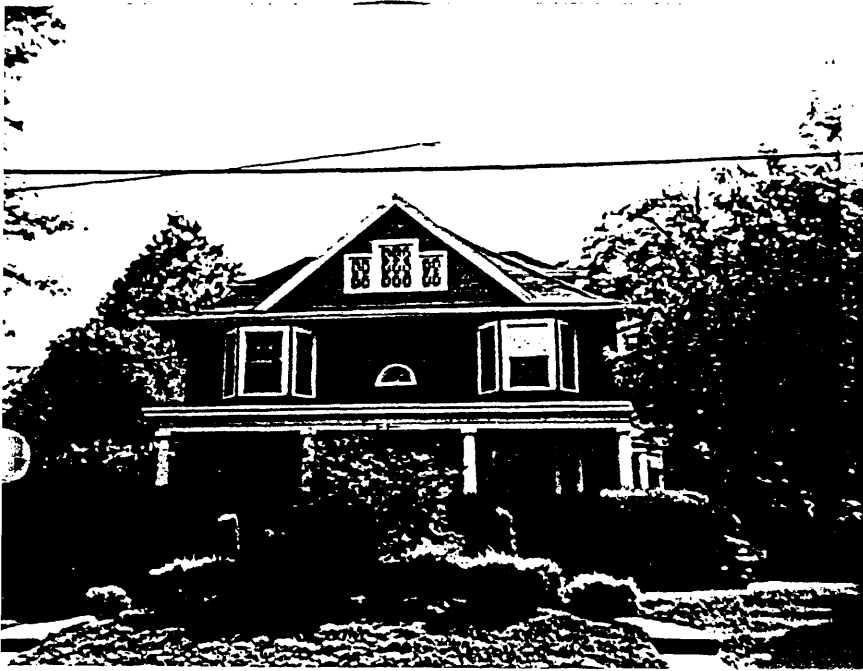
Negative File No. C-1 (W)

- Front porch with Doric columns on stone piers
- Classical doorway with stained glass side lights
- 2nd floor center fanlight flanked by two bays
- Palladian window in front gable end
- Rear addition
- Side bay windows and dormers; Windows on 1st floor appear altered

Garage
Horseshoe walkway to front

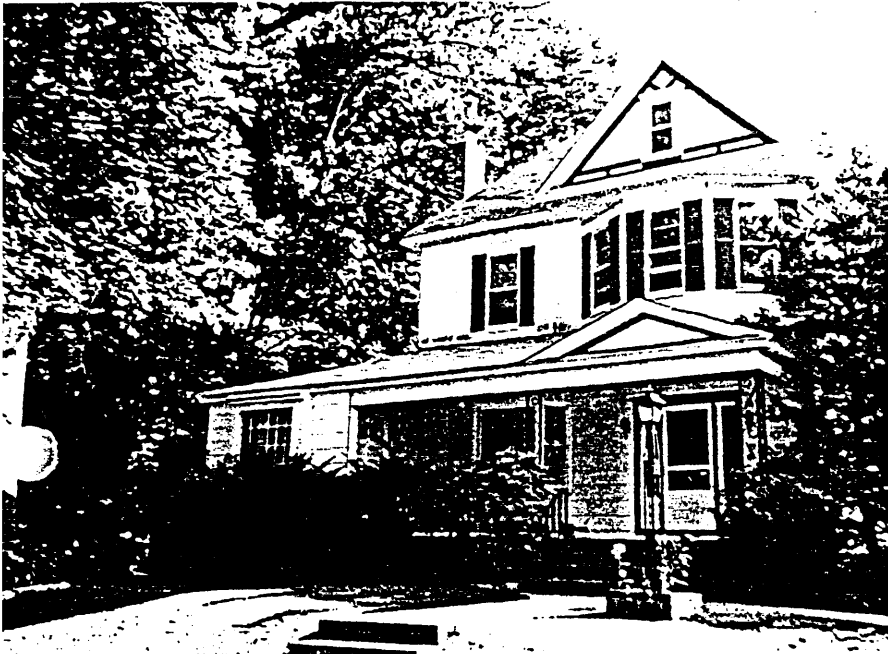
Negative File No. C-3 (W)

- Partially enclosed front porch with wrought iron supports
- Classical doorway with stained glass side lights
- Porch and roof pediments have stucco facade with wooden trim
- Second story front bay window
- Rear addition
- First floor windows altered

Two story garage

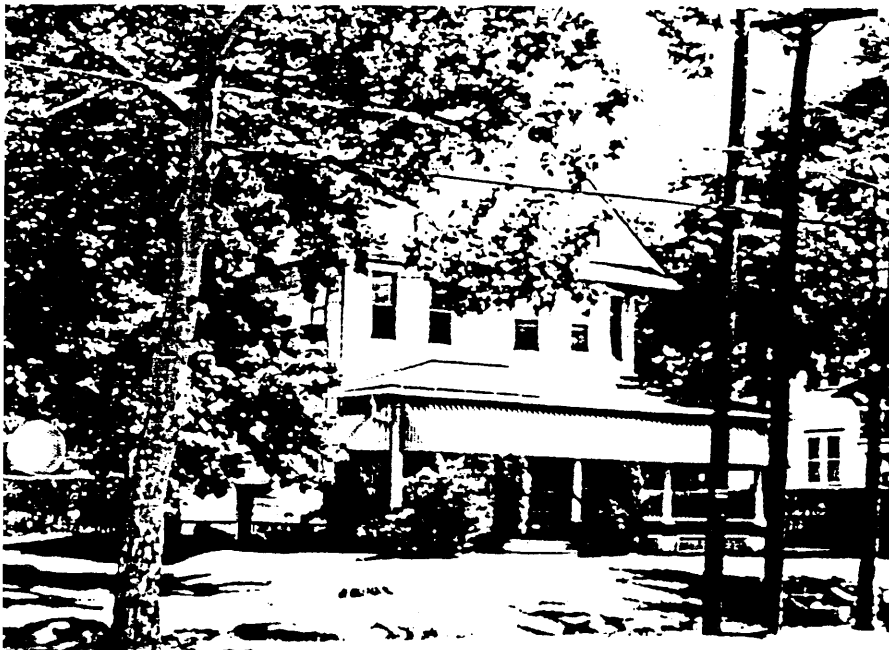
PHOTO Negative File No. DD-18/NE

Construction Date: 1906 Source of Date: Tax records and historic maps
 Architect: Builder:
 Style: Colonial Revival Form/Plan Type: Rectangle
 Number of Stories: 2.5
 Foundation: 18"; concrete
 Exterior Wall Fabric: Aluminum siding
 Fenestration: 3 bay; 1/1
 Roof/Chimneys: Hipped with intersecting gables; asphalt/ chimney not visible
 Additional Architectural Description:
 Wraparound front porch, aluminum awnings, Doric columns, balustrade
 2-story side bay
 Palladian window in offset front gable

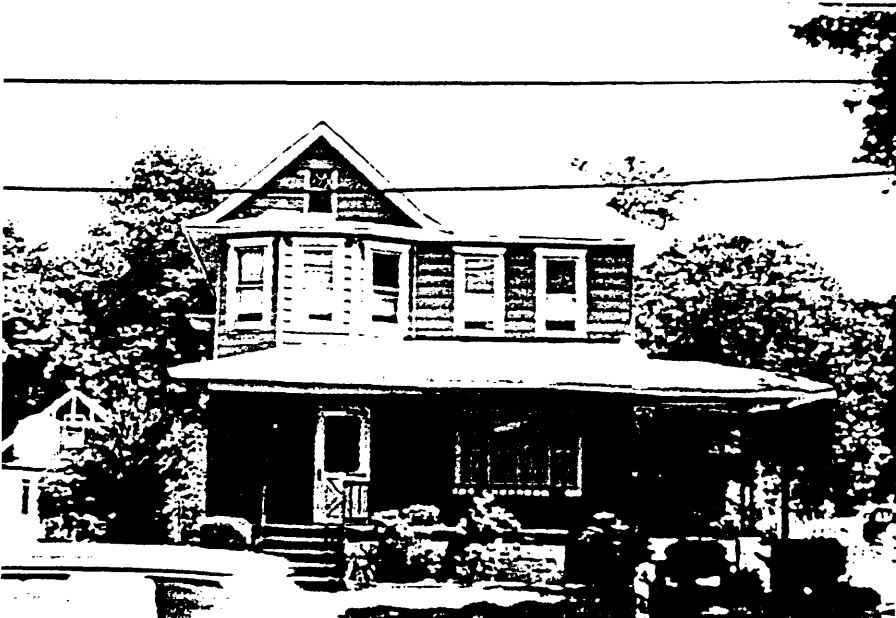
PHOTO Negative File No. DD-22/NE

Additional Architectural Description:
 Second floor bay
 Open front porch, wrought iron balustrade
 2-story side bay

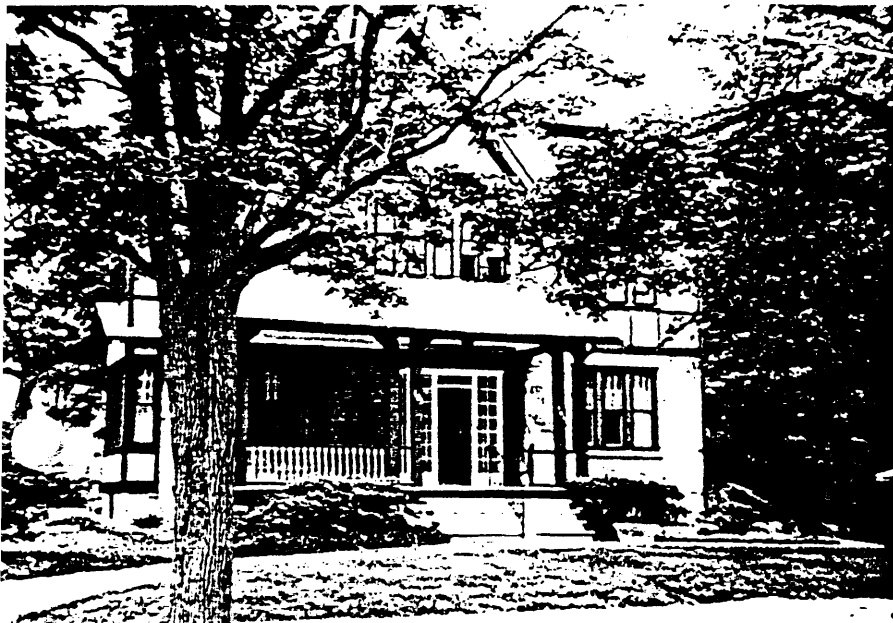
PHOTO Negative File No. B4/se

Front porch with paired post and spindled balustrade on stone piers
 High front gable dormer with eight multilight windows (some 6/6); intersects porch roof
 Side dormers
 Side bay window
 New rear addition

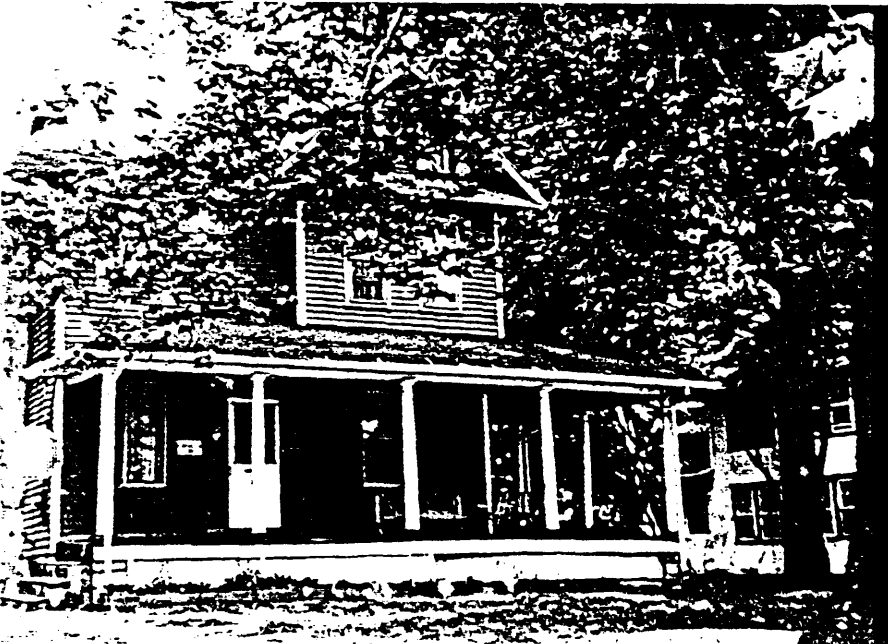
Negative File No. B9/se

2 door clapboard garage with hipped roof

ORIGINAL USE: Residential PRESENT USE: Residential
PHYSICAL CONDITION: Excellent X Good ___ Fair ___ Poor ___
REGISTER ELIGIBILITY: Yes X Possible ___ No ___ Part of District X
THREATS TO SITE: Roads ___ Development ___ Zoning ___ Deterioration ___
No Threat ___ Other ___

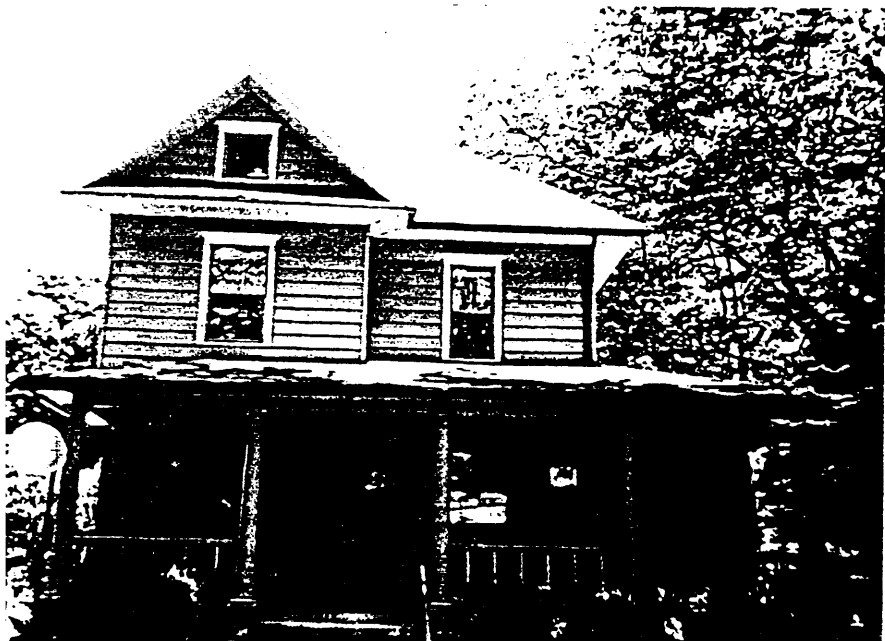
Negative File No. C-33 (E)

Construction Date: ca. 1910 Source of Date: Historic maps
 Architect: Builder:
 Style: Prairie Form/Plan Type: Square
 Number of Stories: 2.5
 Foundation: 22"; cement
 Exterior Wall Fabric: Synthetic siding
 Fenestration: 3 bay; 1/1
 Roof/Chimneys: Hipped; synthetic/ interior chimney

- Front porch with full length Roman Doric columns
- Classical doorway with stained glass side lights
- Bay window on the front of the first floor
- Projecting section with roof pediment on 2nd floor and on attic
- Rear 2nd floor porch over small addition

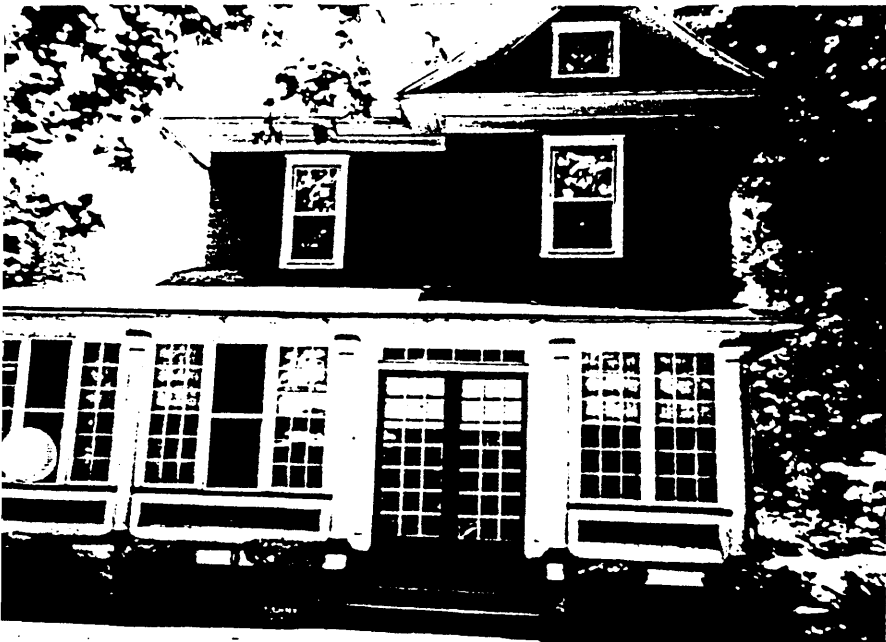
PHOTO Negative File No. C-36 (W)

Construction Date: ca. 1908	Source of Date: Historic maps
Architect:	Builder:
Style: Prairie	Form/Plan Type: Square
Number of Stories: 2.5	
Foundation: 34"; cement	
Exterior Wall Fabric: Wooden shingle	
Fenestration: 2 bay; 1/1	
Roof/Chimneys: Hipped; synthetic/ interior chimney

Additional Architectural Description:
 Enclosed front porch with 18 light windows and doors
 Projecting 2nd floor and attic level section with roof pediment
 Dormers with double windows on sides
 Rear addition

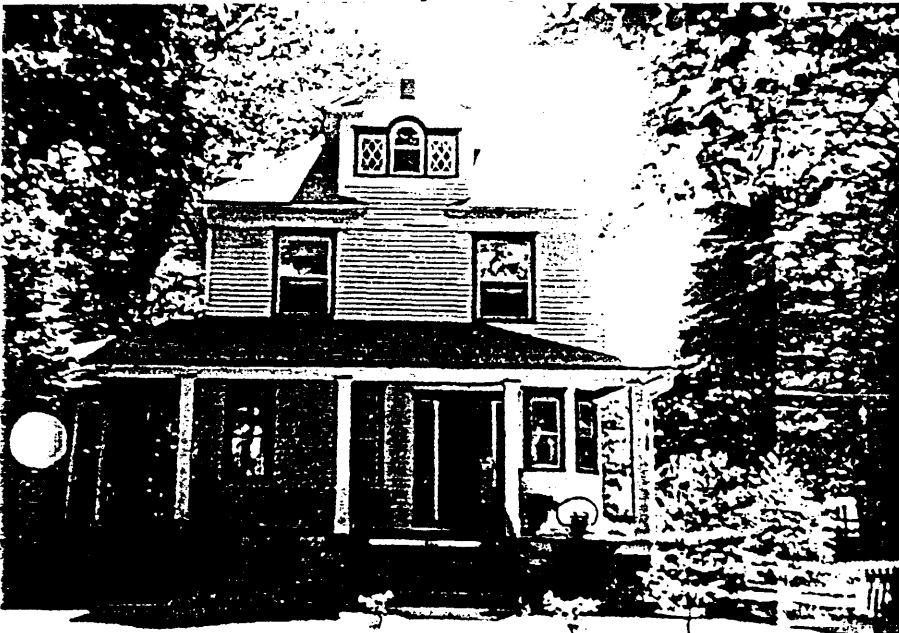
Negative File No. E-1 (W)

Construction Date: ca. 1908
 Architect:
 Style: Colonial Revival
 Number of Stories: 2.5
 Foundation: 36"; cement
 Exterior Wall Fabric: Wood siding
 Fenestration: 4 bay; 1/1
 Roof/Chimneys: Hipped asphalt/ center chimney

Wraparound porch with full length Roman Doric columns and new Roman Doric posts
 Classical doorway with leaded glass lights
 Pedimented front dormer with Palladian window over a broken cornice line
 Pedimented side dormers; Oriel window on right
 Back porch with columns, balustrade, and railing

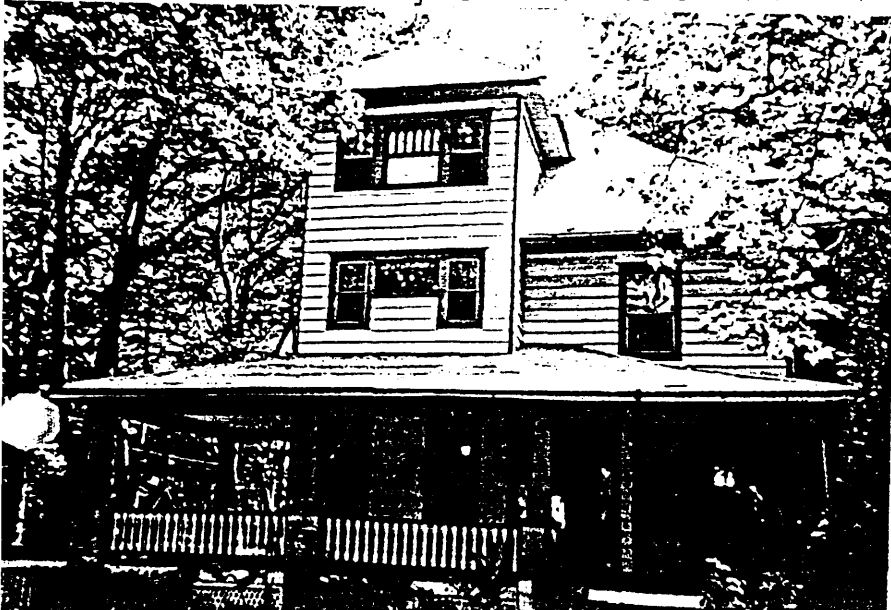
PHOTO Negative File No. E-2 (W)

Foundation: 34"; cement and stone

Wraparound porch with Roman Doric posts on stone piers
Classical doorway
Projecting bay on 2nd floor which extends through cornice line and
has a hipped roof and triple windows on each level
Rear facade has a full length extension

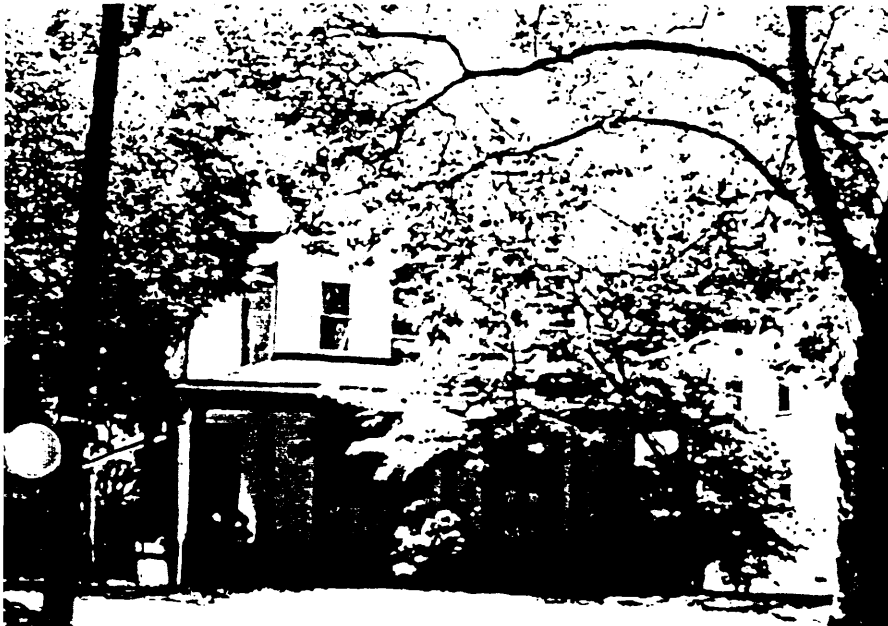
PHOTO Negative File No. CC-17/SW

Open wraparound front porch, Doric columns
Front gable over projecting second floor bay
2 side hipped dormers

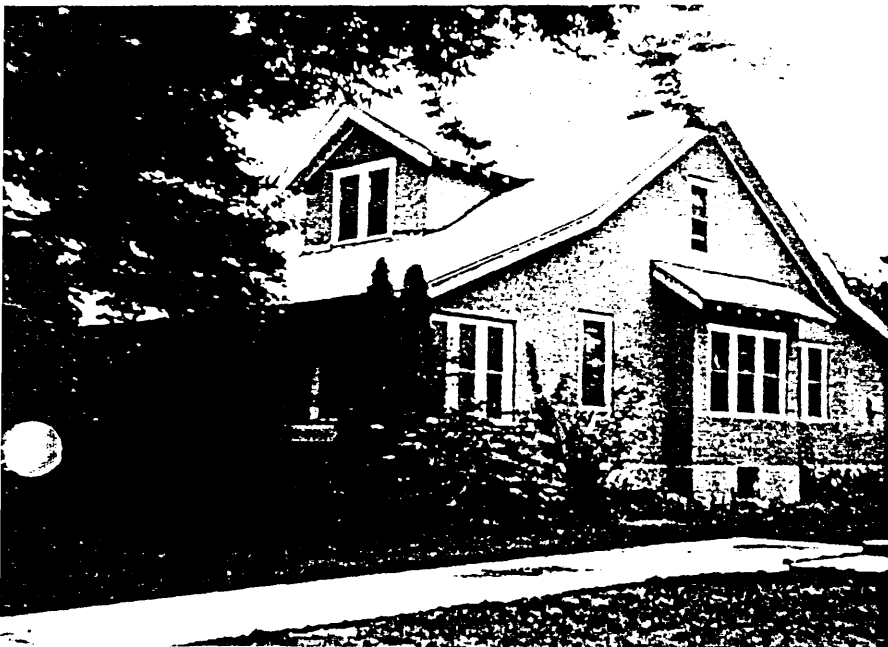
PHOTO Negative File No. B 15/ne

Additional Architectural Description:
Rear wing on right side
Front and rear dormers with double windows
Side bay window

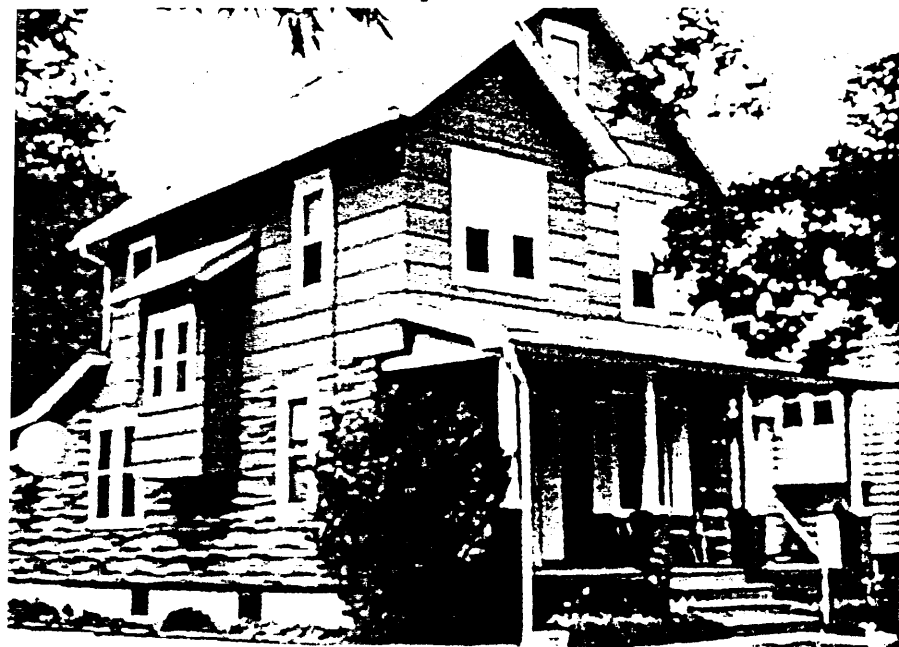
PHOTO Negative File No. B17/se

Construction Date: 1911 Source of Date: Tax records and historic records
Architect: Builder:
Style: Vernacular Queen Anne/Colonial Revival Form/Plan Type: Square
Number of Stories: 2.5
Foundation: 30" of concrete block
Exterior Wall Fabric: Synthetic siding
Fenestration: 2 bay; 1/1
Roof/Chimneys: Gable; synthetic/ center chimney
Additional Architectural Description:
Rear one story wing
Front porch with four unfluted columns on brick piers
Side bay window and oriel window
One roof dormer
One intersecting front gabled dormer (boxed in)
One window in front attic gable

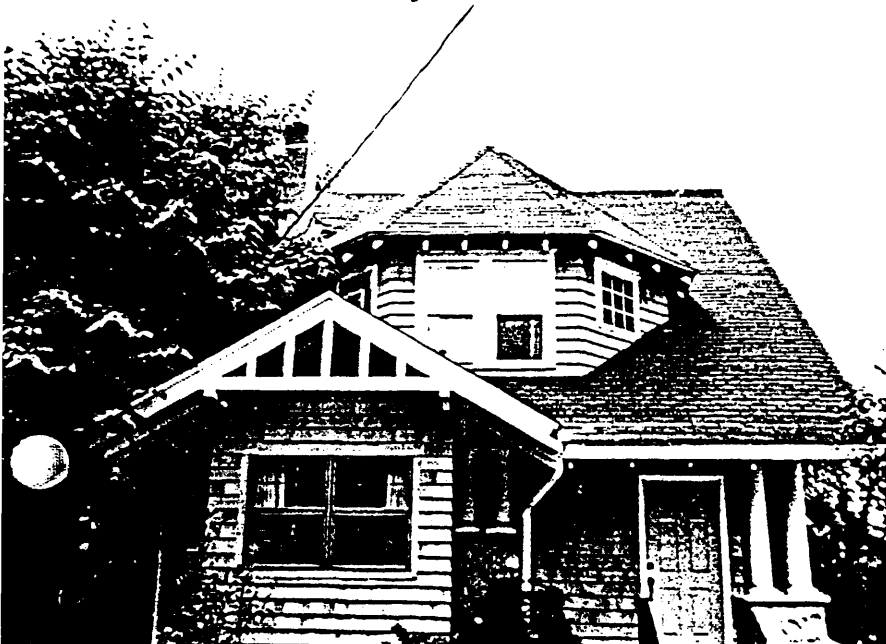
Negative File No. S-35 (W)

ORIGINAL USE: Residential PRESENT USE: Residential
PHYSICAL CONDITION: Excellent ___ Good X Fair ___ Poor ___
REGISTER ELIGIBILITY: Yes X Possible ___ No ___ Part of District X
THREATS TO SITE: Roads ___ Development X Zoning X Deterioration ___
No Threat ___ Other ___

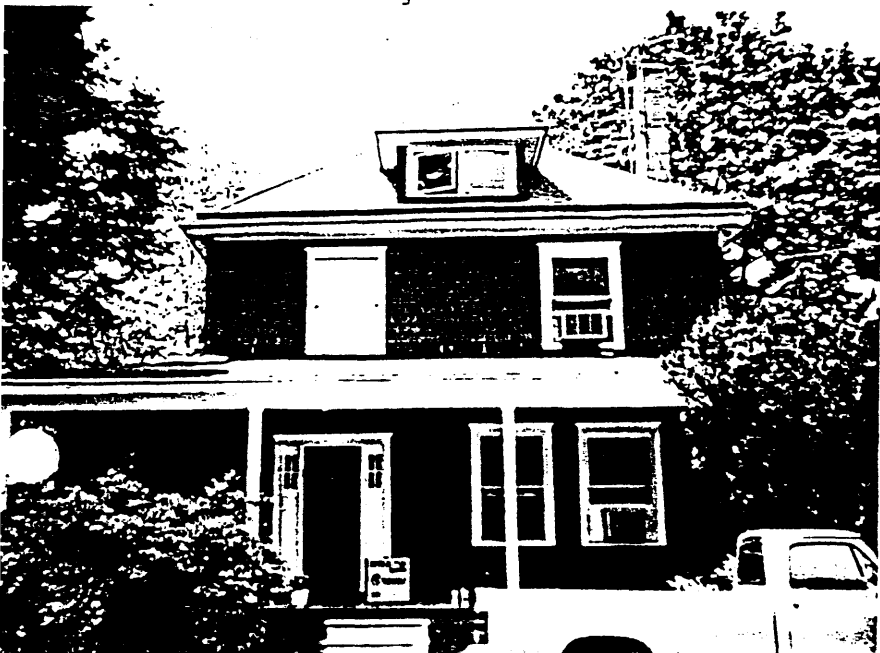
Negative File No. S-31 (W)

ORIGINAL USE: Residential PRESENT USE: Residential
PHYSICAL CONDITION: Excellent ___ Good X Fair ___ Poor ___
REGISTER ELIGIBILITY: Yes X Possible ___ No ___ Part of District X
THREATS TO SITE: Roads ___ Development X Zoning X Deterioration ___
No Threat ___ Other ___
