National Register of Historic Places  
Registration Form

historic name Winemiller Family Farm  
other names CARR-1684

street & number 1909 Francis Scott Key Highway (MD Route 194)  not for publication  
city or town Taneytown  vicinity  
state Maryland code MD county Carroll code 013 zip code 21757

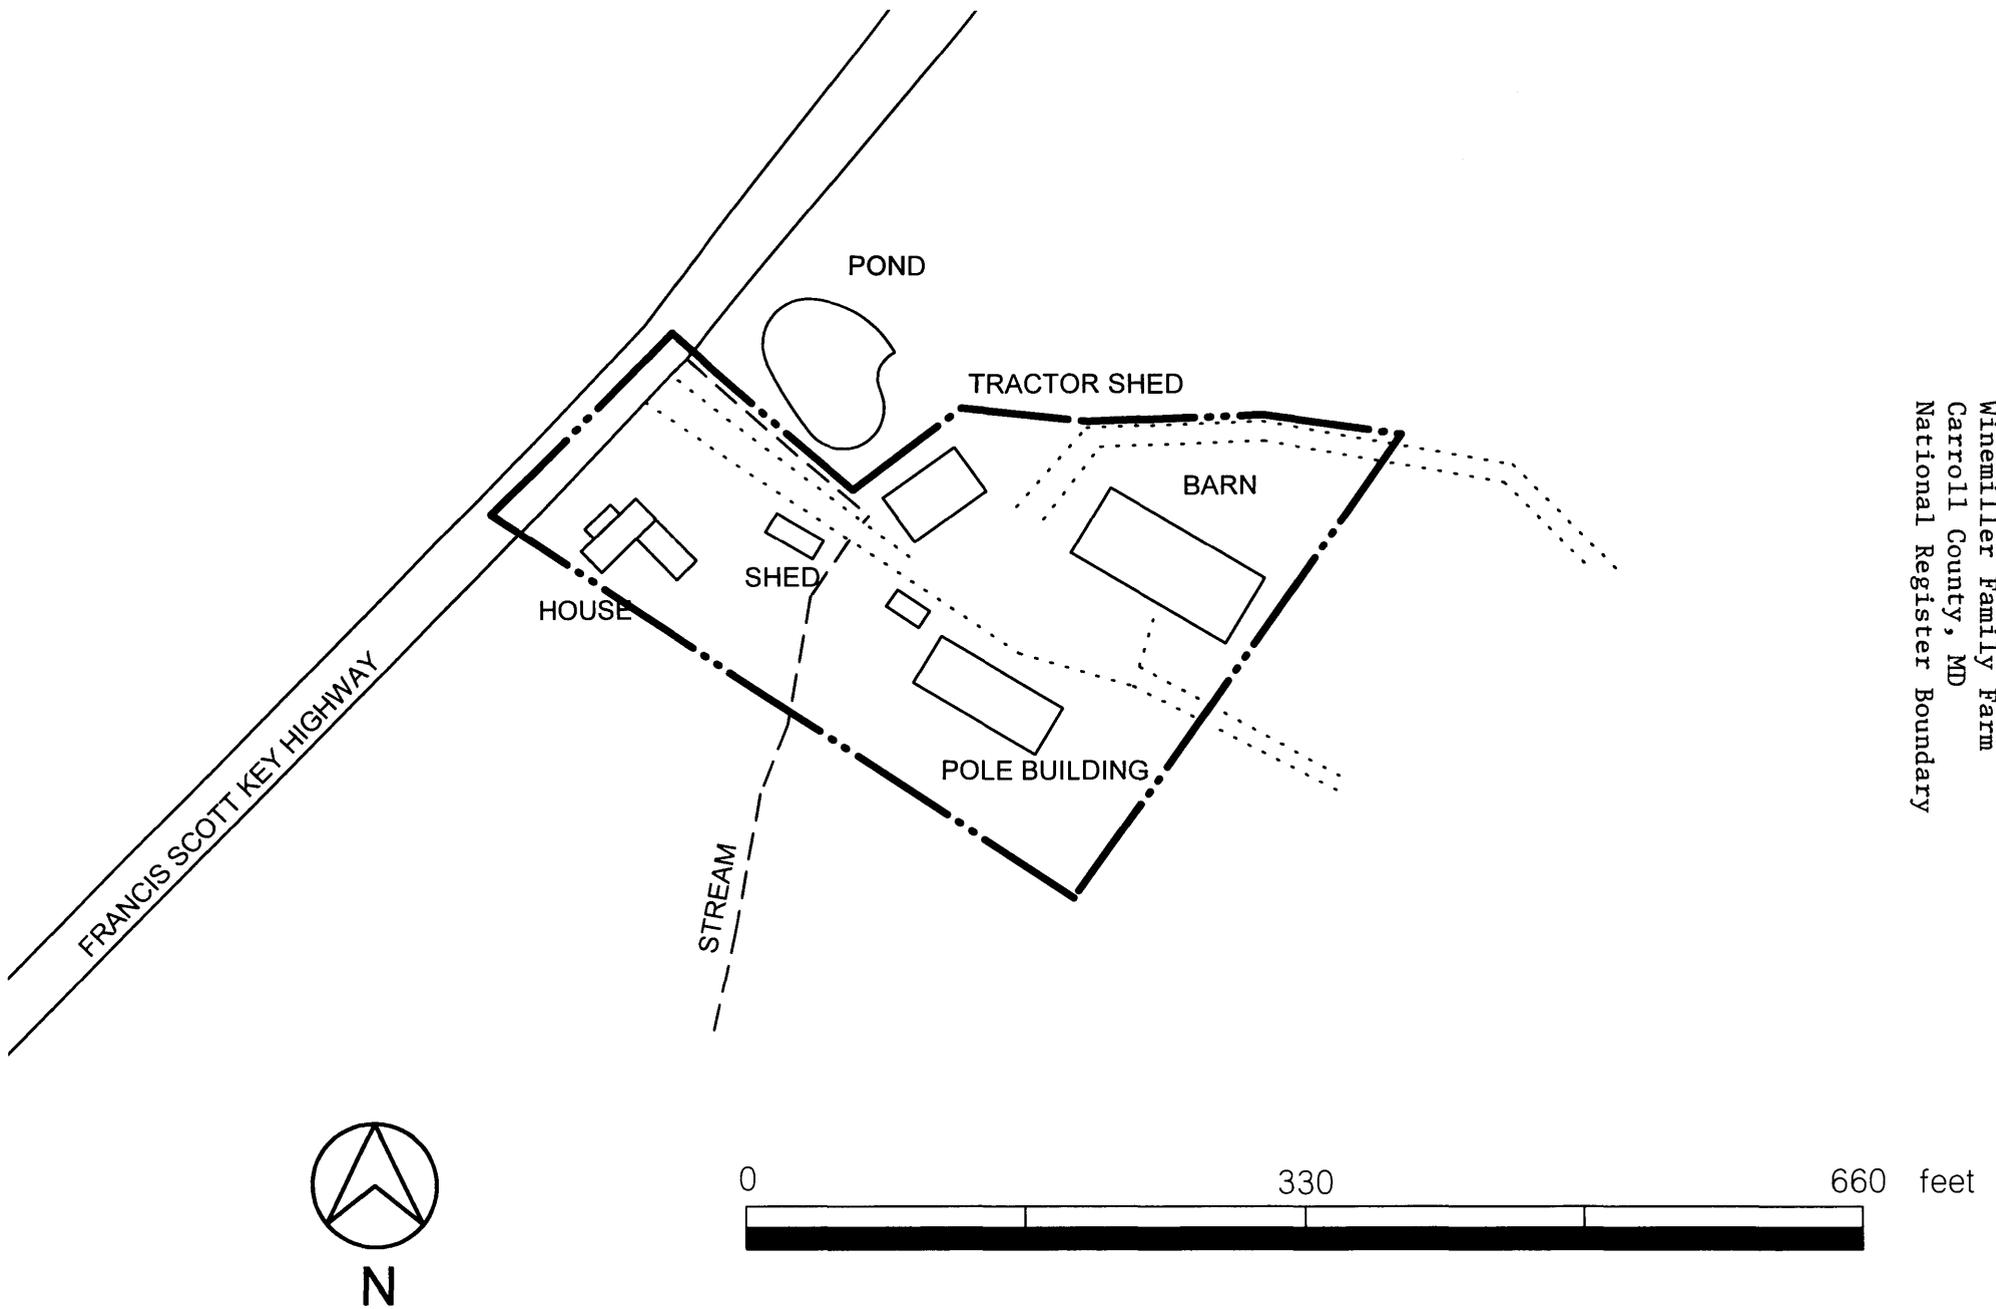
Winemiller Family Farm  
Carroll County, MD  
National Register Boundary

# WINEMILLER FAMILY FARM (CARR-1684) 1909 FRANCIS SCOTT KEY HWY

NATIONAL REGISTER BOUNDARIES - DRAWN BY KEN SHORT - BASED ON AERIAL PHOTOGRAPH

The nominated property, approximately 3 acres, encompasses all of the historic structures associated with the Winemiller Family Farm within an appropriate landscape setting.
