National Register of Historic Places Registration Form,

ories and subcategories from the instructions.	NAT PERIODE
1. Name of Property	NAT. REGISTER OF HISTORIC NATIONAL PARK SERVIC
Historic name: Downtown Guntersvil	lle Historic District
Other names/site number:	ite Historie District
Name of related multiple property listing:	
N/A	
(Enter "N/A" if property is not part of a multiple

2. Location	
Street & number: Gunter Ave., Blount Ave., Ri	ngold St., and Scott St
City or town: Guntersville State: AL	County: Marshall
Not For Publication: Vicinity:

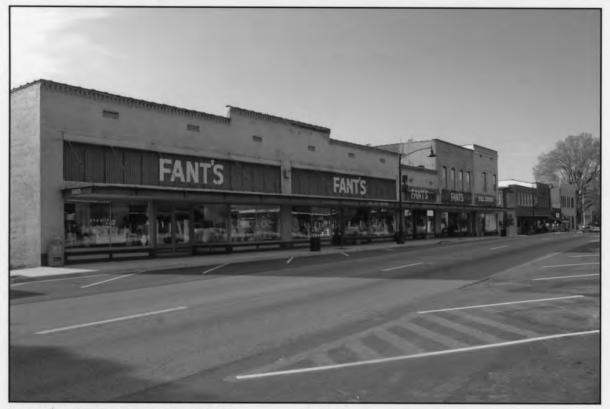
Photo #1 300 Block Gunter Avenue, streetscape, east side, camera facing south

aluminum 1/1 windows (ca. 1970) within segmental arched openings at the 2nd floor level; upper facade is painted brick veneer with a decorative raised brick panel with 2 decorative cast iron attic vents and a flat parapet cast cap; exposed brick side and real elevations set in common bond; continuous brick foundation. (Photos #1, #2, and #6, Streetscape)

Gunter Avenue, [381] 1935 ca. Contributing Two story masonry Early 20th Century Commercial style two-part commercial block form building with a flat roof concealed at its facade by a flat parapet; faces west, abuts an adjacent building to the south and is exposed along an alley to the north, 1-story extension along the rear elevation; modern replacement brick veneer storefront system (ca. 1985), 6 replacement aluminum 6/6 windows within rectangular openings at the 2nd floor level, similar windows at the north elevation; upper facade and north elevation are exposed brick veneer; exposed brick elevation set in common bond; continuous brick foundation. (Photos #1 and #6, Streetscape)

Gunter Avenue, 383 1930 ca. Contributing Two story masonry Early 20th Century Commercial style two-part commercial block form building with a flat roof concealed at its facade by a flat parapet and at its side by shaped parapets; faces west, abuts adjacent buildings to either side; modern replacement storefront system (ca. 1985) with continuous shed canopy, 6 single 1/1 windows within rectangular openings at the 2nd floor level; upper facade is exposed brick veneer; exposed brick veneer; continuous brick foundation. (Photos #1 and #6, Streetscape)

Gunter Avenue, 385 1925 ca. Noncontributing One story masonry Early 20th Century Commercial style one-part commercial block form building with a flat roof concealed at its facade by a flat parapet; faces west, abuts adjacent buildings to either side; modern replacement aluminum storefront system (ca. 1965) with continuous shed canopy (ca. 1985), lower facade is painted brick veneer; applied synthetic siding at the parapet (ca. 1985); continuous brick foundation. (Photos #1 and #6, Streetscape)

- 34 Bank of Guntersville 1905 Gunter Avenue, 395 Contributing Two story brick Folk Victorian style two-part commercial block form building with a flat roof concealed by flat parapets; faces west, abuts an adjacent building to the north and is exposed along Taylor Street to the south; cutaway corner to the southwest with a corner entrance within a trabeated stone surround with the word "Bank" incised in its entablature; replacement single, double, and triple windows within historic segmental arched openings at the three southern bays of the facade and at the south elevation, single pedestrian entrance within a round arched opening with a transom at the north bay of the facade, similar windows at the 2nd level, narrow paired doors within a segmental arched opening with an iron balconette above the main entrance; window openings have stone imposts and keystones; painted brick exterior walls with a recessed corbelled panel at the upper level above the main entrance; molded pressed metal cornice with modillions and finials along the facade and south parapets; continuous brick foundation. (Photo #7; Photos #1 and #6, Streetscape)

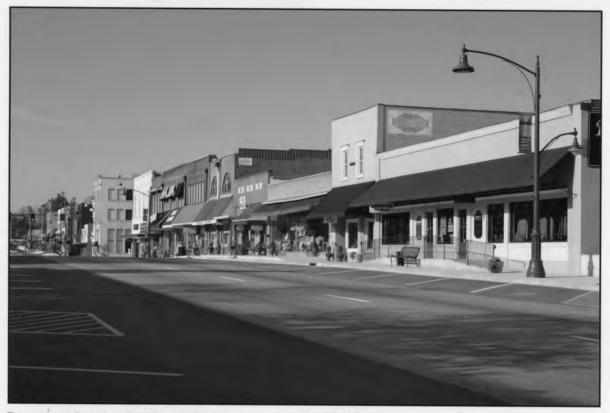
Photo #3 300 Block Gunter Avenue, streetscape, west side, camera facing southwest

Gunter Avenue, 352 1925 ca. Noncontributing Altered one story masonry one-part commercial block form building with a flat roof concealed by a flat parapet at its facade; faces east, abuts an adjacent building to the south and an open yard to the north; modern aluminum-framed storefront system; modern stucco finish at the facade (ca. 1990); foundation not visible. (Photos #3 and #5, Streetscape)

Gunter Avenue, 356 1940 ca. Noncontributing Altered two story masonry two-part commercial block form building with a flat roof concealed by a flat parapet at its facade; faces east, abuts adjacent buildings to either side; modern aluminum-framed storefront system at 1st floor with 2 replacement aluminum windows at the 2nd floor (ca. 1990); modern stucco finish at the facade (ca. 1990); foundation not visible. (Photos #3 and #5, Streetscape)

Gunter Avenue, 368 1955 ca. Contributing One story masonry one-part commercial block form building with a flat roof concealed by a flat parapet at its facade; faces east, abuts adjacent buildings to either side; two aluminum-framed storefront systems, each with a spayed recessed central entrance with a single door with transom flanked to either side by display windows on low brick veneer bulkheads, continuous canvas awning; exposed brick veneer at the facade with a cast parapet cap; concrete slab foundation. (Photos #3 and #5, Streetscape)

Two story masonry two-part commercial block form building with a flat roof concealed by a flat parapet at its facade; faces east, abuts adjacent buildings to either side; modern aluminum-framed storefront system with a continuous pent awning (ca. 1975); 2nd floor has two oversized segmental arched openings each with a double 1/1 window; exposed brick veneer at the facade with a clay tile parapet cap; continuous brick foundation. (Photos #3 and #5, Streetscape)

Two story masonry two-part commercial block form building with a flat roof concealed by a flat parapet at its facade; faces east, abuts adjacent buildings to either side; modern aluminum-framed storefront system with a continuous pent awning (ca. 1975); 7 single 4/1 windows at the 2nd floor; exposed brick veneer at the facade with decorative patterned brick work; continuous brick foundation. (Photos #3 and 5, Streetscape)

Gunter Avenue, 382 1925 ca. Contributing Two story masonry two-part commercial block form building with a flat roof concealed by a flat parapet at its facade; faces east, abuts adjacent buildings to either side; two modern aluminum-framed storefront systems (ca. 1965) with a continuous pent awning (ca. 1985); 3 pairs of single windows at the 2nd floor, all windows are infilled and have shed awnings (ca. 1985); exposed brick veneer at the facade with decorative patterned brick work; continuous brick foundation. (Photos #3 and #5, Streetscape)

Gunter Avenue, 384 1925 ca. Contributing Two story masonry two-part commercial block form building with a flat roof concealed by a flat parapet at its facade; faces east, abuts adjacent buildings to either side; modern aluminum-framed storefront system (ca. 1970) with a continuous pent awning (ca. 1985); single windows within segmental arched openings at the 2nd floor, all windows have been infilled (ca. 1985), modern shed canopies extends across the outer 2 windows (ca. 1985); exposed brick veneer at the facade with a corbelled parapet cap; continuous brick foundation. (Photos #3 and #5, Streetscape)

Gunter Avenue, 390 1910 ca. Contributing Two story masonry two-part commercial block form building with a flat roof concealed by a flat parapet at its facade; faces east, abuts an adjacent buildings to the north and an open lot to the south; 2 modern aluminum-framed storefront systems (ca. 1975) with a continuous flat awning below a transom concealed behind a metal panel (ca. 1975)); 4 single synthetic replacement windows (c1. 2000) within segmental arched openings at the 2nd floor; painted brick veneer at the facade with a corbelled parapet cap and decorative brick window hoods; continuous brick foundation. (Photos #3 and #5, Streetscape)

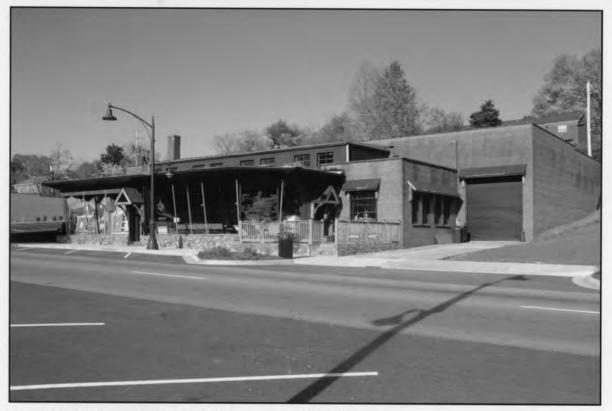
Photo #4
Resource #16, streetscape, east side, camera facing northwest

One story masonry Early 20th Century Commercial style commercial building with a flat roof; faces east, freestanding, rectangular core with a split level rectangular projection centered at its facade from which projects a glazed pavilion with cutaway corners; pavilion has angled aluminum window walls atop a low brick bulkhead, rear sections are brick veneer with steel industrial windows, garage entrance at the north bay of the core; concrete slab foundation. (Photo #4)

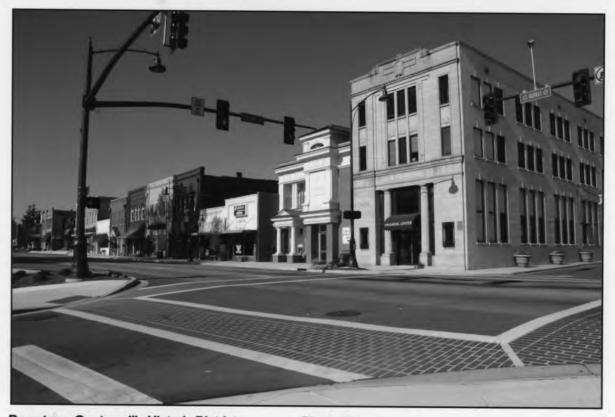
Photo #8 400 Block Gunter Avenue, streetscape, west side, camera facing southwest

either side by single windows, 6 sets of triple fixed windows at the north elevation, similar triple lower-height windows at the center bays of the facade and north elevation at the 2nd and 3rd levels with single windows at the outer bays of the 2nd and 3rd level of the facade; decorative panel centered at the facade parapet; exposed stone veneer exterior walls and foundation. (Photos #8 and #10, Streetscape)

Gunter Avenue, [406] 1915 ca. Contributing One story masonry Folk Victorian style one-part commercial block form building with a flat roof concealed by a flat parapet at its facade; faces east, abuts adjacent buildings to either side; modern replacement storefront system (ca. 1975) with a continuous suspended flat aluminum canopy; painted brick veneer facade with corbelled brick cornice; continuous brick foundation. (Photos #8, #9, and #10, Streetscape)

Gunter Avenue, 408 1910 ca. Contributing One story masonry Folk Victorian style one-part commercial block form building with a flat roof concealed by a flat parapet at its facade; faces east, abuts adjacent buildings to either side; modern replacement storefront system (ca. 1975) with a continuous suspended flat aluminum canopy; painted brick veneer facade with corbelled brick cornice; continuous brick foundation. (Photos #8, #9, and #10, Streetscape)

Gunter Avenue, 412 1890 ca. Contributing Two story masonry Folk Victorian style two-part commercial block form building with a flat roof concealed by a flat parapet at its facade; faces east, abuts adjacent buildings to either side, two interior units now under separate ownership; replacement storefront at the southern unit (ca. 1995) flanked to the south by a pedestrian entrance in a round arched opening, similar opening at a hyphen between the 2 units flanked to the north by a fixed window, an entrance and a fixed window, 4 single 1/1 windows grouped at each unit at the 2nd level separated by a similar single window; painted brick veneer facade with corbelled cornice; continuous brick foundation. (Photos #8, #9, and #10, Streetscape)

Gunter Avenue, 414 1890 ca. Contributing Two story masonry Romanesque Revival style two-part commercial block form building with a flat roof concealed by a flat parapet at its facade; faces east, abuts adjacent buildings to either side; replacement storefront with continuous fixed awning (ca. 1975); single 1/1 windows within arched openings at the 2nd level; painted brick veneer facade with corbelled cornice and continuous archivolt band above the 2nd floor windows; continuous brick foundation. (Photos #8, #9, and #10, Streetscape)

Two story masonry two-part commercial block form building with a flat roof concealed by a flat parapet at its facade; faces east, abuts adjacent buildings to either side; central entrance at the facade with a modern pedimented surround (ca. 1980) flanked to either side by single 12-light fixed replacement windows (ca. 1980), single 6/6 replacement windows at the 2nd level; painted brick veneer facade; continuous brick foundation. (Photos #8, #9, and #10, Streetscape)

One story masonry one-part commercial block form building with a flat roof concealed by a flat parapet at its facade; faces east, abuts adjacent buildings to either side; modern replacement storefront system (ca. 1980) with a continuous canvas barrel awning; painted brick veneer facade with decorative patterned brickwork; continuous brick foundation. (Photos #8, #9, and #10, Streetscape)

Two story brick Folk Victorian style two-part commercial block form building with a flat roof concealed by a flat parapet at its facade and stepped parapets at its sides; faces east, abuts adjacent buildings to either side, appears to have been a 4-bay wide core with a 4-bay wide historic addition; 2 modern storefront systems with pent roofs (ca. 1990); replacement fixed glass windows at the 8 bays of the upper level; painted brick veneer exterior walls with a decorative corbelled parapet cap; continuous brick foundation. (Photos #8, #9, and #10, Streetscape)

exposed brick set in common bond at the side elevations; continuous stone foundation. (Photo #11; Photos #8 and #9, Streetscape)

Gunter Avenue, 460 1910 ca. Contributing Two story brick Folk Victorian style two-part commercial block form building with a flat roof concealed by flat parapets; faces east, abuts an adjacent building to the north and is exposed along Worth Street to the south; cutaway corner to the southeast with a corner entrance within a round arched opening with a prominent keystone; 2 historic storefront systems to the north with a canvas awning at the northern system; replacement fixed glass windows at the 7 bays of the upper level each within a flat opening with stone lintels and sills, similar windows at the south elevation with those at the lower level now infilled; exposed brick veneer exterior walls with a thin corbelled band below the parapet and corner and intermediate pilasters that rise slightly above the parapet, stone inset at the parapet above the entrance reads "Bank," continuous brick foundation. (Photo #12; Photos #8 and #9, Streetscape)

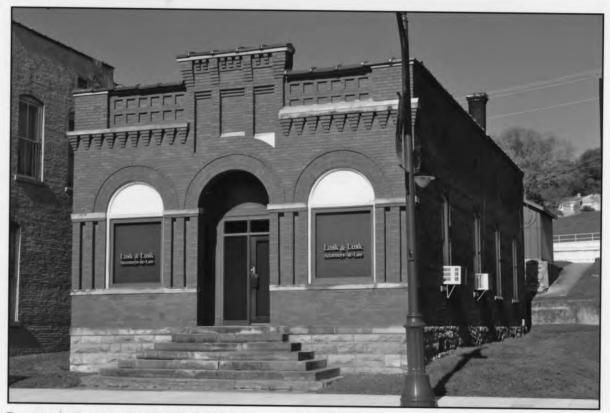
Photo #11 Lusk Law Office (Resource #46), camera facing west

46 Lusk Law Office Gunter Avenue, 452 1895 Contributing One story brick Romanesque Revival style one-part commercial block form building with a flat roof concealed by a stepped parapet at its facade and flat parapets at its sides; faces east, freestanding, 3x4 bay core; central entrance at the facade recessed within a round arched opening flanked to either side by a single fixed replacement window within a round arched opening with blind transom; single 1/1 windows within segmental arched openings at the side elevations; exposed brick veneer at the facade with an elaborate corbelled parapet,

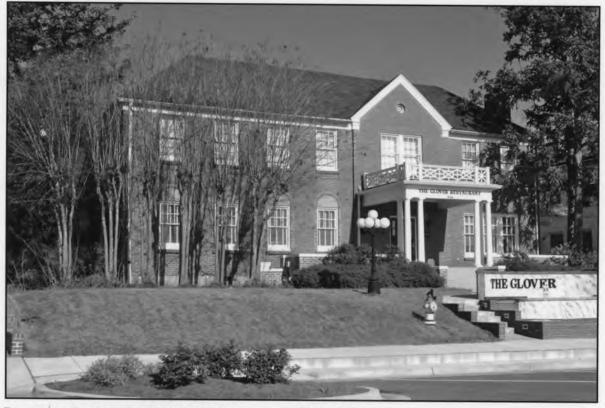
Photo #15
Glover Hotel (Resource #55), camera facing west
Image: AL_MarshallCo_DowntownGuntersvilleHD_0015.tif
Print: Epson Ultrachrome Ink on Premium Glossy Photo Paper

supported by paired columns and with a Chippendale railing along its top; off-center entrance at the facade flanked to the north by a tripartite picture window and to the south by 3 6/6 windows in round arched openings, a similar double window is centered at the 2nd level above the entrance and is flanked by similar single windows, similar single and double windows at the side elevations; exposed brick veneer exterior walls; continuous concrete foundation. (Photo #15; Photo #14, Streetscape)

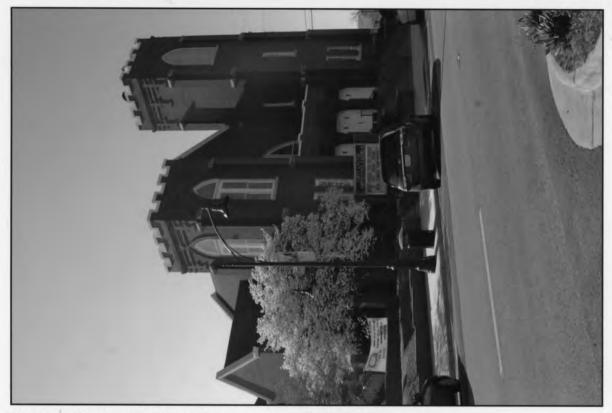
Photo #17
First United Methodist Church (Resource #17),
camera facing south

level of the southwest tower with a pointed arched bell screen at the 3rd level, single, double and triple 1/1 windows at the 1st floor of the side elevations, large pointed arched stained glass windows centered at the side elevations; exposed brick veneer exterior walls and foundation. (Photo #17; Photo #18, Steeetscape)

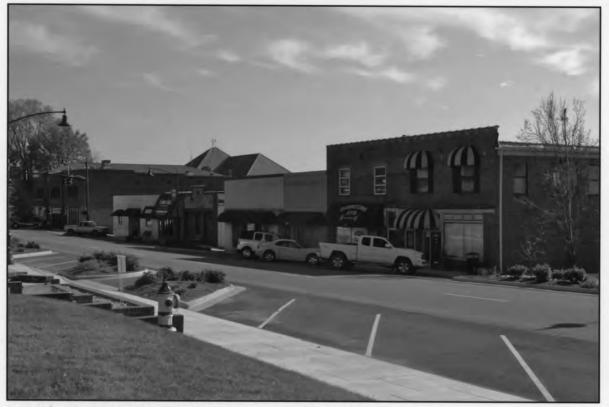
Photo #19 500 Block Gunter Avenue, streetscape, east side, camera facing east

Two story masonry two-part commercial block form building with a flat roof concealed by flat parapets; faces west, freestanding, 3 interior retail units at the 1st floor; replacement storefront systems at each unit (ca. 1980), 3 sets of 5 grouped 6/6 windows at the 2nd level separated by single 6/6 windows, similar triple windows at the side elevations; exposed brick exterior walls set in common bond, decorative brick band at the parapet above round attic vents, cast parapet cap; continuous brick foundation. (Photo #19, Streetscape)

One story masonry one-part commercial block form building with a flat roof concealed by flat parapets; faces west, abuts an adjacent building to the south and is exposed along Worth Street to the north; recessed central bay entrance at the facade with an entrance at its north end and a fixed aluminum display window at its south end, flanked to either side by triple sliding aluminum windows, all openings with shed canvas awnings; exposed white glazed brick veneer at the facade with patterned brickwork at the center bay, painted synthetic stone at the side elevation; concrete slab foundation. (Photos #19, 20 and 20, Streetscape)

Gunter Avenue, 505 1964 ca. Noncontributing Altered one story masonry one-part commercial block form building with a flat roof concealed by a flat parapet at its facade; faces west, abuts adjacent buildings to either side; entrance at the south bay of the facade flanked to the north by 2 fixed replacement windows, continuous canvas awning over a modern pent roof (ca. 1995) across the storefront; stone veneer at the facade; concrete slab foundation. (Photo #19, Streetscape)

Gunter Avenue, 507 1940 ca. Contributing One story masonry one-part commercial block form building with a front-gable composition shingle roof concealed by a stepped parapet at its facade; faces west, abuts an adjacent building to the north and is exposed along an alley to the south; recessed entrance at the south bay of the facade flanked to the north by 2 double 9/9 replacement windows; exposed rubble stone facade with brick veneer trim, painted concrete block side and rear elevations; concrete slab foundation. (Photo #19, Streetscape)

One story masonry one-part commercial block form building with a flat roof concealed by a flat parapet at its facade and stepped parapets at its side elevations; faces west, abuts an adjacent building to the south and is exposed along an alley to the north; entrance at the south bay of the facade flanked to the north by an aluminum framed storefront window, continuous canvas awning across the storefront; painted stucco facade, painted concrete block side and rear elevations; concrete slab foundation. (Photos #18 and #19, Streetscape)

Gunter Avenue, 513 1955 ca. Contributing One story masonry one-part commercial block form building with a flat roof concealed by a flat parapet at its facade; faces west, abuts adjacent buildings to either side; entrance at the north bay of the facade flanked to the south by an oversized glass block window, continuous canvas awning across the storefront; painted stucco facade with decorative band at the base of its parapet; concrete slab foundation. (Photos #18 and #19, Streetscape)

Gunter Avenue, 515 1940 ca. Contributing Two story masonry two-part commercial block form building with a flat roof concealed by a flat parapet at its facade; faces west, abuts an adjacent building to the north and an open lot to the south, two interior units now under separate ownership; replacement storefront systems at each unit (ca. 1975) replacement synthetic 1/1 windows with barrel canvas awnings at the 2nd floor of the south unit and replacement 1/1/1 awning windows at the northern unit; exposed brick veneer facade with cast insets; concrete slab foundation. (Photos #18 and #19, Streetscape)

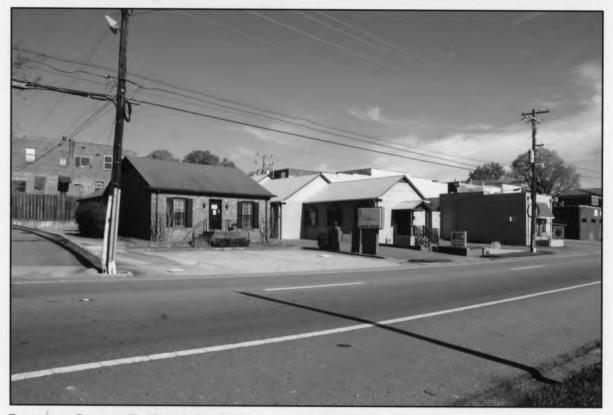
Photo #21 500 Block Blount Avenue, streetscape, west side, camera facing north

One story brick veneer former telephone exchange building with a front-facing gable industrial metal roof; faces east, 1x3 bay core with a large rear gable addition (ca. 1985); entrance by gable portico (ca. 1985); 3 single windows added at the south elevation (ca. 1985); painted brick veneer exterior walls; foundation not visible. (Photo #21, Streetscape)

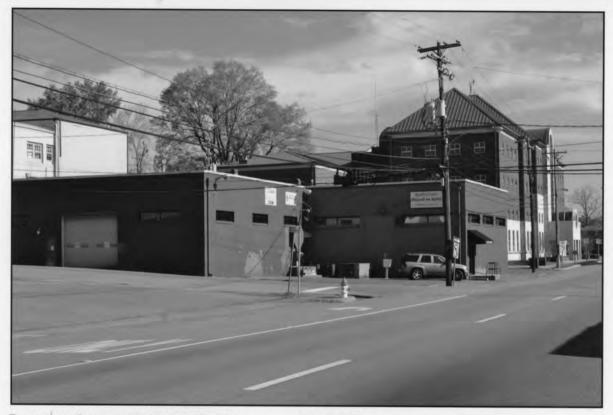
Photo #22 400 Block Blount Avenue, streetscape, west side, camera facing north

One story masonry commercial building with a flat roof concealed by flat parapets; faces east, freestanding, 6x3 bay core with a 3x3 bay wing at the north side of its east elevation; most openings blocked down with modern replacement windows; painted brick veneer exterior walls; foundation not visible. (Photo #22, Streetscape)

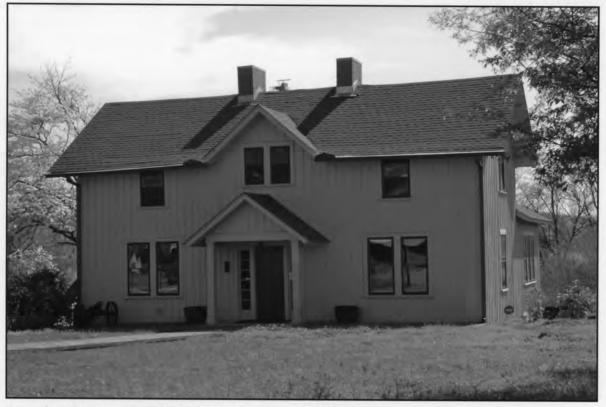
Photo #24 Gilbreath, Col. Montgomery, House (Resource #10), camera facing east

Two story frame dwelling with a cross gable composition shingle roof; faces west, rectangular 3x1 bay core with a rear 1-story gable wing to the south; entrance bay gable porch with a wood posts; central entrance at the facade with sidelights flanked by double 1/1 windows, double 1/1 window at the 2nd floor above the porch flanked by similar single windows, single and double windows at the side elevations; board & batten siding; continuous brick foundation. (Photo #24)

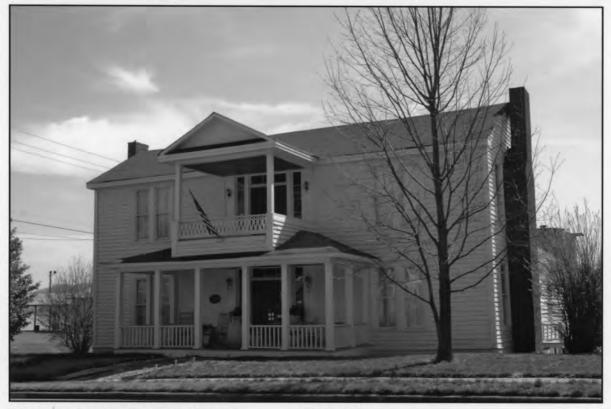
Photo #27 Henry-Jordan House (Resource #1), camera facing southeast

- 1 Henry-Jordan House Blount Avenue, 301 1875 ca. Contributing Two story frame I-house form dwelling with a side gable composition shingle roof; 3x1 bay core 1-story gable wing at its southern bay; less than full facade hipped porch with a pedimented gable balcony (ca. 1890); central entrance at the facade with transom and sidelights flanked to either side by double 2/2 windows, similar openings at the 2nd floor, similar single and double windows at the side elevations; plain weatherboard siding; continuous brick foundation; frame garage to rear. Individually listed in the NR (1979). (Photo #27)
