United States Department of the Interior
National Park Service
**National Register of Historic Places
Registration Form**

historic name MILNER-SCHWARZ HOUSE
other names/site number 5LR.6744

street & number 710 SOUTH RAILROAD AVENUE
city or town LOVELAND
state COLORADO code CO county LARIMER code 069 zip code 80537

Milner-Schwarz House, circa 1873, photos 1-28

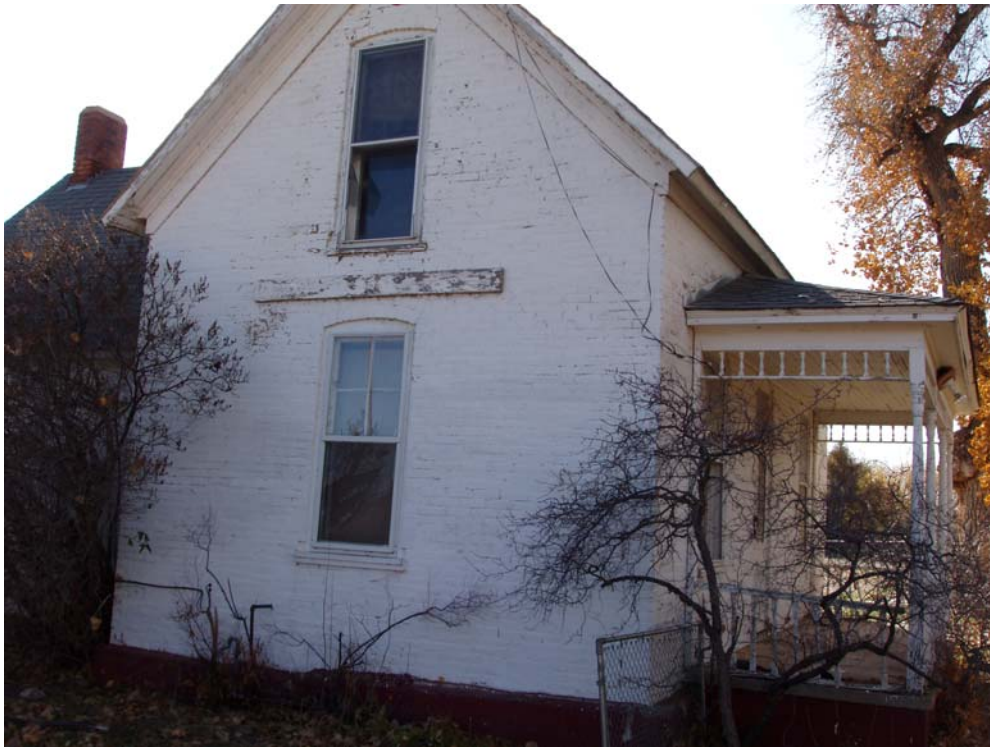
Fig. 6 2009 Southwest (main) Façade, prior to restoration

The house's main entry is found on the southwest-facing side which overlooks a newly installed small concrete plaza, and the enclosed community gardens. The entry features a front porch with wood lattice at the base, railings with decorative turned balusters and turned columns, and a hipped porch roof with a spindle frieze. The railing and balusters enclose the porch on all sides with an opening at the stairs to exit the porch. The ceiling is painted, beaded wood siding. A non-historic five-panel solid wood entry door with an upper light is centered on the façade and is topped with a transom light, beneath a double rowlock segmental brick arch header, and is flanked by two four-over-four double-hung sash windows with painted wood frames and surrounds with double rowlock segmental brick arch headers.

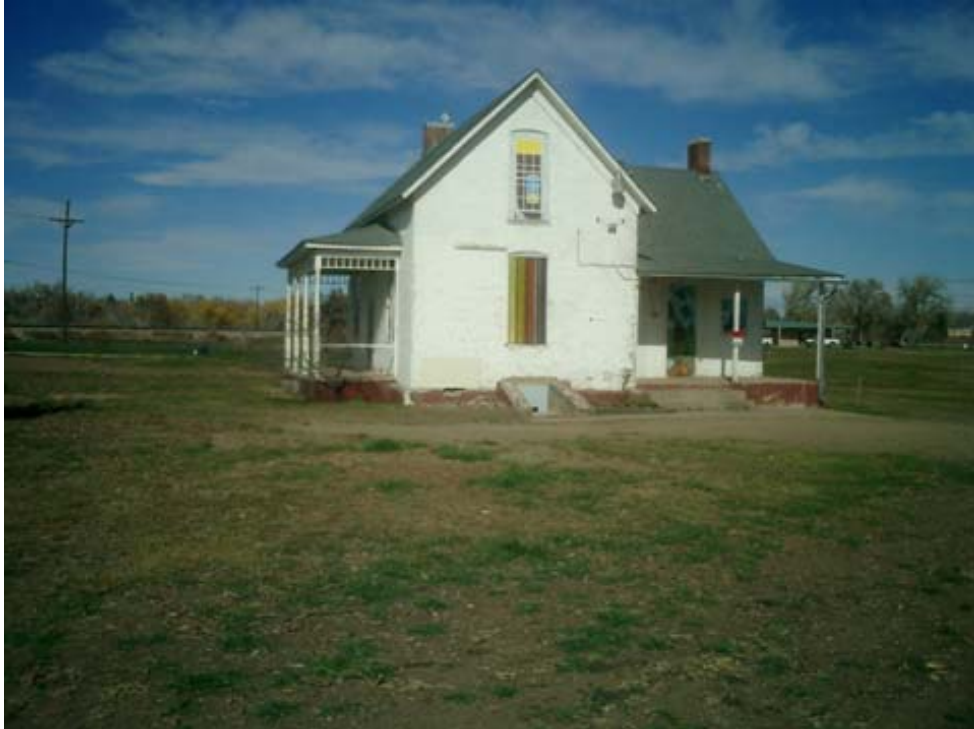
Fig7. 2009 Southeast -facing side, prior to restoration

The southeast façade of the house features a rear porch. The porch is substantially concrete with a small portion at the entry consisting of wood plank floor. The gabled roof extends over the wood entry portion. Two small concrete steps provide access to the rear porch. Domestic water for the home was historically contained in an underground cistern that remains in place and is now enclosed in the concrete rear porch. The opening is still visible and is covered by a wood lid. An off-center door leads into the kitchen wing; originally exposed to the exterior, this door had been enclosed by the addition of a bathroom and entry space. Recent restoration work removed this enclosure and re-exposed the door. The masonry opening is unique due to its rough-cut sandstone lintel. Due to the poorer quality of the brick masonry workmanship above this opening, it appears likely it was not an original component to the building and was reconstructed later. To the right of the rear porch door, an area that may have historically served as dry storage features a four-light in-swinging casement unit with a double rowlock segmental brick arch header. On the main section of the house, the upper and lower levels each feature one four-over-four double-hung sash window with double rowlock segmental brick arch header centrally aligned. Between the upper and lower windows the upper floor reinforcement can be seen with a small wood panel bolted to the masonry. The cellar/crawlspace is accessed by an opening with retaining walls and three concrete steps covered by a solid panel of wood, bolted to the retaining walls.

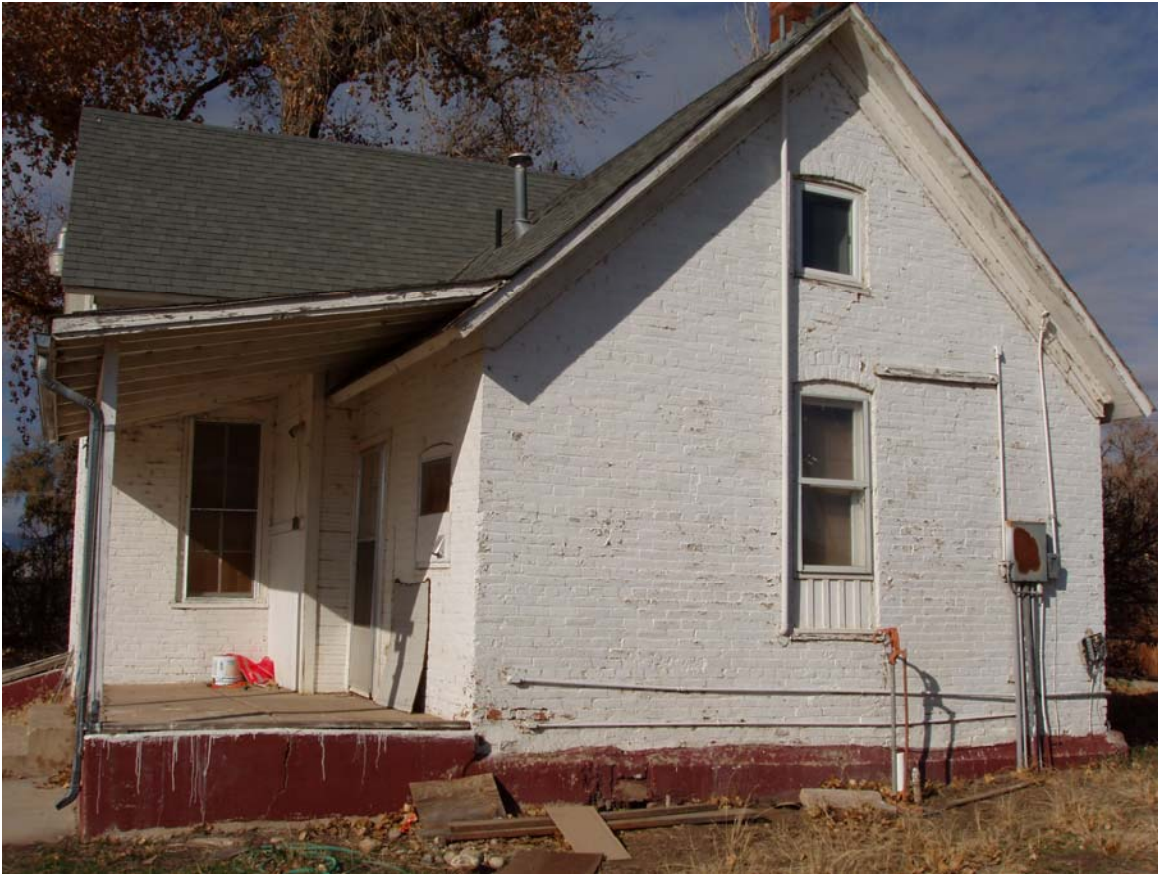
Fig. 8 2009 Northeast Façade, prior to restoration

The upper story of the northeast façade of the kitchen wing includes a four-light in-swinging casement window. The lower level of the kitchen portion features a four-over-four double-hung sash window with painted wood frames and surrounds with a double rowlock segmental brick arch header. The main section of the house is set back from the kitchen wing and also features a four-over-four double-hung sash window with a double rowlock segmental brick arch header. A utility panel box is mounted on the western end of the northeast façade and an

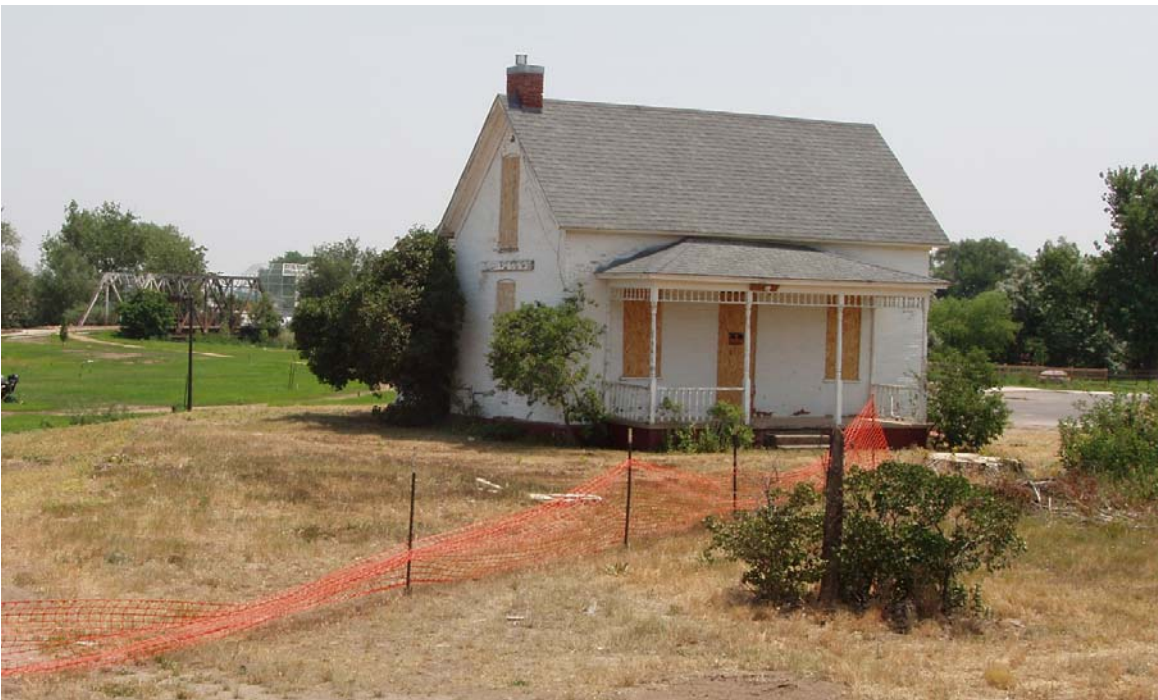
Fig. 9 2009 Southwest (main) Façade, prior to restoration

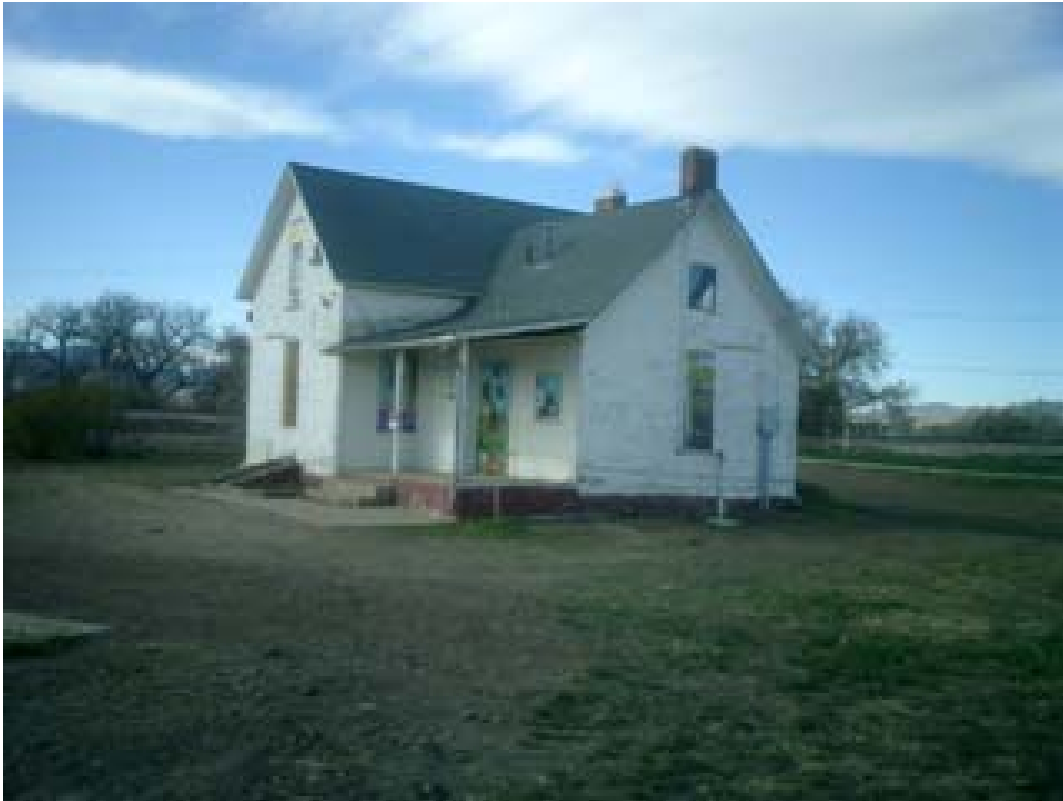
Fig. 10 2009 Northeast-facing side, prior to restoration

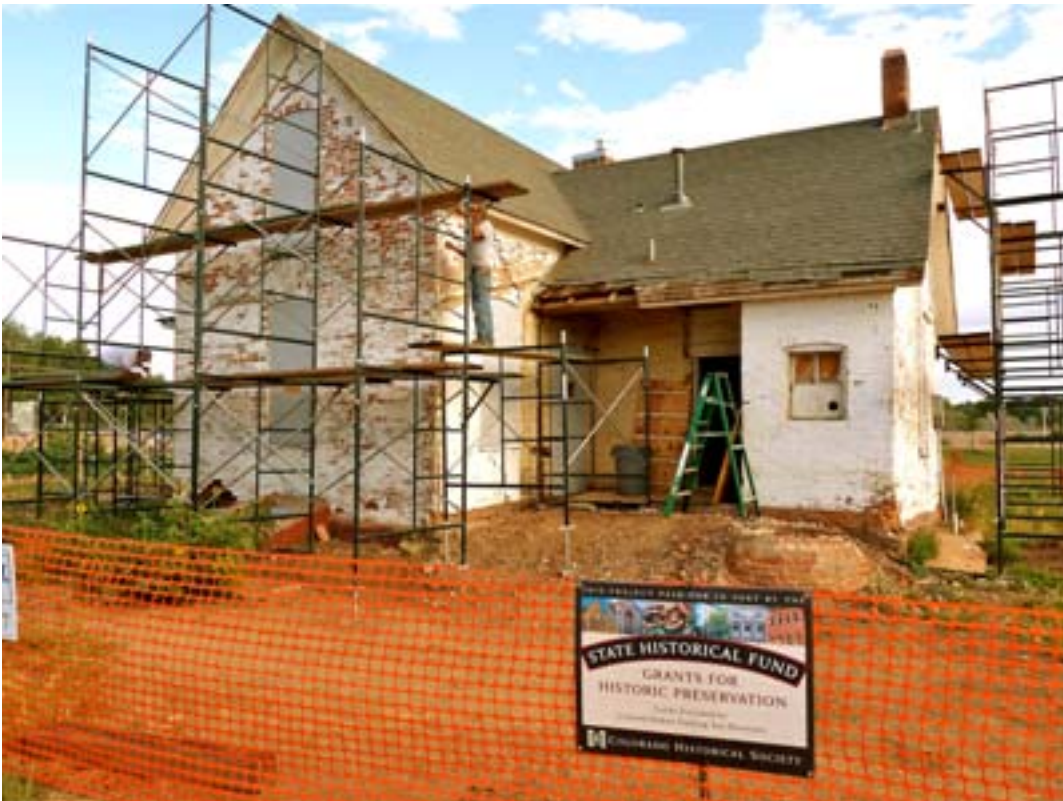
Fig. 11 2010 Southeast Façade, during restoration

Using Colorado State Historical Fund (SHF) grant assistance, the Milner-Schwarz House underwent significant rehabilitation and restoration from 2010-2012. The foundation was repaired and a new perimeter drainage system was installed. A non-historic rear porch, along with the rear enclosure including the bathroom was demolished and a new rear porch floor deck, step and concrete were installed. The front porch was repaired and restored, and missing elements were reconstructed using historic photographs and the historic balusters and spindles available. The exterior paint was removed; the brick masonry was repointed and a new coat of paint was applied. The wood fascias and box soffits were also repaired and restored. The original wood windows were repaired and five non-historic wood windows were replaced with wood windows in the same configuration as the original wood windows found elsewhere. Storm windows were also added to the windows to prevent vandalism. The original wood doors were repaired and non-historic doors replaced. New galvanized sheet metal gutters and downspouts were also installed.

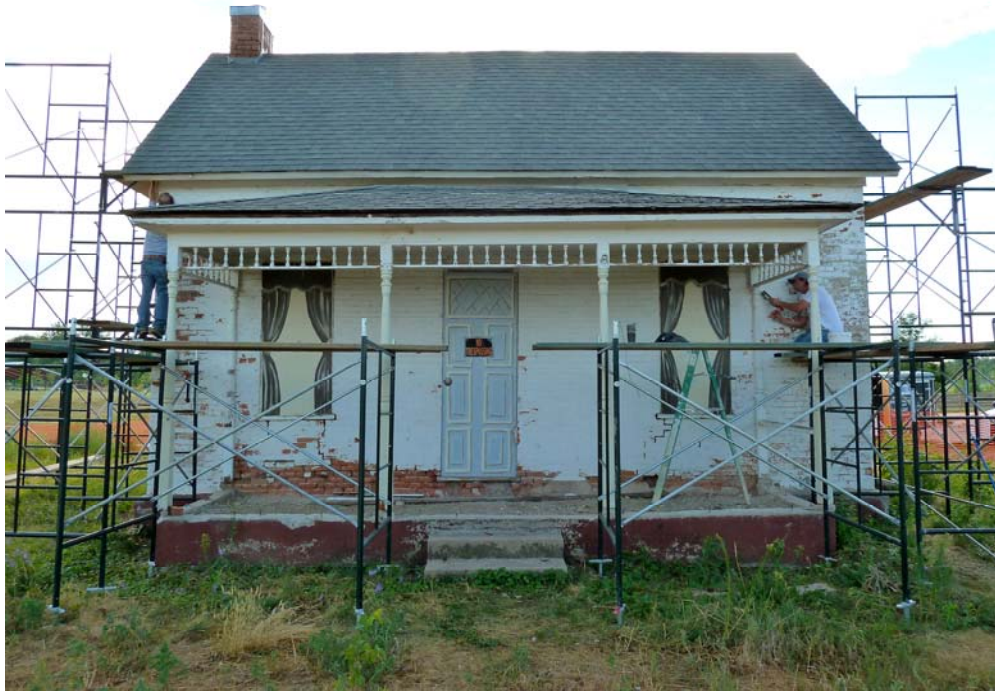
Fig. 12 2010 Southwest Façade, during restoration

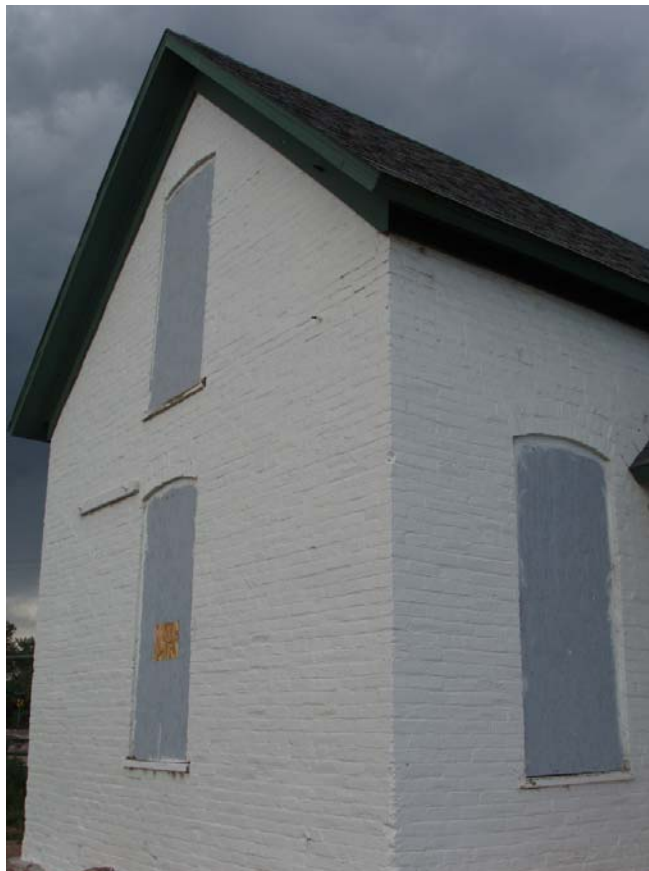
Fig. 13 2011 Southeast-facing side, during restoration

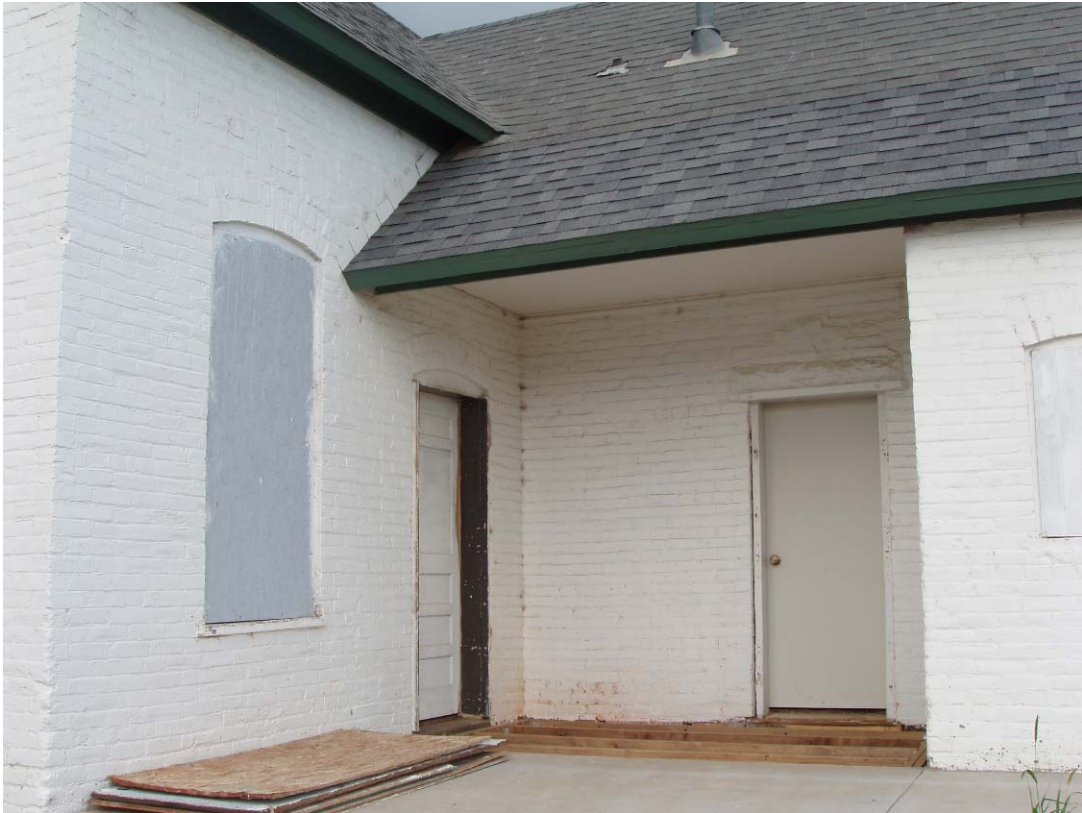
Fig. 14 2011 Southeast Porch, during restoration

foundation stabilization work, install a drainage system, rebuild a historic rear porch, repoint brick masonry, repair chimney flashing, restore/reconstruct the front porch, repair and repaint porch floor posts and missing railing sections, remove and repaint exterior brick, repair, scrape and repaint wood fasciae, repair, repaint the original wood windows, replace non-original kitchen windows, replace broken glass in windows, replace missing exterior front door with historically appropriate wood door, frame and hardware, repair and paint rear exterior wood entry door and frame, install new inoperable historically appropriate exterior kitchen door and framing and install new galvanized sheet metal gutters and downspouts on the roofs. The restoration project was completed in 2011 with a ribbon-cutting ceremony held and celebrated by Loveland dignitaries and citizens. The Loveland Historical Society, through many small local donations completed the interior rehabilitation/restoration of the first floor of the house and is planning to begin work on the second story in the Fall of 2013.

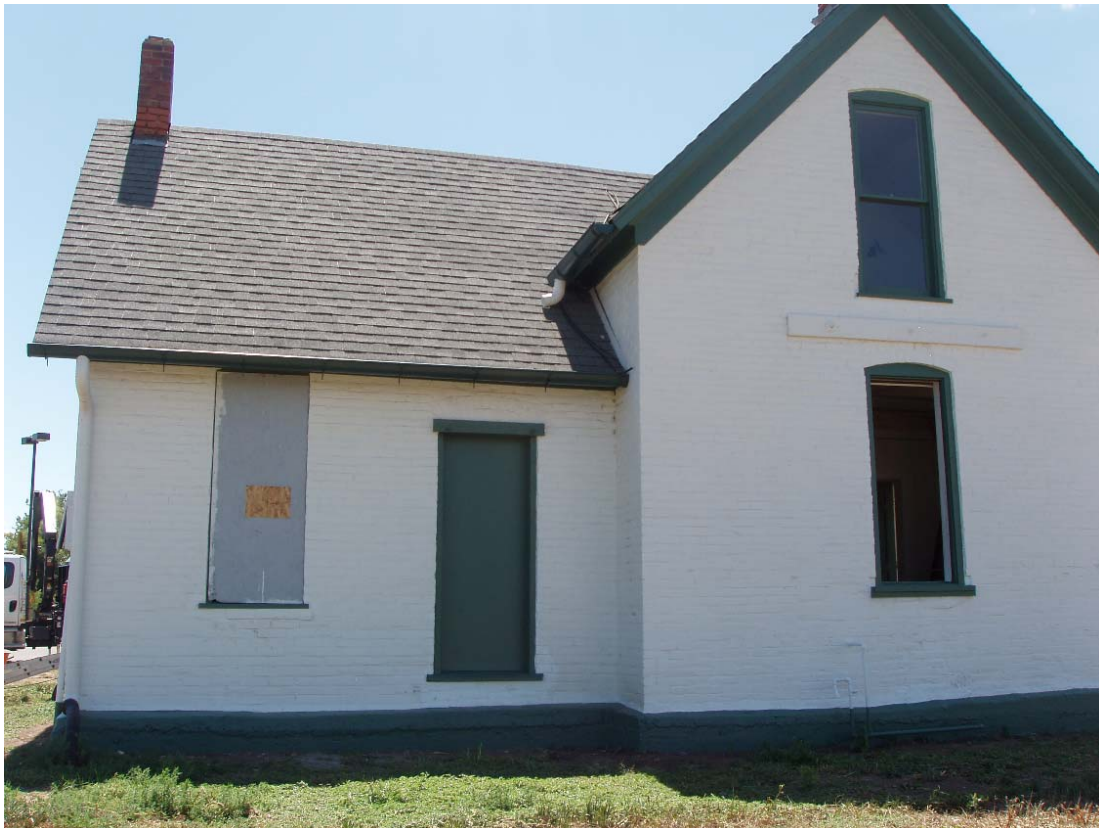
Fig. 15 2011 Northwest-facing side, during restoration

This side features the rear wing kitchen set back from the main portion of the house. The upper story of the main portion features a one-over-one double-hung sash window with painted wood frames and surrounds and a single rowlock segmental brick arch header. Directly below the upper story window is a four-over-four double-hung sash window with painted wood frames and surrounds with a double rowlock segmental brick arch header. Between the upper and lower window is an extension of inner wall blocking to support the flooring at the upper level. It is believed that this was necessary because the framing as constructed at the chimney flues failed at some point. Because the roof top chimneys are directly above the windows, the chimney flue would have had to come up beside the window. These reinforcements are seen on the walls that have a rooftop chimney. Reinforcement can also be seen on the southeast wall; interior evidence shows that a rooftop chimney in this location likely existed historically. On the kitchen wing there is a four-over-four double-hung sash window with painted wood frame and surrounds and a non-historic solid wood four-panel door with painted trim beneath a double rowlock segmental brick arch header. This door sits at least 1' above grade and likely had steps leading out onto the now landscaped grounds.

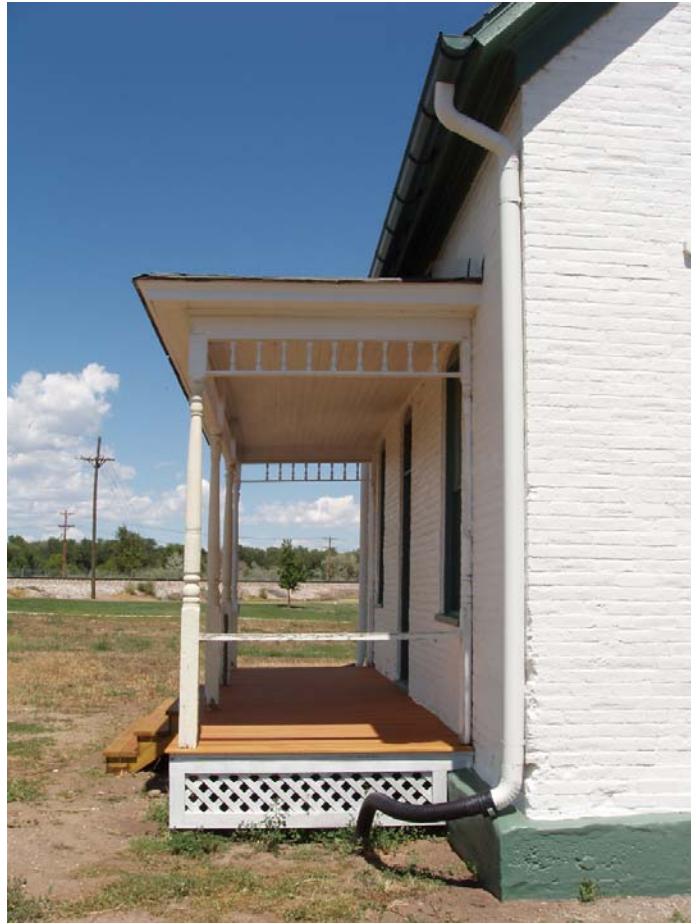
Fig. 16 2011 Southwest Porch, during restoration

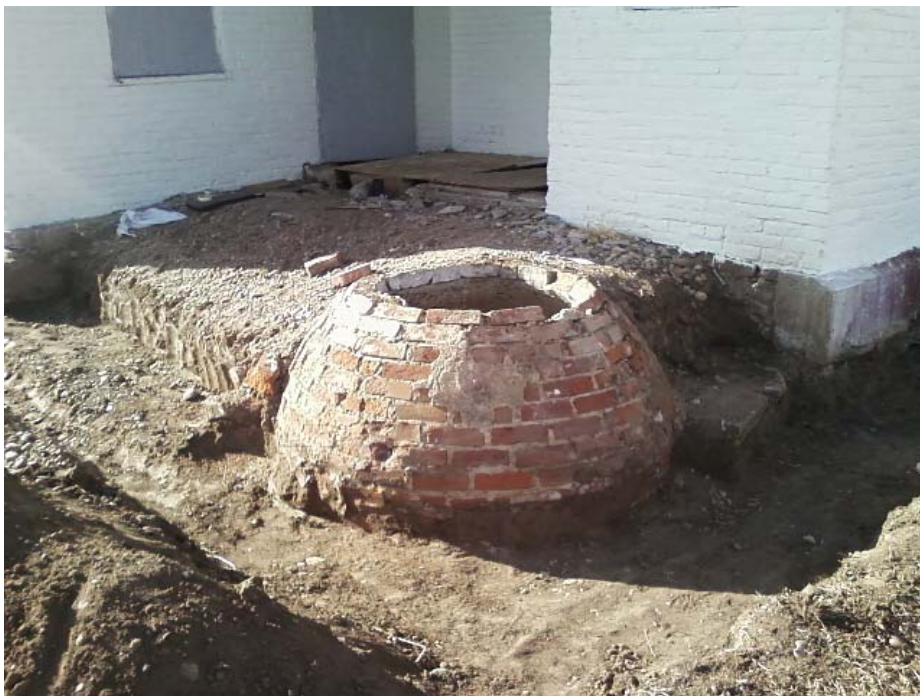
Fig. 17 2011 Cistern Uncovered (Northeast -facing side), during restoration

During the restoration and rehabilitation project, an archaeologist conducted an on-site survey and discovered the house cistern. However, no other archaeological resources were found. All of the restoration and rehabilitation work completed under the guidance of the Colorado State Historical Fund and by the LHS and was in accordance with the Secretary of Interior's Standards for the Treatment of Historic Properties.

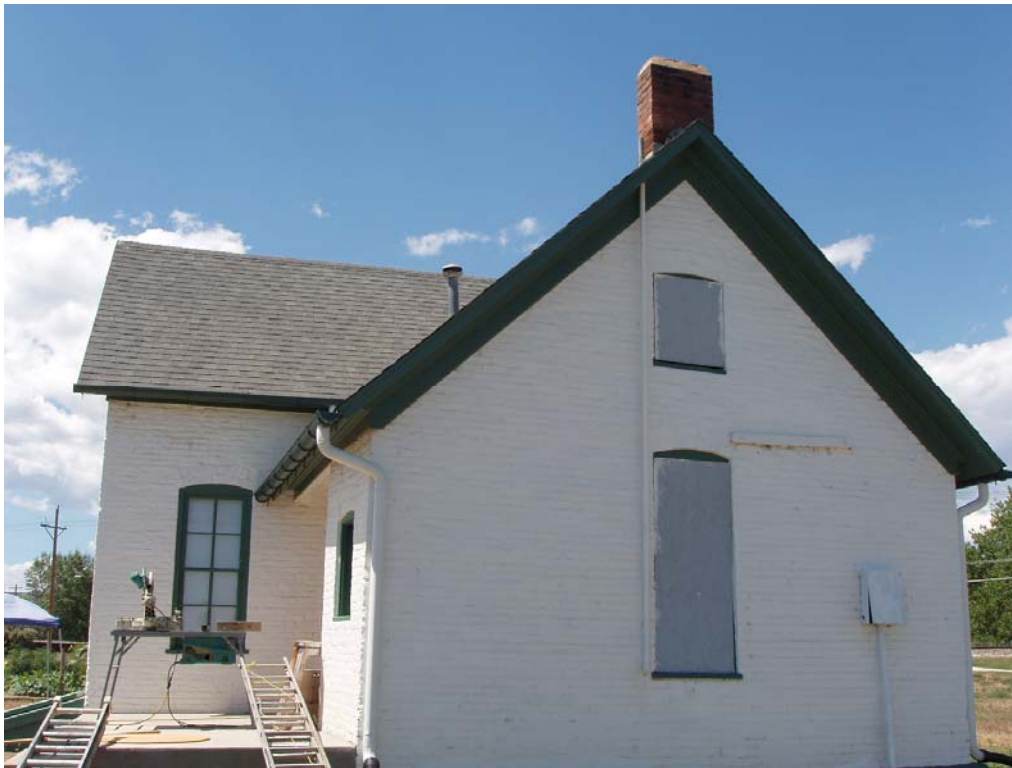
Fig. 18 2011 Northwest-facing side, during restoration

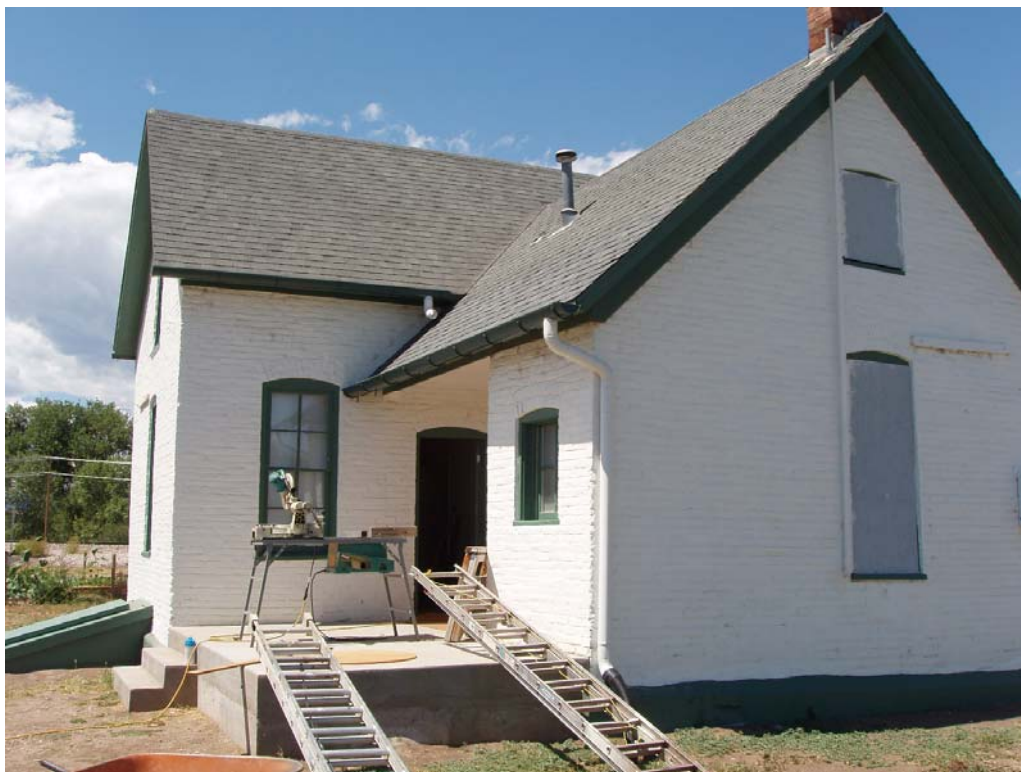
Fig. 19 2011 Northwest-facing side, during restoration
