**NATIONAL REGISTER OF HISTORIC PLACES
REGISTRATION FORM**

historic name: Kimbrough, John Hall House
other names/site number:

Kimbrough, John Hall House
Attala County, Mississippi

Narrative Description

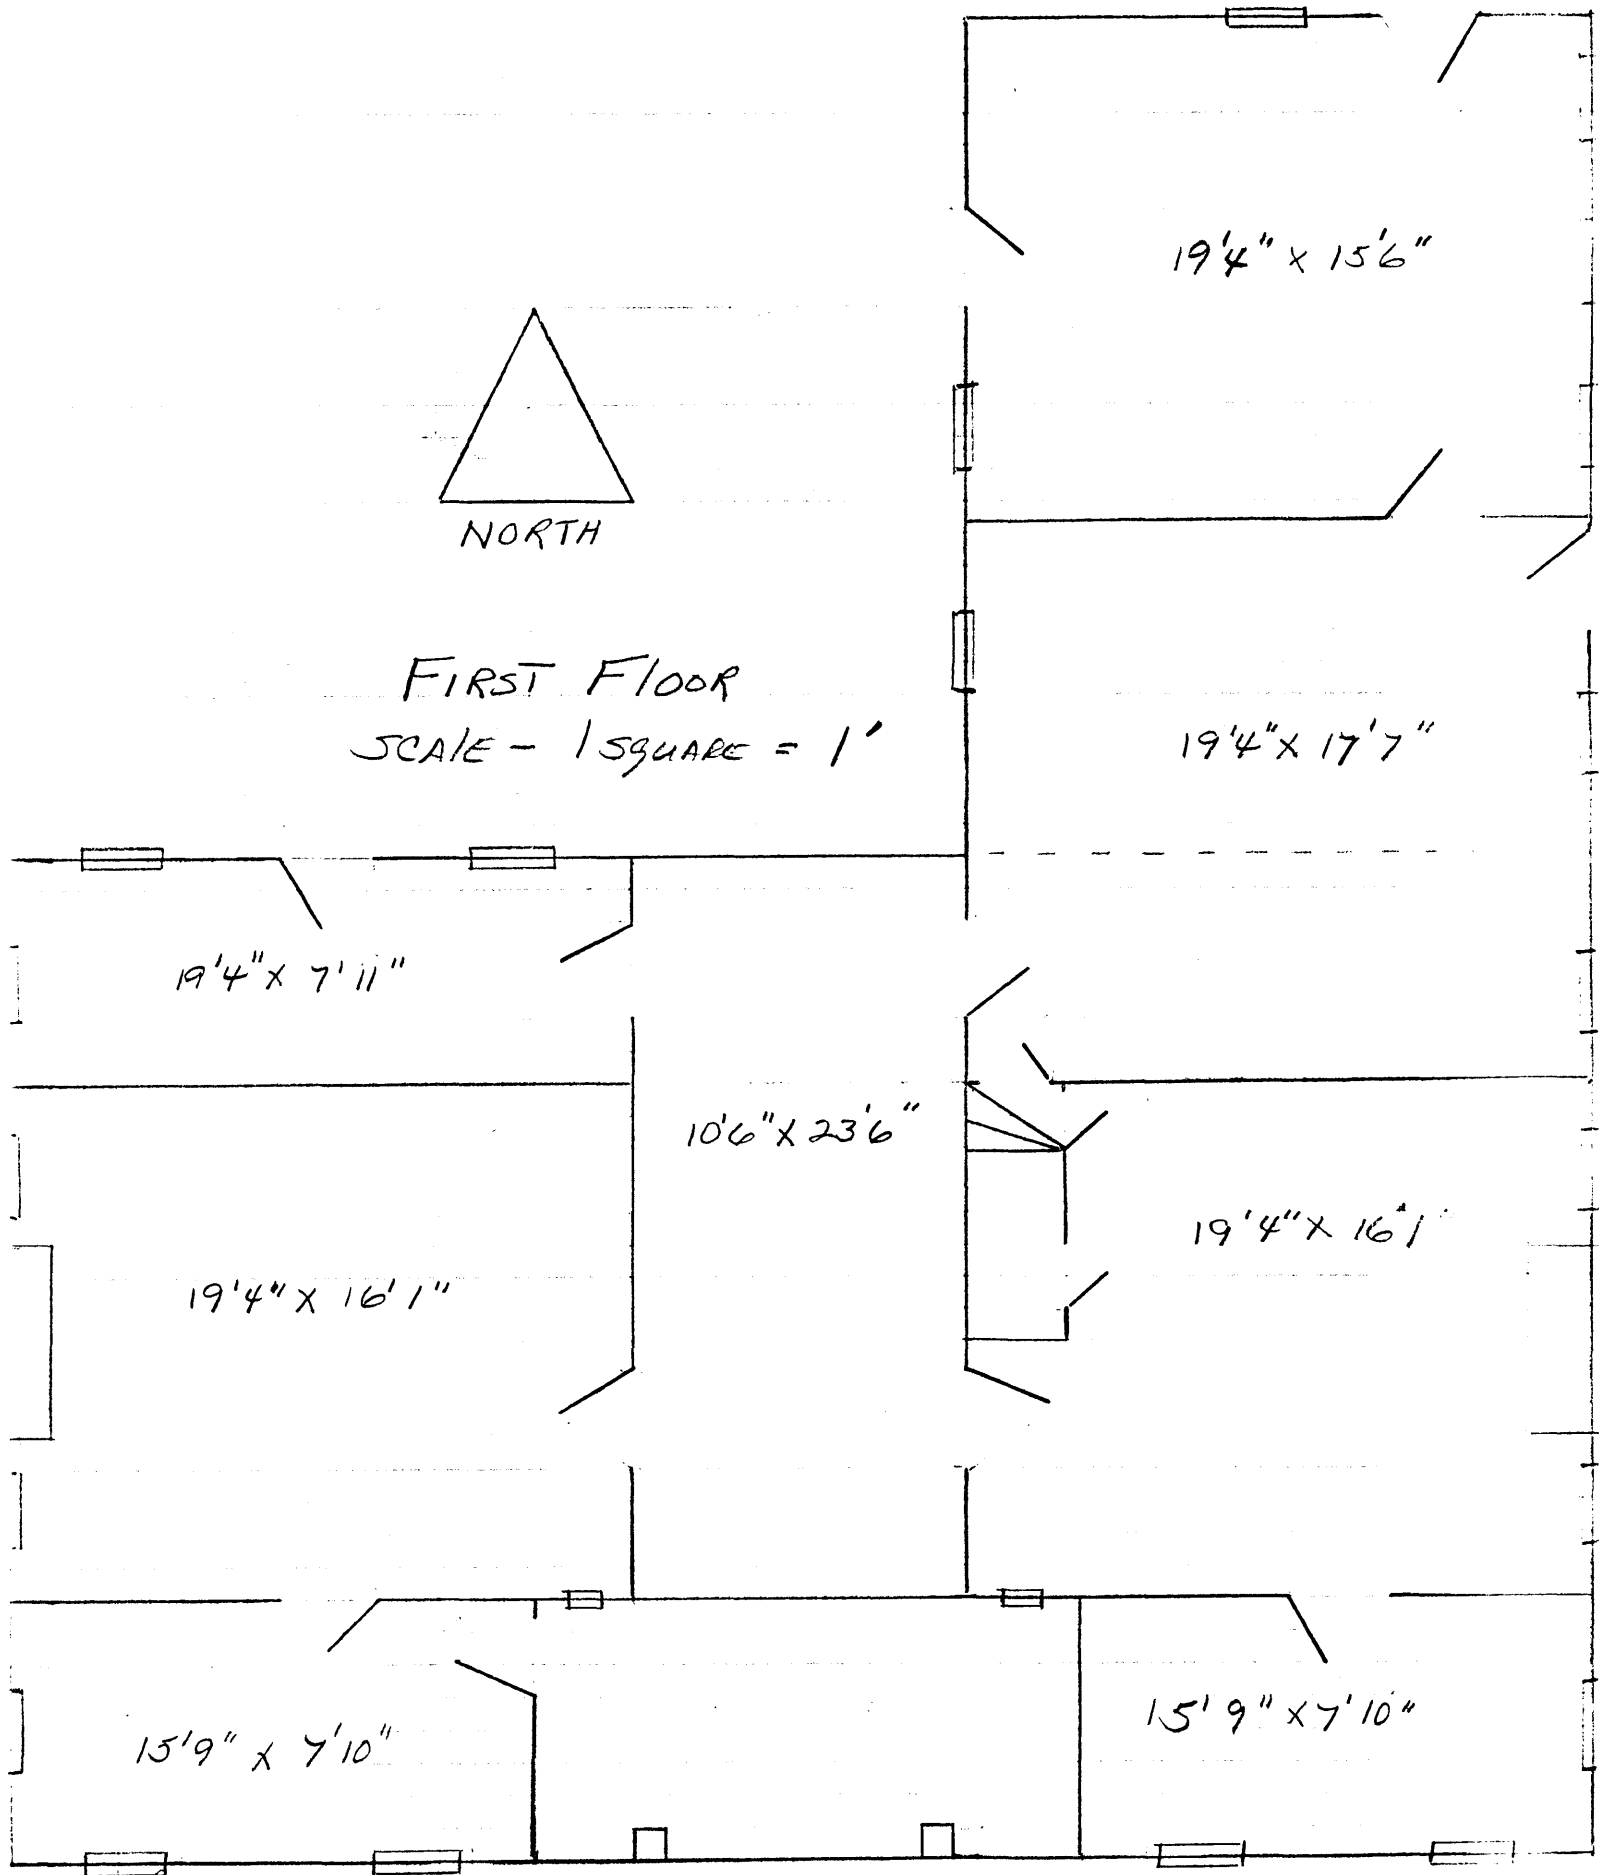
FIRST FLOOR
SCALE - 1 SQUARE = 1'

The original 1860 rooms have retained their flushboard interior walls with wainscoting that were covered with lath and plaster. The cabinet rooms and rear ell feature beaded board walls indicating their later date. The ceilings throughout the house are board-and-batten along with a section of the wall of the east room near the staircase. Doors and windows throughout the house feature plain eared surrounds, and various forms of vernacular panel doors with their original hardware. The mantels are plain with mantel shelves and limited moldings. The upper half story is accessed by an interior staircase in the southeast room from both the southeast and dining room ell that connects the kitchen.
