NATIONAL REGISTER OF HISTORIC PLACES NOMINATION, GLACIER NATIONAL PARK

STRUCTURE NAME: East Glacier Ranger Station Historic District      STRUCTURE NUMBER: 135  
Residence/Office

# EAST GLACIER RANGER STATION HISTORIC DISTRICT

East Glacier Ranger Station Historic District (addendum), Glacier County, MT.

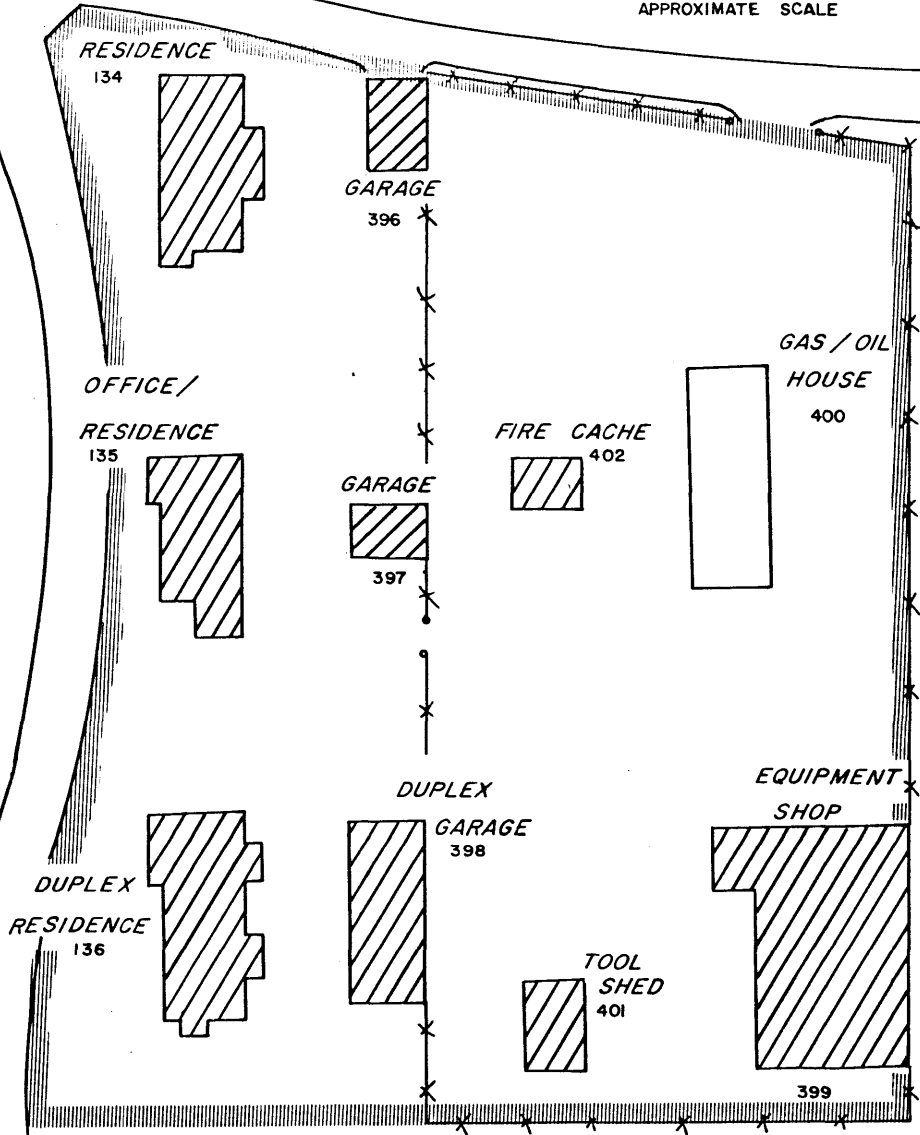
||||| HISTORIC DISTRICT BOUNDARY

▨ CONTRIBUTING STRUCTURE

□ NONCONTRIBUTING STRUCTURE
