**NATIONAL REGISTER OF HISTORIC PLACES  
REGISTRATION FORM**

Historic Name: Beavers, Dr. James Alvis, House  
Other Names/Site Number: N/A

Beavers, Dr. James Alvis, House, Sumter County, Alabama

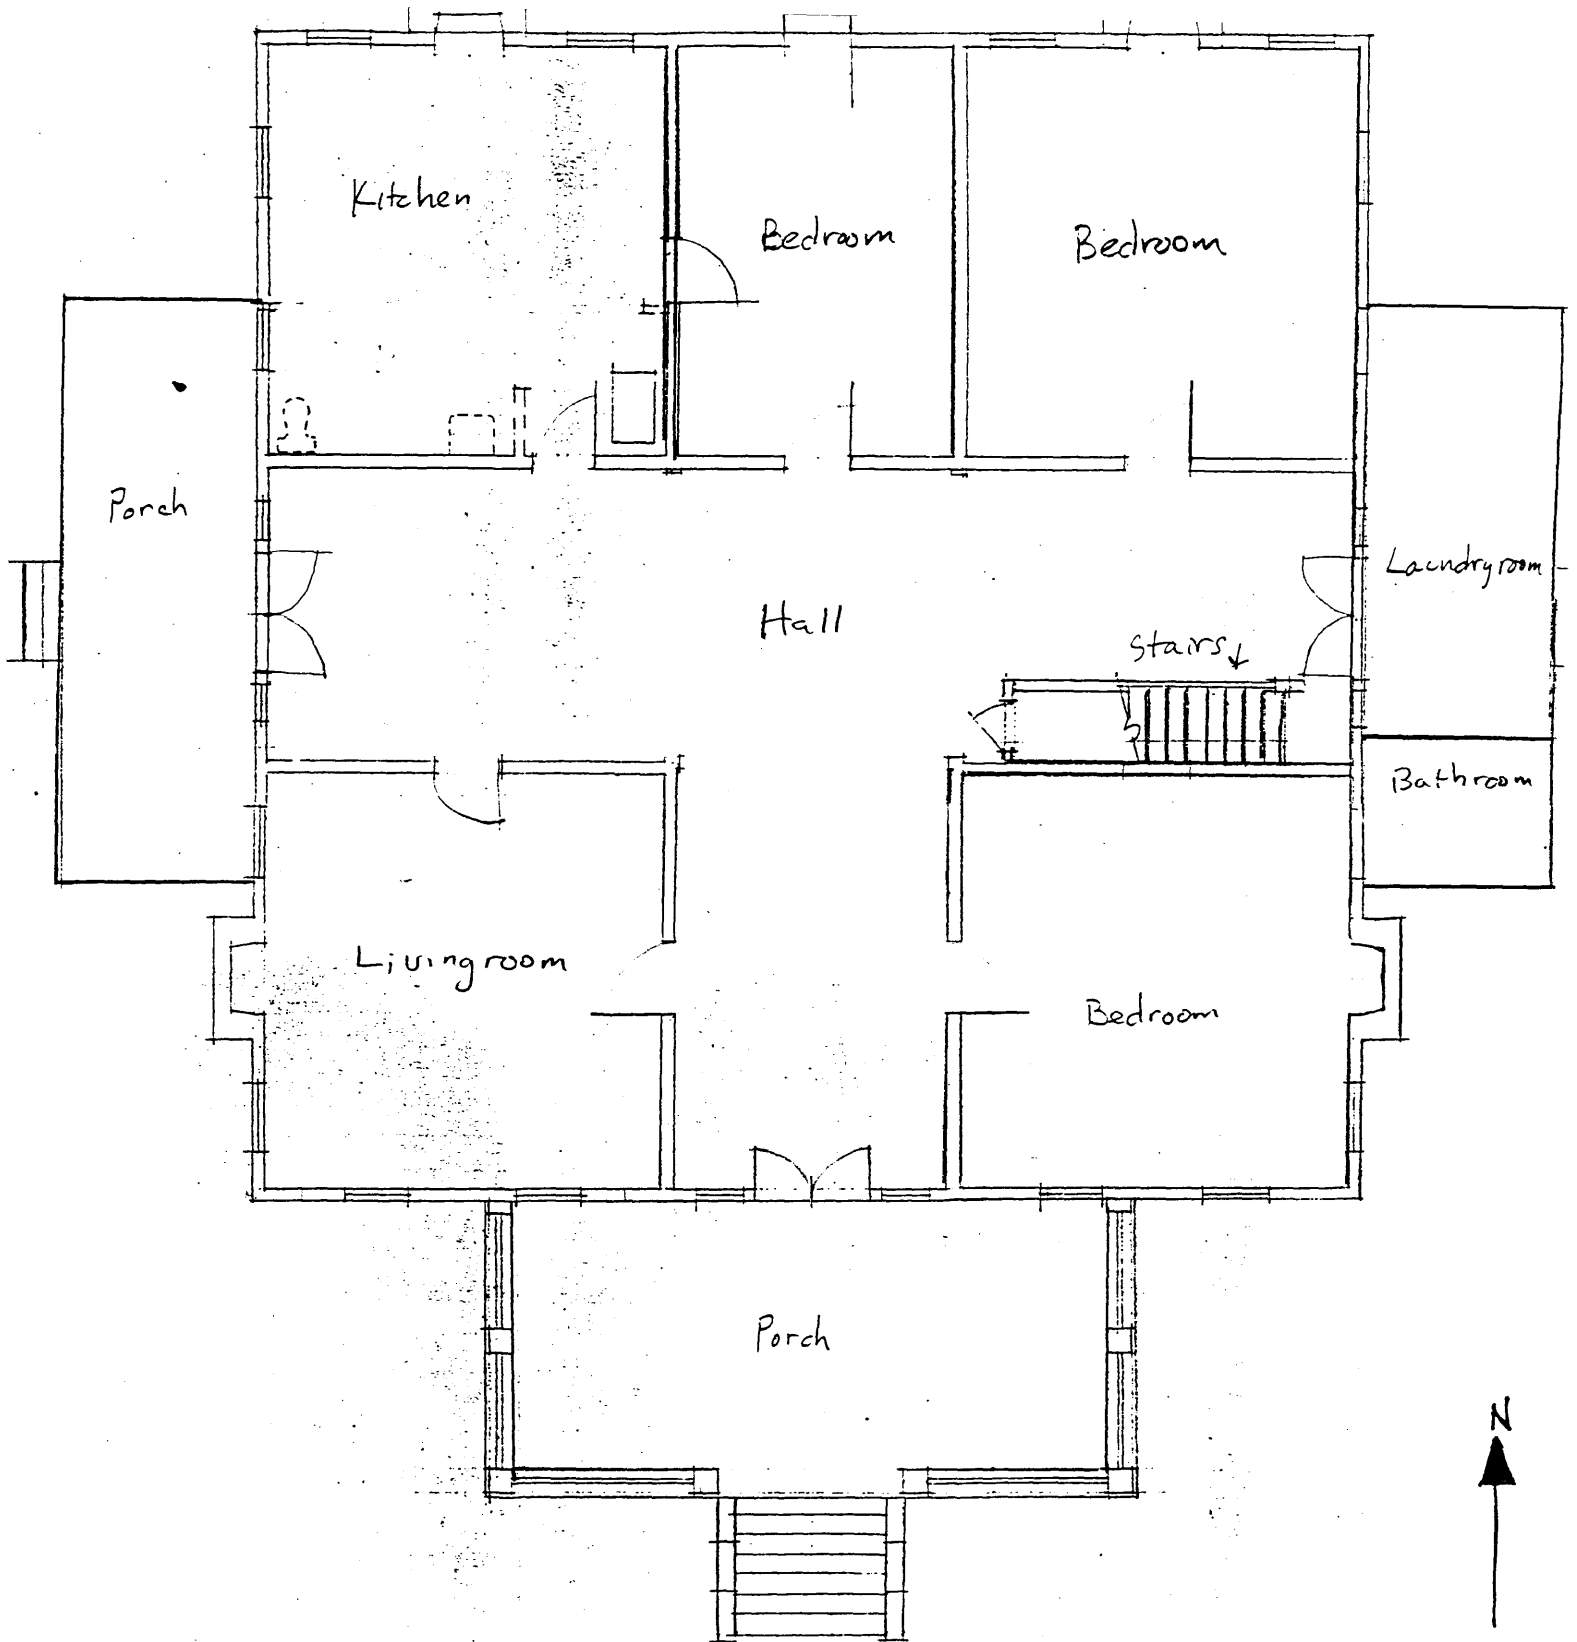
MAIN FLOOR PLAN

Dr. James Alvis Beavers House  
Cuba, Sumter County, Alabama

- not to scale -

The interior of the first floor is characterized by a T-shaped hallway. Each end of the hall terminates at a double-leaf wood door with sidelights and transom. One is the front door; the other two coincide with the east side shed room and west side shed porch. The floor consists of stained hardwood boards; plaster sheathes the walls; beaded board lines the

ceiling; wainscoting and a chair rail wrap around the base of the hallway. Three flattened arches that rest on pilasters form the perimeter of the crux of the hall. The ceiling of the square formed by the archways is clad with beaded boards. Placed at a 45-degree angle, the beaded board forms a diamond-shaped pattern. A light fixture is suspended from the center of the ceiling. On the south side of the east side hall, a stairwell rises to the attic floor. Beneath the stair is a bathroom.

The T-shaped hall forms the core of a four-room first floor. The living room is situated at the southwest corner of the hall. The walls, floor, and ceiling are clad like those of the hall. Between the two windows on the west wall is a mantel. Decorative scroll work and brackets embellish the mantel. In all, four windows punctuate the living room walls. Window and door treatments are plain. The rooms at the southeast and northeast corner of the house, which now serve as bedrooms, are similar in design to the living room. The northwest room has been converted into a kitchen. The mantel is unadorned.

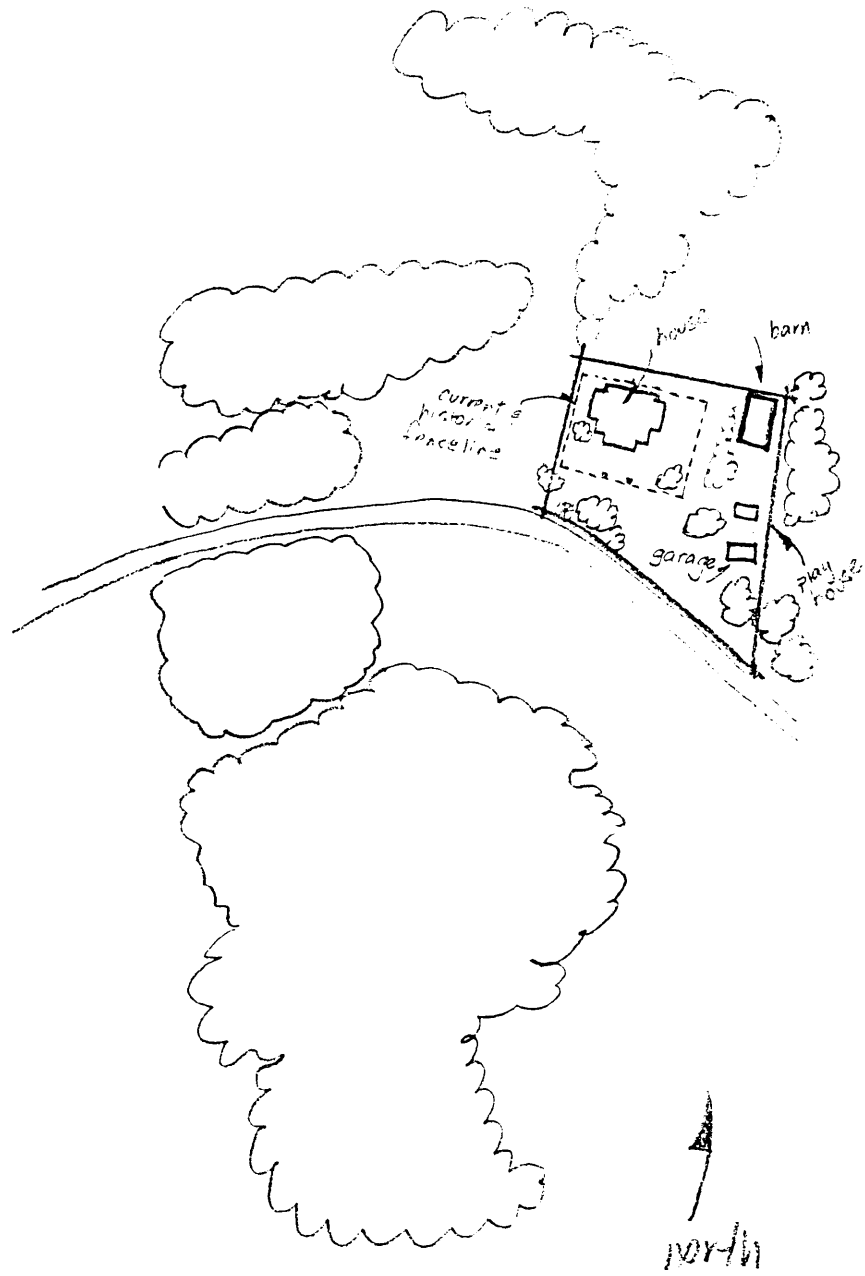
EASE MAP - 1" = 200'

DR. JAMES ALVIS BEAVERS HOUSE  
SUMTER CO., AL

Verbal Boundary Description: The boundaries of the Dr. James Alvis Beavers House are defined on the accompanying base map, the scale of which is 1" = 200'.

Boundary Justification: The boundaries of the Dr. James Alvis Beavers House include the historic core of the property (house, fence line, barn, garage, and playhouse) and its immediate yard, terminating at the drive.
