historic name Freegrace Marble Farm (preferred) Historic District  
other names/site number Dona Farm

street & number 80 Burbank Road N/A not for publication  
city, town Sutton N/A vicinity  
state Massachusetts code 025 county Worcester code 027 zip code 01590

Freegrace Marble Farm Historic District,  
Sutton, MA

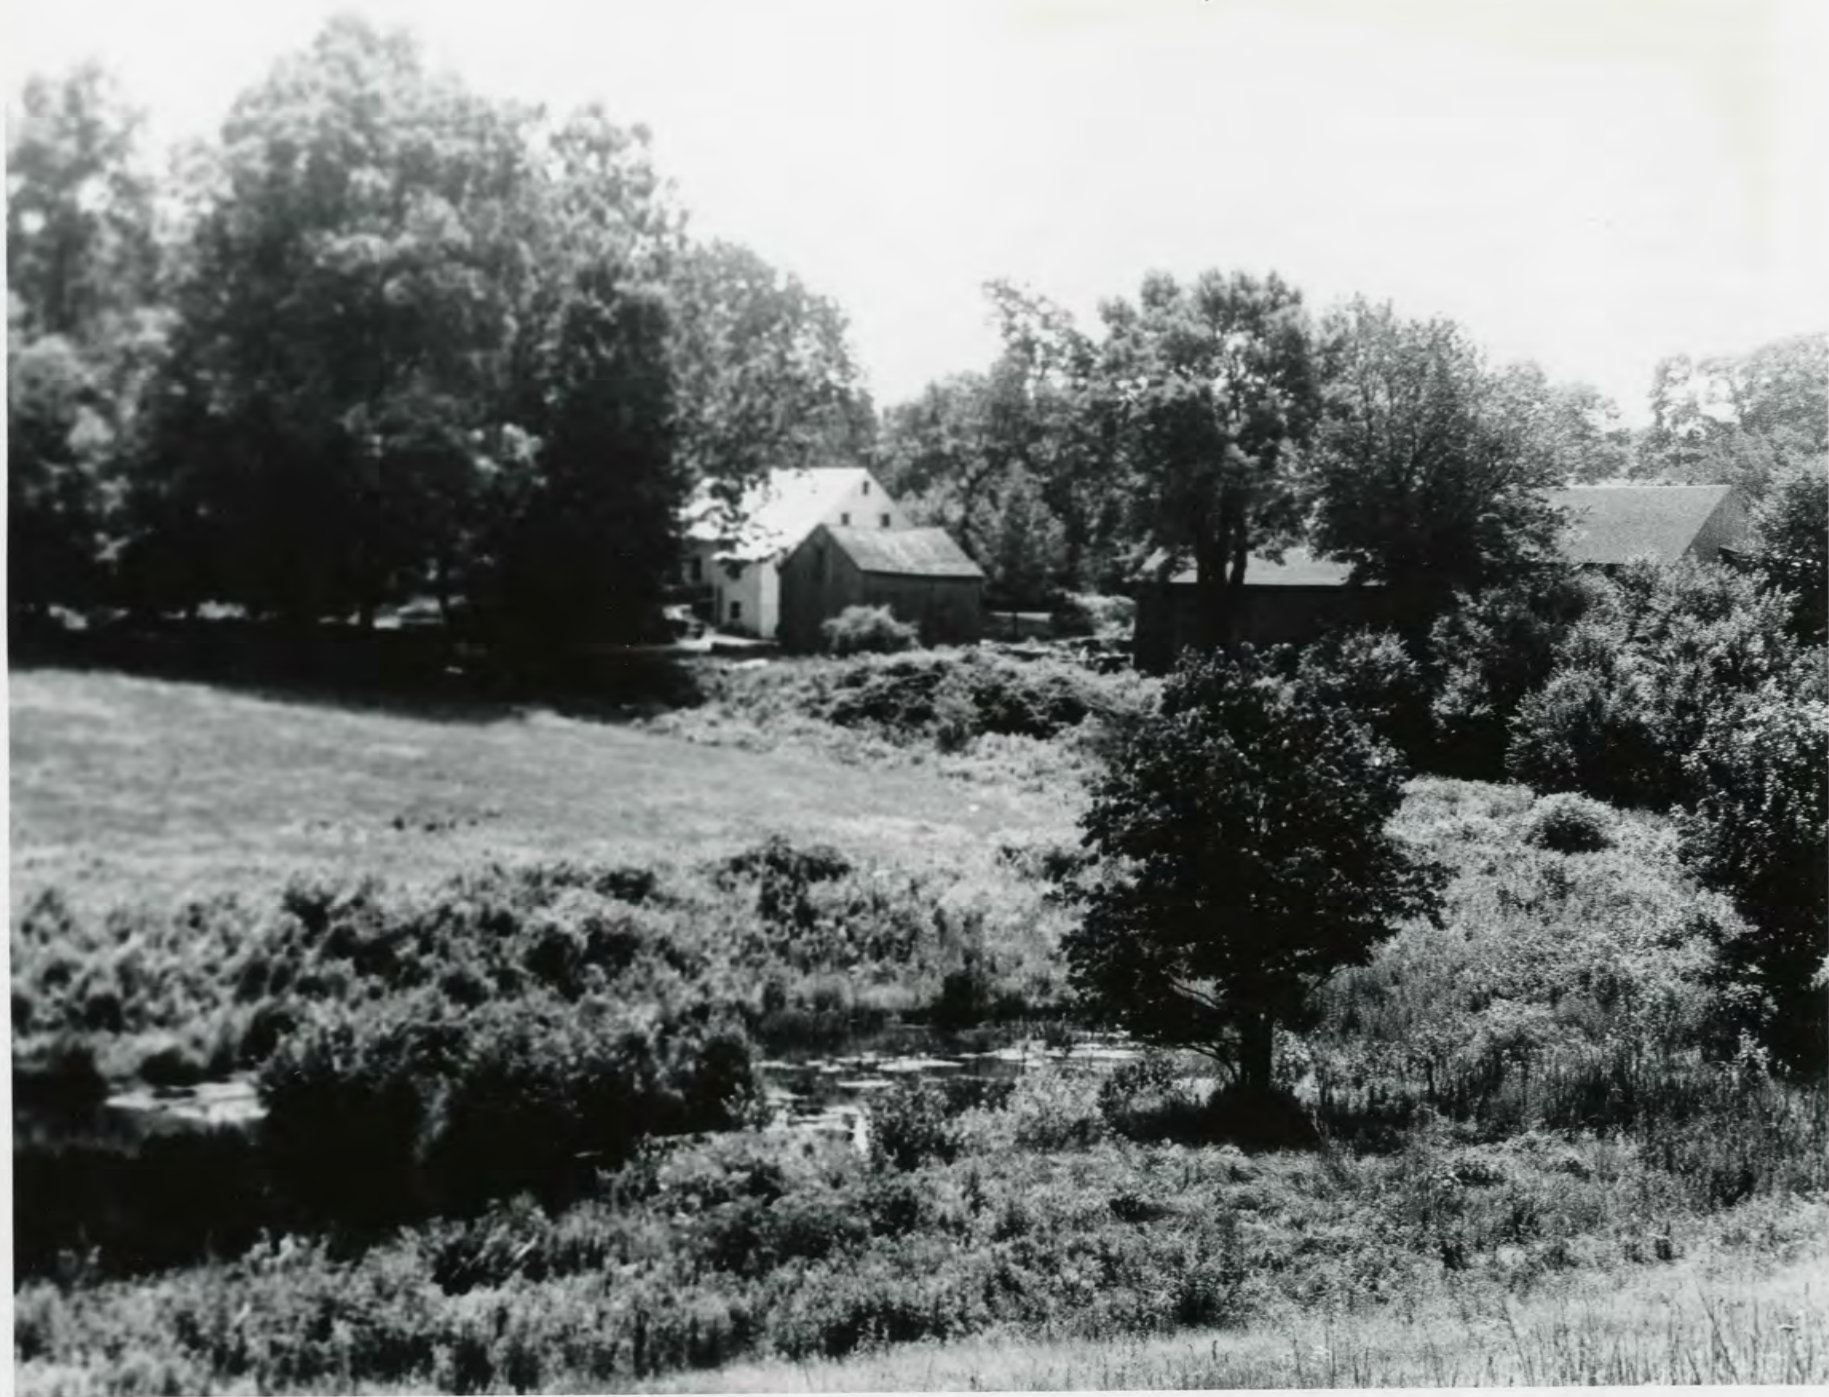
PHOTO #1 OF 4

POND IN CENTER FOREGROUND

Comprising meadow, woodland, and wetland, Marble Farm (Photo #1) ranges across two drumlins, one each at the northern and southern ends of the property. In the vale created by the drumlins is a stream that bisects the farm from west to east, beginning at Sibley Reservoir. A small pond was created by the damming of the stream, which is spanned by a low stone bridge to the northeast; a spring is located further to the east. Along this stream is clear evidence of the old cowpath, lined with trees, leading to the northeast pasture. A second stream bisects the northeastern section of the farm from north to southeast, meeting the first stream in a wooded area. Walls of uncut stone define most fields on the farm, as well as the paddock east of the farmyard and a former vegetable garden on the southwestern boundary of the property. [See sketch maps]

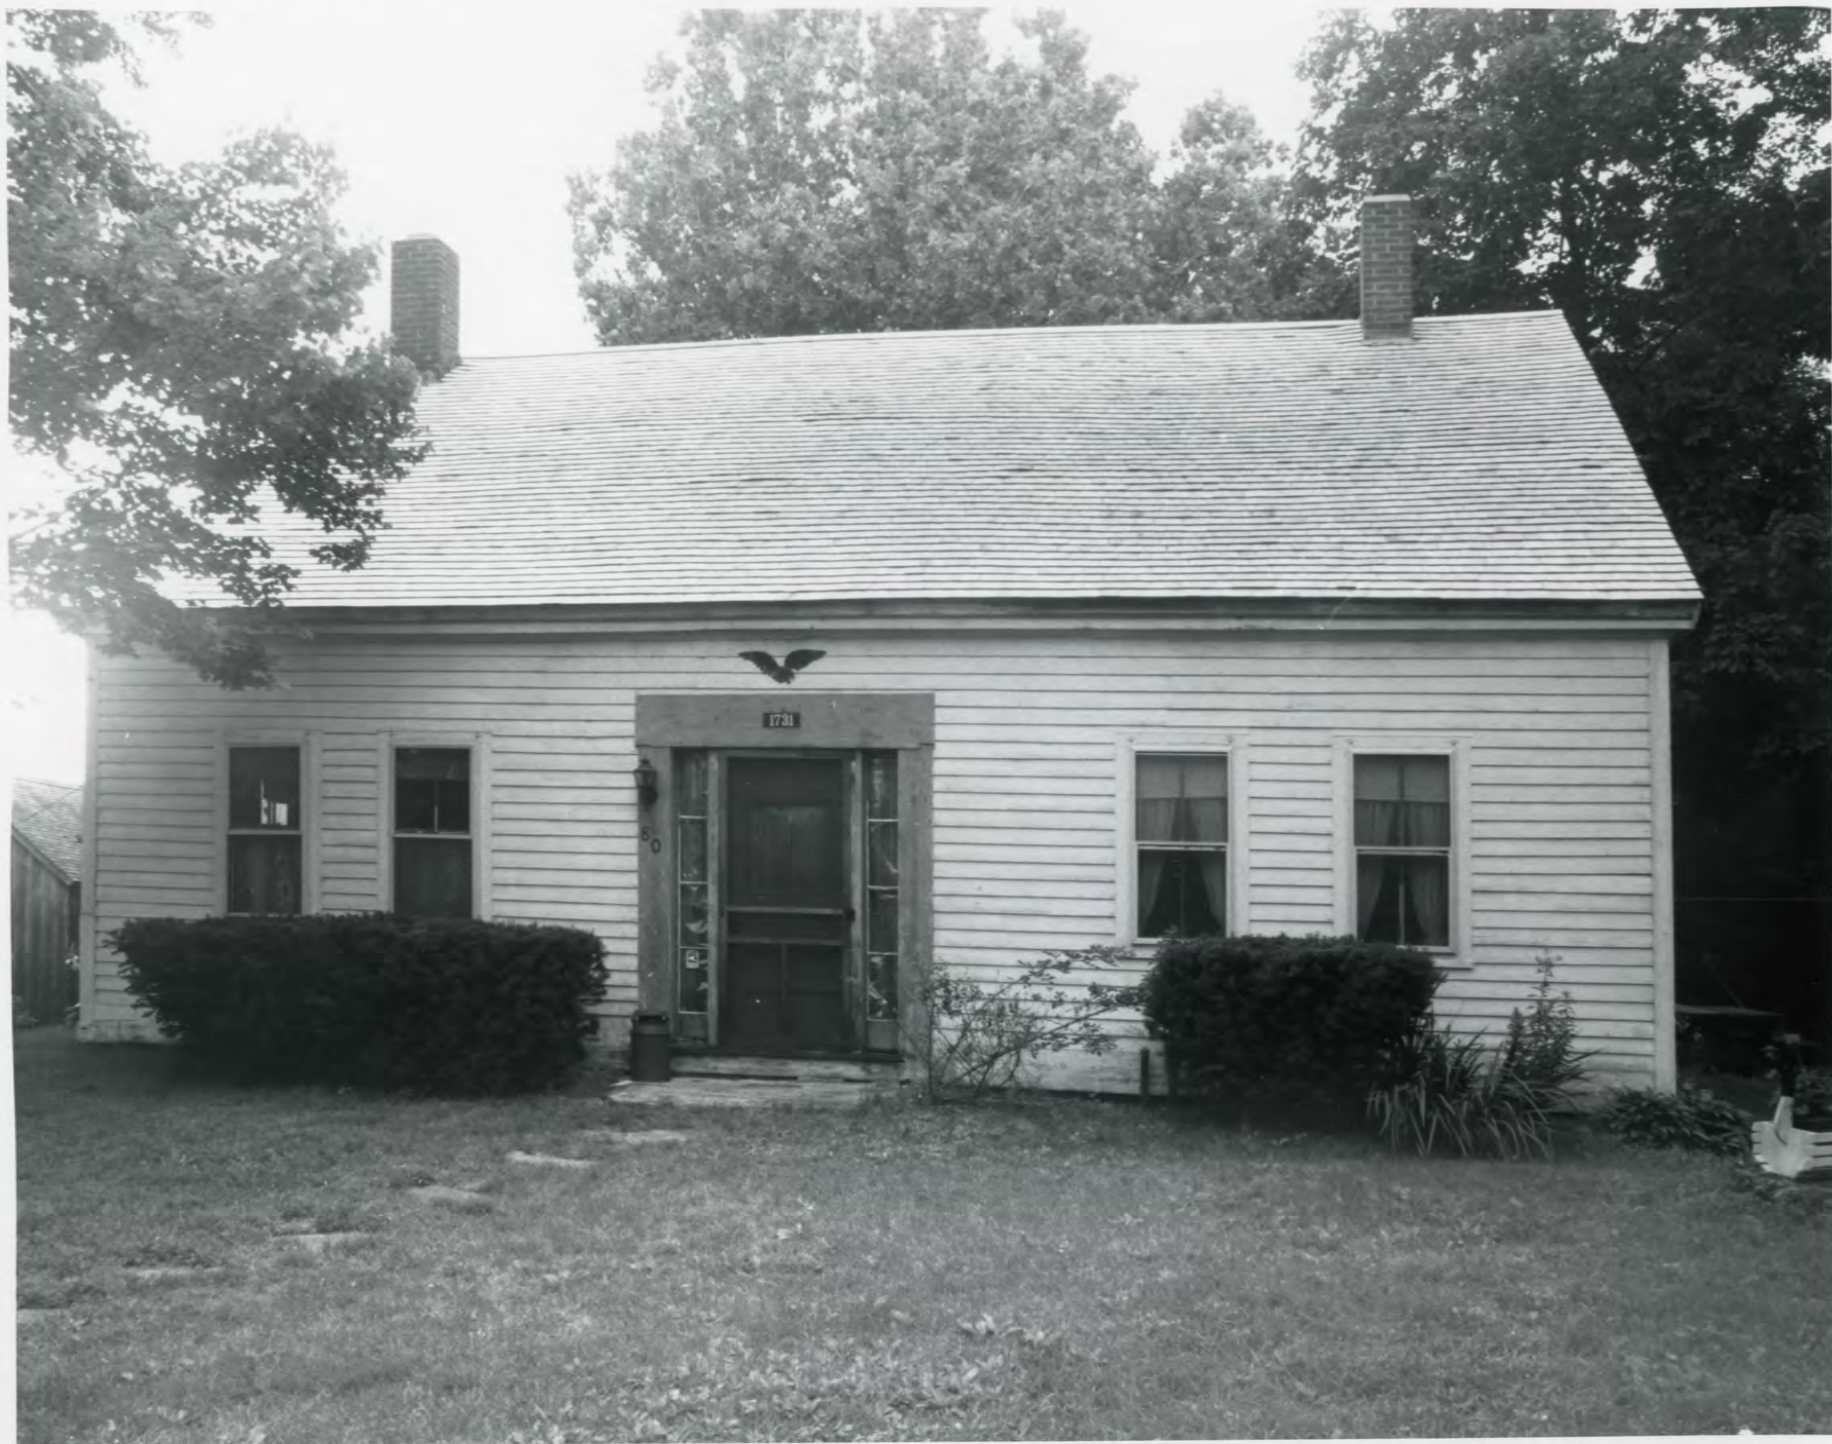
~~DONA FARM~~ MARBLE FARM HISTORIC DISTRICT  
80 Burbank Road  
Sutton, MA 01590  
Photg.- Malcolm Pearson, 7/14/89  
Neg. % Sutton Historical Commission  
Photo #4 of 2 2 OF 4  
"W front elevation"

MARBLE FARM HISTORIC DISTRICT  
80 BURBANK ROAD, SUTTON, MA  
PHOTO: MALCOLM PEARSON 1989  
NEG: SUTTON HISTORICAL COMMISSION  
4 UXBRIDGE ROAD  
SUTTON, MA 01590  
W FRONT OF FARMHOUSE  
PHOTO # 2 OF 4

The farmhouse (Photo #2) is the oldest building on the farm. A 1 1/2-story clapboarded dwelling of plank construction on a stone foundation, the house has a gable roof, five-bay facade parallel to the ridge pole, and double-pile, center-hall plan. Two brick chimneys of unequal size appear at either end of the house in front of the roof ridge. Essentially rectangular in massing, the house includes a one-bay, shed-roofed lean-to at the northern end of the rear (east) elevation (Photo #3). Oriented to the west on a southerly ascending slope, the house has a full cellar that is clad in clapboards where it is exposed at the base of the shed-roofed lean-to. Adjacent to the lean-to is a short driveway from Sibley Road. Fieldstone steps lead from the driveway to the house's rear entrance on the south wall of the lean-to. South of the house is a sunken terrace delineated by a stone wall parallel to the south elevation. Stone steps lead from the terrace to the level of the house.

The facade or west elevation consists of an entrance placed slightly left of center between pairs of windows containing double-hung 2/2 wood sash. The distance between windows and cornice suggests a stylistic transition in evidence in Cape Cod houses by the turn of the 19th century, reflecting the use of extended stud heights in houses of conventional frame construction. Full-length sidelights of four-pane glazing (each pane 9"x18") flank the seven-panel glazed door. The whole entry is contained in a plain surround with a broad lintel. Cornice, cornerboards, and window surrounds are unornamented.

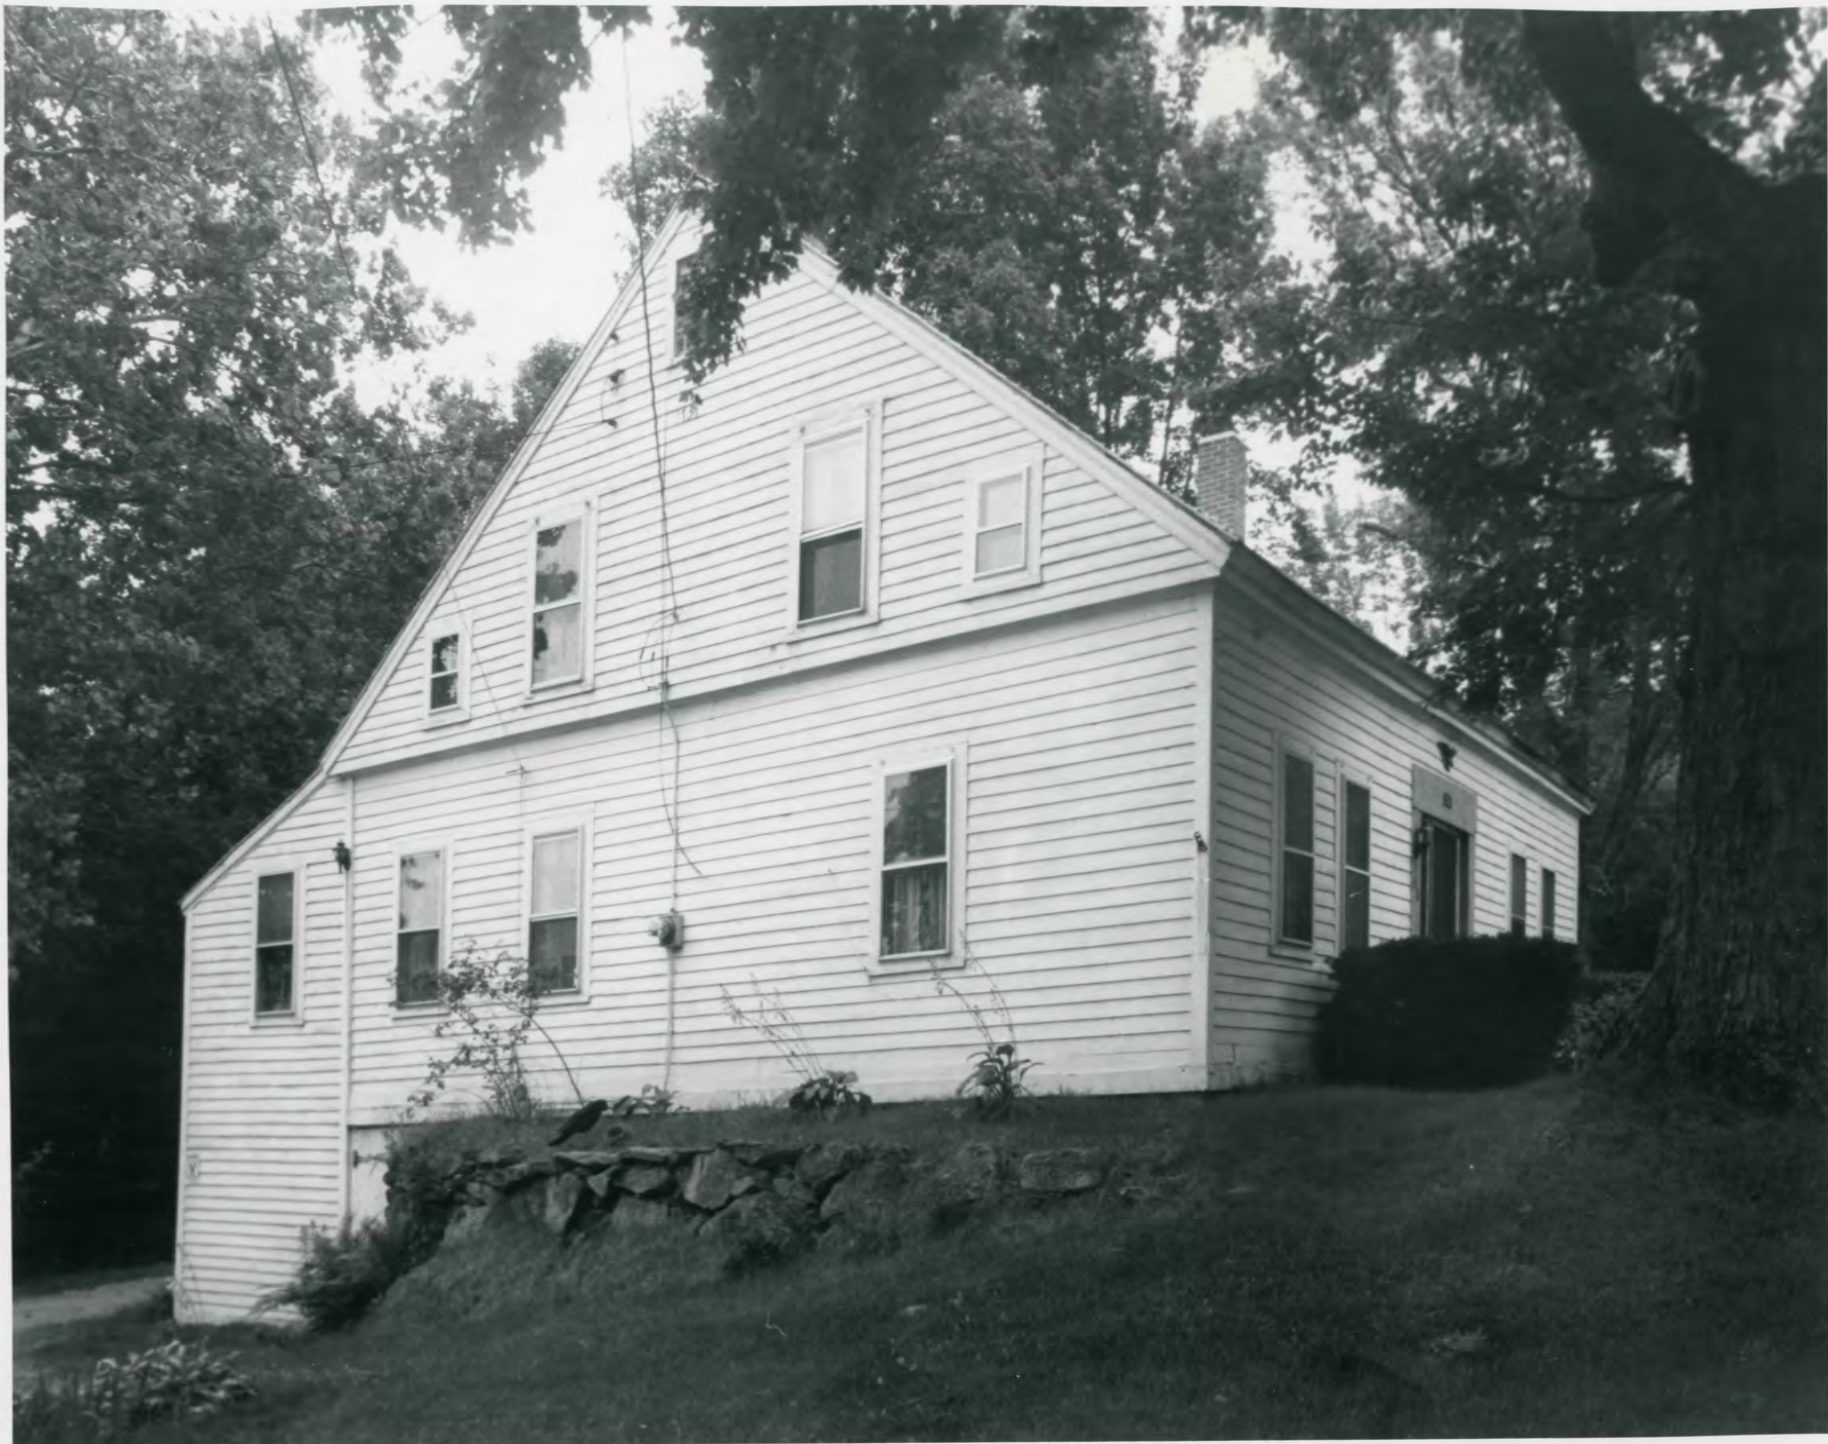
~~DONA FARM~~ MARBLE FARM HISTORIC DISTRICT  
80 Burbank Road  
Sutton, MA 01590  
Photg.- Malcolm Pearson, 7/14/89  
Neg. % Sutton Historical Commission  
~~Photo #3 of 2~~ PHOTO #3 OF 4  
"N end & W front elevations"

MARBLE FARM HISTORIC DISTRICT  
80 BURBANK ROAD, SUTTON, MA  
PHOTO: MALCOLM PEARSON 1989  
NEG: SUTTON HISTORICAL COMMISSION  
4 UXBRIDGE ROAD  
SUTTON, MA 01590  
NORTH END AND WEST FRONT OF FARMHOUSE  
PHOTO #3 OF 4

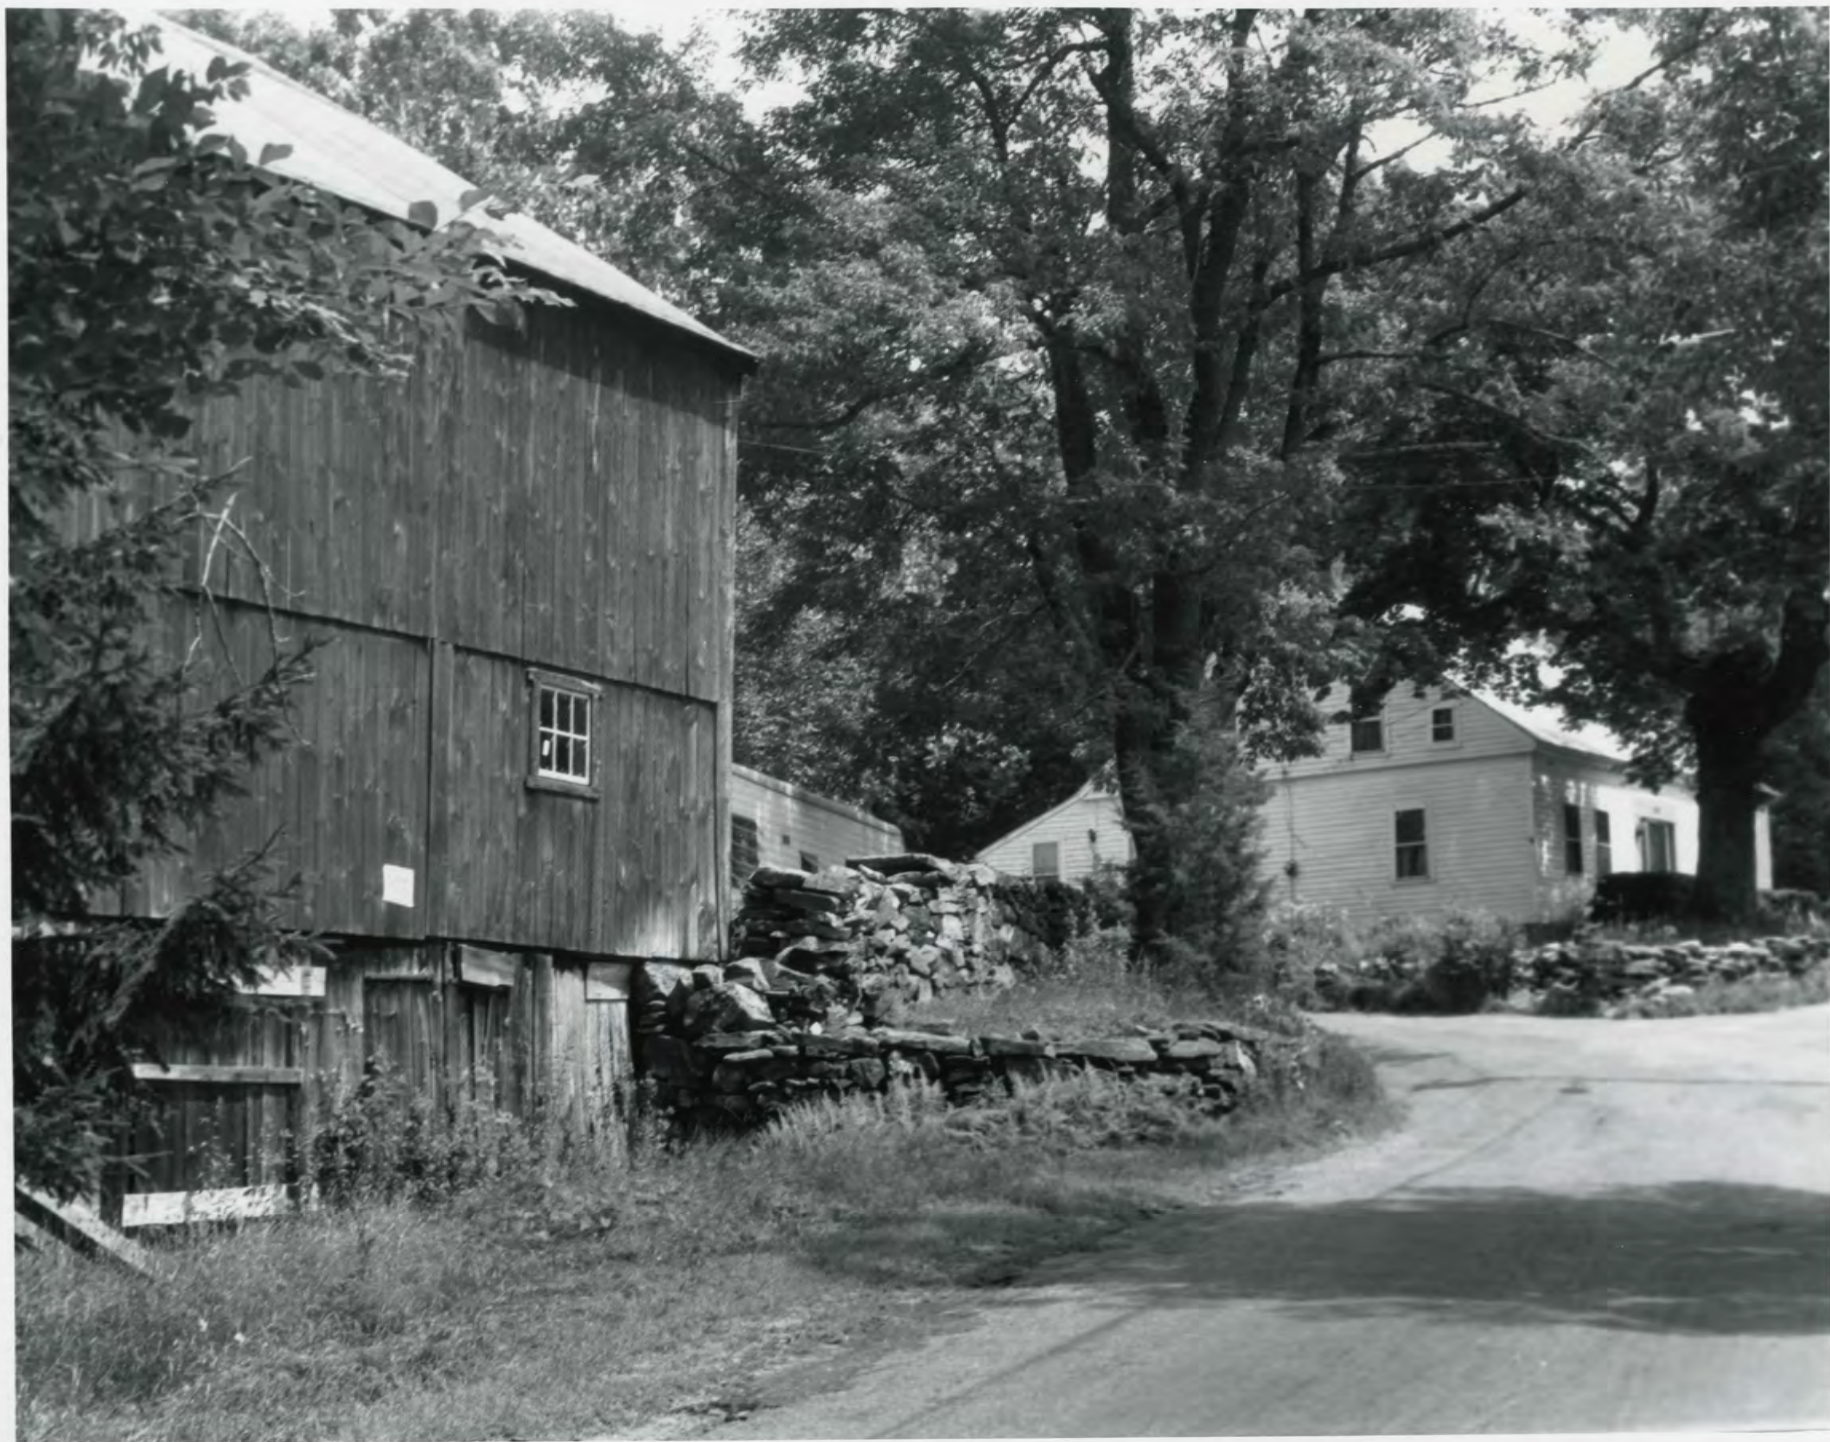
PHOTO # 4 OF 4

WEST VIEW OF BARN IN RELATIONSHIP  
TO HOUSE

The barn and outbuildings are located on lower ground north of the house and across Sibley Road (Photo #4). A farmyard is delineated by a stone wall rounding the Sibley Road-Burbank Road intersection, with the barn on the north, an open equipment shed on the east, and a smaller storage barn southeast of the shed. All three buildings have gable roofs and vertical board sheathing, and incorporate 6-pane sash (fixed in the main barn and equipment shed, double-hung in the small barn) lighting gable ends or

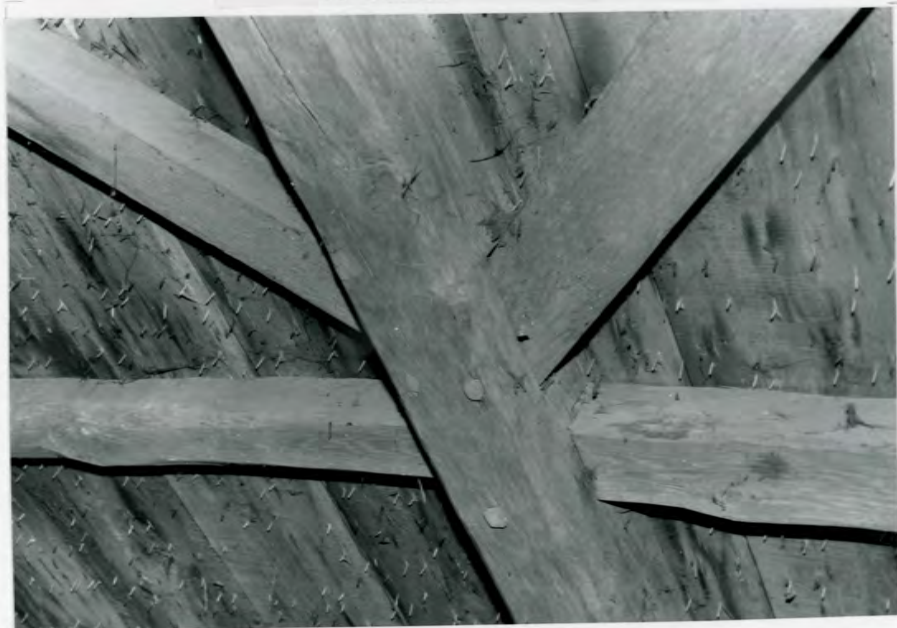
#12- Detail of roof beam  
construction

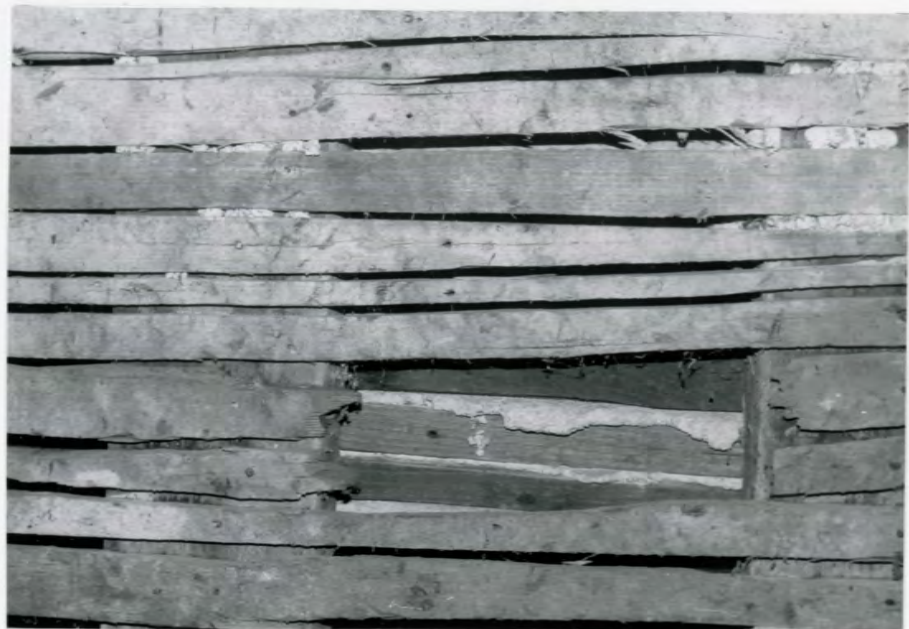
#15- Hand split lathes

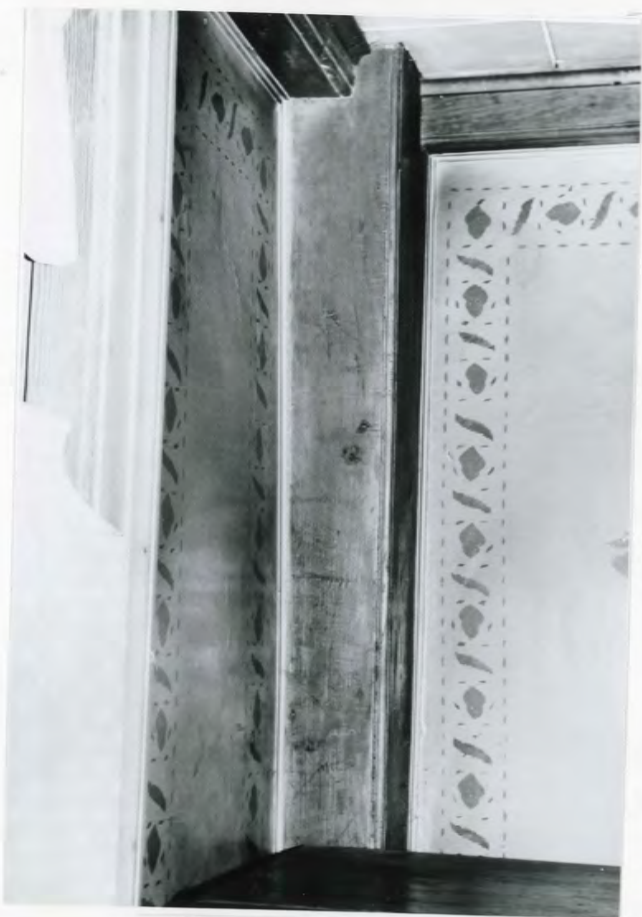
#17- Gunstock post in  
kitchen corner

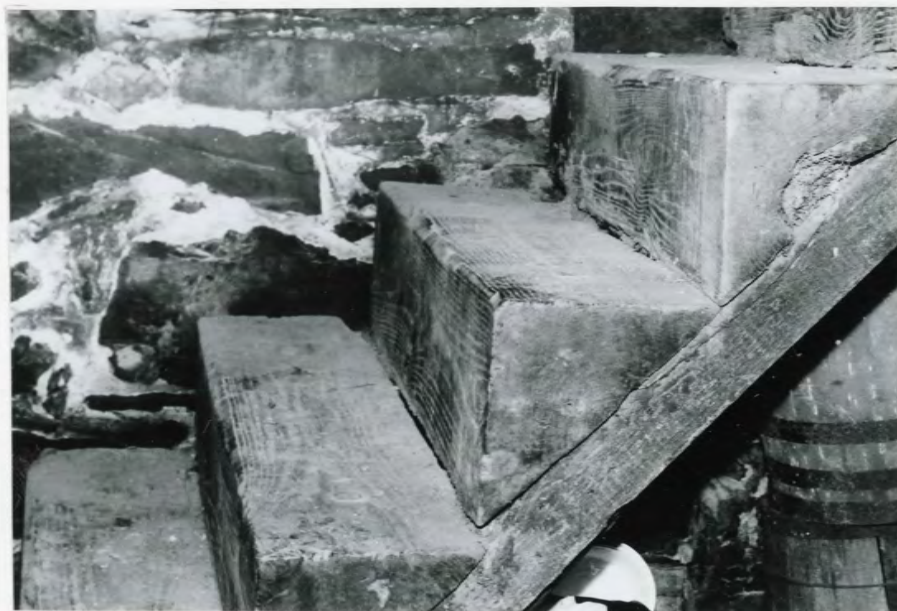
#18- Cellar steps from diagonally  
sawed timber

Interior finishes, however, appear to date to the late 18th century, including beading on boxed beams in the northwest parlor, as well as nails, pintles and straps, latches, and doors. Accordion lath with cut nails is exposed in the southeast room. A single gunstock post behind boxing at the northeast corner of the house may be a survival of the earlier house. Other notable interior features include the central stair with its beaded paneling and turned balustrade at the first floor, and the pegged stairs to the finished cellar consisting of steps of diagonally sawn timbers.

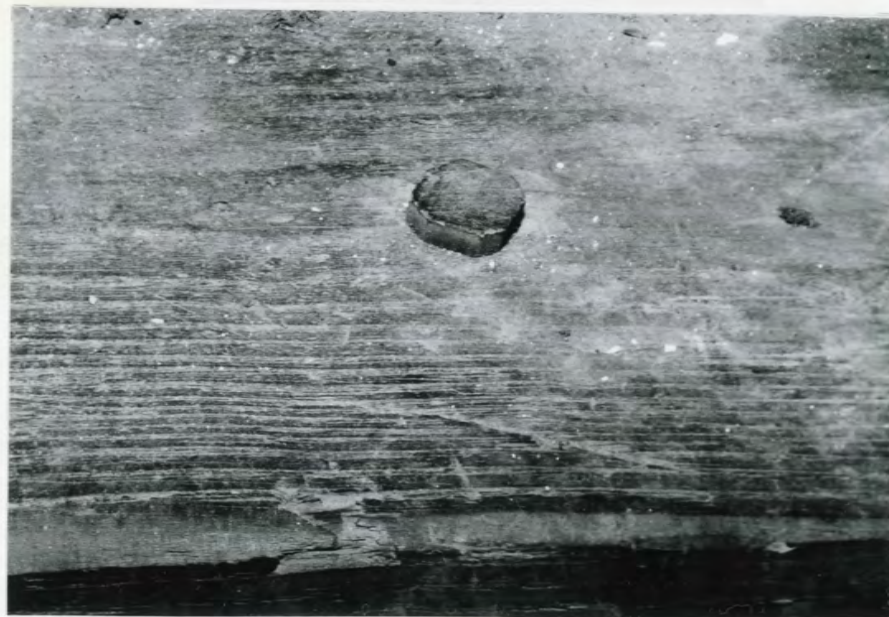
#19- Pegged cellar step

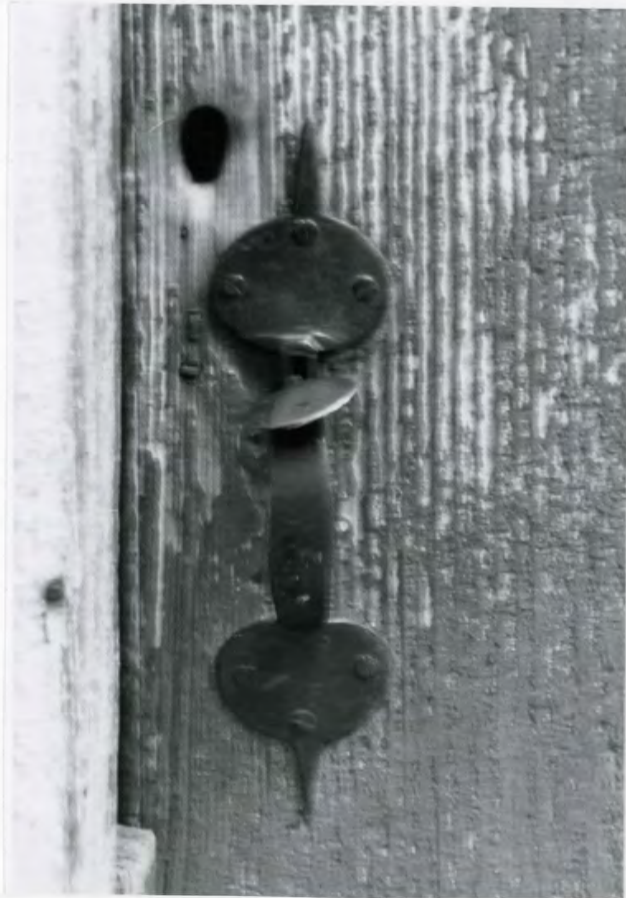
#20- Ell door hand forged  
latch

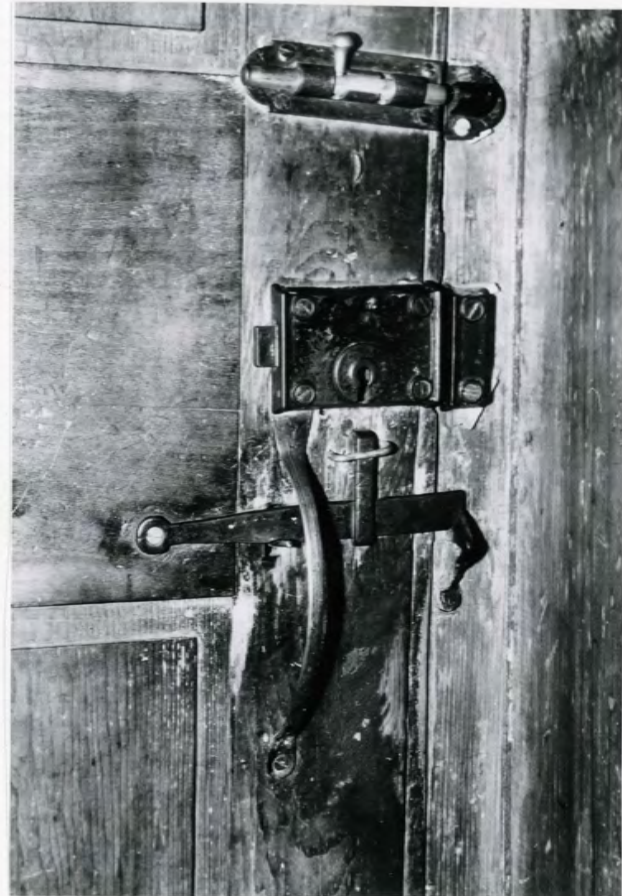
#21- Ell door inside lock  
and latch (original)

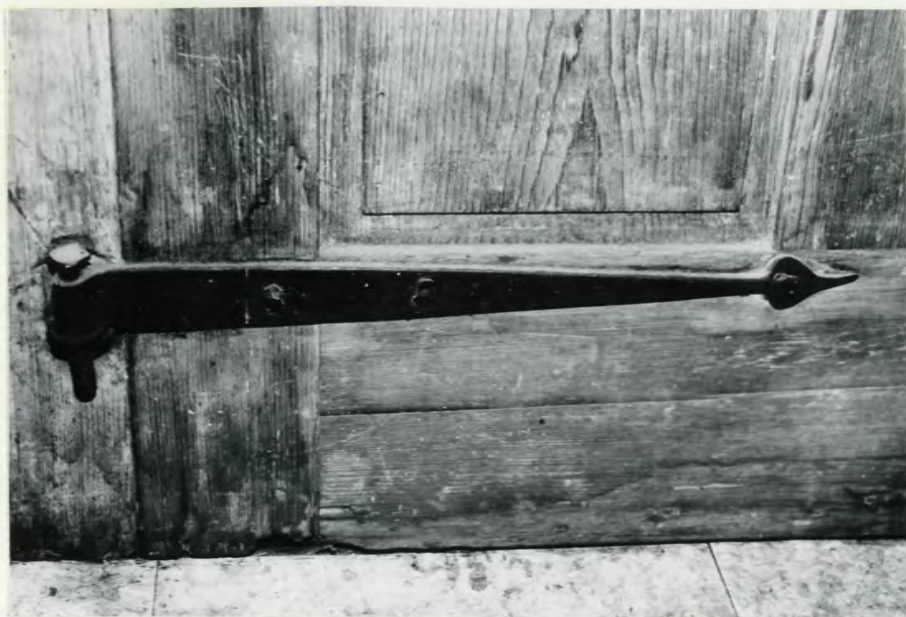
#22- Ell door strap hinge  
(original)

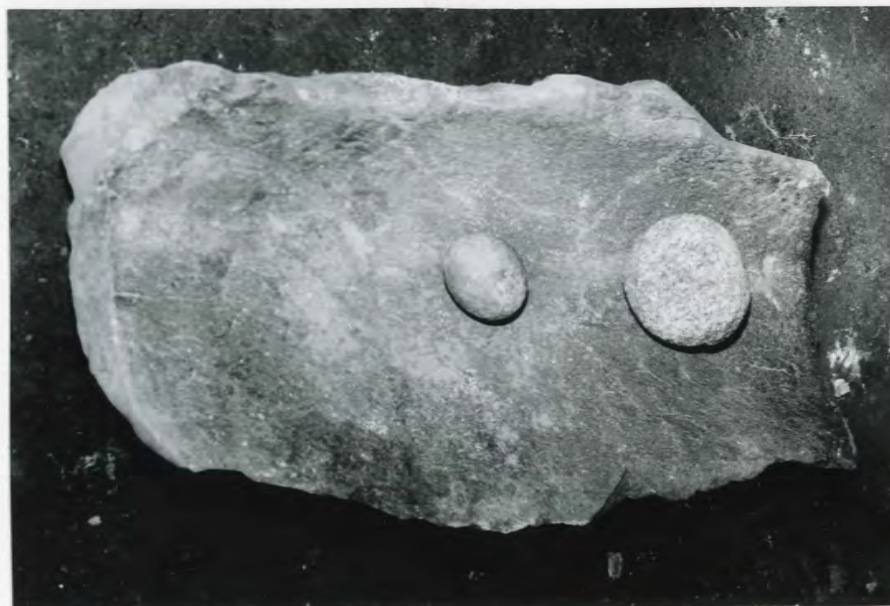
#29 Indian trough shaped mortar and pounding  
stones found in Indian campground 300yds.  
northwest of farmstead

clearing of a portion of Marble's farm. Indian occupation of the terrace at the heart of the farm is evidenced by surface finds such as stone mortars and pestles near the spring northeast of the house. [Bowden, 16-18]
