INDIANA THEATRE

134 West Washington Street, Indianapolis

Marion County

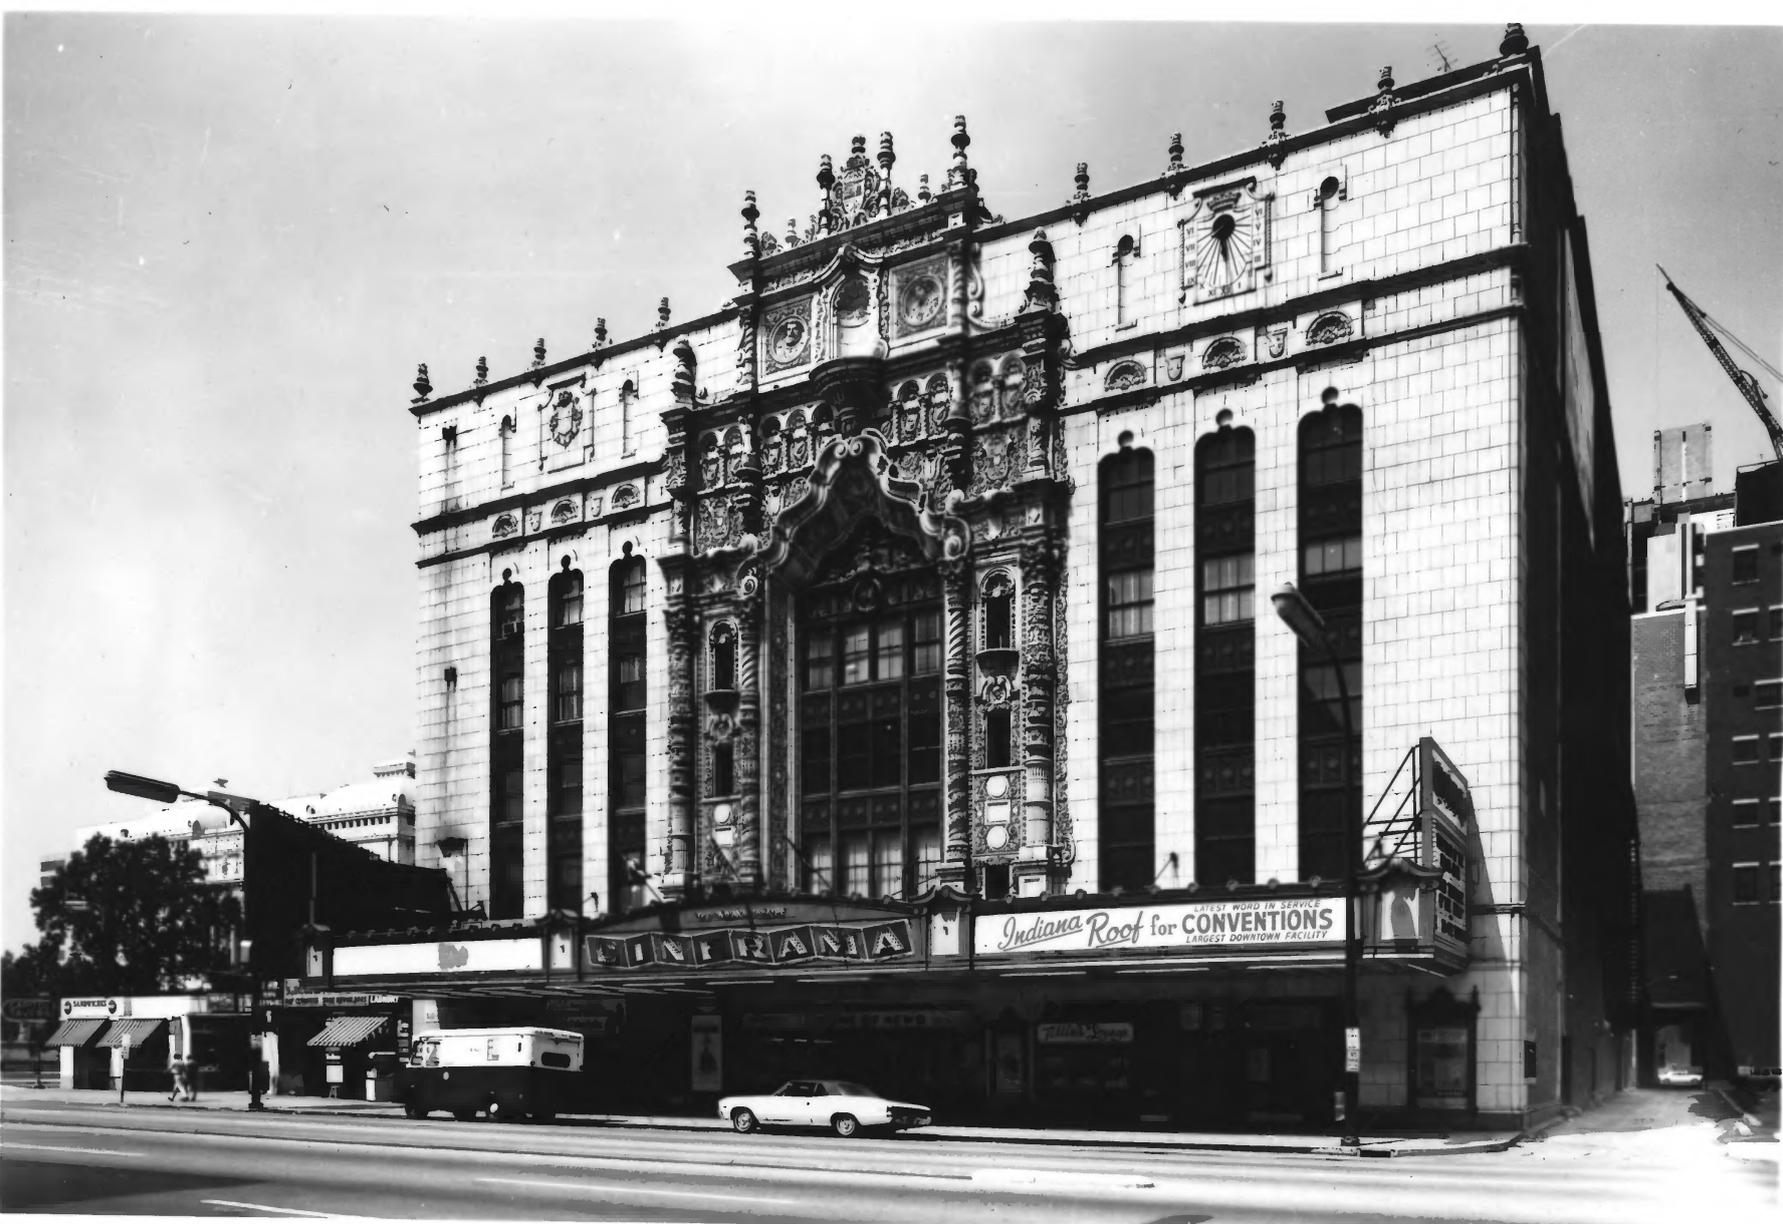
PHOTO 1 -- View of main facade, looking towards the northwest. Indianapolis architectural firm Rubush & Hunter designed the building in 1926-27. Note elaborate terra cotta ornament in "frontispiece," typical of Churrigueresque style of Spanish Baroque architecture. Sculpted ornament was the work of Alexander Sangernebo, chief designed for the F.E.Gates Tile and Marble Company. Marquee, with exception of signs standing at either end, is largely unaltered.

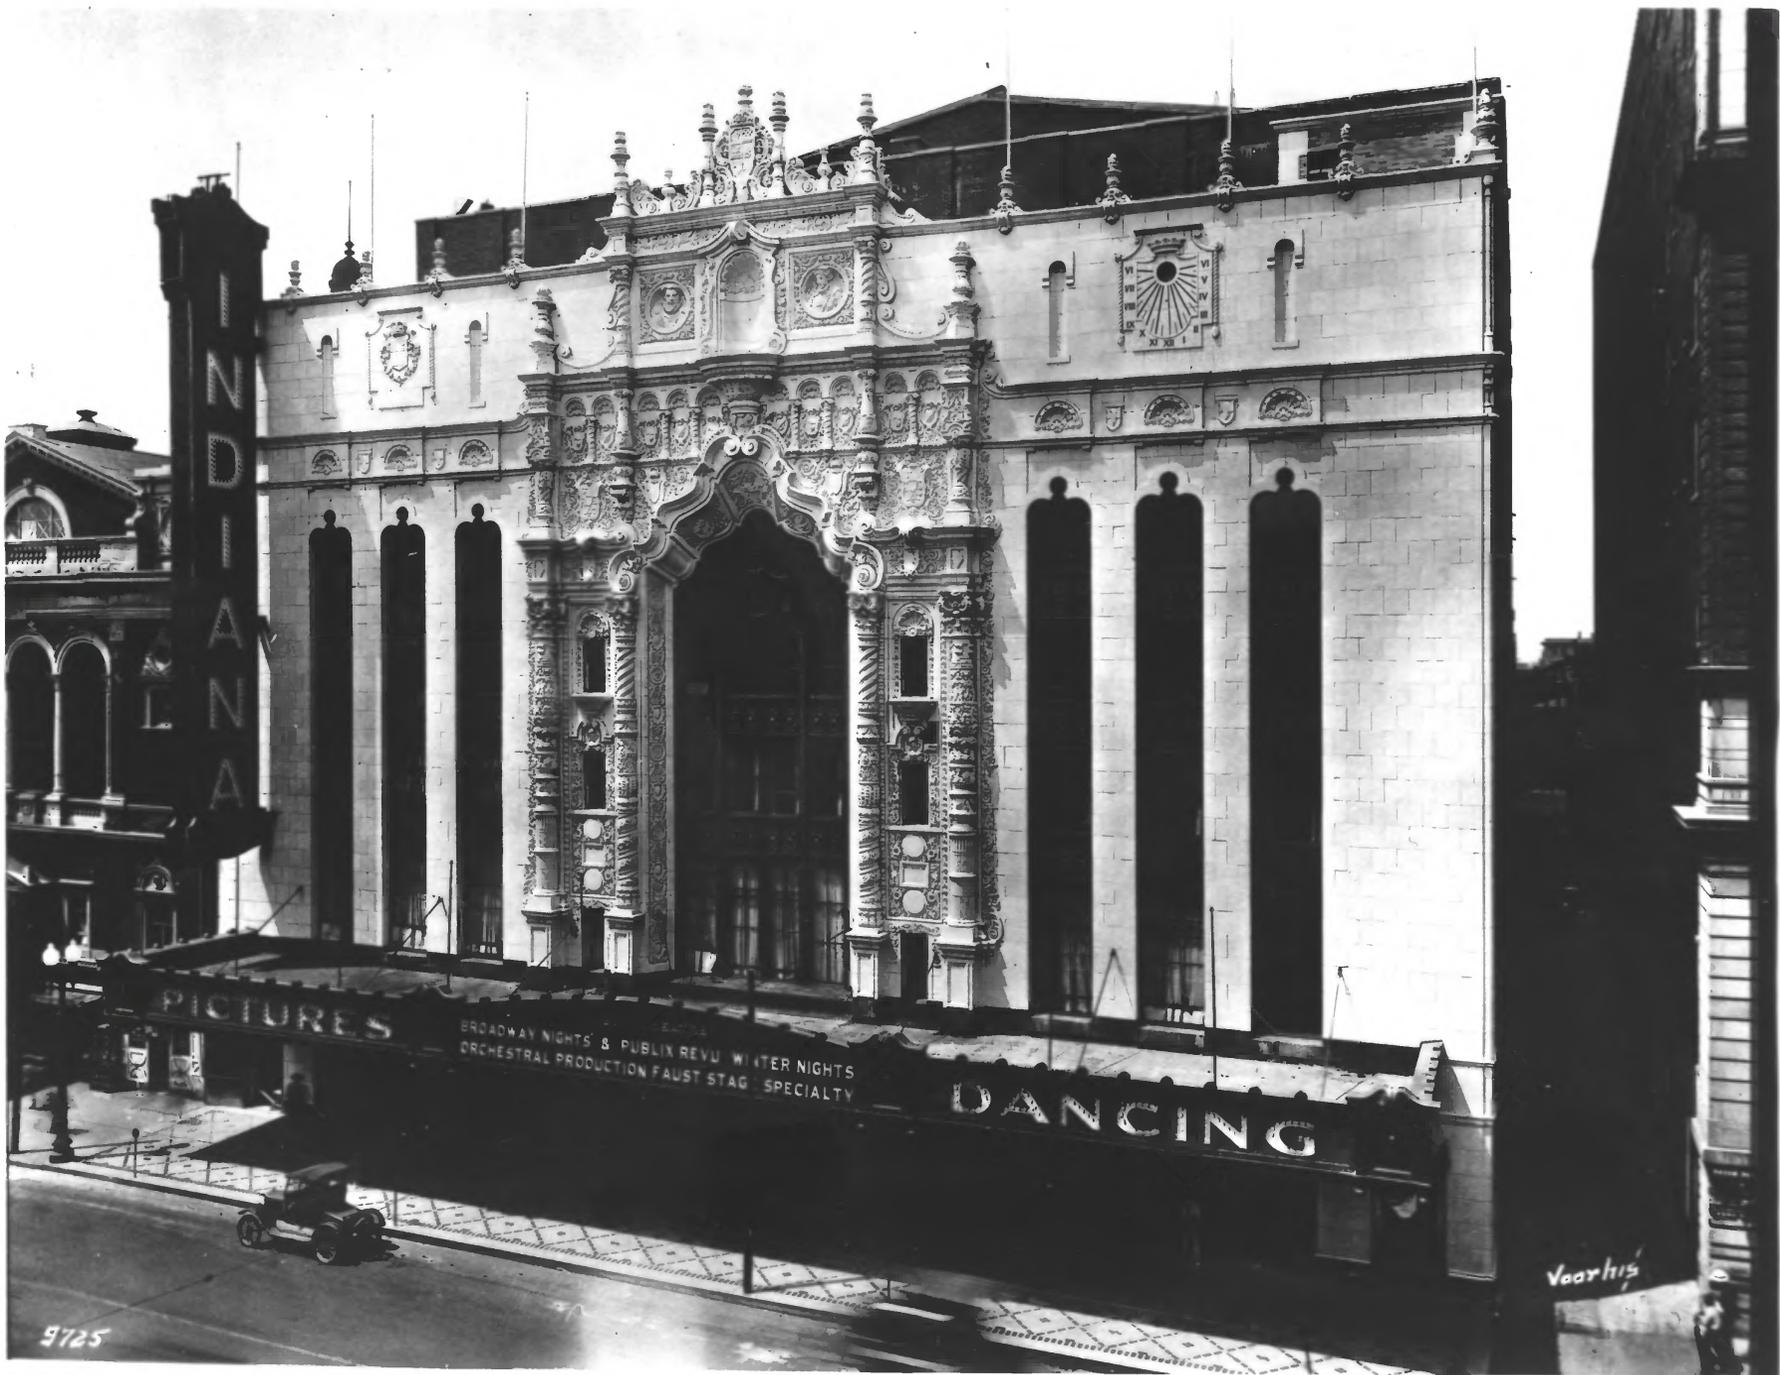
PHOTO 2 View of the Indiana Theatre soon after it was completed. Note vertical sign at far left: this was removed some time prior to 1960. Aside from accumulation of dirt, sign and flagpole removals, little has changed in the facade.

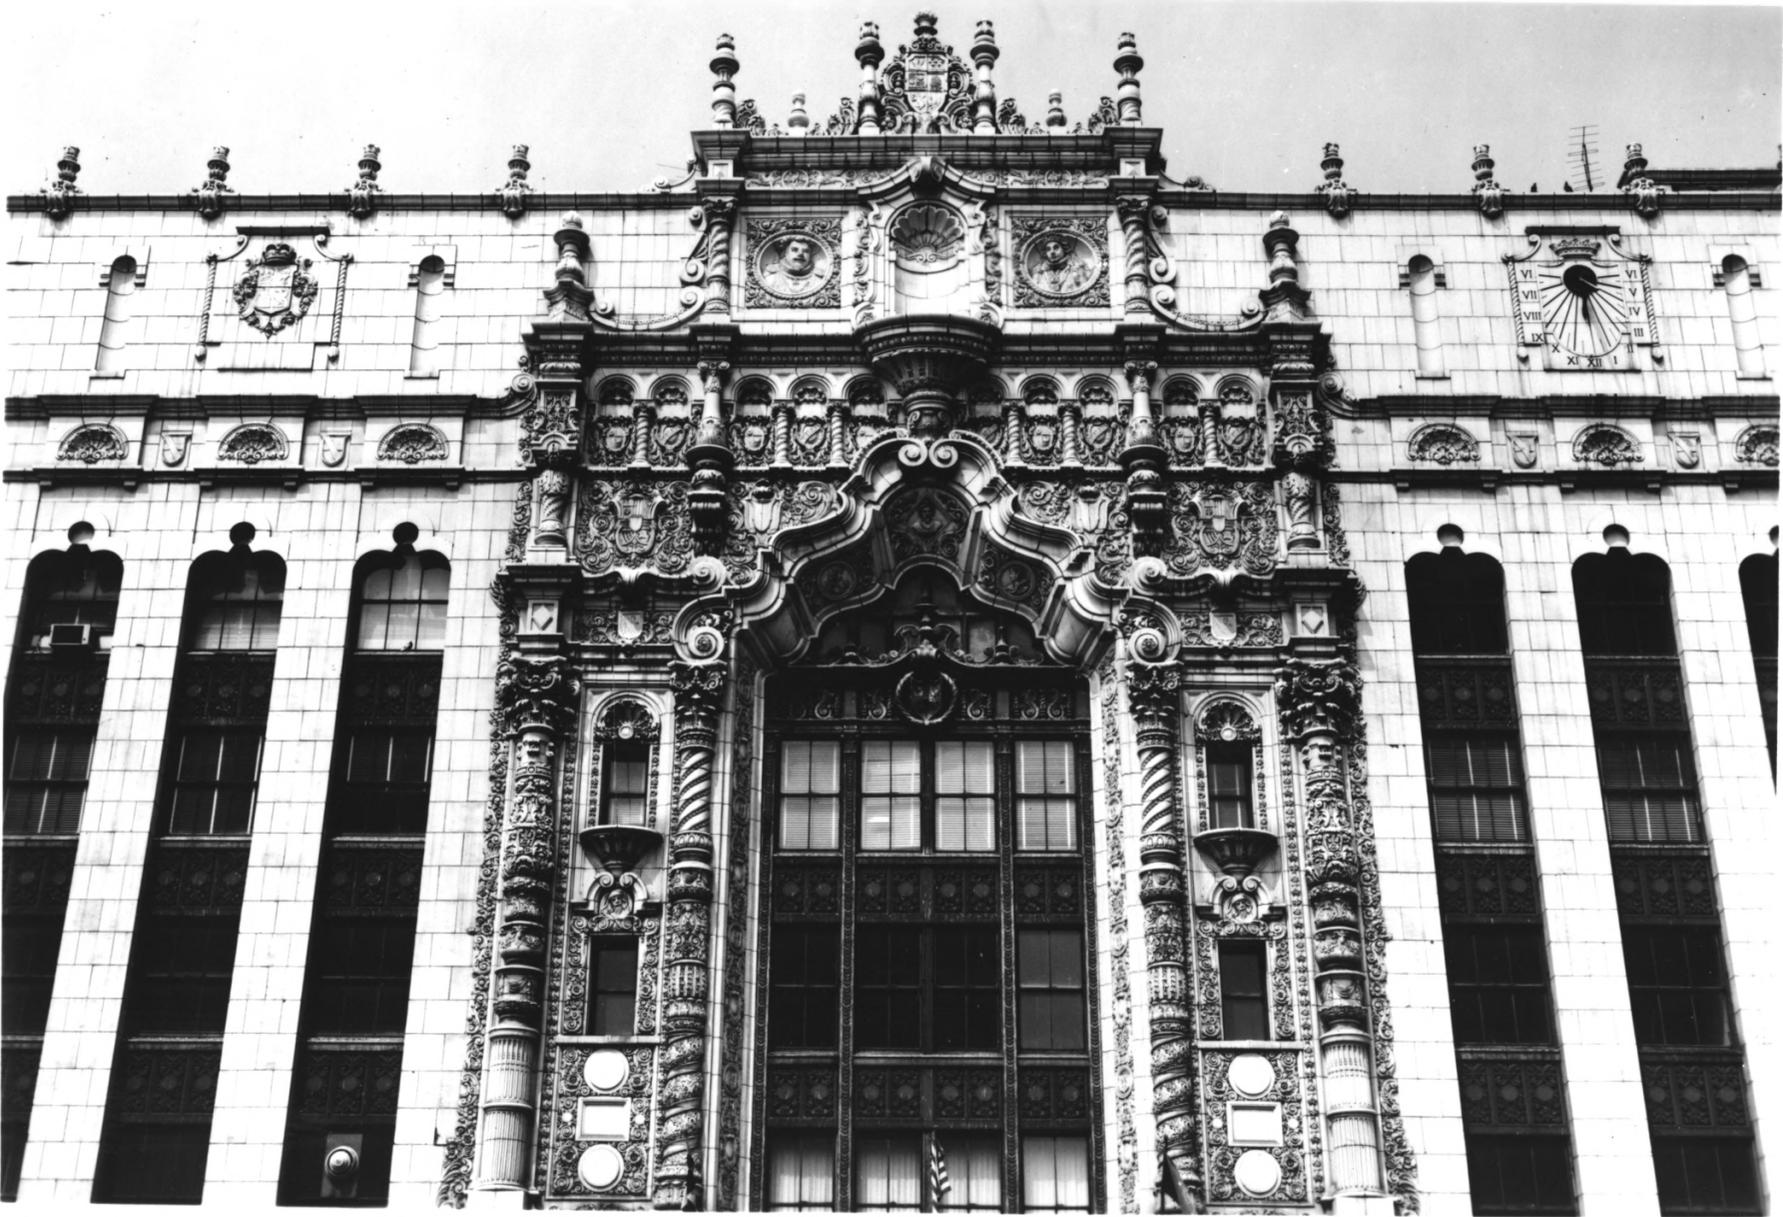
PHOTO 3 Detail of facade, showing "Frontispiece," or central bay stories two through six. Note pairs of elaborate columns on either side, decorative treatment of small windows between columns and decorative metal window spandrels in center and side bays.

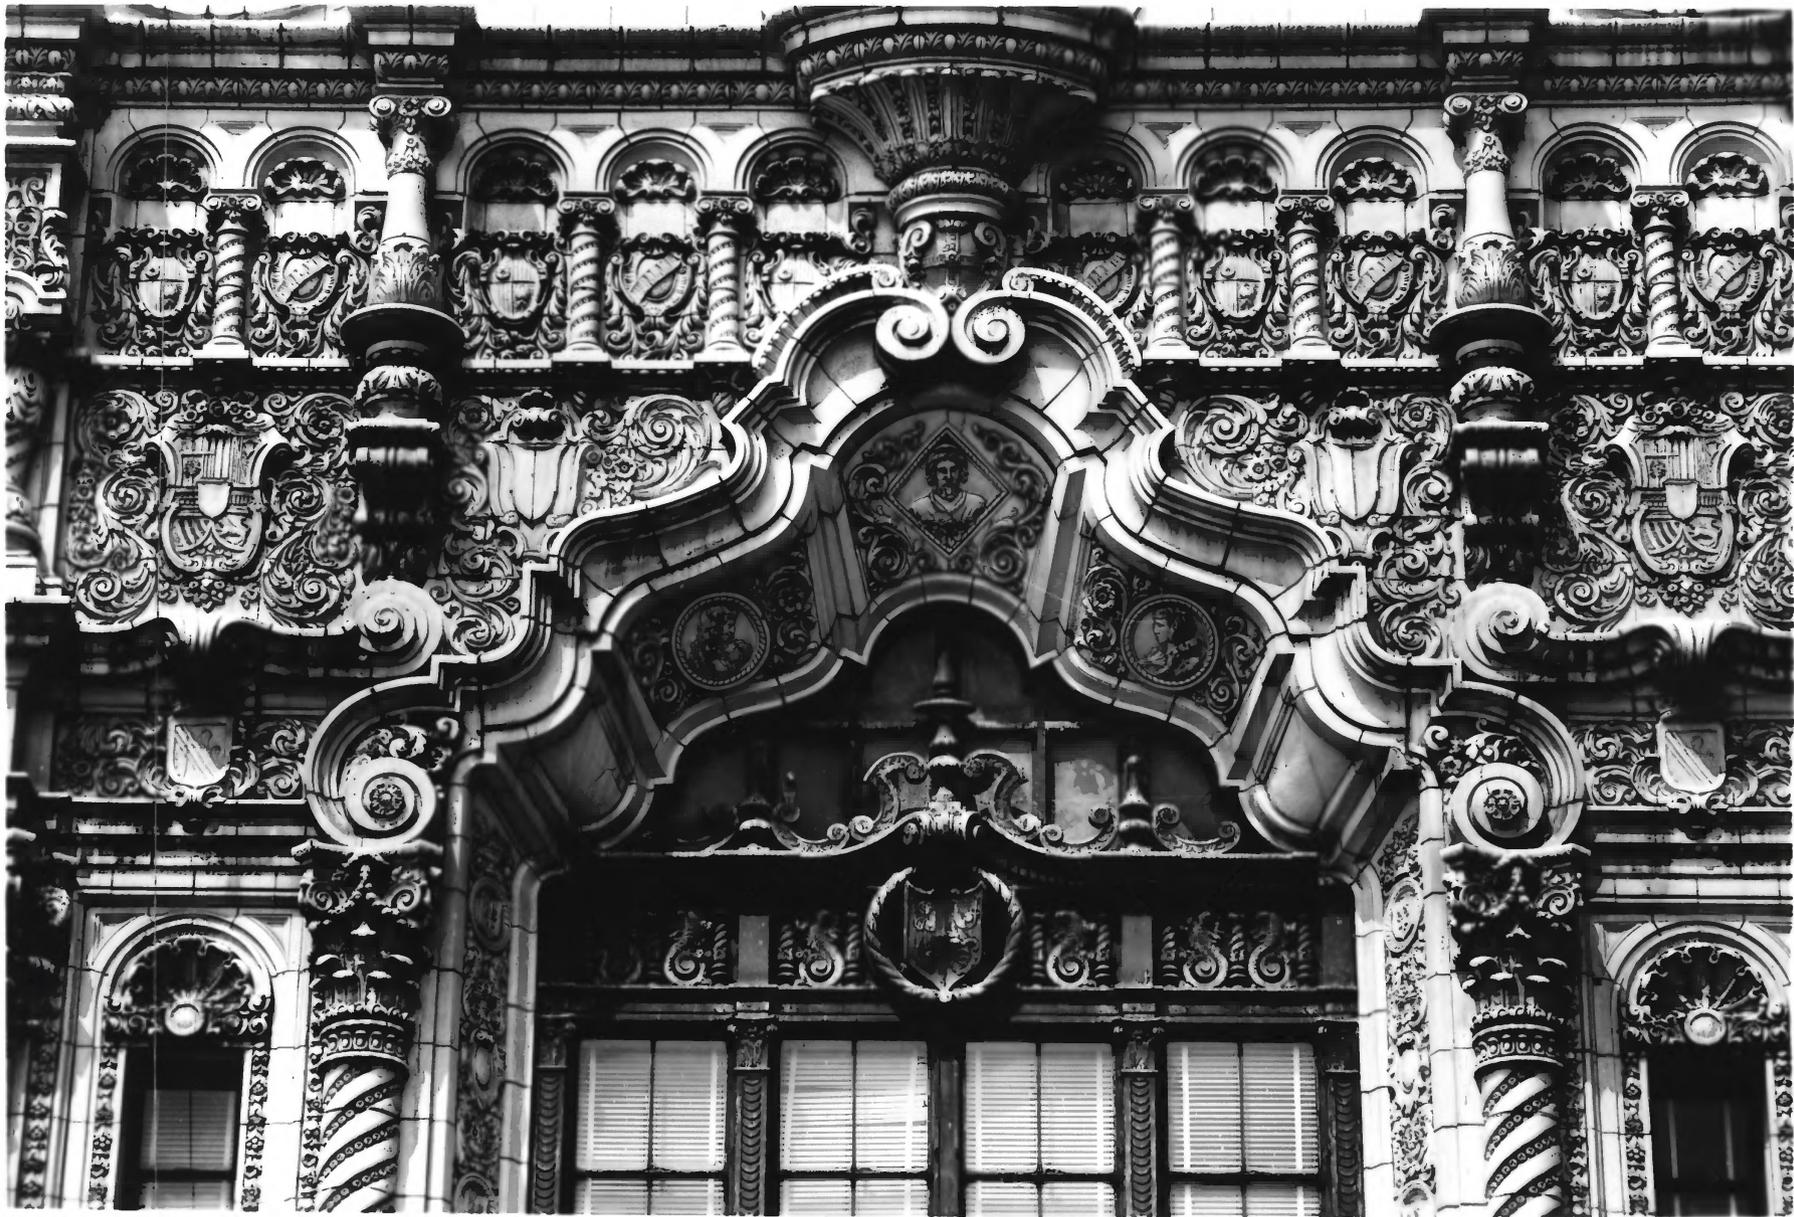
PHOTO 4

Detail, Frontispiece. Note: compound-curved architrave over central arch; diamond portrait medallion of Christopher Columbus; round portrait medallions of Spanish Grandees; wide double frieze with arcaded detail (upper) and foliate and floral detail surrounding shields (lower).

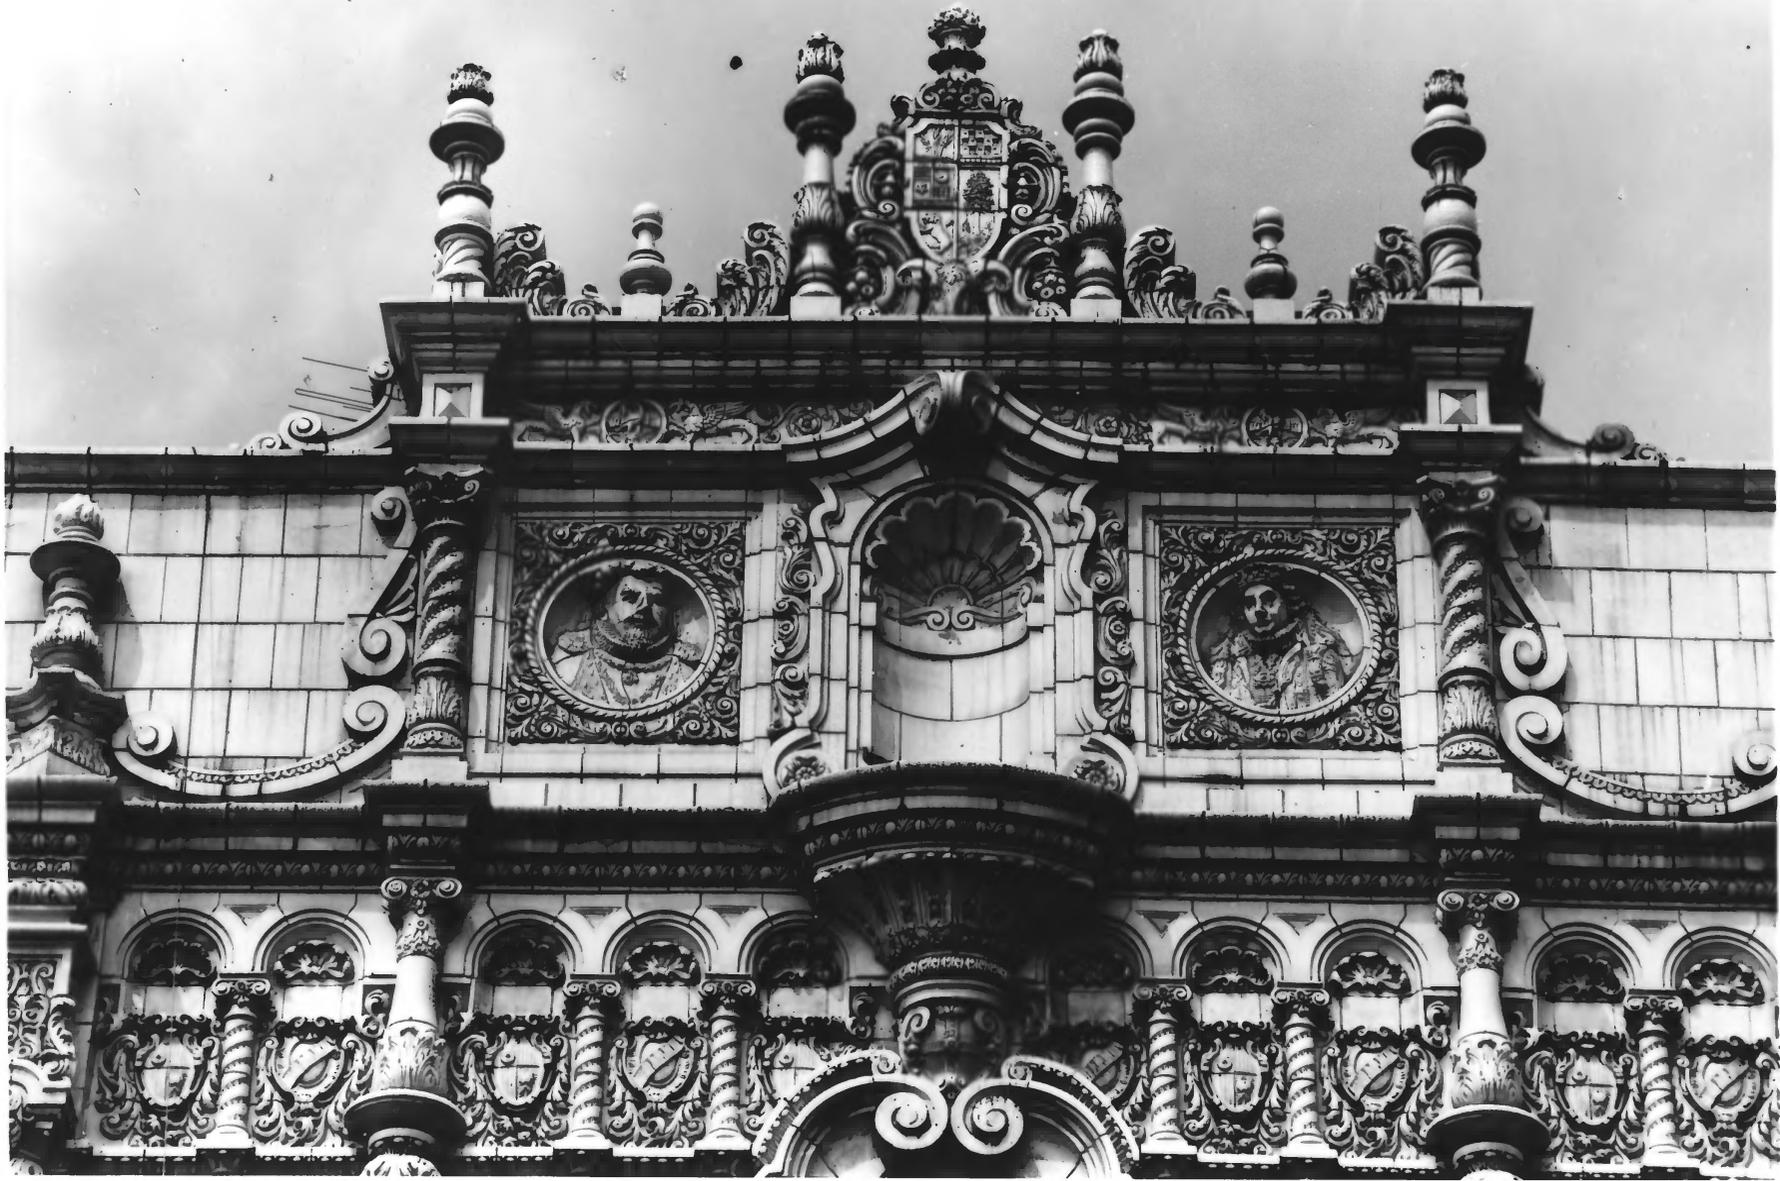
PHOTO 5 Detail, Frontispiece. Round portrait medallions depict King Ferdinand and Queen Isabella; centered, a niche topped with ornamental concha; above, a frieze with griffins and swans, symbols of royalty. At the very top, a shield resting on a bull's head supports a bowl of pomegranates.

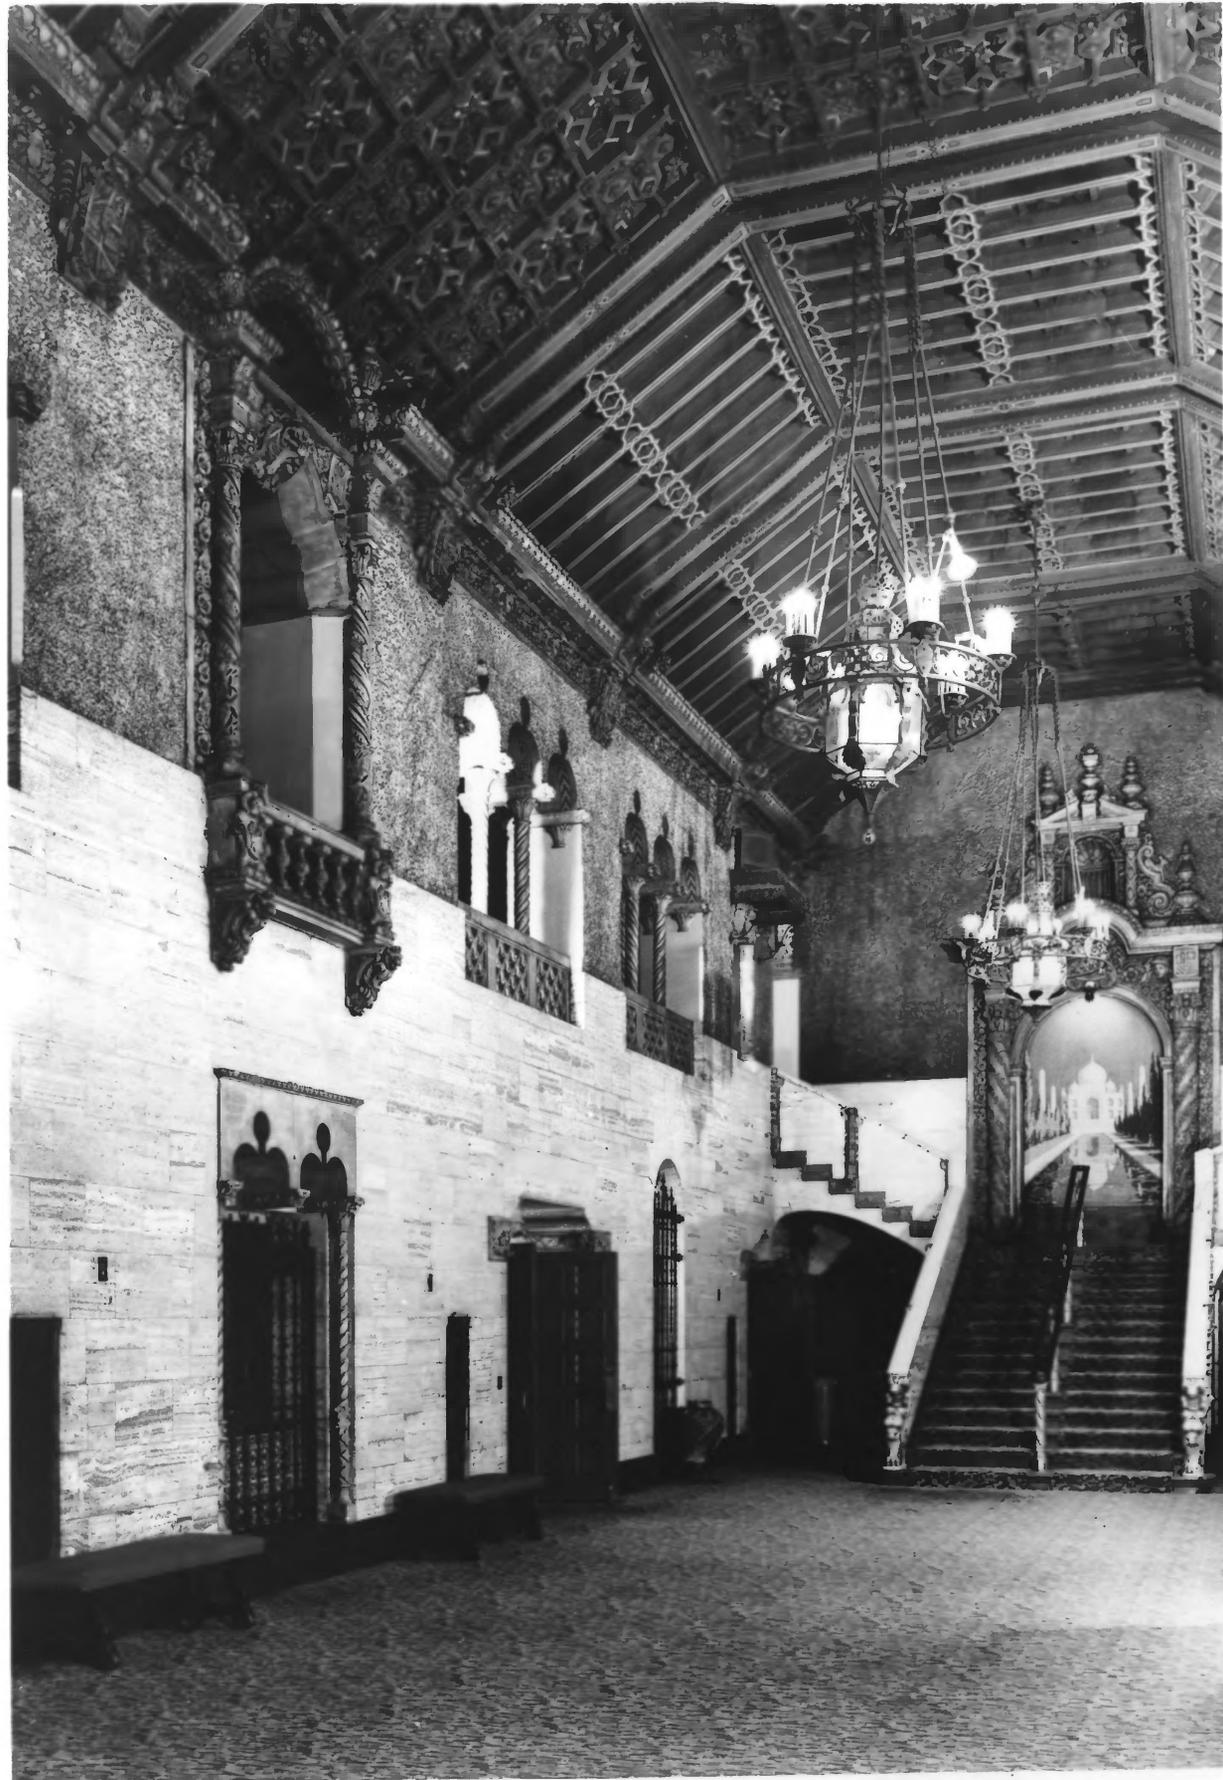
PHOTO 6 Main Lobby, Grand Stairs, Mezzanine Promenade,
view looking northeast towards auditorium. Walls
are polished travertine ashlar; ceiling is plaster.
Stairway landing displays a painting of the Taj
Mahal by noted Indiana artist Randolph LaSalle
Coats.

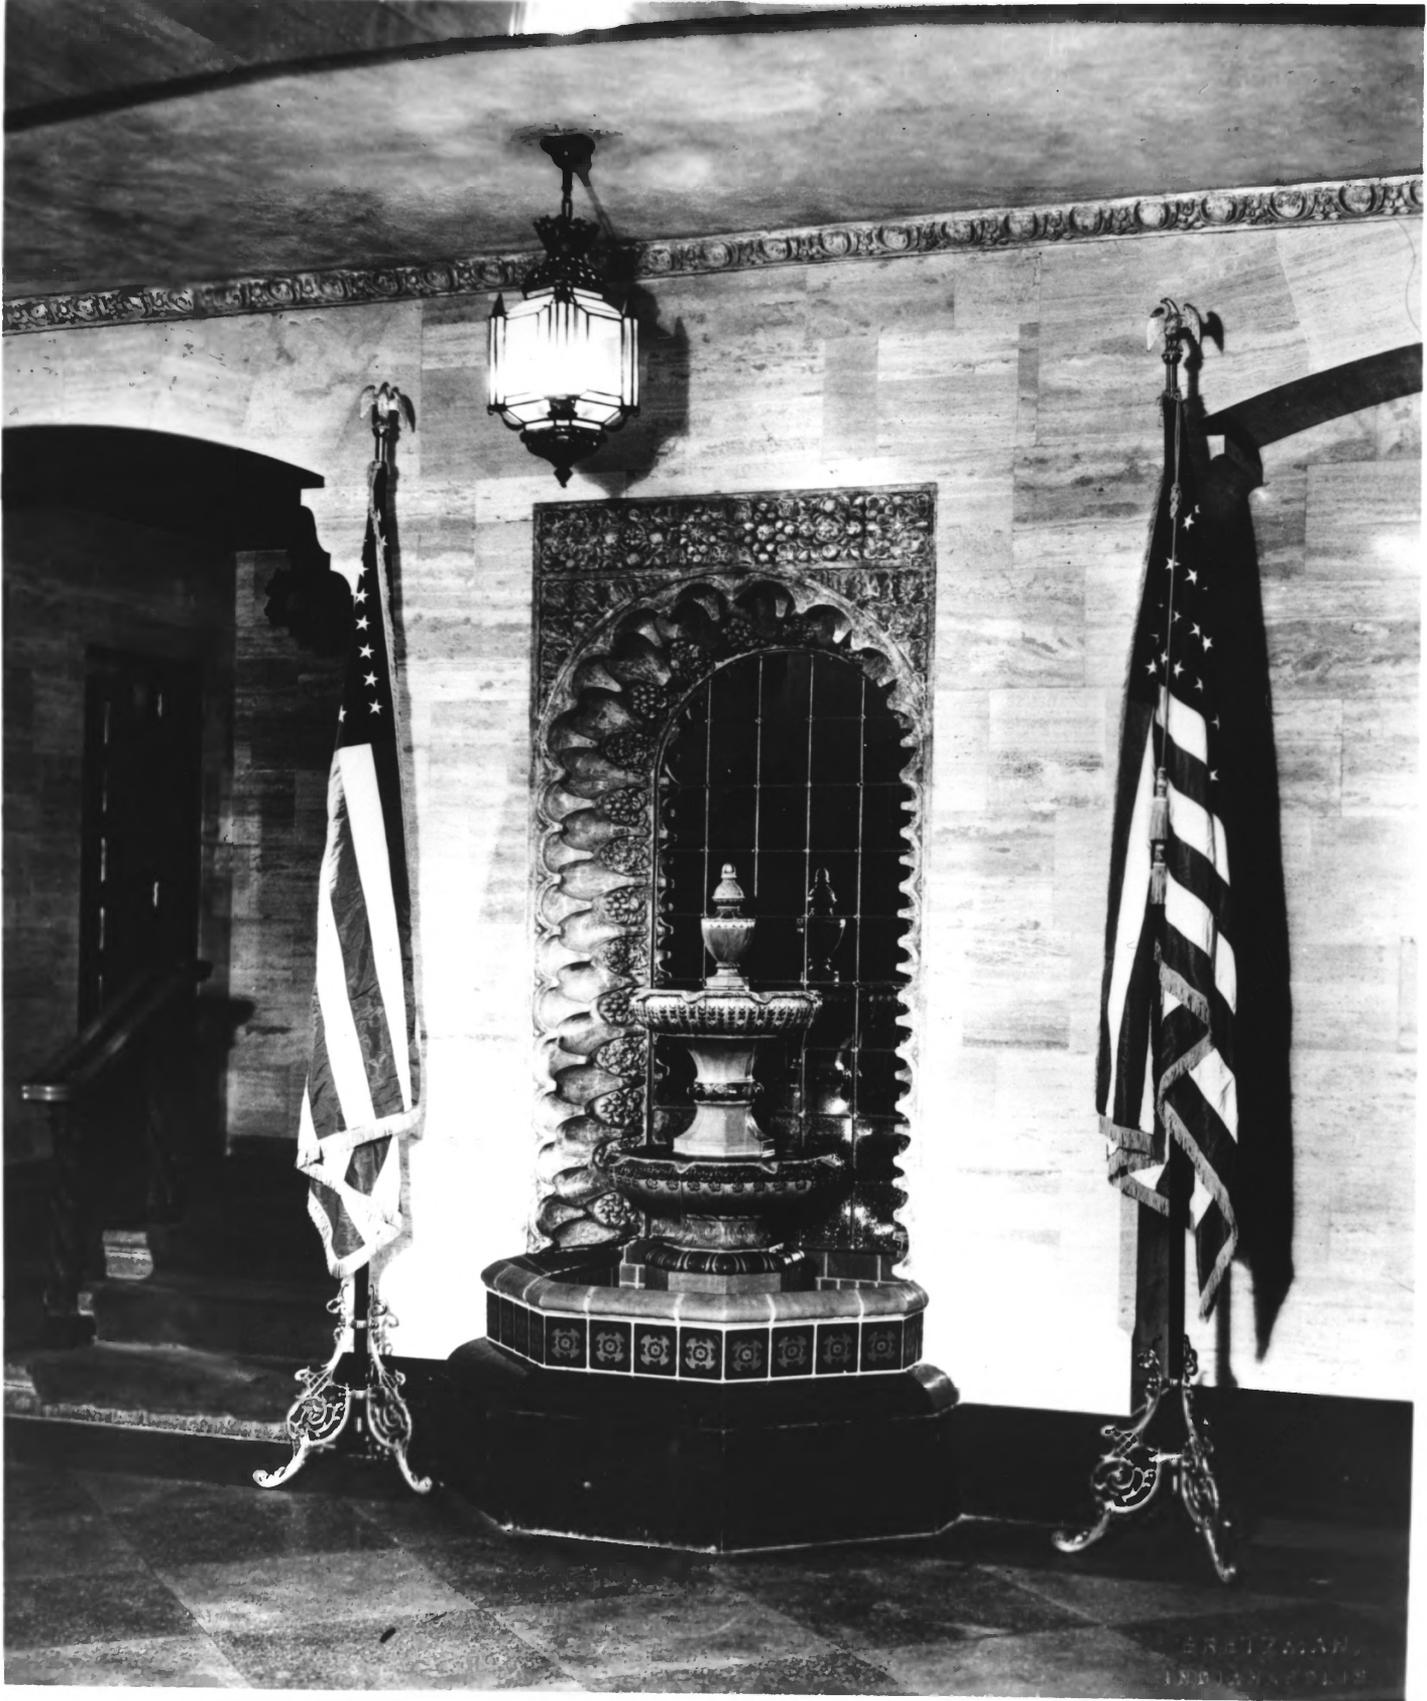
PHOTO 7 Interior detail: west wall of Main Lobby.
Rookwood tile fountain in mirrored niche. Note
also light fixture, one of several styles created
for the building.

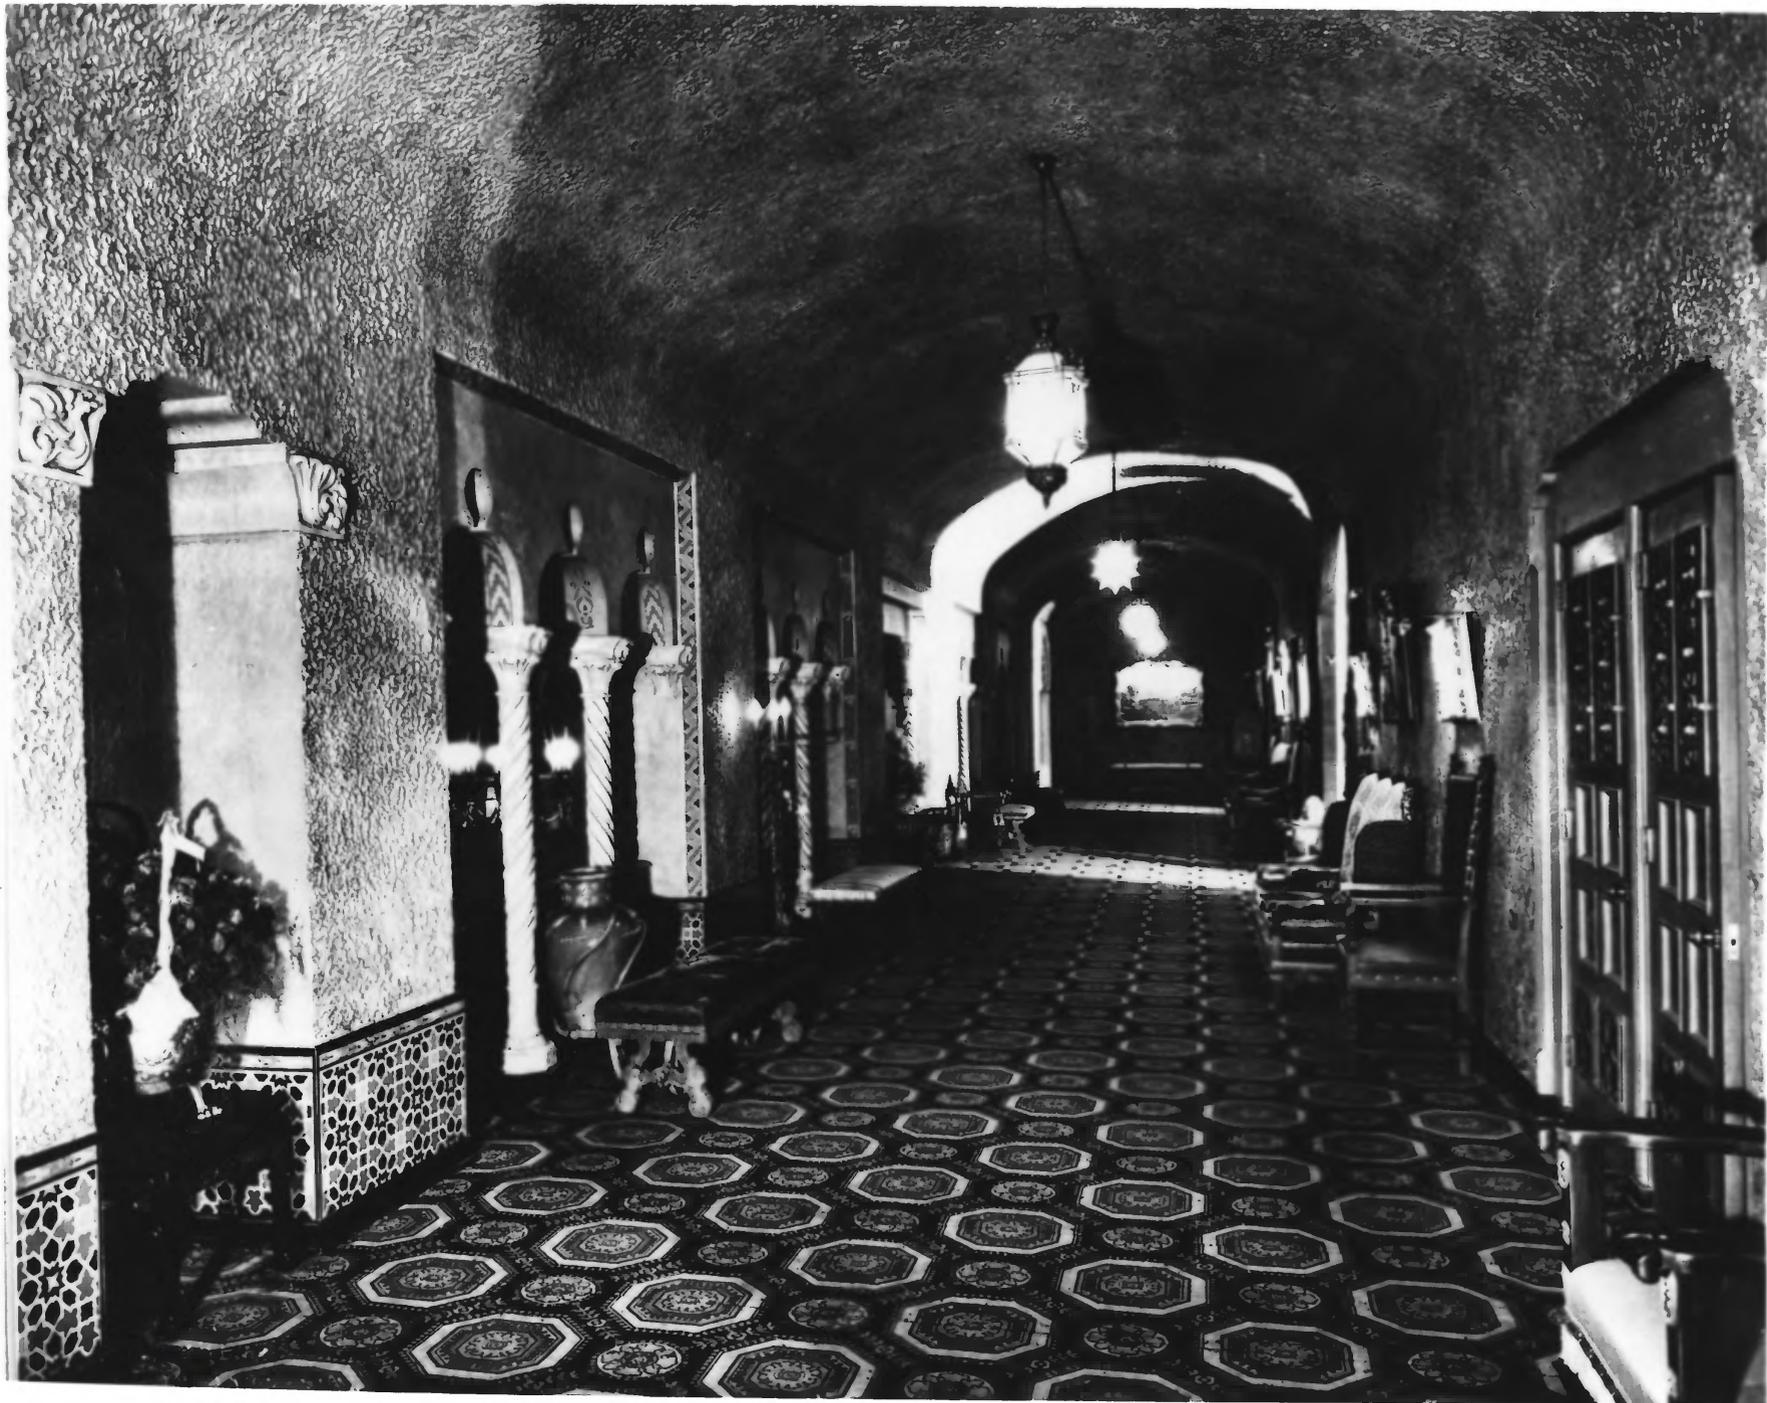
PHOTO 8

Interior detail; north side of mezzanine promenade, old view. Shows some of the decorative furnishings, Spanish tile, stencilled arch undersides, and different types of lighting fixtures. Doors on right lead to auditorium balcony.

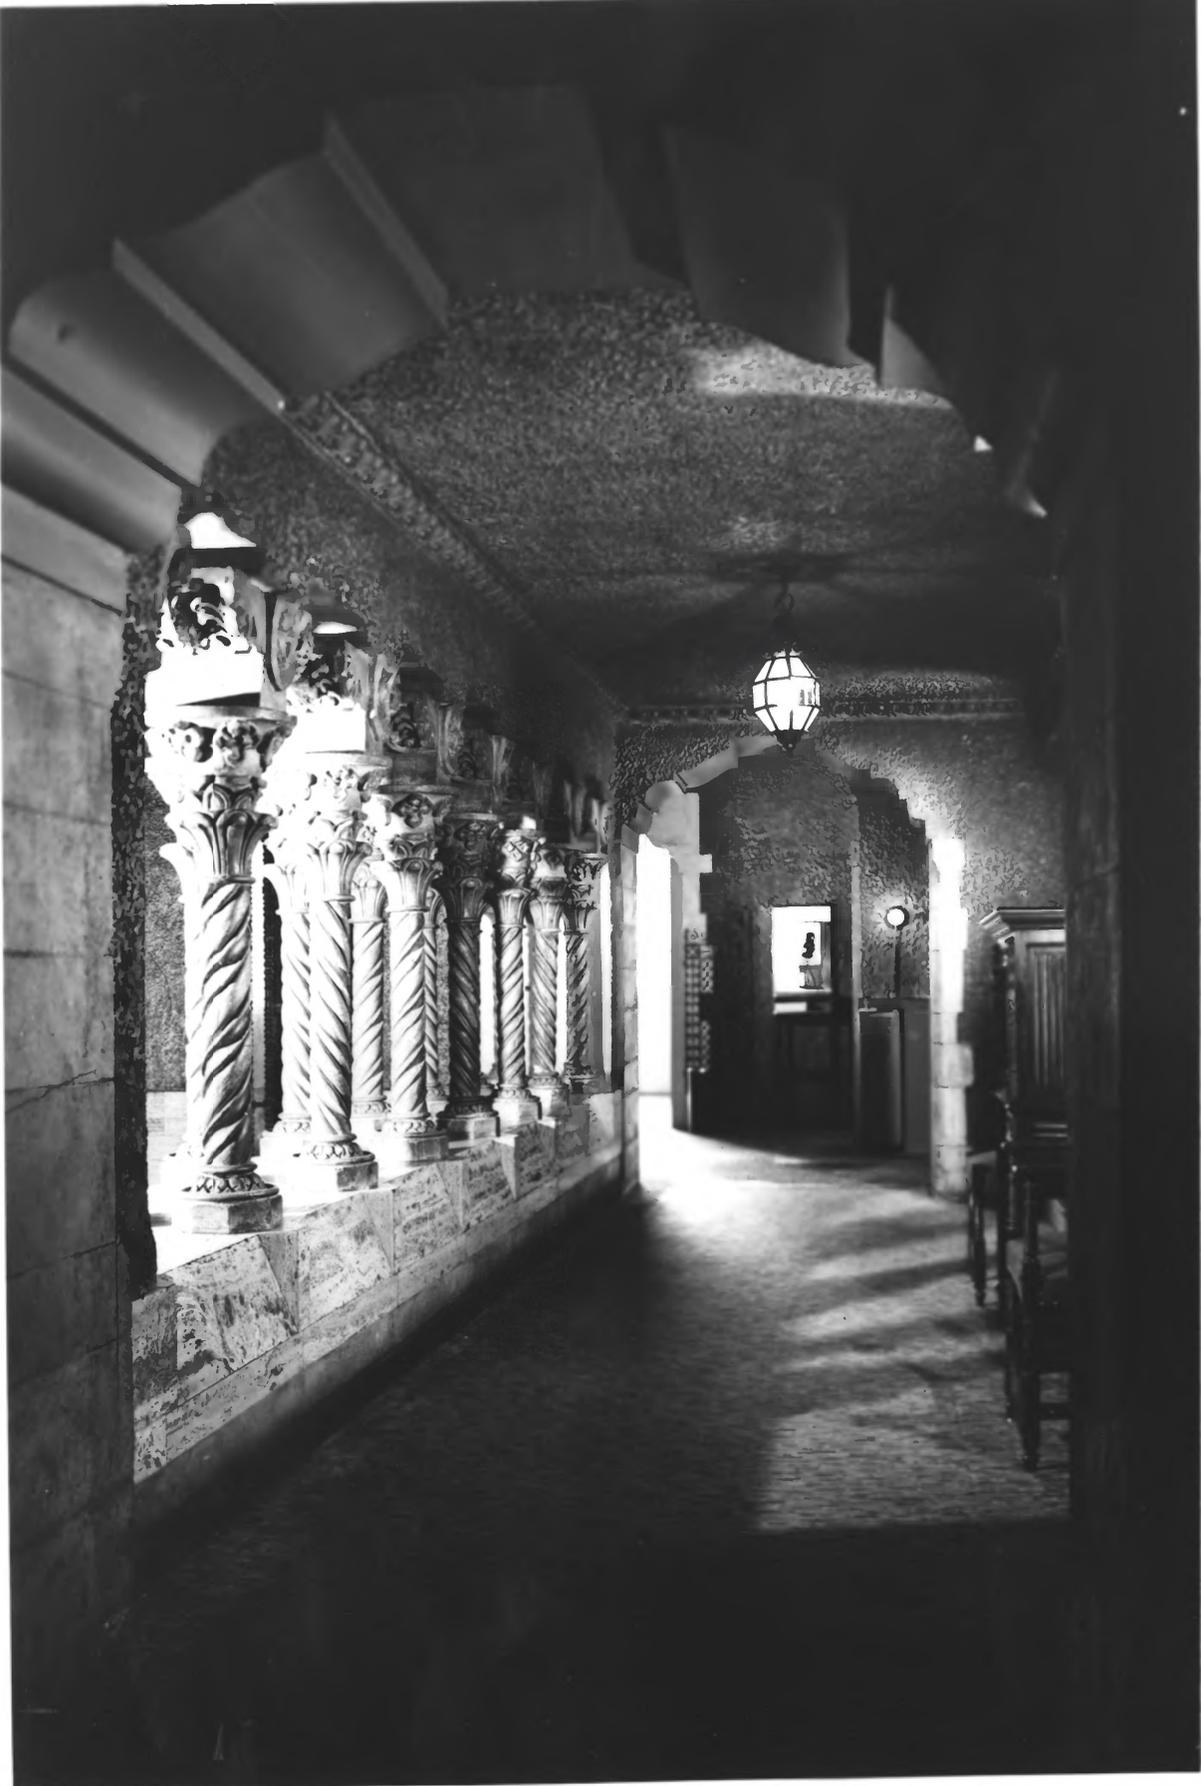
PHOTO 9 Interior detail, West end of Mezzanine Promenade,
looking toward south. Note double row of spiraled
columns, through which one views the Main Lobby
below.

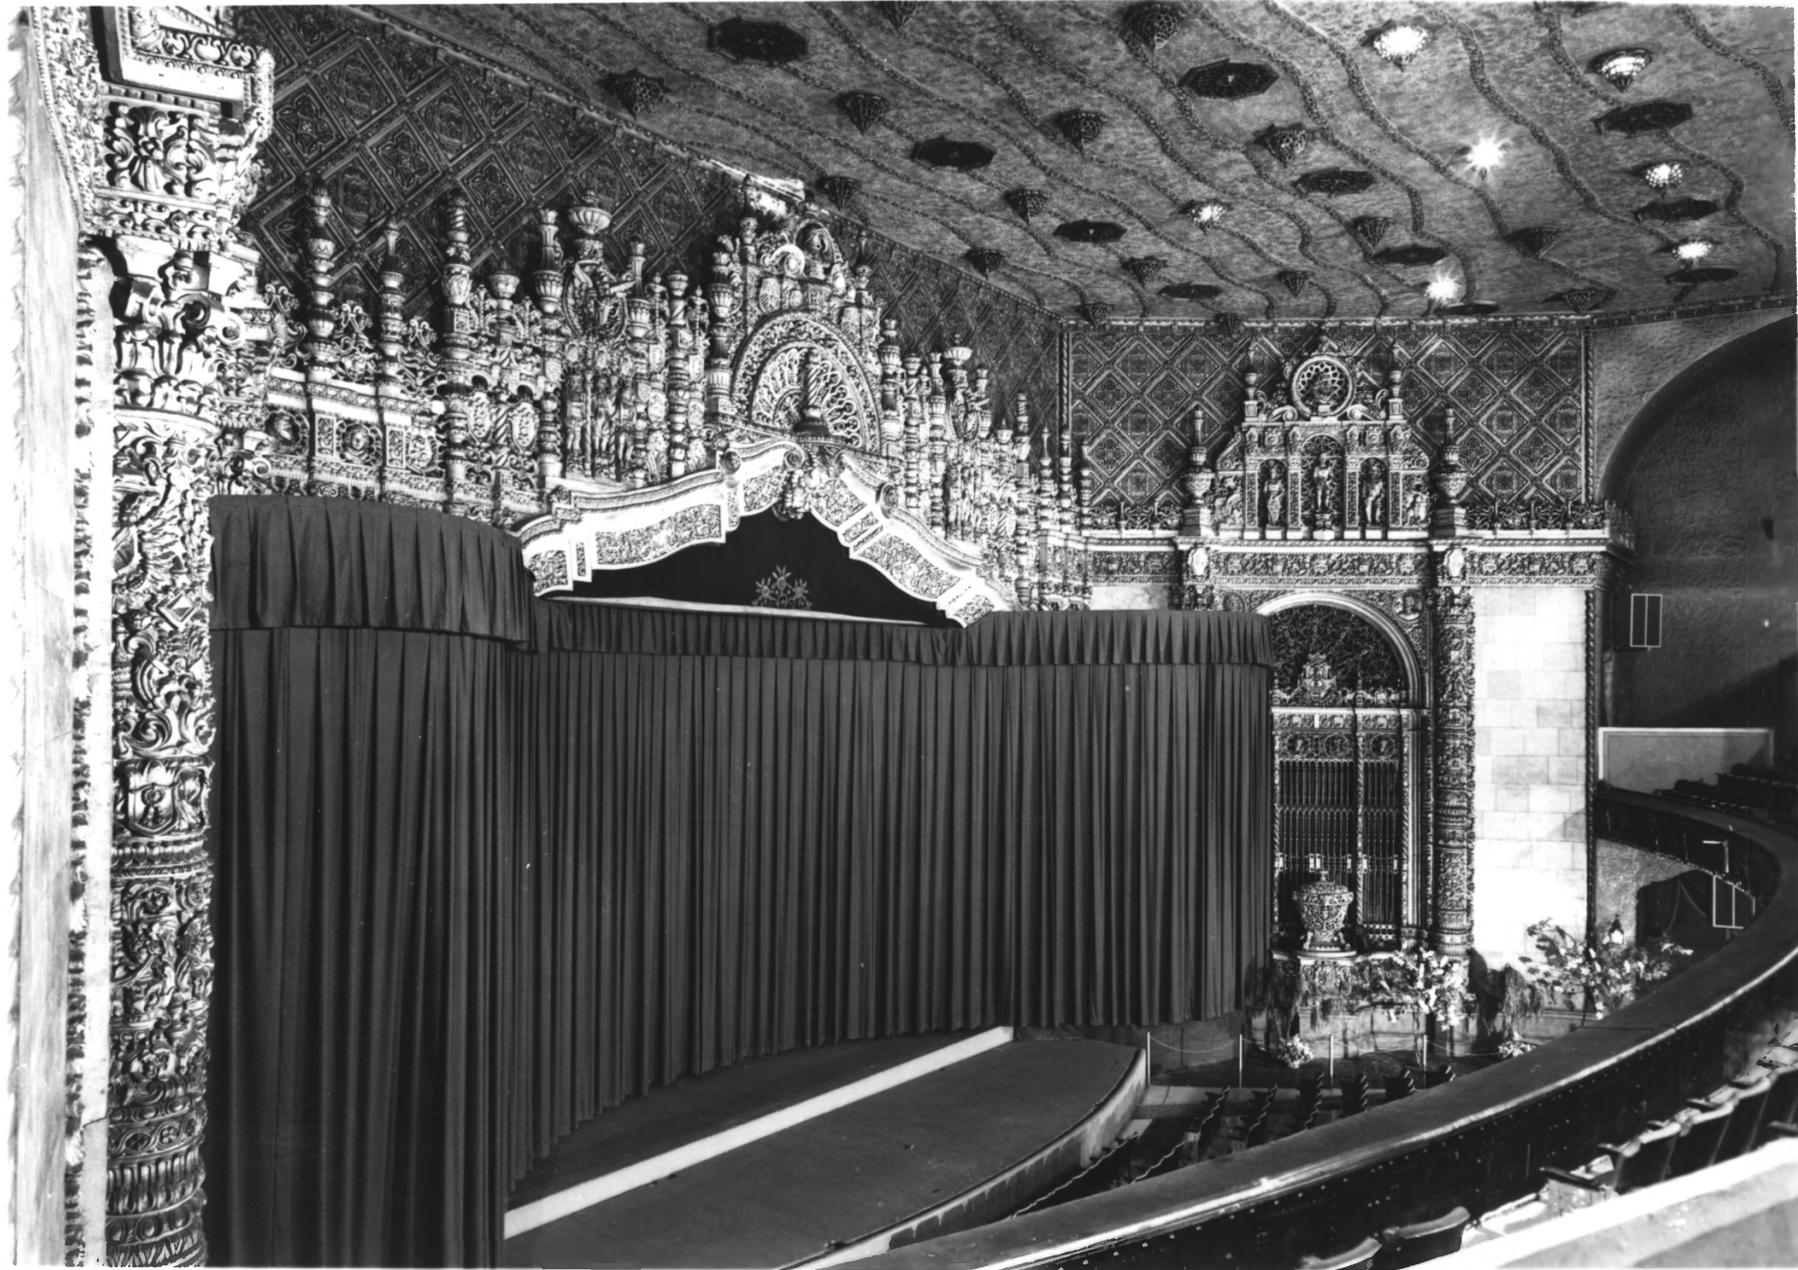
PHOTO 10 Interior, Indiana Theatre Auditorium, view towards northeast. Note diagonal rows of "basket-like" lighting fixtures and serpentine patterned ceiling; "Cinerama" screen (since removed) covers detail on proscenium. Orchestra stage is seen here in "up" position.
