INDIANA THEATRE

134 West Washington Street, Indianapolis

Marion County

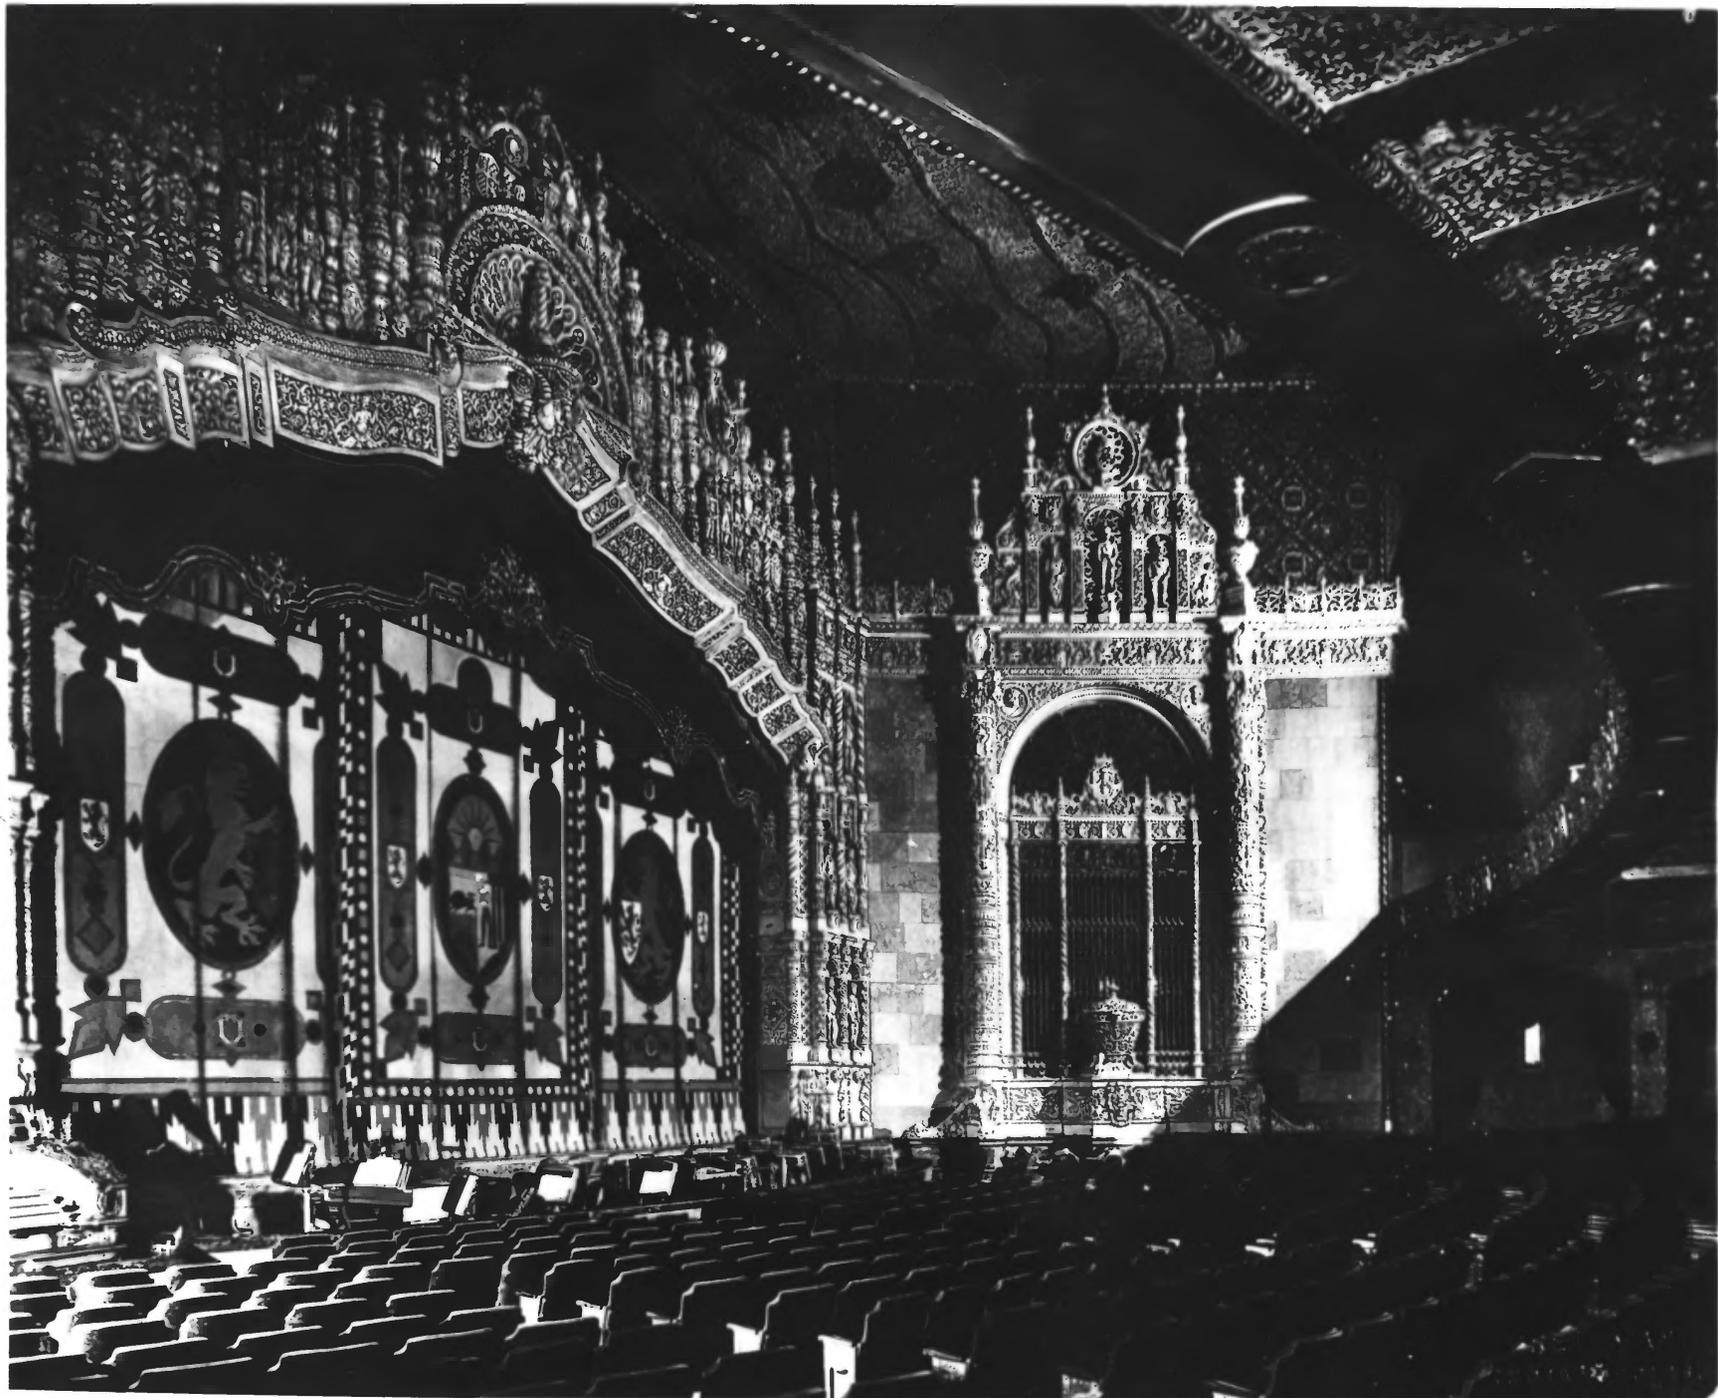
PHOTO 11 Early view of auditorium. Orchestra stage is in "down" position, at floor level; Barton organ can be seen in lower left corner; note decoration on front of balcony; much of the modeled plaster was designed by Joseph Wollenborg.

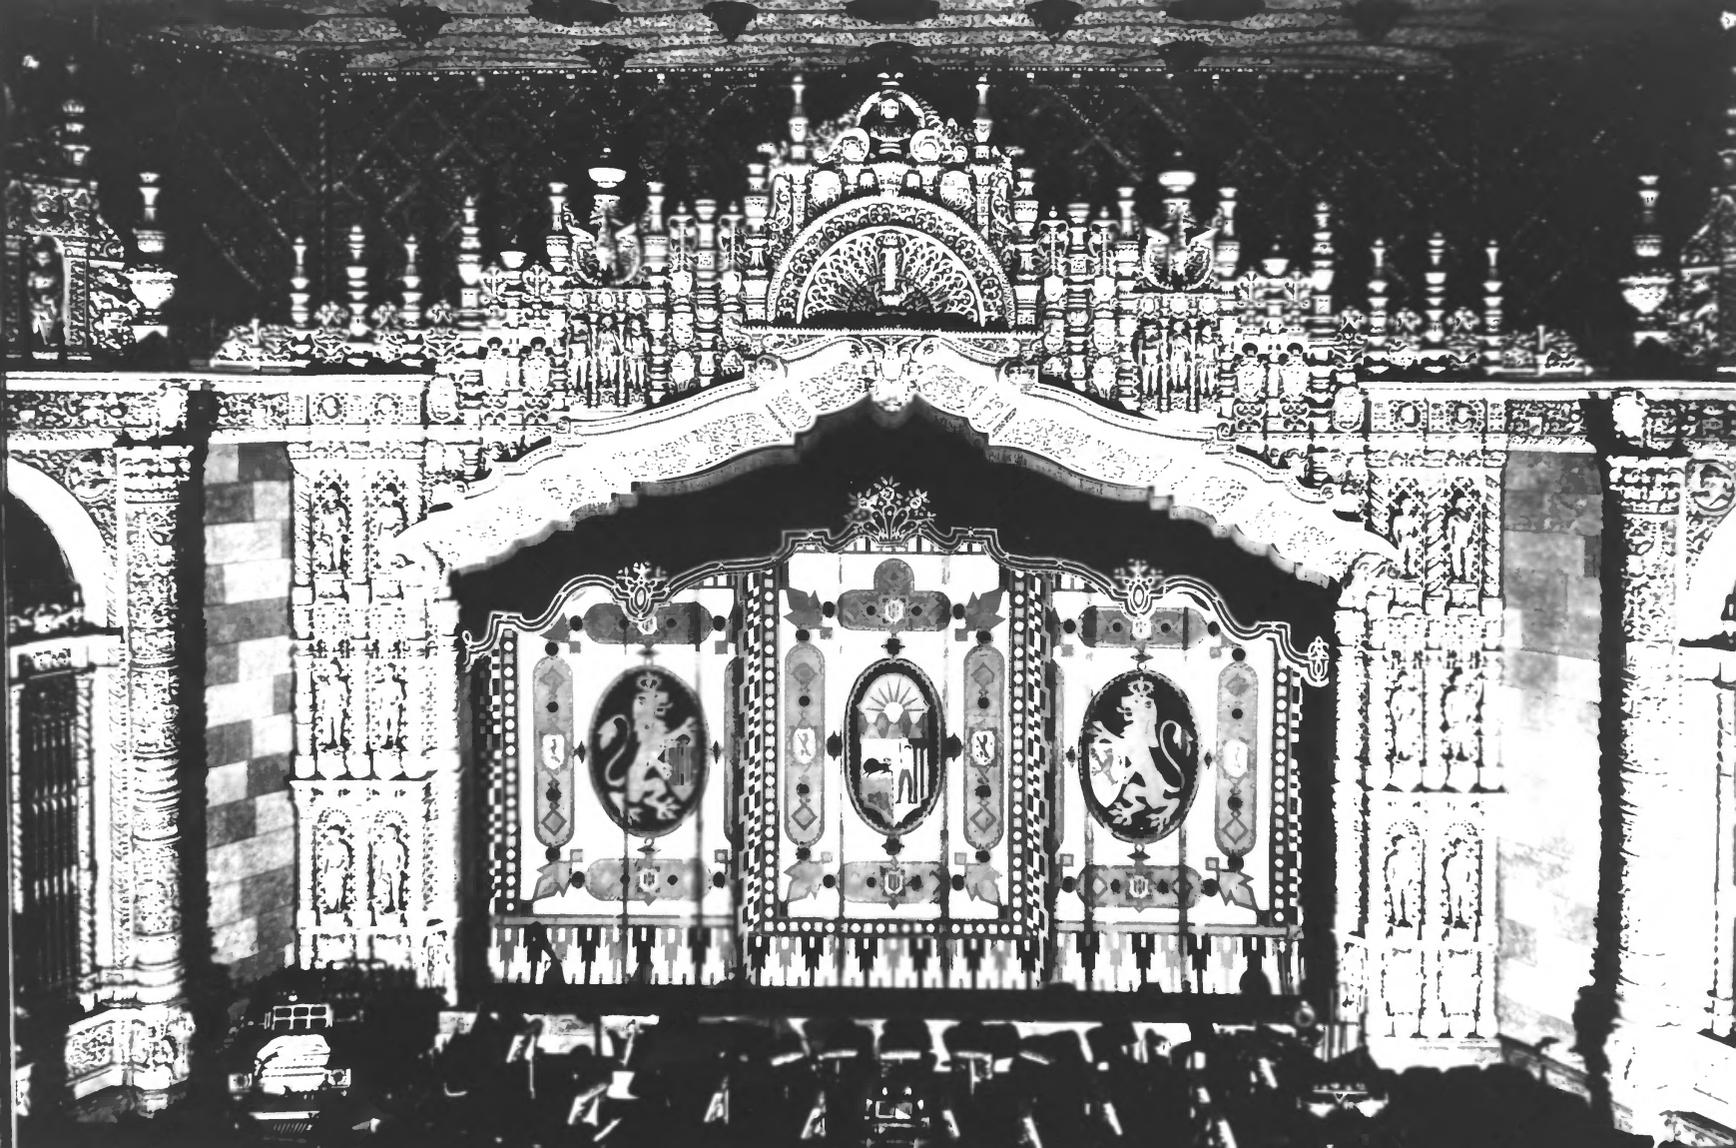
PHOTO 12 Early view of Proscenium. Note: curtain with Spanish motifs flanking central, "Frontier Indiana" scene; two vertical rows of three tiers of portrait statues appear on either side of proscenium.

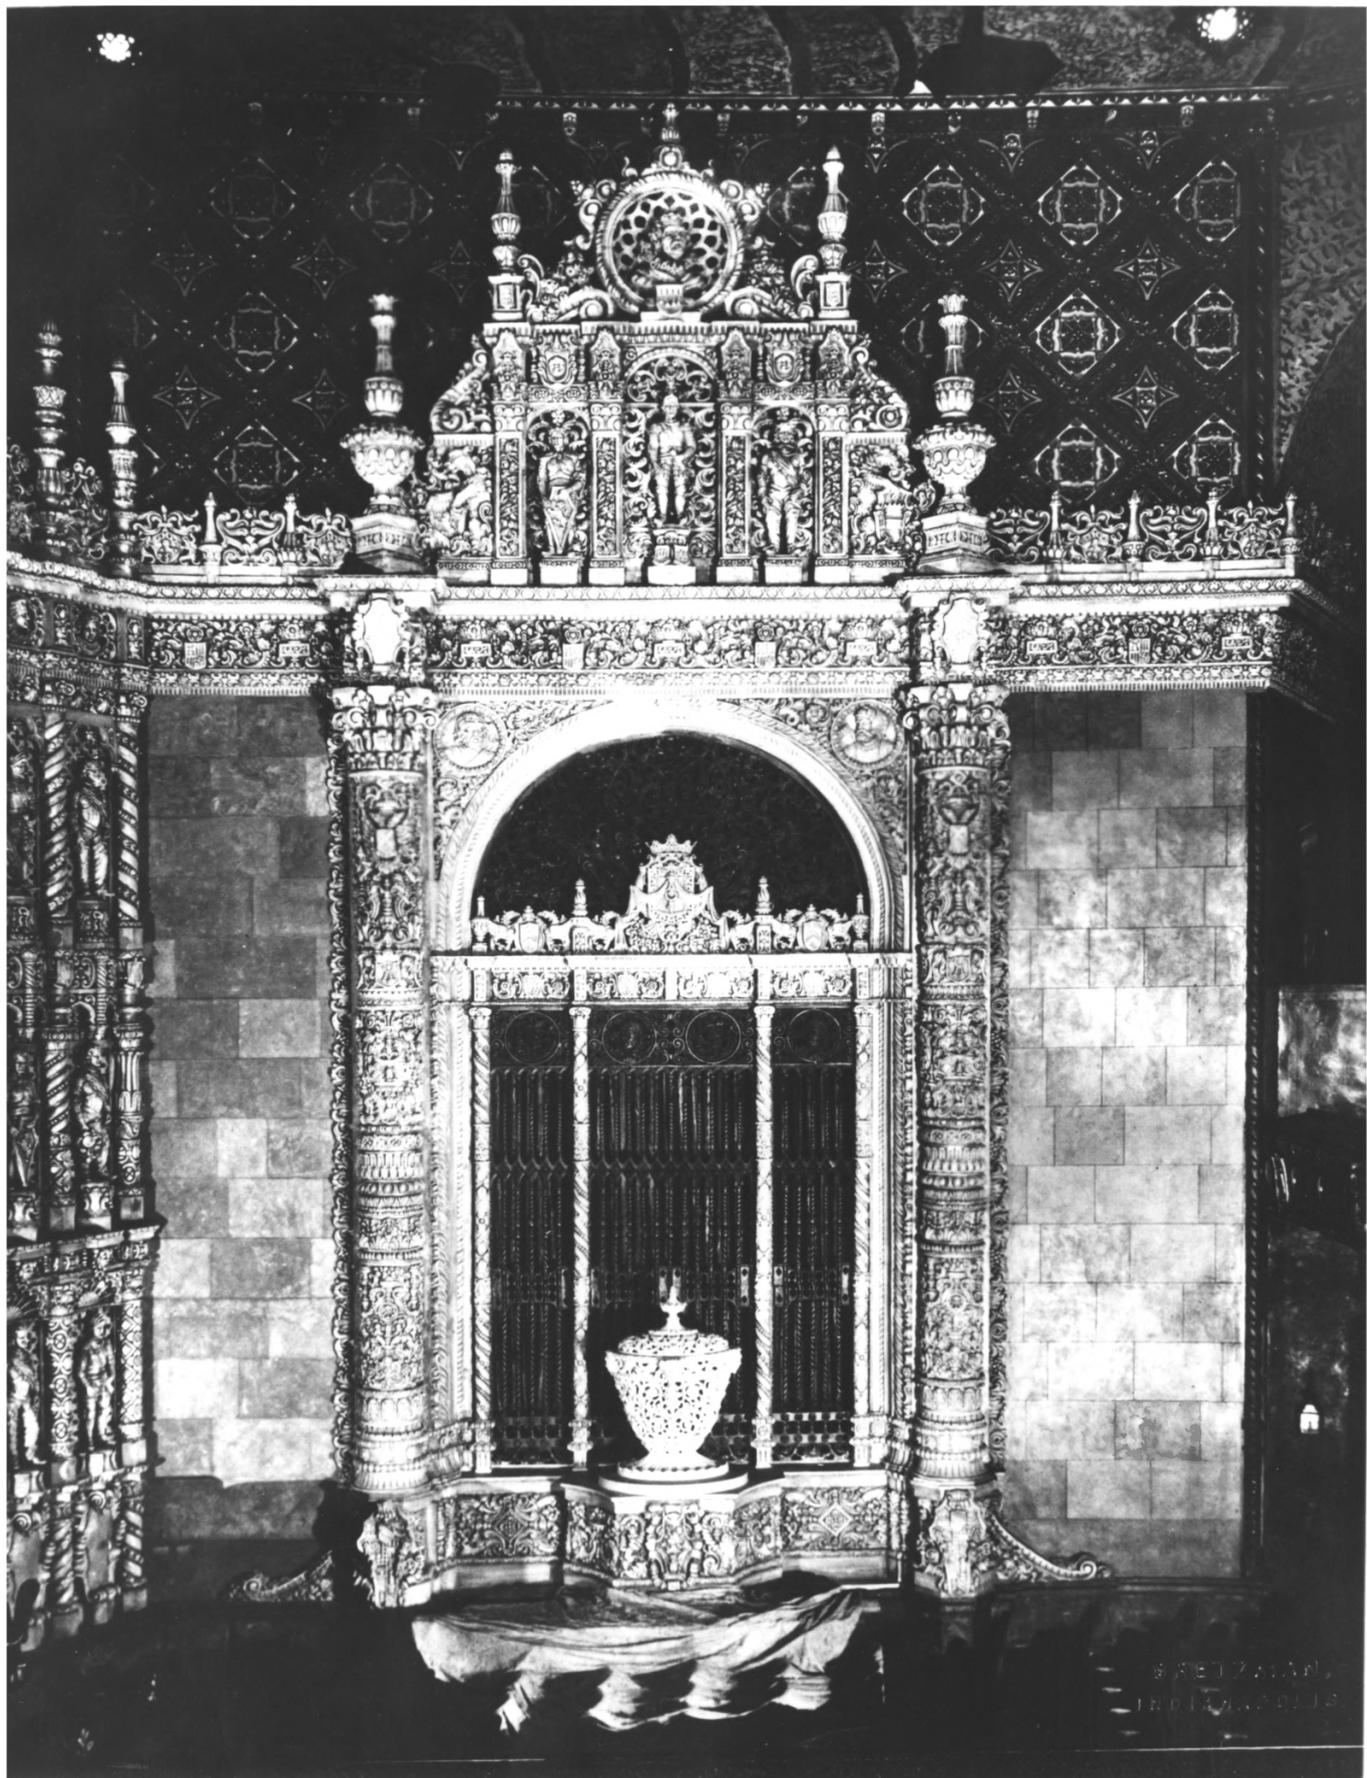
PHOTO 13 Organ grille, view looking east. Photo was taken before decorative treatment was complete; urn is without its four dachshund "feet."

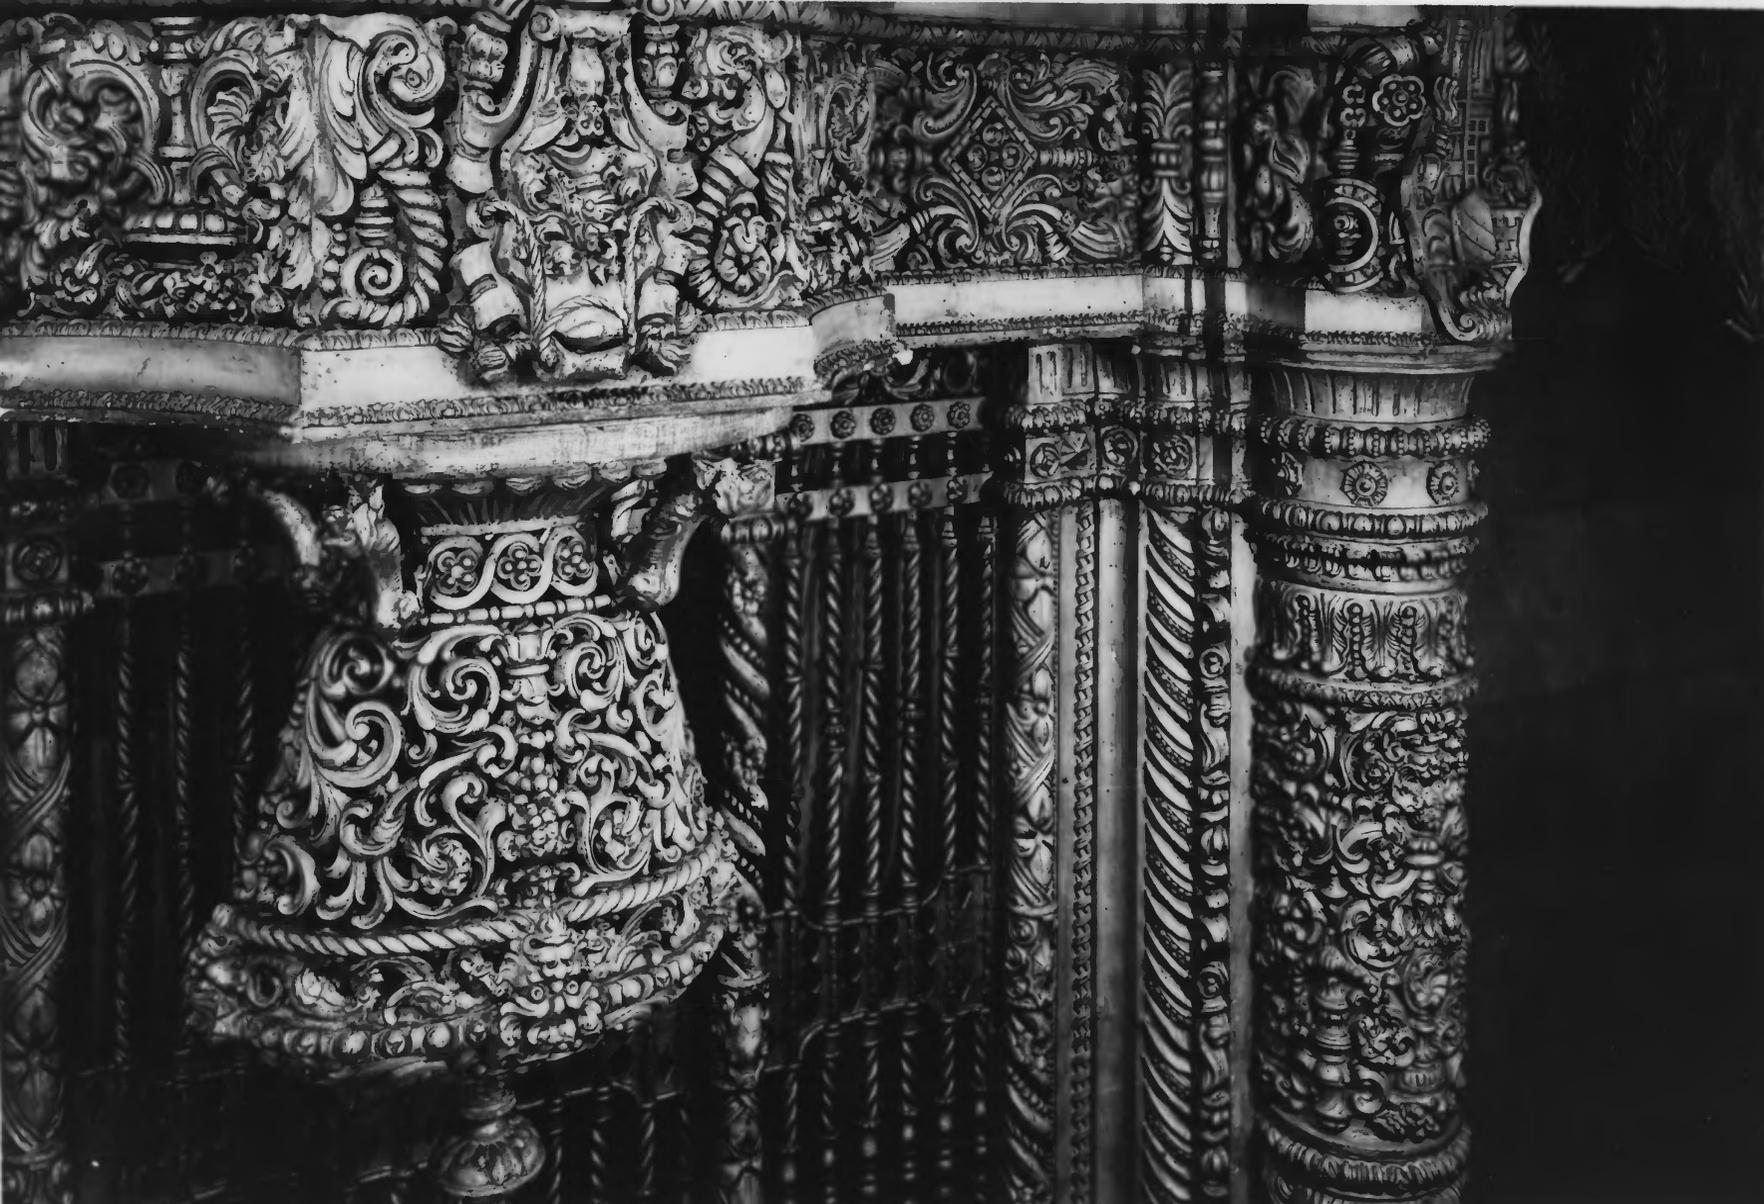
PHOTO 14 Interior detail, organ screen treatment, east side of auditorium. Openwork plaster urn is supported by four life-size dachshunds.

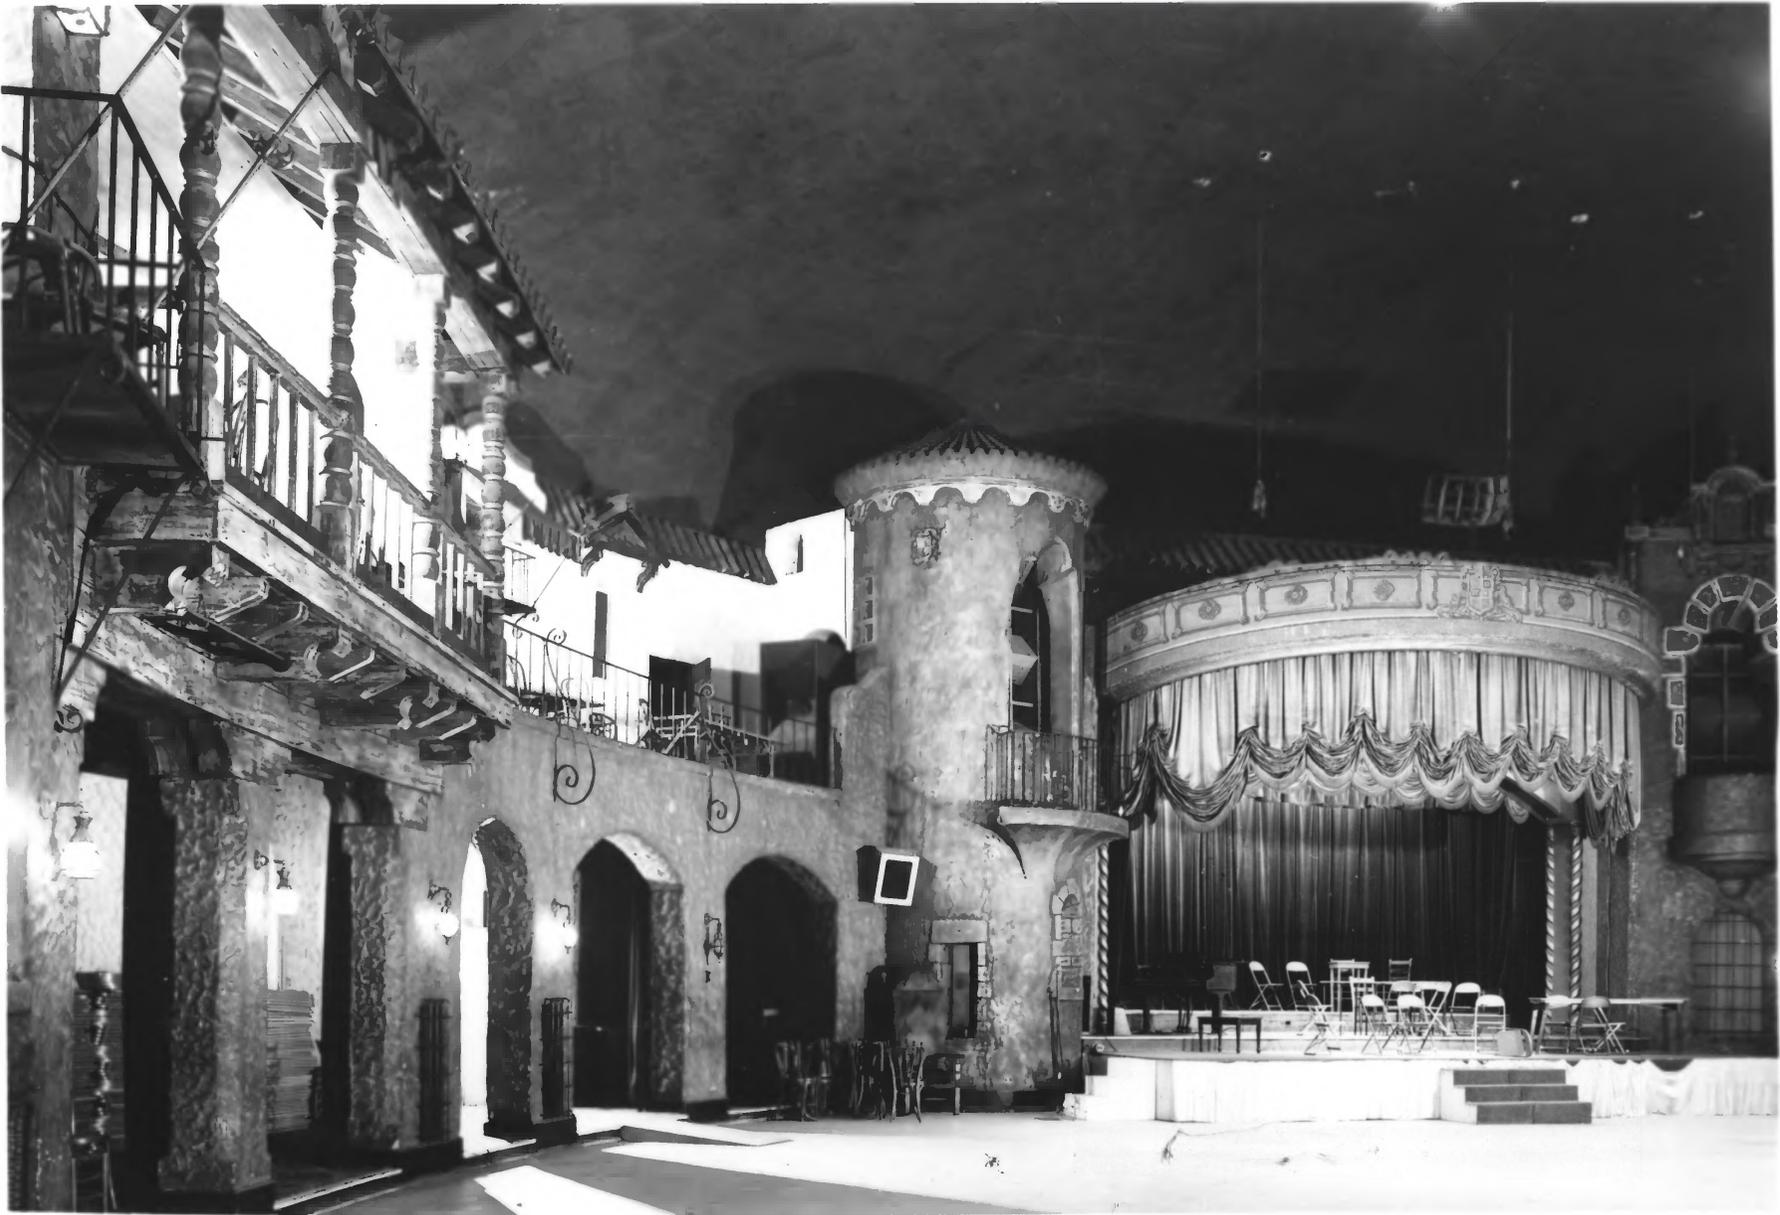
PHOTO 15 Indiana Theatre Roof Ballroom, view looking north along west wall. Oval "walls" surrounding dance floor appear as building facades surrounding a courtyard. Elliptical dome ceiling, painted blue, is studded with tiny electric "stars." Stage is flanked by two towers; semi-circular canopy over stage was a later addition, made when orchestra stage was enlarged.
