National Register of Historic Places  
Registration Form

historic name El Portal Old Schoolhouse

other names/site number El Portal Chapel, NPS Building No 8847

state California code CA county Mariposa code 043 zip code 95318

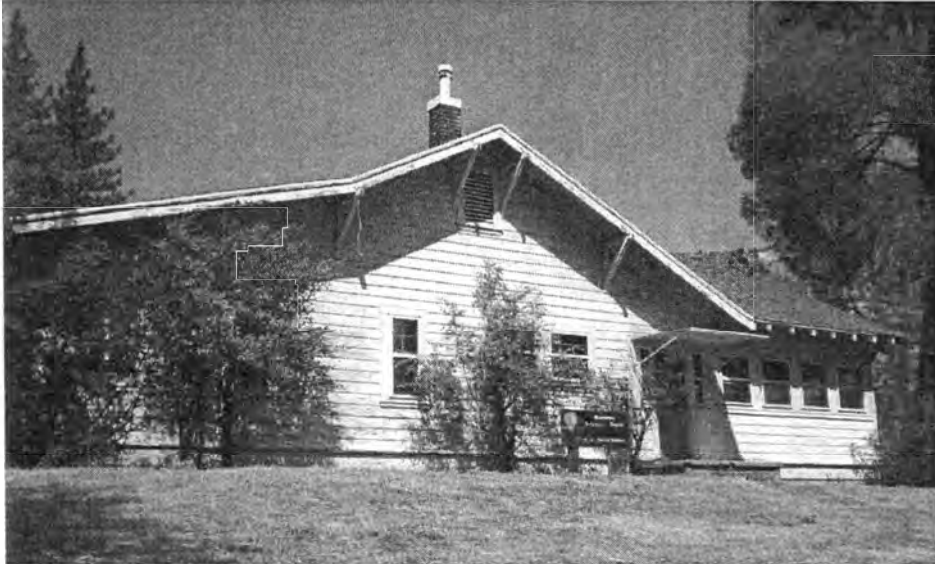
Example #1, Murchison House, El Portal, CA. Constructed by National Lead Company.  
Photographer: Jennifer Self, Architectural Historian Intern, Yosemite National Park  
Date: July 2009

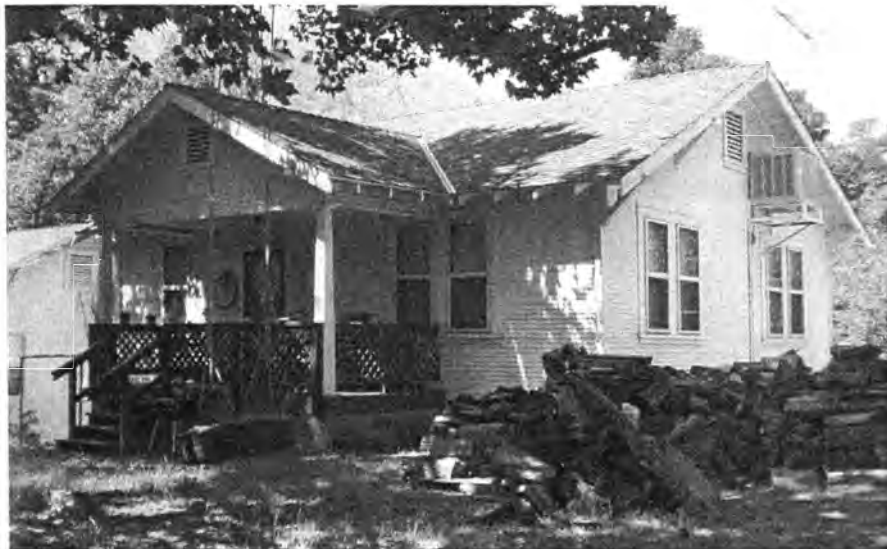
Example #2, Worker's Cottage, El Portal, CA. Constructed by National Lead Company.  
Photographer: Jennifer Self, Architectural Historian Intern, Yosemite National Park  
Date: July 2009

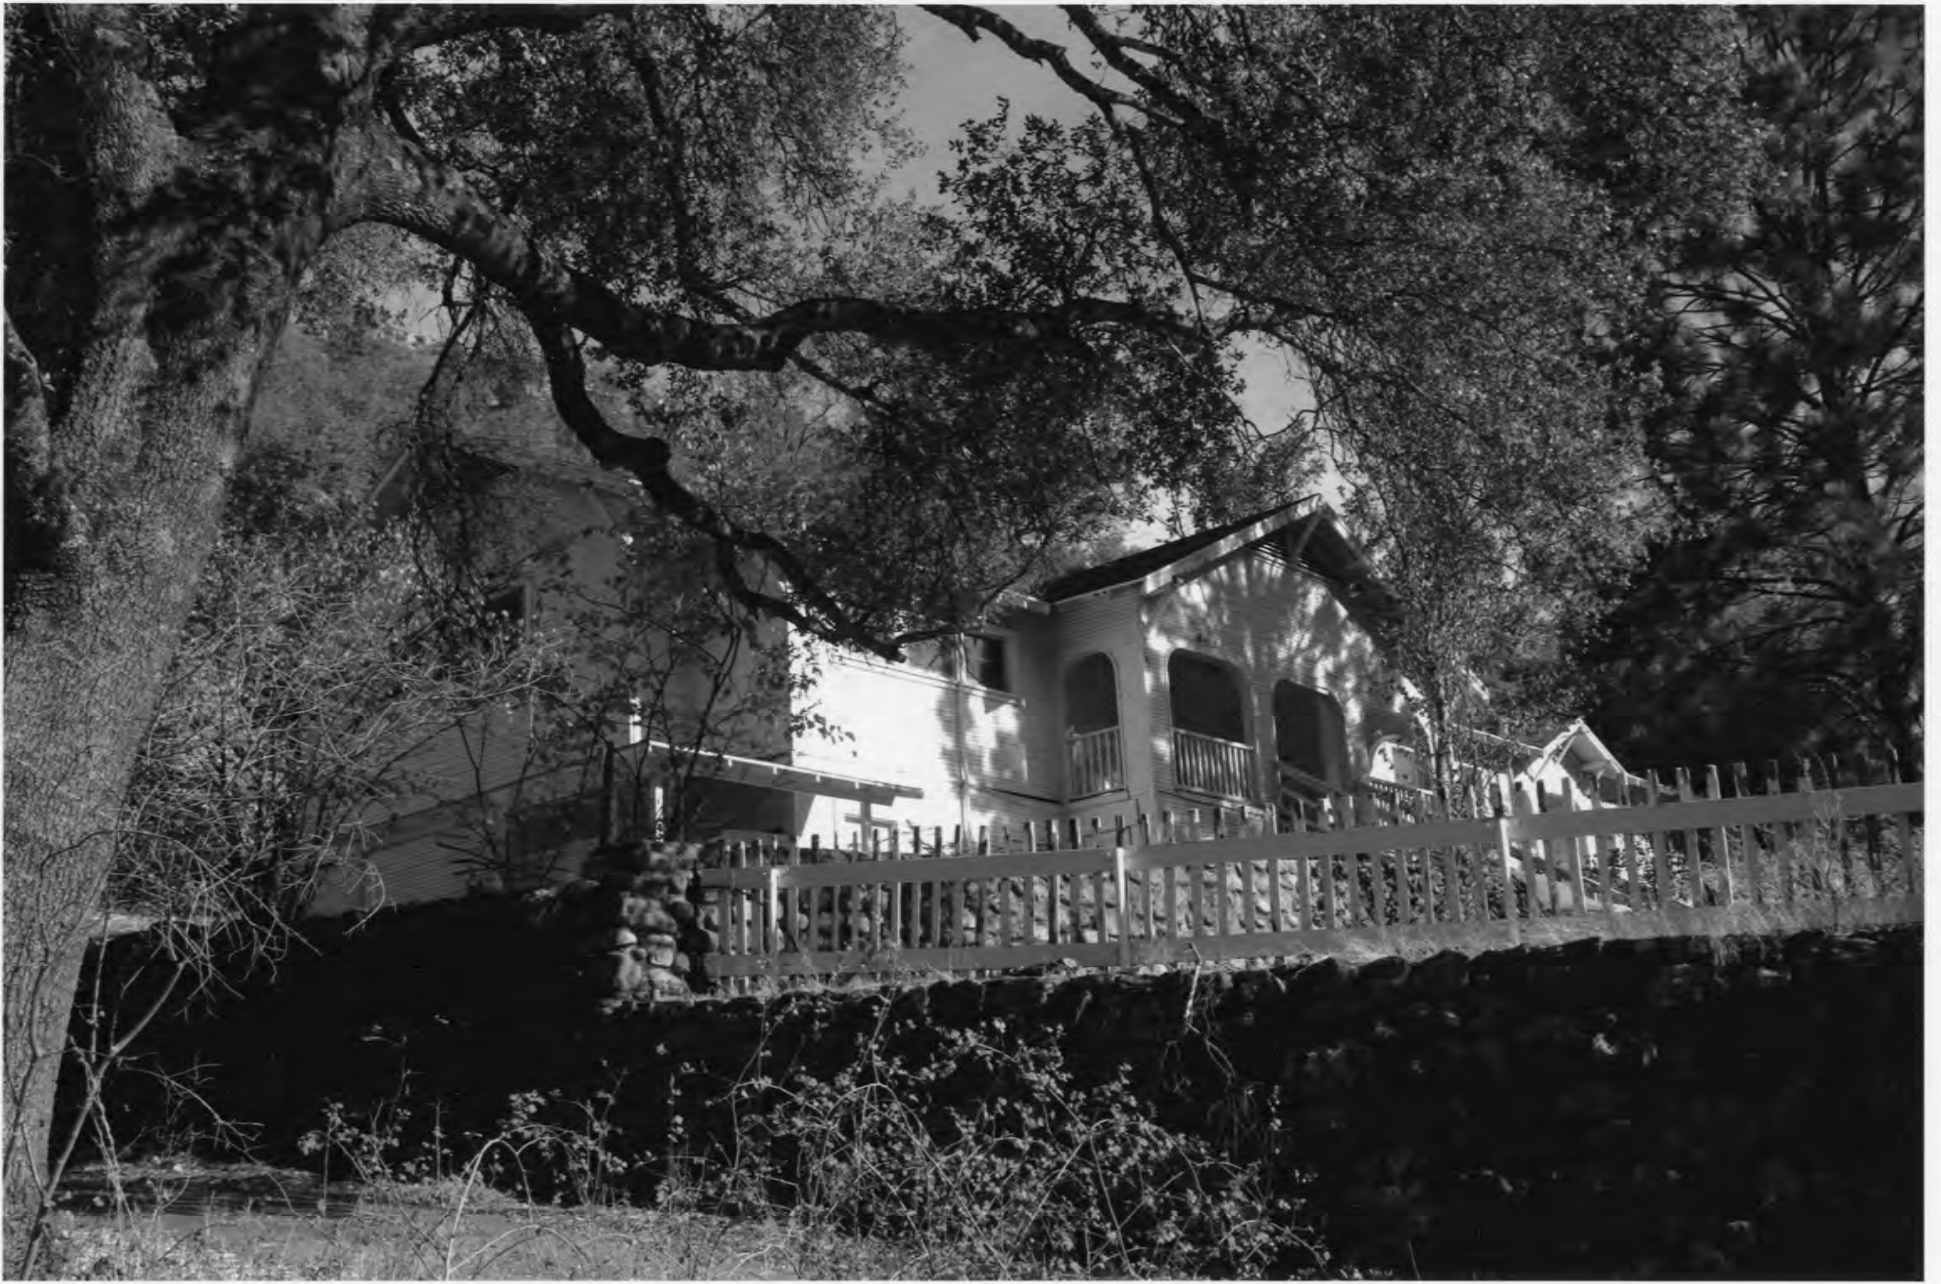
CA\_Mariposa County\_El Portal Old Schoolhouse\_0005

The south elevation (Photo 5) is punctuated with two porches, one being the elevated main entrance to the building and the other smaller porch on the east addition serves as a secondary entrance. The main porch has a front-facing gable roof, which is centrally located on the original portion of the building. (Photo 6) The plan of the porch is T-shaped and both projects from and recesses back into the main volume of the building. There are four entrance doors leading from the porch into the building: two panel doors with top-lights along the north wall leading directly into the classrooms and two solid five panel doors leading to the central and west cloakrooms. (Photo 7) The main porch is finished with painted tongue and groove flooring running north to south and wide wood trim around the openings. Porch fixtures include two wall-mounted "bubbler" water fountains and a pendant light with frosted glass shade mounted to the beadboard ceiling. The secondary inset porch on the east addition of the building is smaller in size but still retains the character of the main porch by use of a three-bay front façade and similar materials. (Photo 8) This complement effectively connects the two portions of the building together. The inset porch is rectangular in plan and is nearly symmetrical. It has two entrances leading into the building: a single panel door with a top light along the north wall leading to the east classroom and a solid five panel door on the east wall leading to the east cloakroom. The porches divide the south elevation into three wall segments, each with a set of three hopper windows and accompanying window screens mounted to the exterior trim. The only other window found along the south elevation is a large four light window near the southwest corner at basement level, in which the glass panes have been painted.

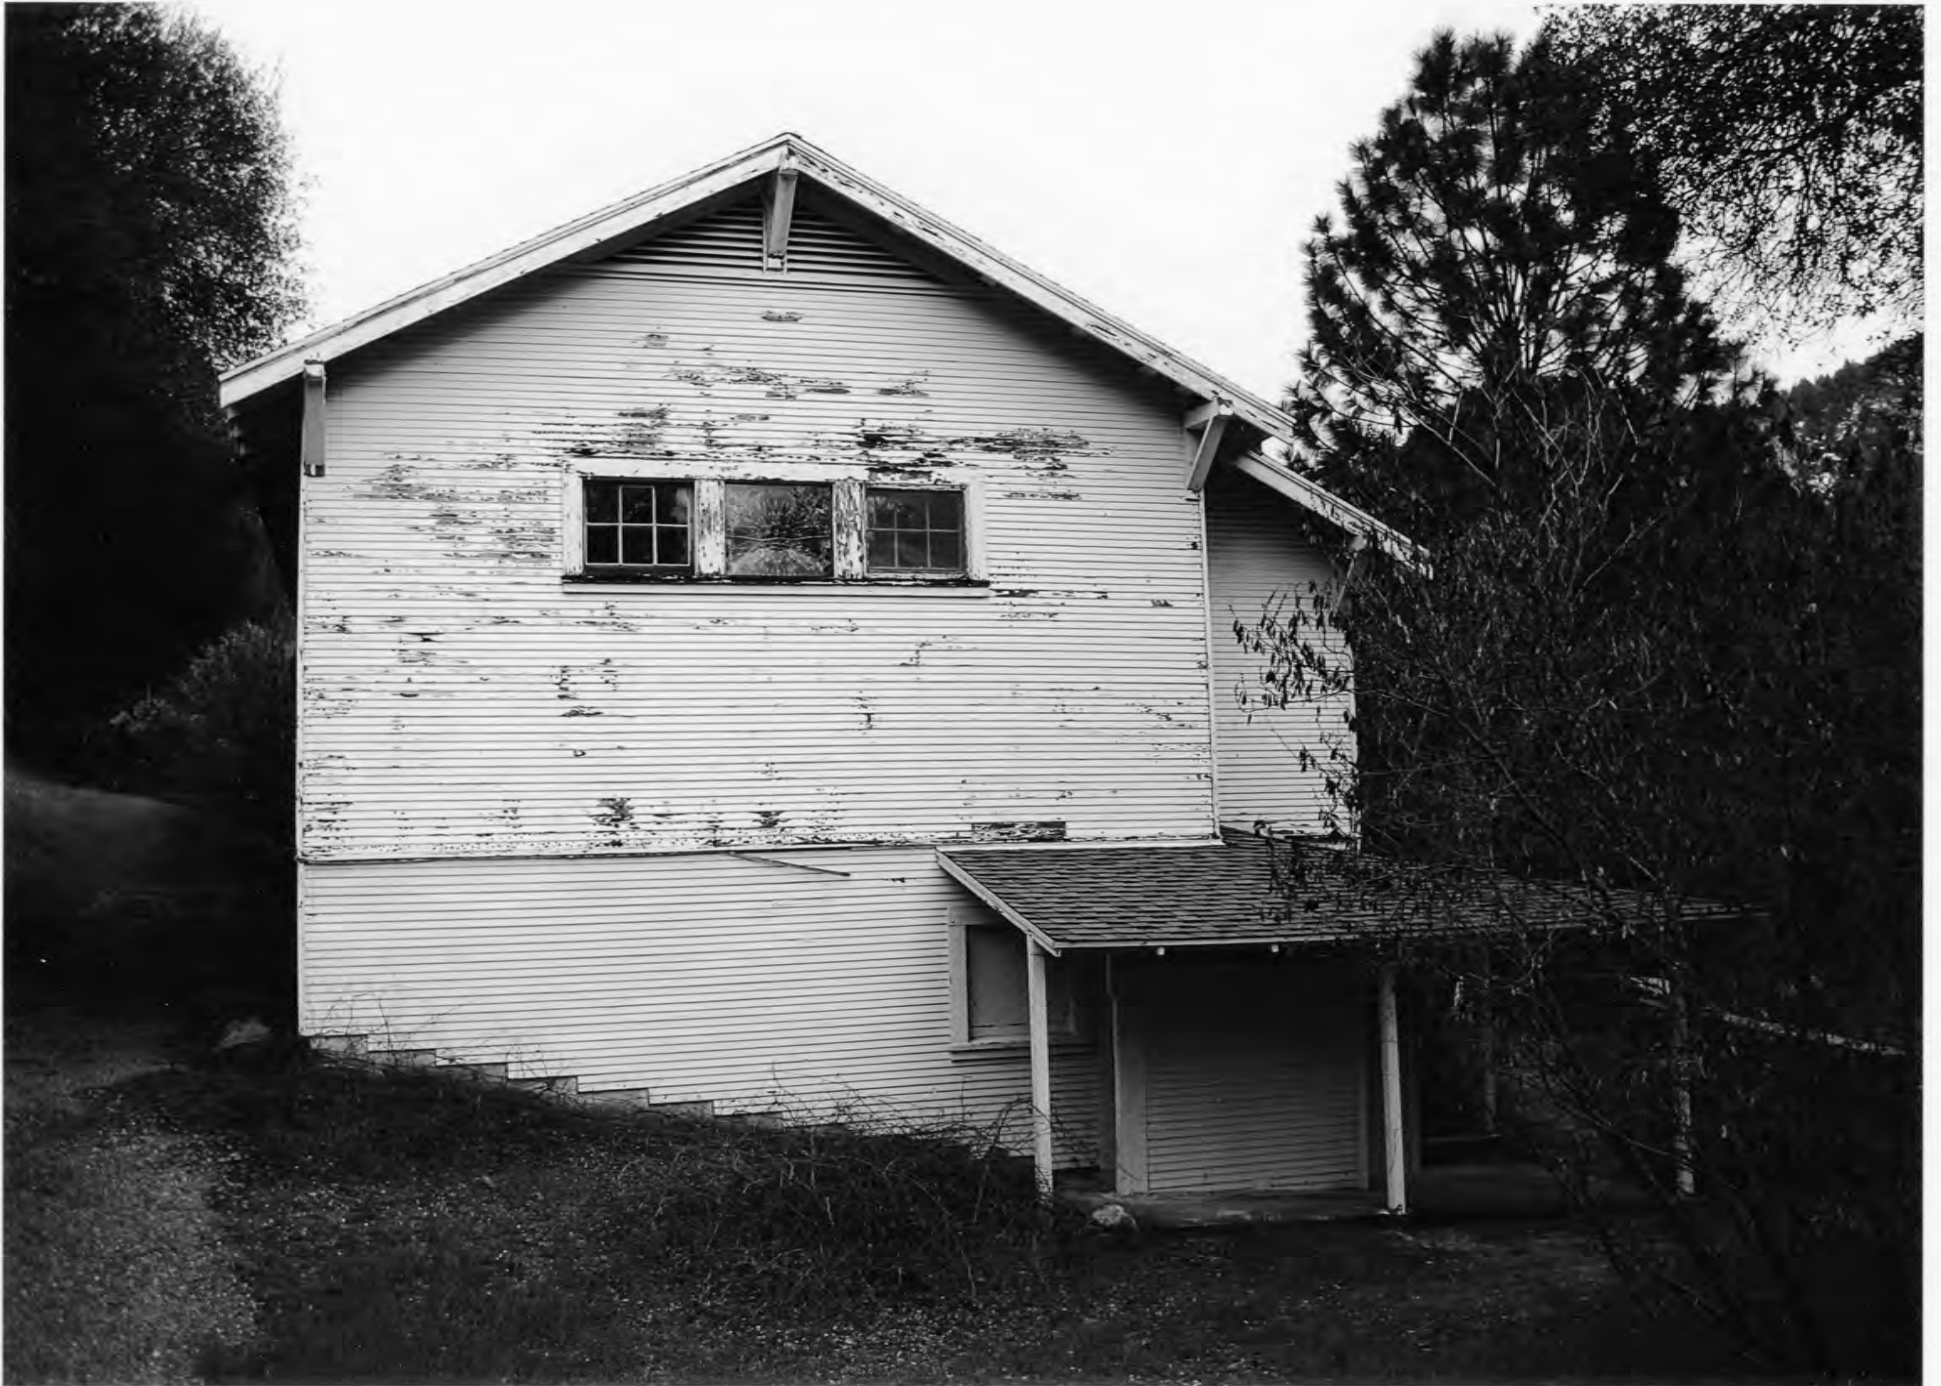
CA\_Mariposa County\_El Portal Old Schoolhouse\_0009

The west elevation is located on one of the gable ends of the building. (Photo 9) The slope of the site affords ample space for two restrooms to be located at the southwest corner of the building. The restrooms are only accessible through the outside of the building and partition walls have been installed atop a concrete slab-on-grade platform to serve as a privacy screen for each of the entry doors. (Photo 10) A quarter-hip roof, with open supports, was added sometime between 1938 and 1960 to provide shelter for the restroom entrances. A window opening within the exterior restroom wall is present but the panes have been removed and the opening boarded up. A group of three windows is centered on the upper portion of the façade; the middle window has been replaced with stained glass and is flanked on either side by hopper windows.

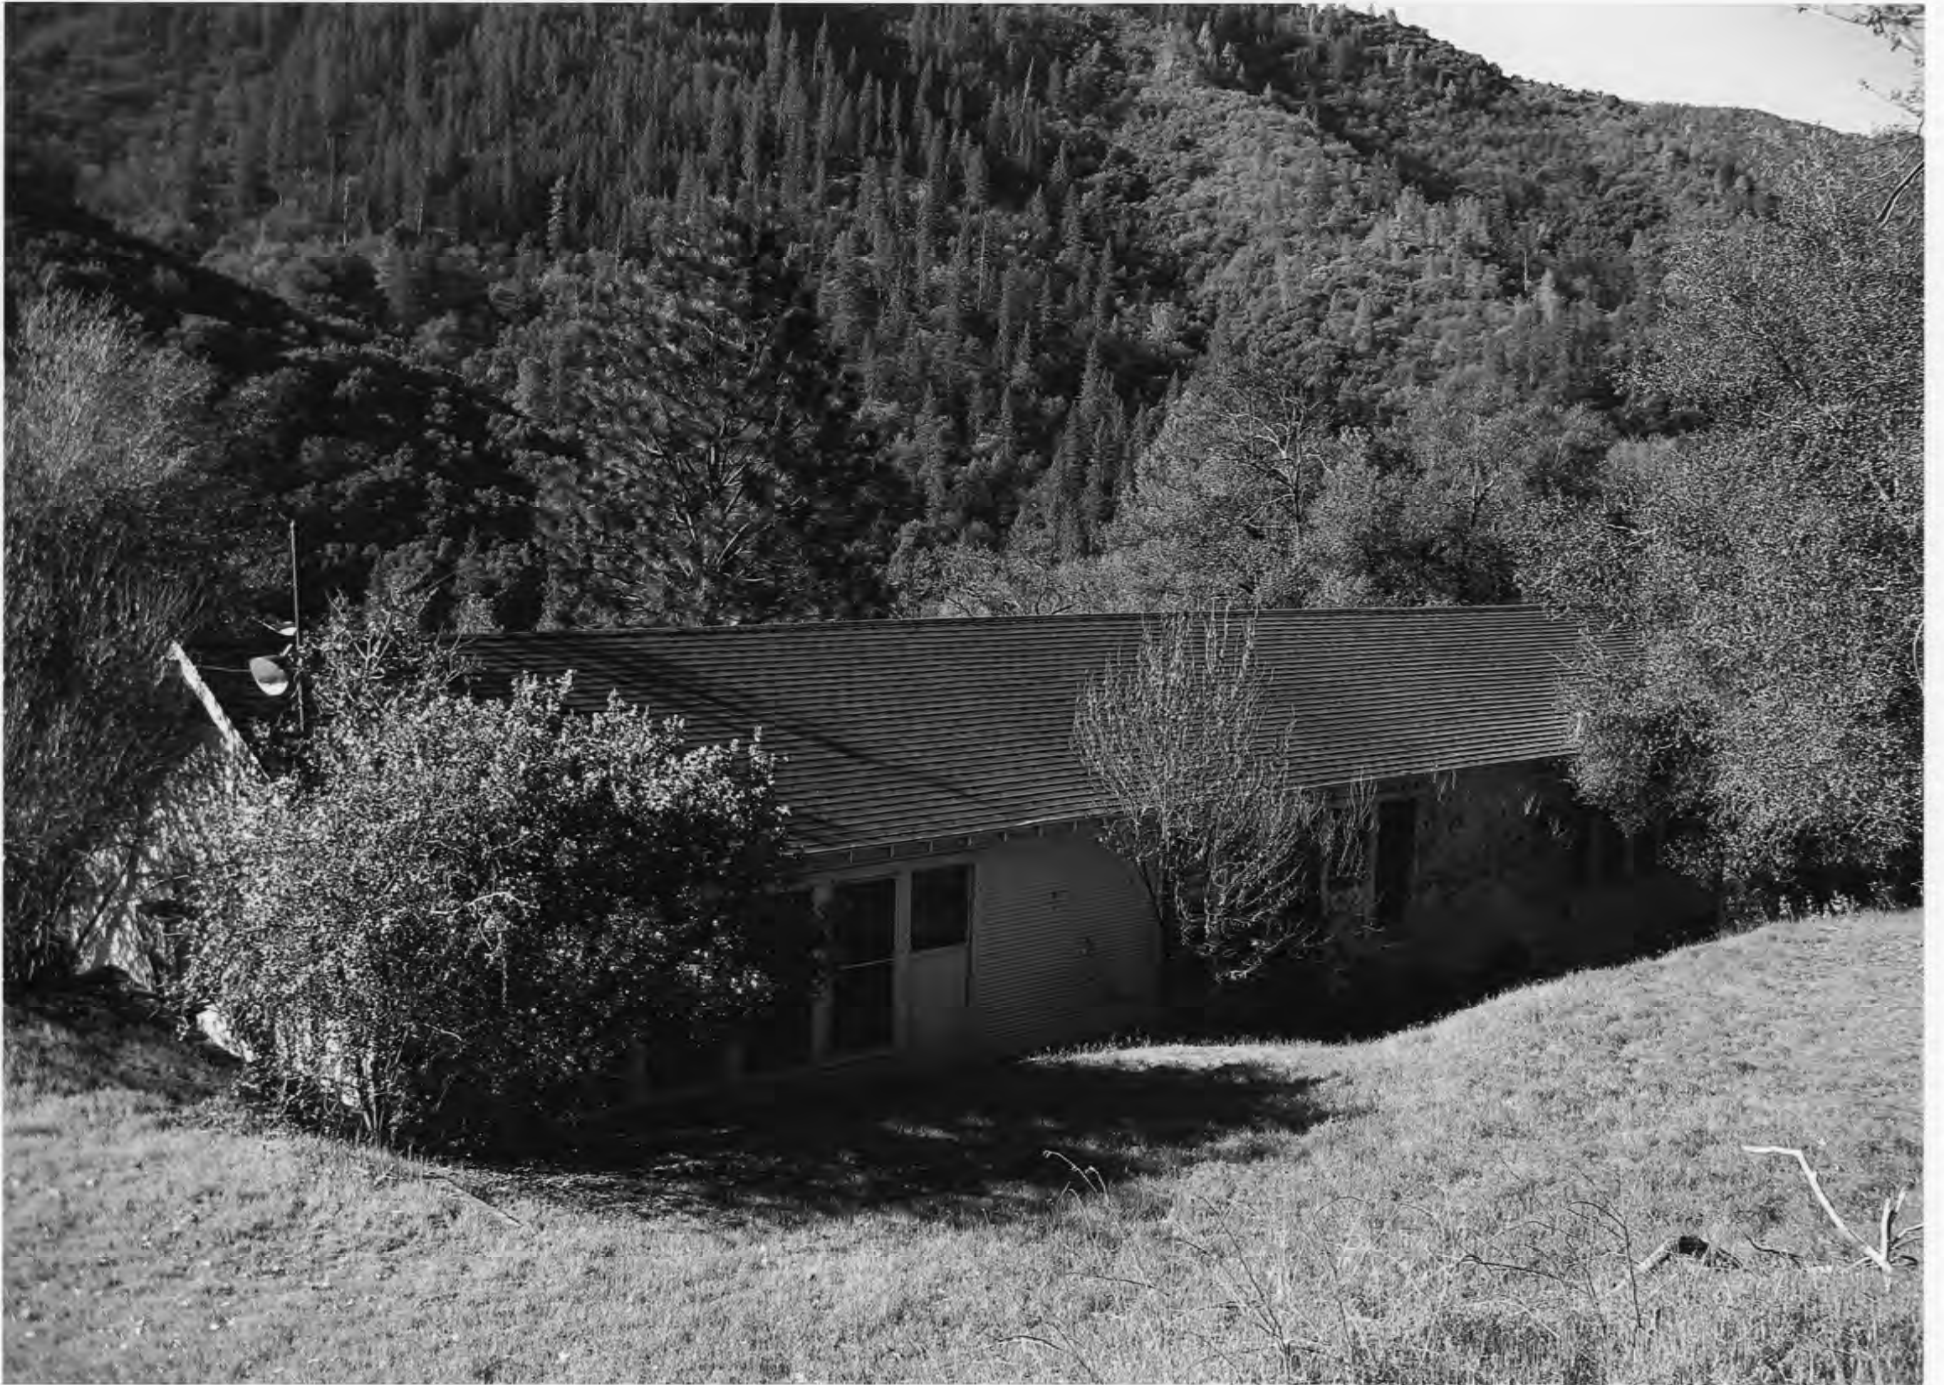
CA\_Mariposa County\_El Portal Old Schoolhouse\_0011

The unbroken north elevation is dominated by evenly spaced groups of five one-over-one double hung windows. (Photo 11) These groupings provide visual reference to the location of the classrooms within the building. The windows have the same consistent wide trim as the smaller hopper windows on the rest of the building. Window

screens were mounted onto the exterior trim for all of the double hung windows at one point in time; however, a number of screens are now missing and several are detached and resting on the ground. In two of the window groupings, a window has been altered to accommodate a short, but wide, emergency door while leaving the top window pane intact. (Photo 12) One window within the far west group of windows is boarded up entirely to accommodate an air conditioning unit. A vertical seam in the siding presents a visual delineation of where the original building and the addition meet.

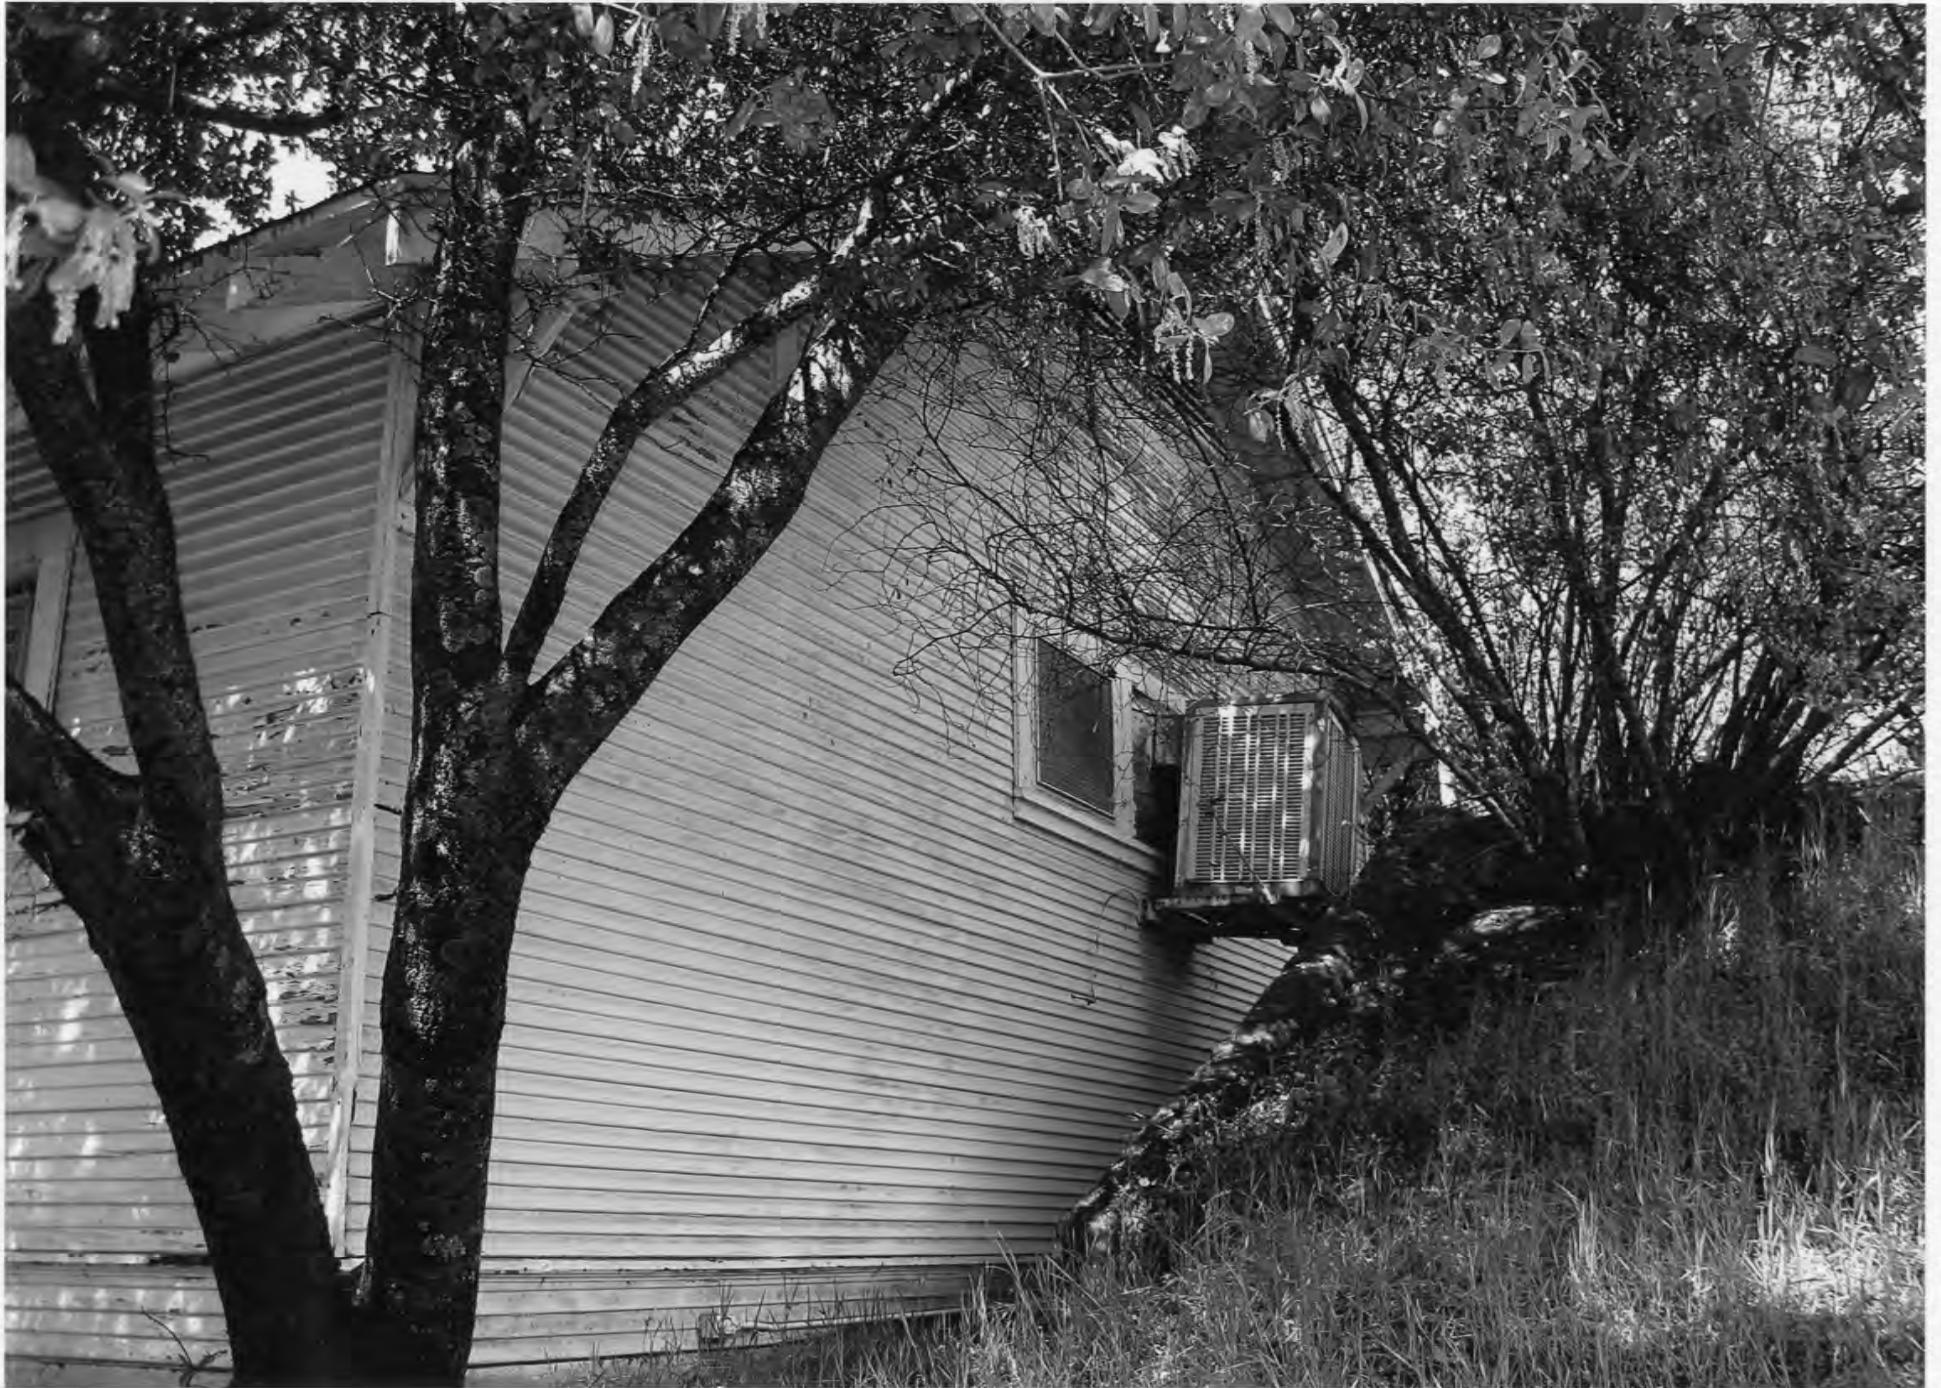
CA\_Mariposa County\_El Portal Old Schoolhouse\_0013

The east elevation of the building is the gable end of the later addition. (Photo 13) A group of hopper windows is centrally located along the façade. The center window has been removed to accommodate an air conditioner, which sits on a metal shelf attached to the façade with brackets and cables. The two flanking windows are intact; however, they have been covered with wire mesh screen.
