NPS Form 10-900 United States Department of the Interior National Park Service National Register of Historic Places Registration Form

Historic Name: SH 203 (Old SH 52) Bridge at Salt Fork of the Red River Other name/site number: State Highway 52 Bridge at Salt Fork of the Red River Name of related multiple property listing: *Historic Road Infrastructure of Texas*

Architectural Classification: Other: Parker Truss Bridge

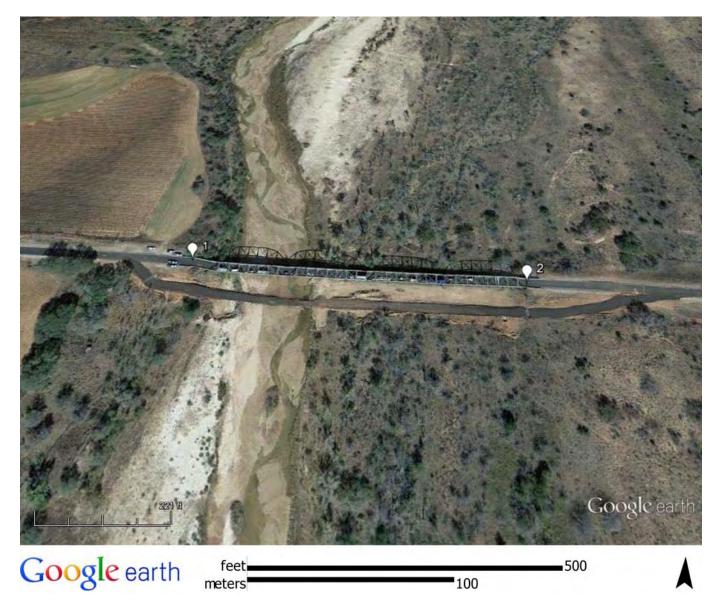
Figure 1. SH 203 Bridge Date: December 11, 1939 View west, from bank of the Salt fork of the Red River, without vegetation Photo: TxDOT Staff

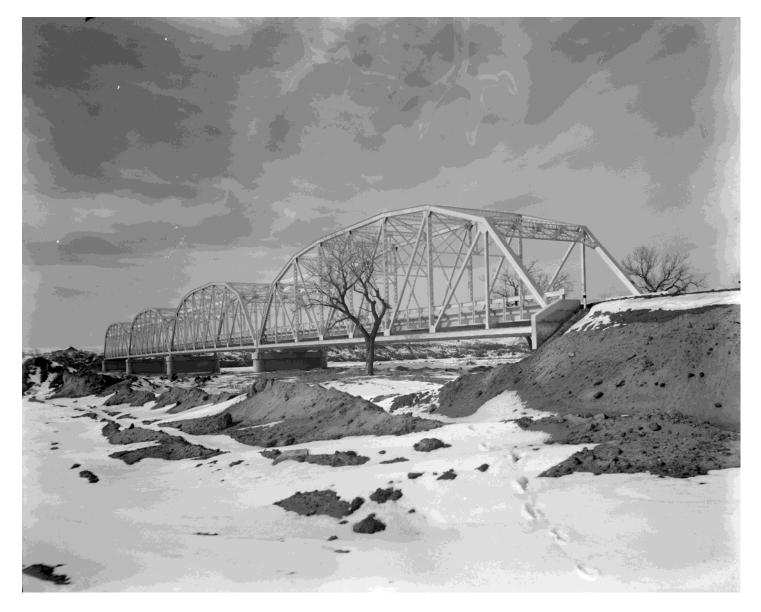
Figure 2. SH 203 Bridge Date: December 11, 1939 View west, from bank of the Salt fork of the Red River, without vegetation Photo: TxDOT Staff

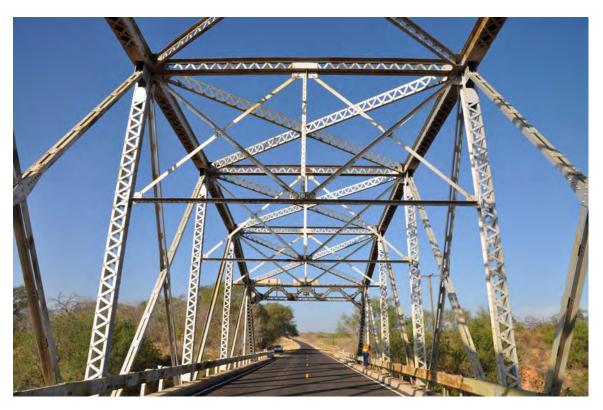
Photo 2

View east, sway braces, struts, and hip vertical, first span from eastern approach Photo: Renee Benn

View east, sway braces, struts, and hip vertical, first span from eastern approach Photo: Renee Benn

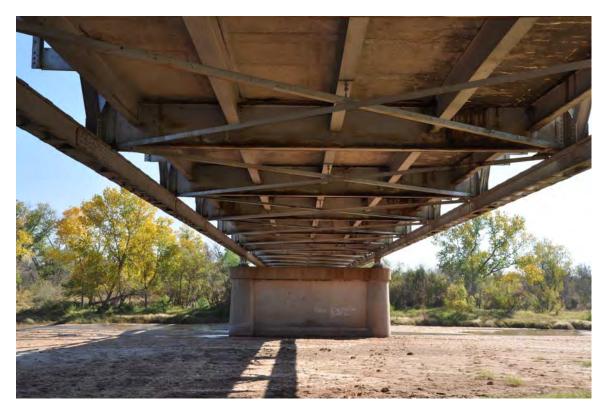
Photo 3

View east, beneath the deck, floor beams, bottom lateral bracing, bottom chord and piers. Photo: Stephen Austin

View east, beneath the deck, floor beams, bottom lateral bracing, bottom chord and piers. Photo: Stephen Austin

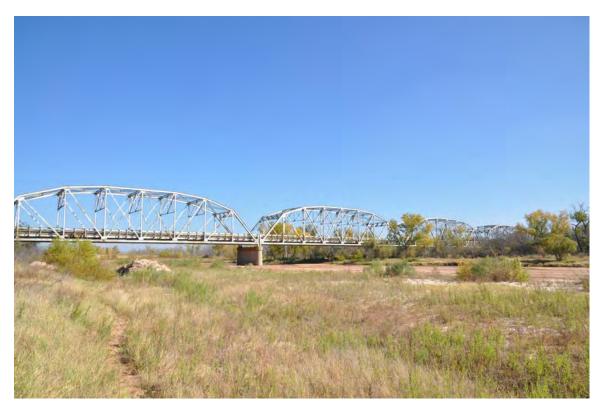
Photo 4

View north, full bridge profile from southeastern banks of the Salt Fork of the Red River Photo: Stephen Austin

View north, full bridge profile from southeastern banks of the Salt Fork of the Red River Photo: Stephen Austin
