National Register of Historic Places Registration Form

historic name Christian, Daniel and Catherine, House

street & number 170 E. 12th Avenue

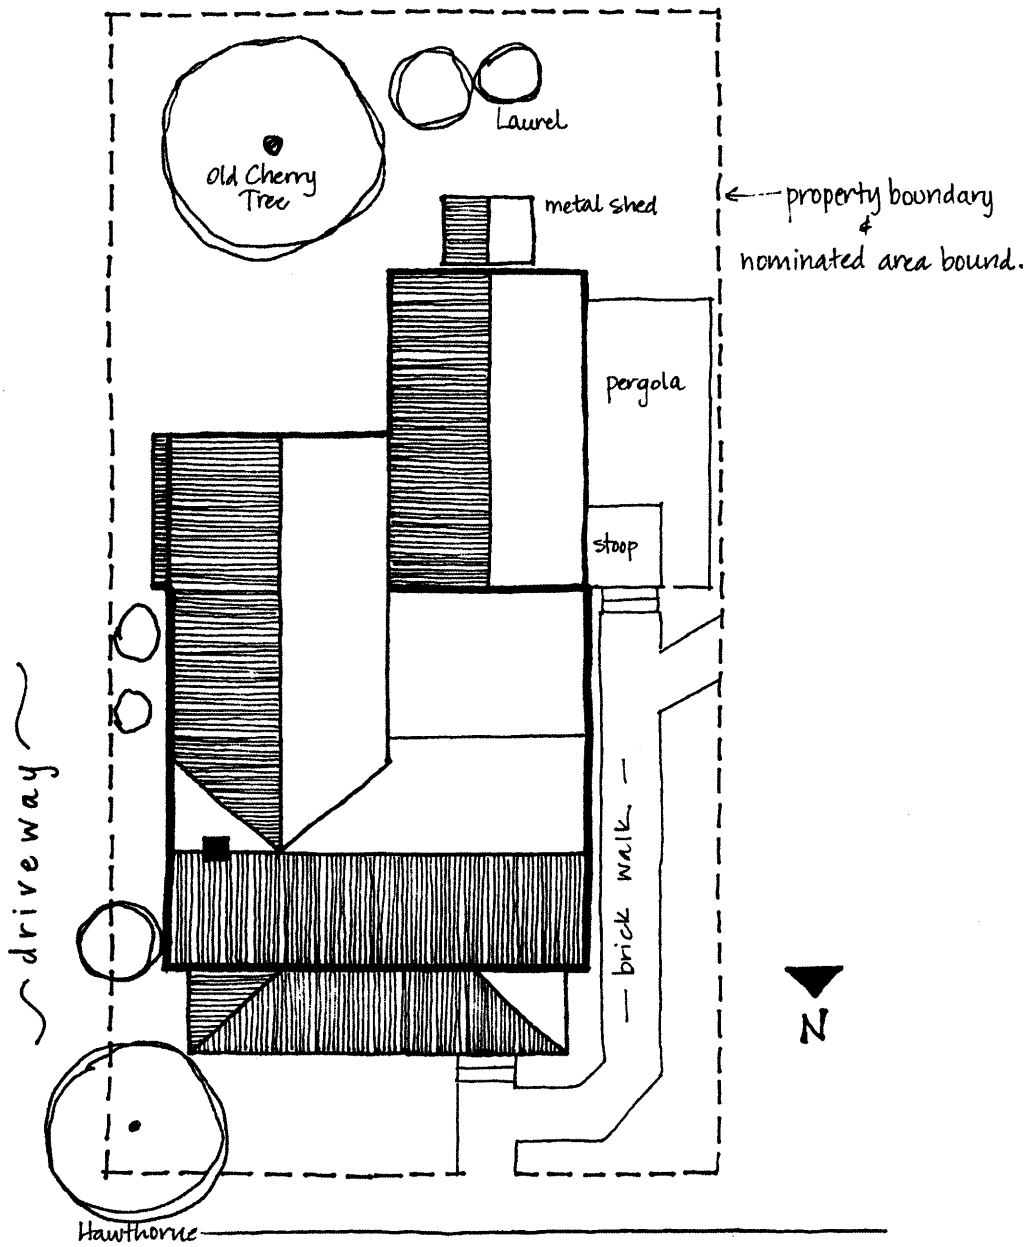
Figure 15. Christian House site plan.

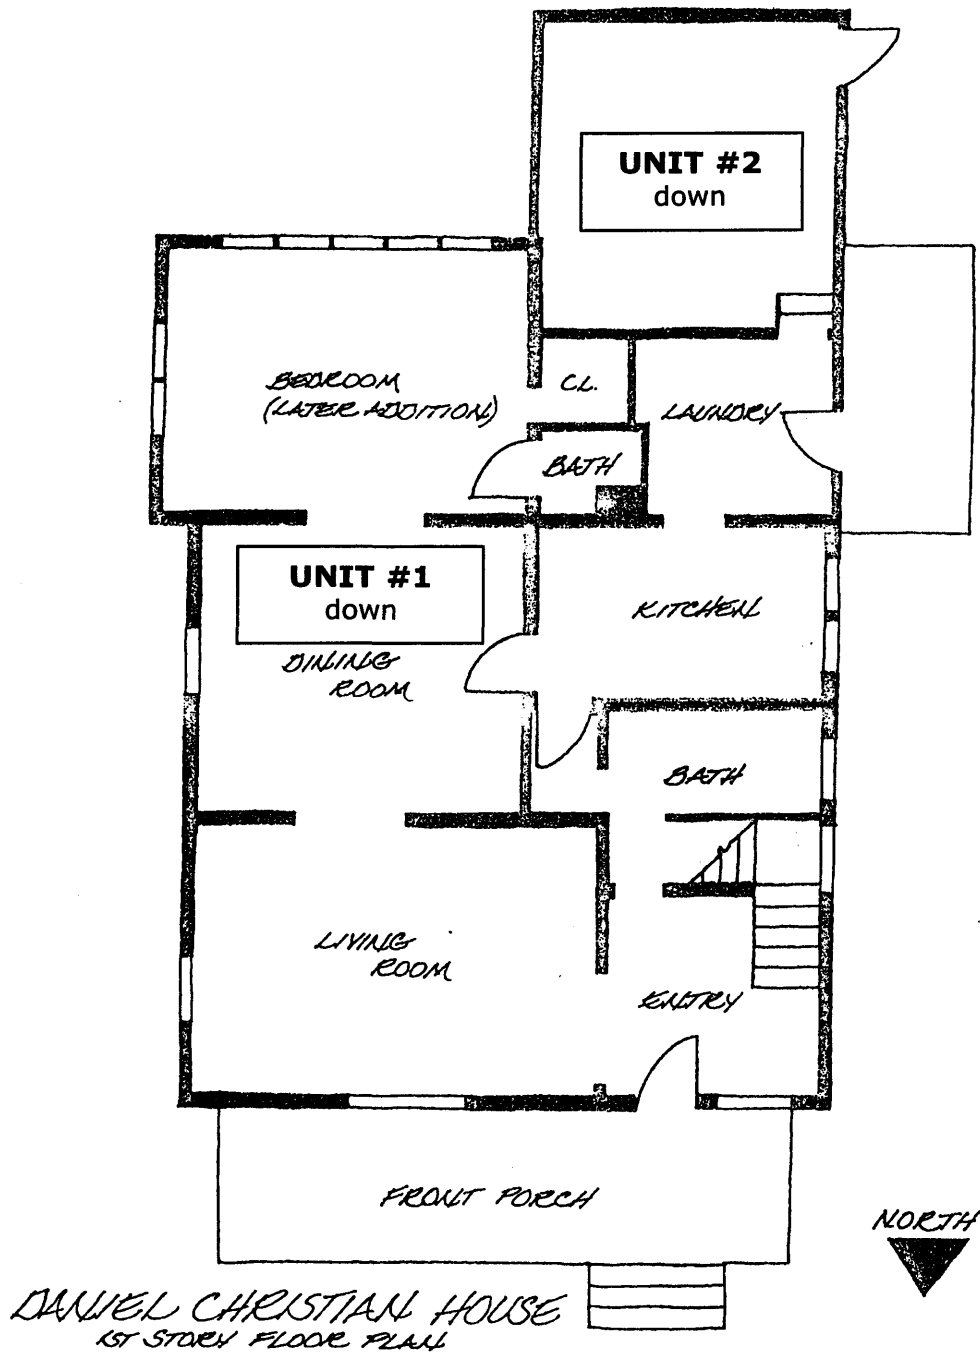
Figure 16. First floor plan (courtesy City of Eugene)

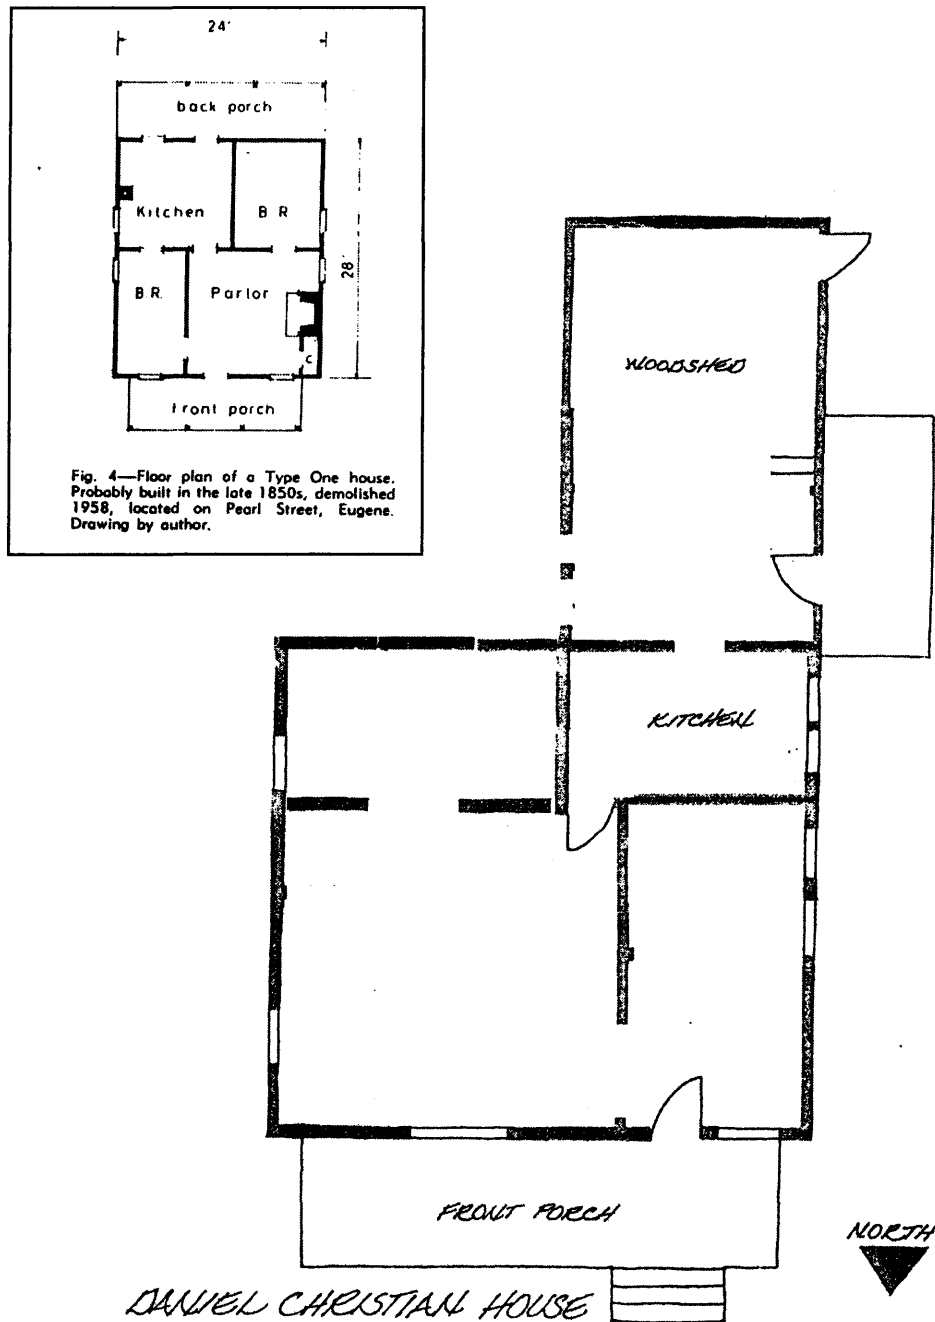
Fig. 4—Floor plan of a Type One house. Probably built in the late 1850s, demolished 1958, located on Pearl Street, Eugene. Drawing by author.

Figure. 18. Possible original configuration of first floor plan based on substructure arrangement and comparison to similar house described by Dole.
Inset: Drawing from Dole's article "Farmhouse & Barn in Early Lane County" showing Type 1 house floor plan.

The original main footprint was nearly square, the plan likely divided into four rooms on the main floor (two rooms deep and two rooms wide) plus an attic. (Fig. 18) The aforementioned one-story wing extended back from the present-day kitchen, accessed by a door that remains in place today. Assumptions about the original floorplan are based on a 1950s analysis of another building of similar age and style (now demolished) by Professor Philip Dole, as well as remaining physical evidence in the Christian House including the configuration of the original substructure, structural details in the first floor walls and ceilings, and the location of walls in the attic.⁸ A fireplace was located in the northeast room but was removed, probably when the house was relocated. The red brick chimney remains in place, and patches in the floor and sill mark the location of the fireplace.
