KENTUCKY HISTORIC RESOURCES INVENTORY

Site No. Tm-42

1. Historic Name(s) Bates House		22. ADD/County No.Ky./Trimble 1 1 2	
Original Owner		23. U.S.G.S. Quadrant (15'/75') Madison East G.I.S. Mod. [] [] []

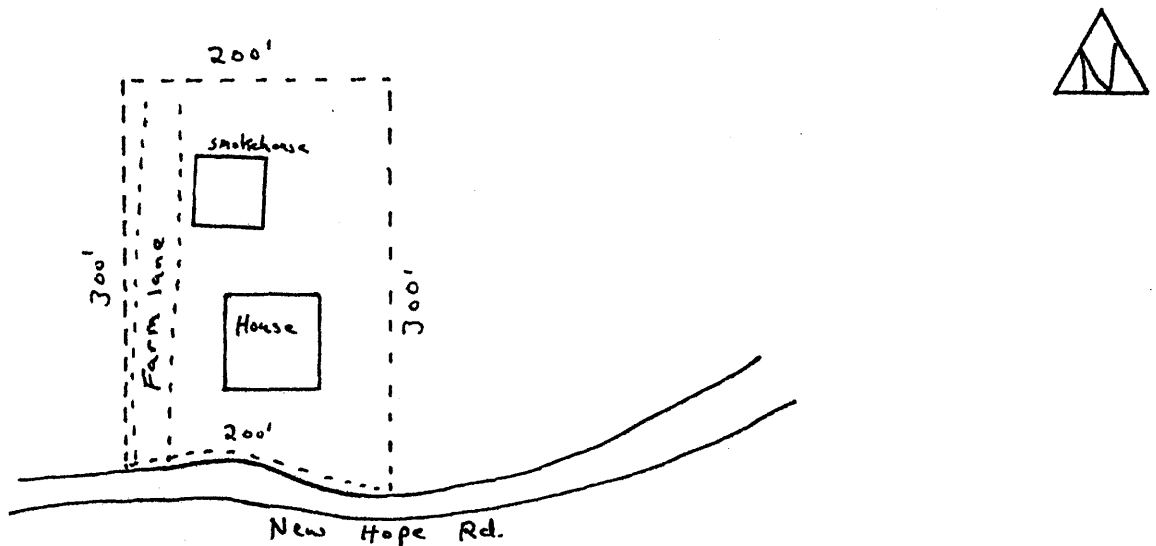
Sketch of Site Plan (Showing outbuildings, structures, landscape features and the site boundary as described above.)

Beginning at the intersection of the farm lane and New Hope Road proceed 300' in a northward direction; thence 200' in an eastward direction; thence 300' in a southward direction; thence 200' in a westward direction to the point of origin. The boundary is drawn to include the house and outbuilding.

Not to scale
