HISTORIC PRESERVATION UNIT
DEPARTMENT of CULTURE & HISTORY
SCIENCE & CULTURE CENTER
CHARLESTON, WEST VIRGINIA 25305

1. NAME(S), historic/common: Parkersburg Woman's Club
(Downtown Parkersburg map)

2. LOCATION, street/road: 323 Ninth St.

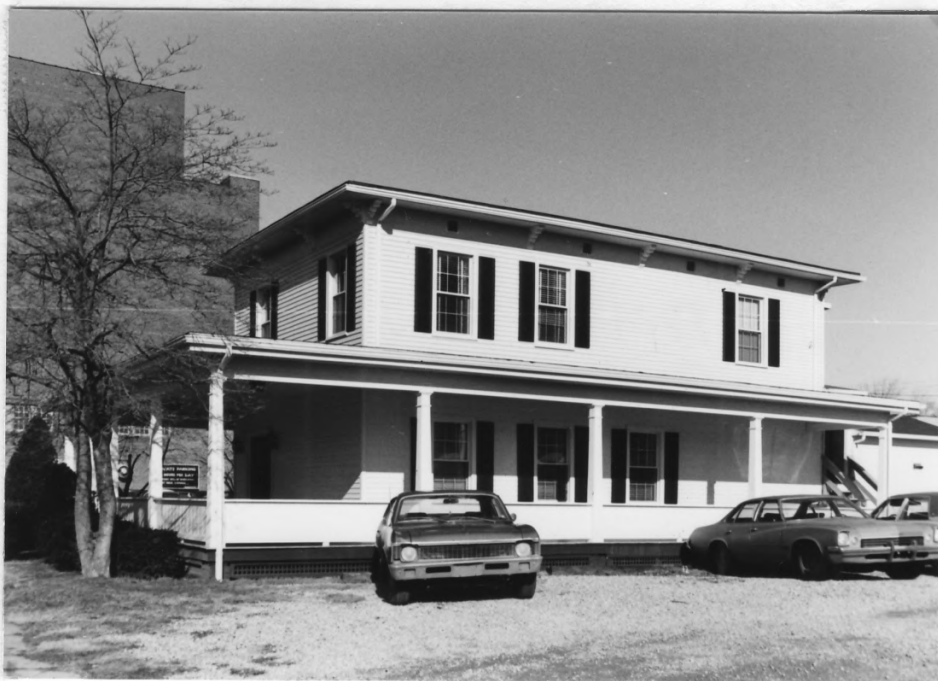
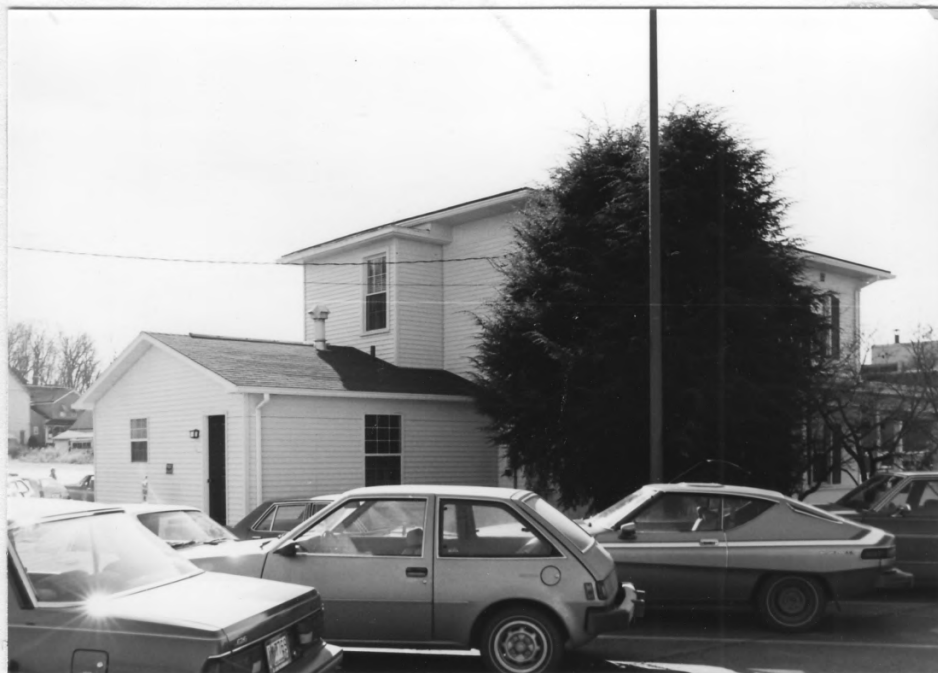
Parkersburg Women's Club
323 Ninth St.
80-113

Sited on a large open lot, this altered two story house has a very low hip roof with brackets and an irregular bay system of approximately two by four bays. Its d/s (6/6) windows have narrow architrave trim and inoperative shutters. A one story porch on square posts with a solid balustrade runs around the SE, SW, and NW sides. A one story gable roofed addition extends to the NE.

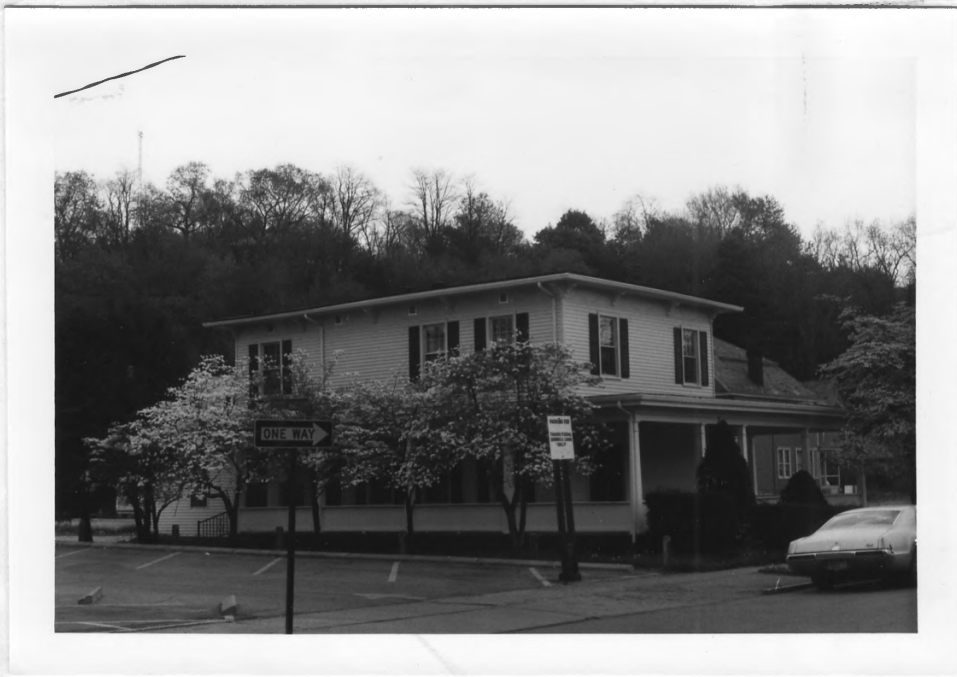
3201-R2-F12

Sited on a large open lot, this altered two story house has a very low
hip roof with brackets and an irregular bay system of approximately
two by four bays. Its d/s (s/e) windows have narrow architrave trim
and inoperative shutters. A one story porch on square posts with a
solid balustrade runs around the SE, SW, and NW sides. A one story
gable roofed addition extends to the NE.
