National Register of Historic Places Registration Form

Historic name: Apartments at 5922 13th Street NW

Other names/site number: Valencia Apartments (current)

Street & number: 5922 13th Street, N.W.

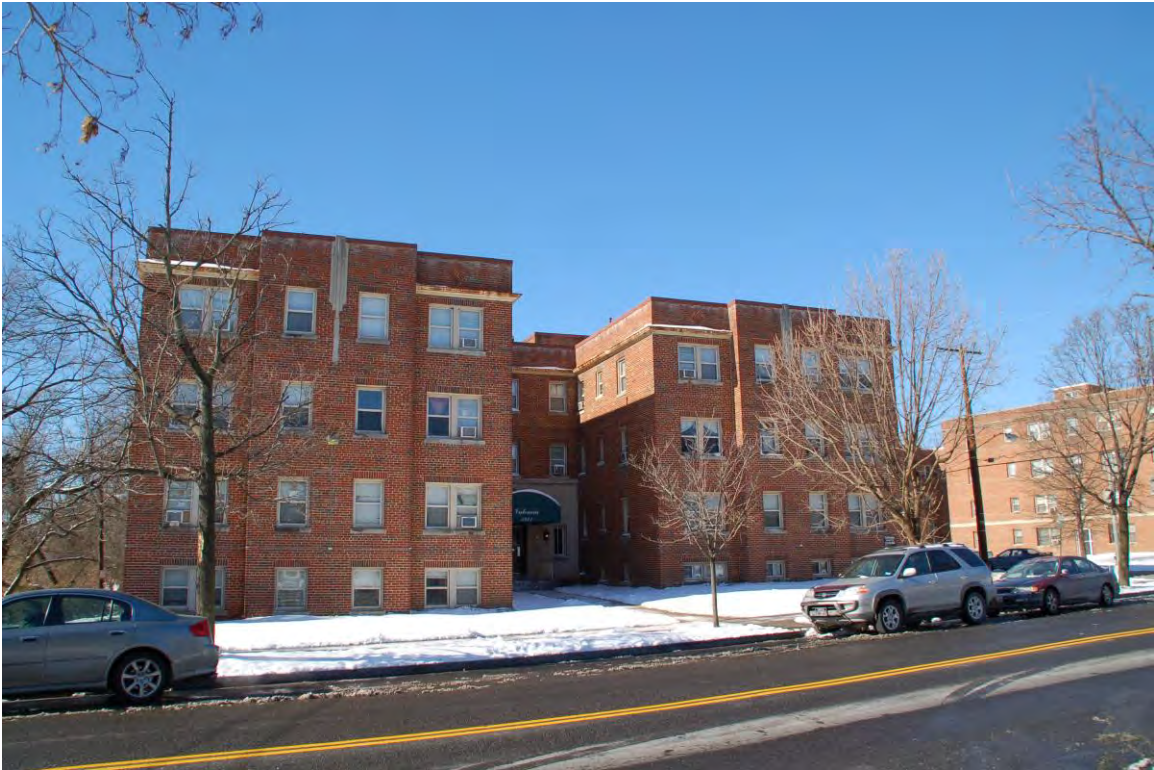
Name of Property: Apartments at 5922 13th Street NW
City or Vicinity: Washington
County: N/A **State:** District of Columbia
Photographer: Jennifer Hembree, MacRostie Historic Advisors, LLC
Date Photographed: January, 2014
Façade (east) elevation, view northwest from east side of 13th Street, N.W.
2 of 15.

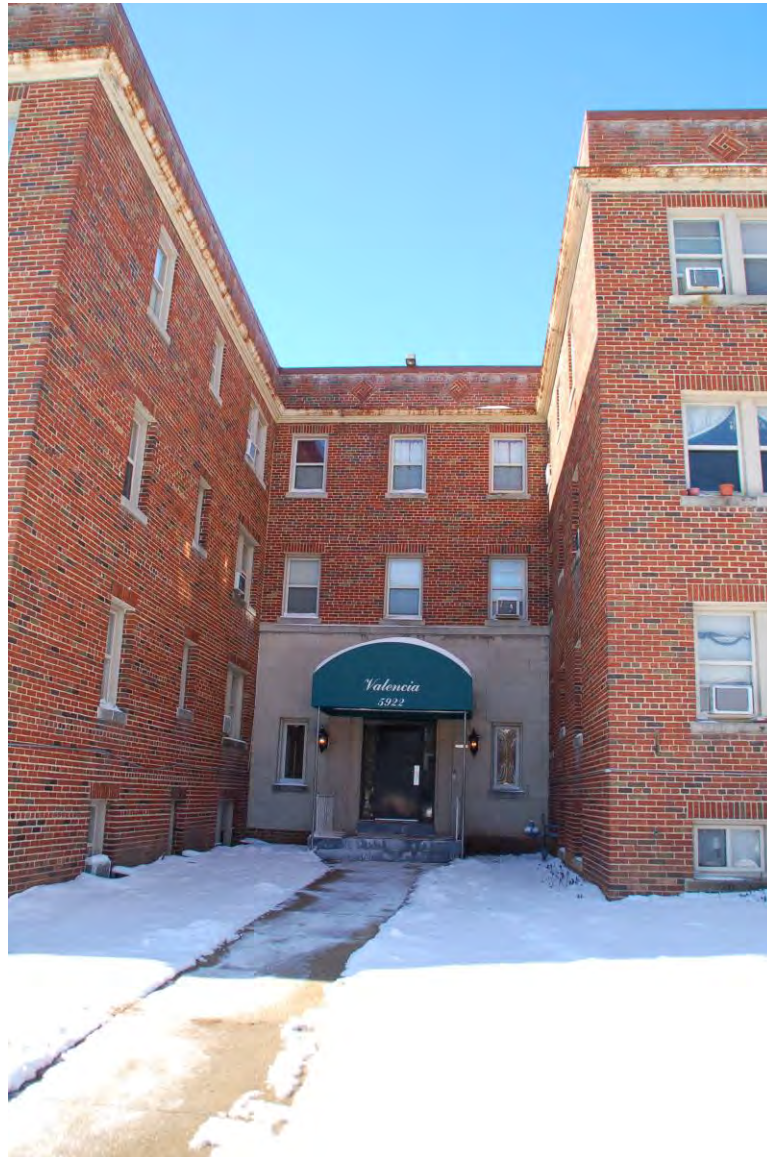
3 of 15.

Façade (east) elevation, center portion featuring recessed main entry, view west from 13th Street, N.W. sidewalk.

The center section of the building's primary (east) elevation is three bays wide and clad with smooth but scored concrete cladding on the first story. A paved walkway from the 13th Street sidewalk leads to a two-step concrete entry landing with metal side railings. A third step from the landing reaches the sill of the single entry door. The door, set into the scored concrete surround, features sidelights and a transom. An awning projects in front of the door and obscures the transom from view.

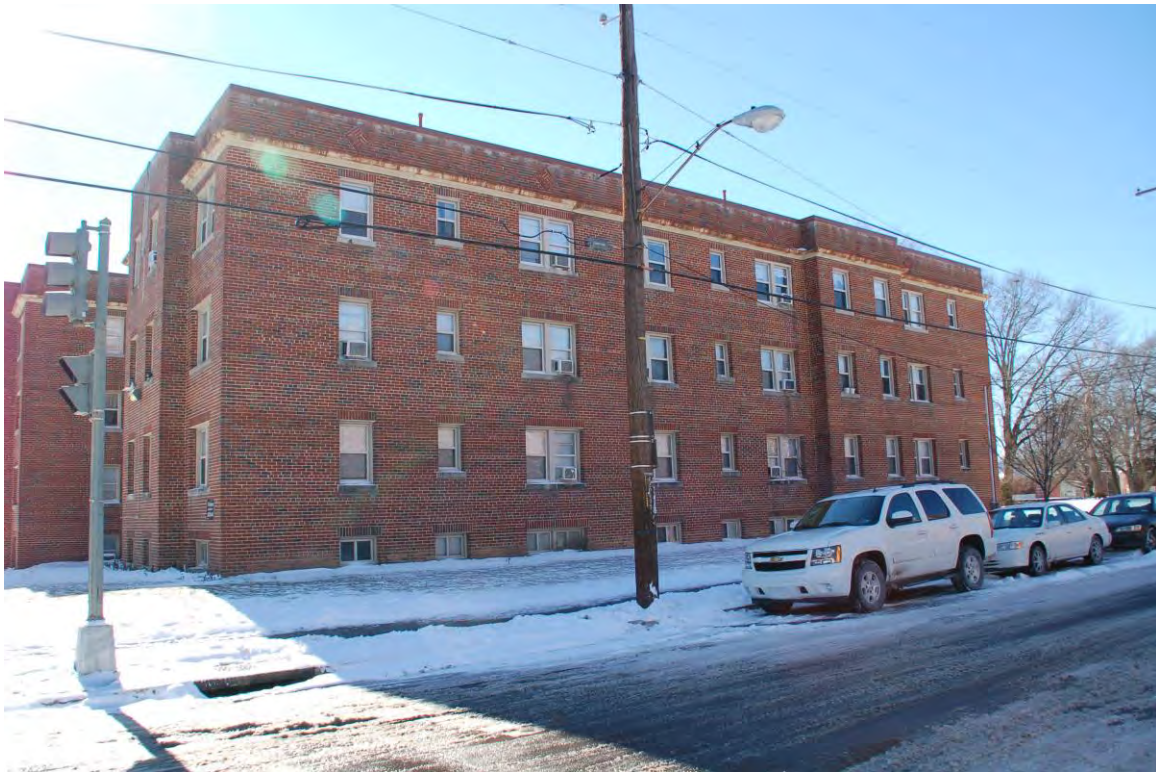
5 of 15.

North elevation, view southwest from north side of Peabody Street, N.W.

The north elevation, also a street-facing elevation consists of ten bays. At the third and fourth bays from the west is a 16'-wide projecting bay. Fenestration is consistent along this elevation with a repeating pattern of two single bays followed by a paired window opening from east to west.

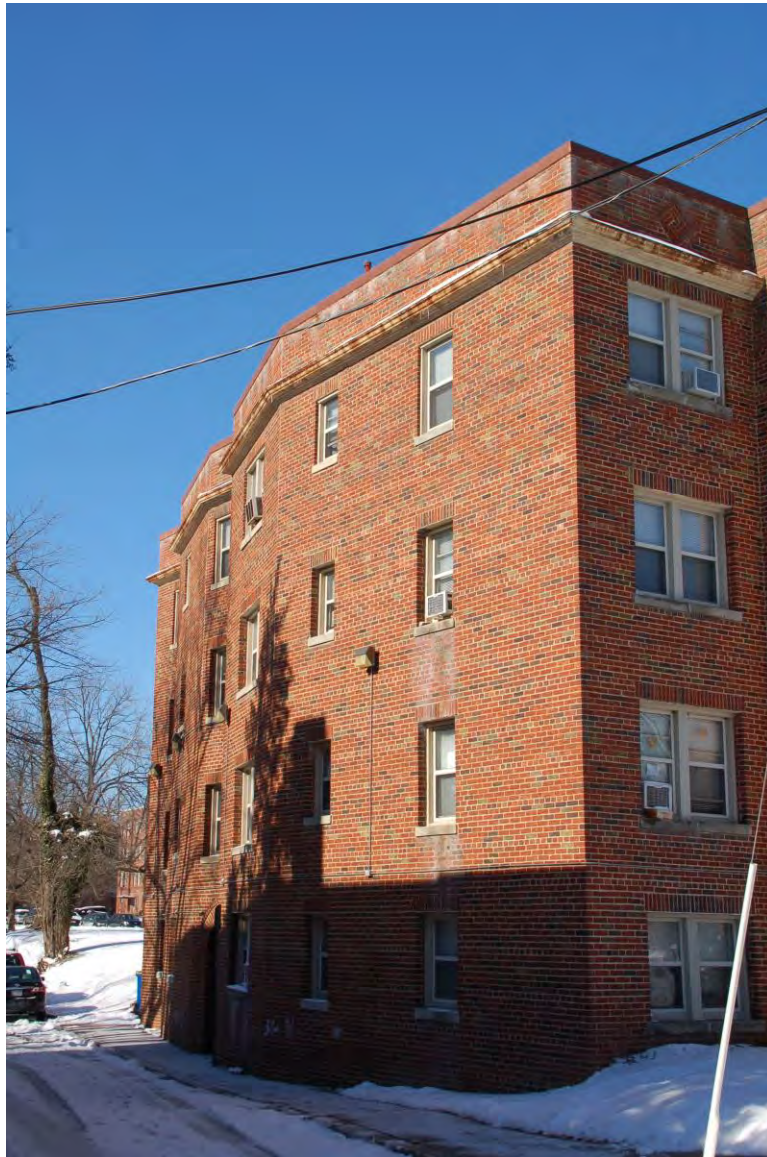
7 of 15.

South elevation, eastern portion, view west showing hexagonal shaped walls along Rock Creek Ford Road, N.W.

The south elevation fenestration is similar in pattern. The south elevation's six eastern-most bays are part of the east wing and abut the Rock Creek Ford Road sidewalk. Two of the honeycomb-like or hexagonal corners here feature dogs-tooth courses. The first floor's fourth bay from the east features an egress door deeply recessed behind a semicircular arched opening ornamented by a three-course brick surround. The remainder of the south elevation is set back from the street by four bays. A portion of the area between street and building provides the building's dumpster facilities.

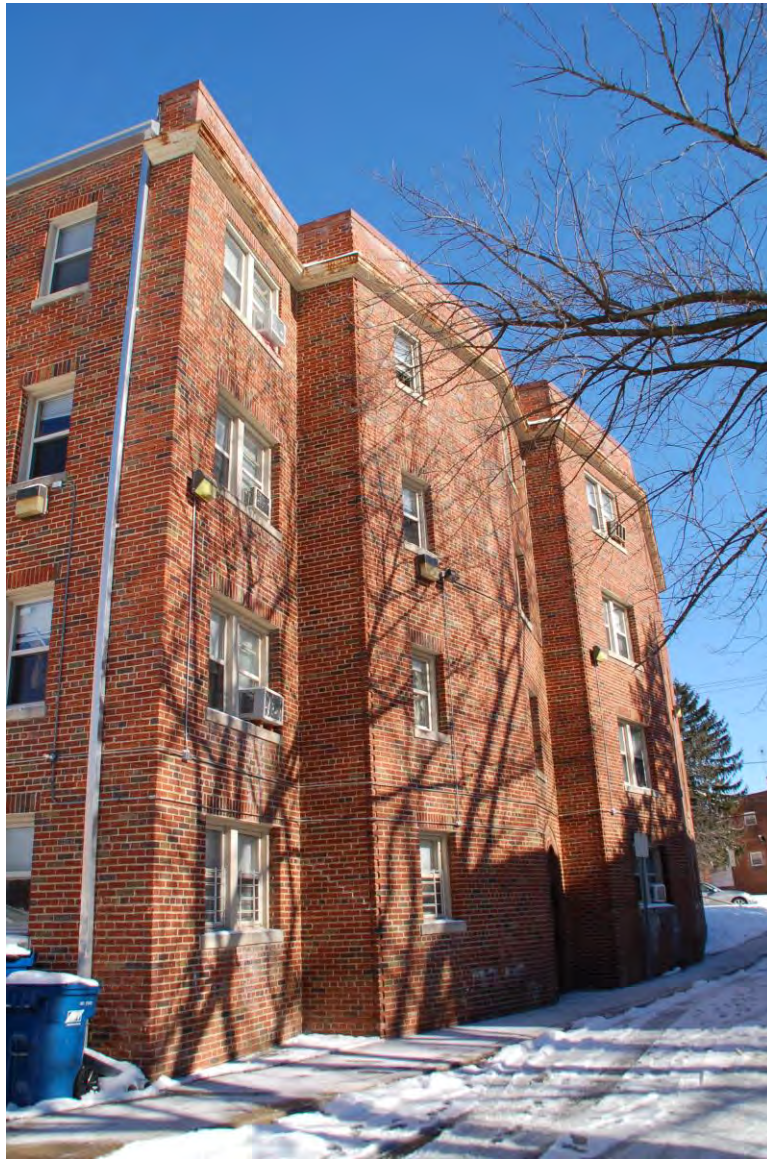
8 of 15.

South elevation, eastern portion, view east showing hexagonal shaped walls along Rock Creek Ford Road, N.W.

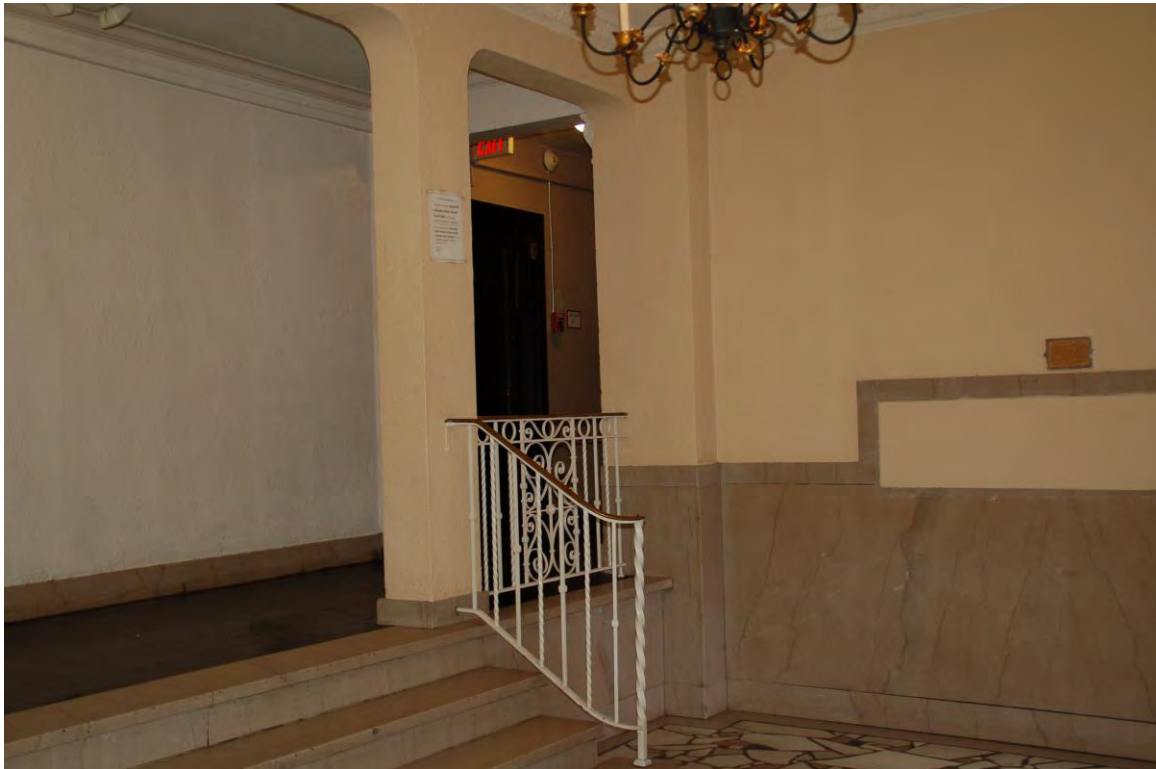
10 of 15.

Interior, first floor, main lobby, view northwest towards marble steps, depressed arch and railings.

The single main entrance provides access directly into the building's lobby. Rectangular in plan, the lobby's west side features three taupe marble steps centered beneath a depressed-arched opening. This opening is flanked by two smaller depressed-arched openings. The steps lead up to the main north-south corridor; they are delineated by a thin metal railing as are the smaller arched openings. Marble wainscoting is featured along the perimeter of the lobby; a crown molding with vegetative relief delineates the lobby ceiling. The lobby's multi-colored tile flooring, geometric in pattern, appears to be historic.

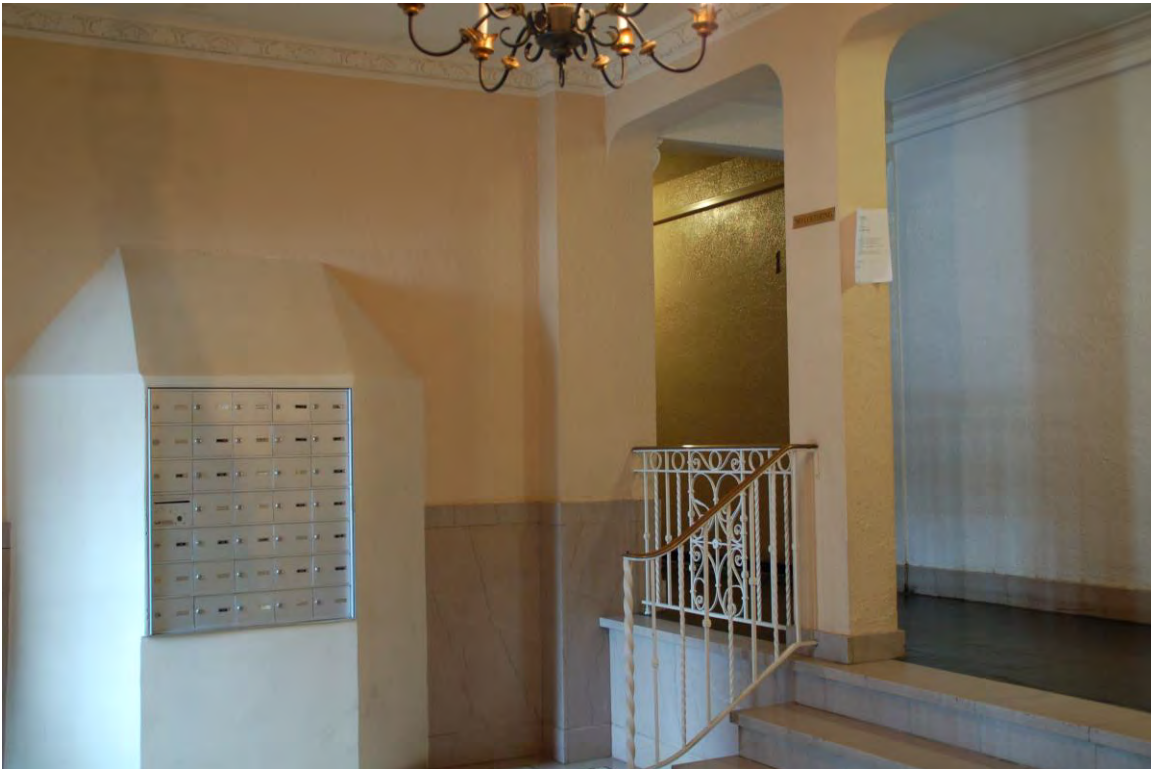
11 of 15.

Interior, first floor, main lobby, view southwest towards marble steps, depressed arch and railings.

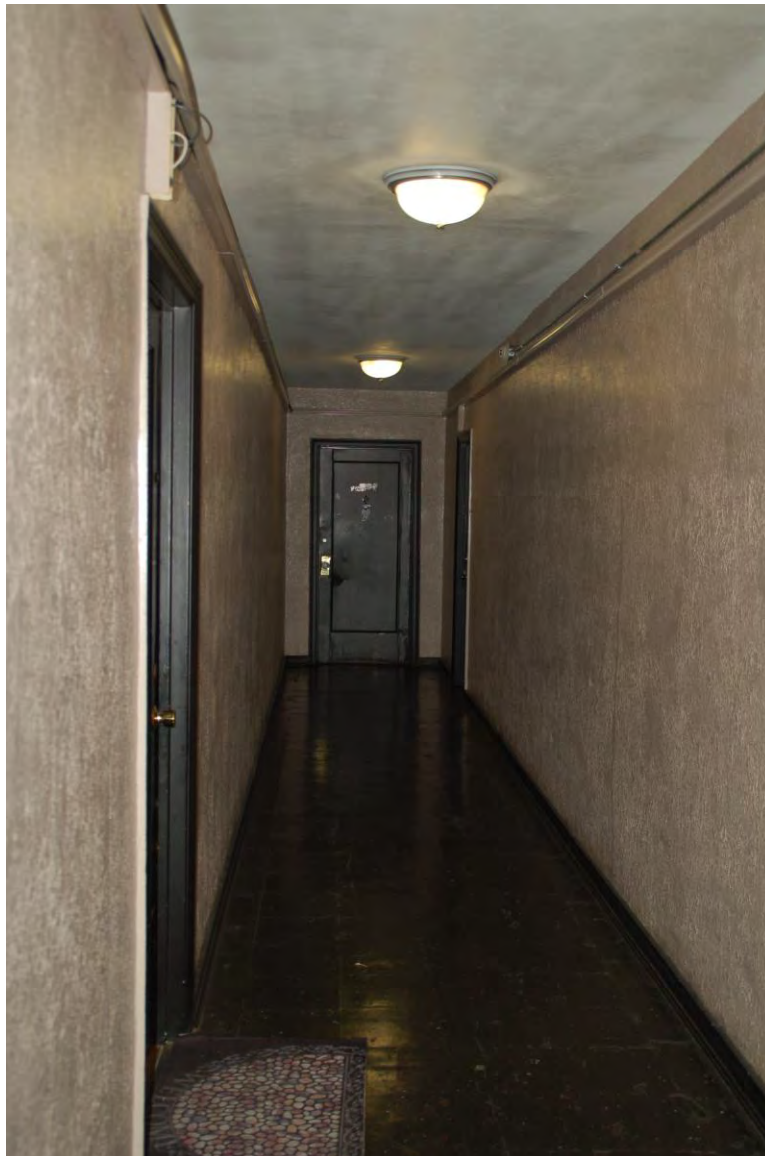
Interior, typical corridor, view showing stucco-finished walls and paneled unit doors.
12 of 15.

The first floor corridor in the space just beyond the arched openings is delineated by concrete beams at the north and south ends and features a marble baseboard and crown molding with decorative scrolls at the concrete beams. All other corridor flooring appears to be vinyl tile (although the basement has painted concrete); a painted concrete base is featured throughout. All corridor walls are painted stucco.

Many unit entries feature what appear to be their historic paneled wood doors and wood trim surround. Stairwell doors are also paneled wood doors and appear to be historic.

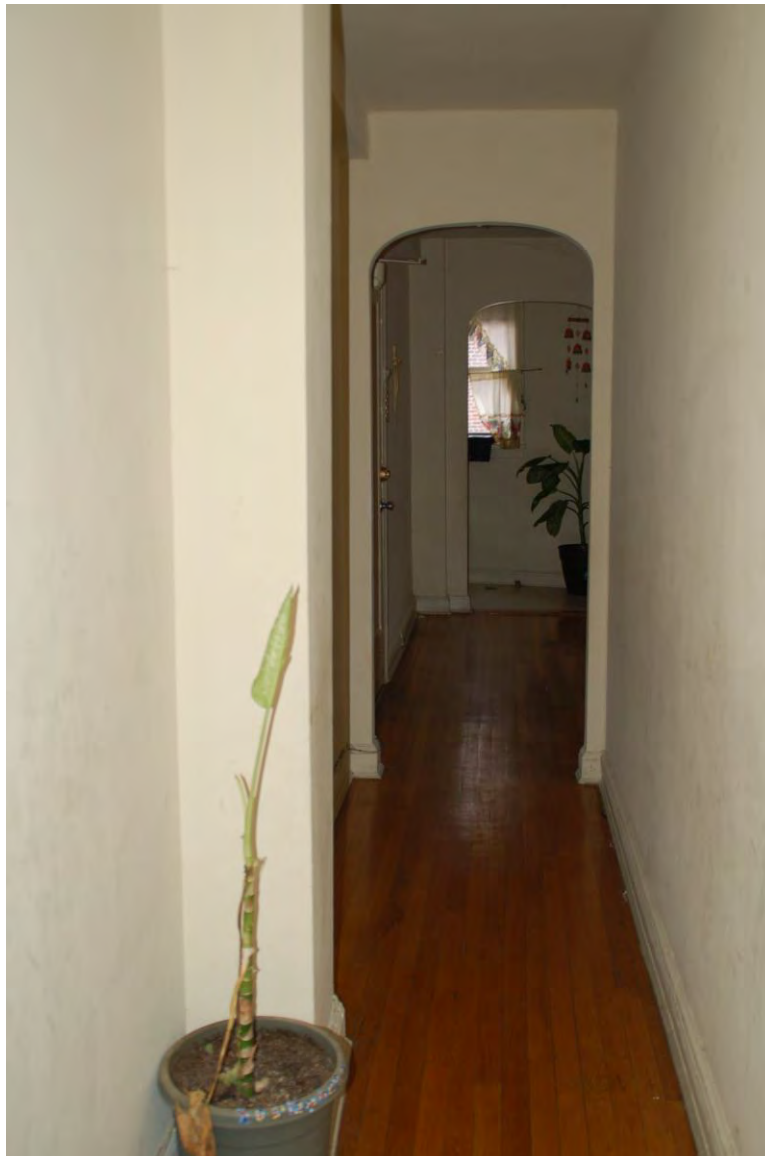
Interior, typical unit featuring hardwood flooring and depressed arch in hallway.
13 of 15.

According to the D.C. Permit to Build application, the building was to comprise 32 units and was estimated to cost \$80,000. All of the 323 units remain intact to their original configuration and are equipped with a bathroom, kitchen and living space. Historic hardwood flooring remains in living spaces as does wood baseboard. Interior window trim and sills remain in many cases, although some windows, such as those that have received air conditioning units, have replacement vinyl sills and trim. Many units feature interior wood paneled doors; those that have been replaced are slab. Unit baths feature tile flooring and wainscoting, although some tile flooring is a modern replacement. Kitchens have received linoleum or vinyl tile flooring and in most cases have replacement cabinetry; a limited number retain historic cabinetry. Kitchen appliances and bathroom vanities have also been updated over time.

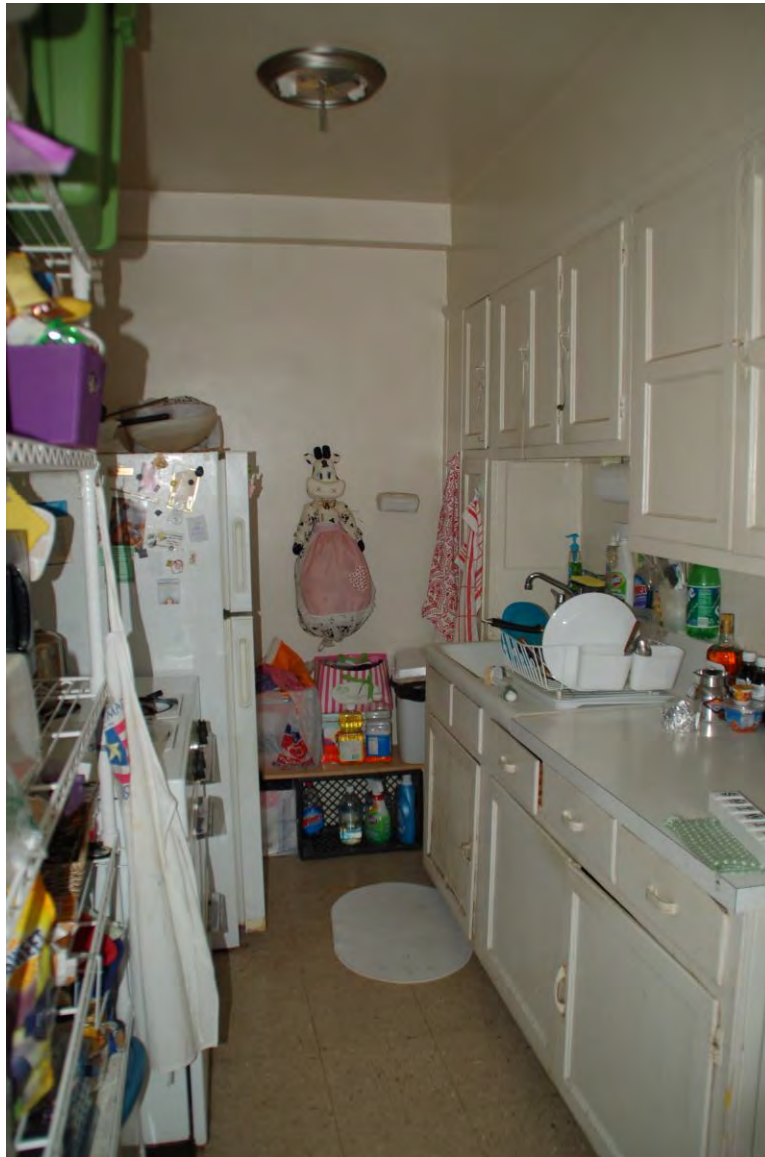
Name of Property: Apartments at 5922 13th Street NW
City or Vicinity: Washington
County: N/A **State:** District of Columbia
Photographer: Annie Dobberteen, MacRostie Historic Advisors, LLC
Date Photographed: February, 2014
Interior, unit featuring historic kitchen cabinetry, typical of a limited number.
14 of 15.

Interior alterations are largely at the cosmetic level. Corridors have received replacement flooring. In units, select finishes (e.g. tile flooring) or furnishings (e.g. cabinetry, appliances, vanities, toilets) of kitchens and baths have been updated over time as needed. However, the interior layout appears to remain original to the building.

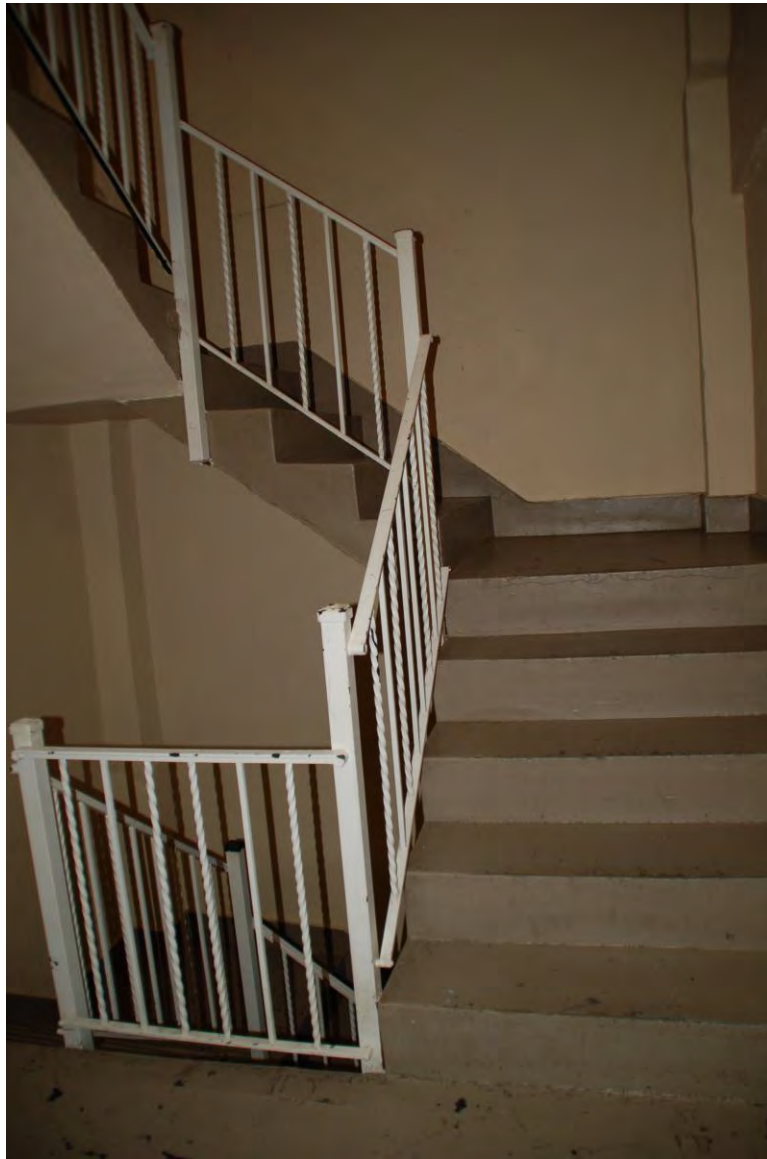
15 of 15.

Interior, concrete stair and metal railings, typical of both stairs in this walk-up apartment building.

The building consists of three floors and a basement, each featuring a main north-south corridor, as well as east-west corridors in the wings. Floors are accessible only by stair. A secondary egress is available from the basement to Rock Creek Ford Road. Residential units are generally located on either side of the corridors, with a stairwell just north of the lobby steps, as well as one in the south wing of the building. The concrete stairs are painted and have thin metal railings.
