KENTUCKY HISTORIC RESOURCES INVENTORY

Site No. **WS-97**

1. Historic Name(s) Kendrick/Tucker/Barber House Original Owner _____		22. ADD. County Lincoln Trail/Wash. 115	
2. Present Name As above		23. U.S.G.S. Quadrant (15/75') Maud G.I.S. Mod.

KENDRICK/TUCKER/BARBER HOME

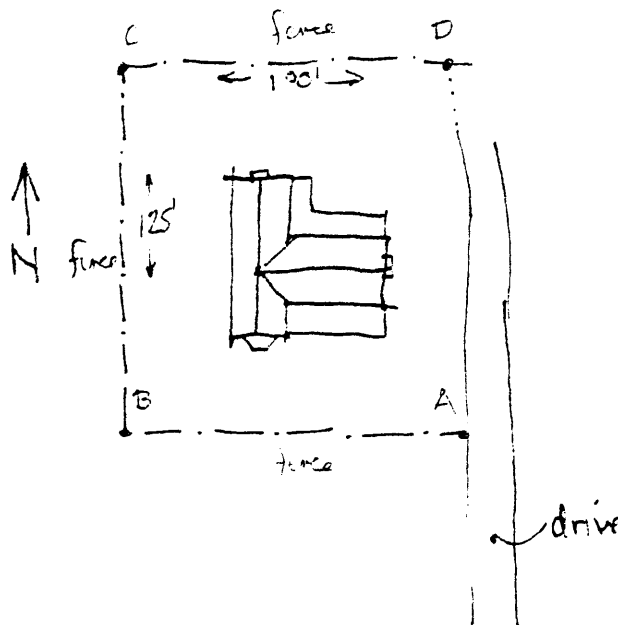
Sketch of Site Plan (Showing outbuildings, structures, landscape features and the site boundary as described above.)

Point A is 35 feet southeast of the southeast corner of the house. Beginning at Point A, proceeding west 100 feet along a fence to Point B, thence north 125 feet along a fence to Point C, thence 100 feet east along a fence to Point D, thence south along a drive 125 feet to the point of origin. The boundaries were drawn to include the house and domestic-related space as enclosed by fences and drive. There are no outbuildings. The nomination area contains one contributing building.
