National Register of Historic Places Registration Form

Historic name Brungardt-Dreiling Farmstead
Other names/site number Old Dreiling Dairy; KHRI #051-89
Name of related Multiple Property Listing Historic Agricultural-related Resources of Kansas

Street & number 2567 Golf Course Rd not for publication
City or town Victoria vicinity
State Kansas Code KS County Ellis Code 051 Zip code 67671

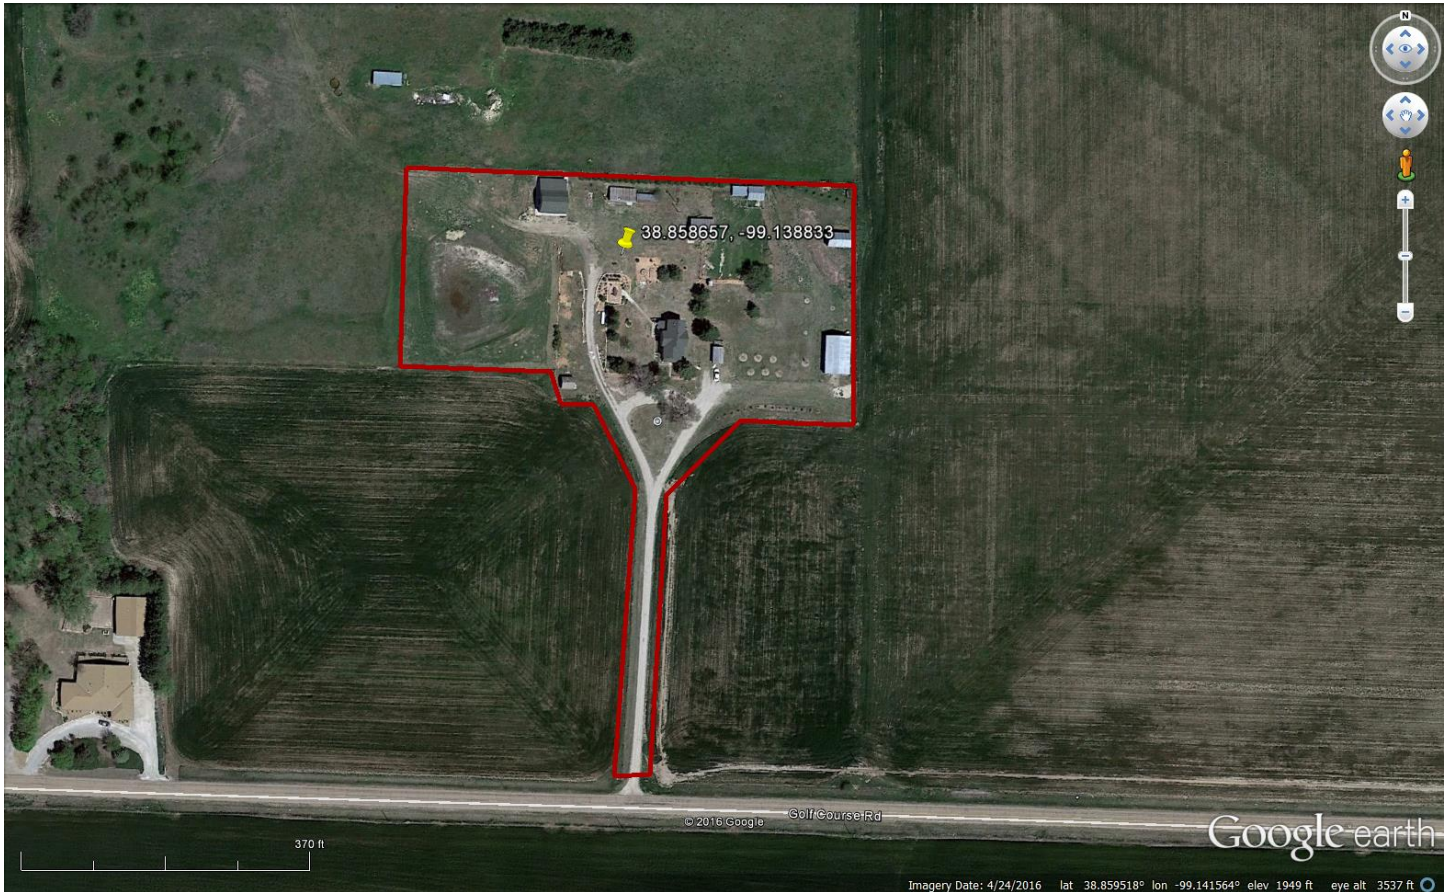
Boundary Map.

The nominated 4.2-acre site is depicted by the outlined shape.
See Figure 1 for contextual map.
