NATIONAL REGISTER OF HISTORIC PLACES  
REGISTRATION FORM

historic name: Many Glacier Barn and Bunkhouse

Section number        7                                Page    1                                Many Glacier Barn and Bunkhouse, Glacier Co., MT.

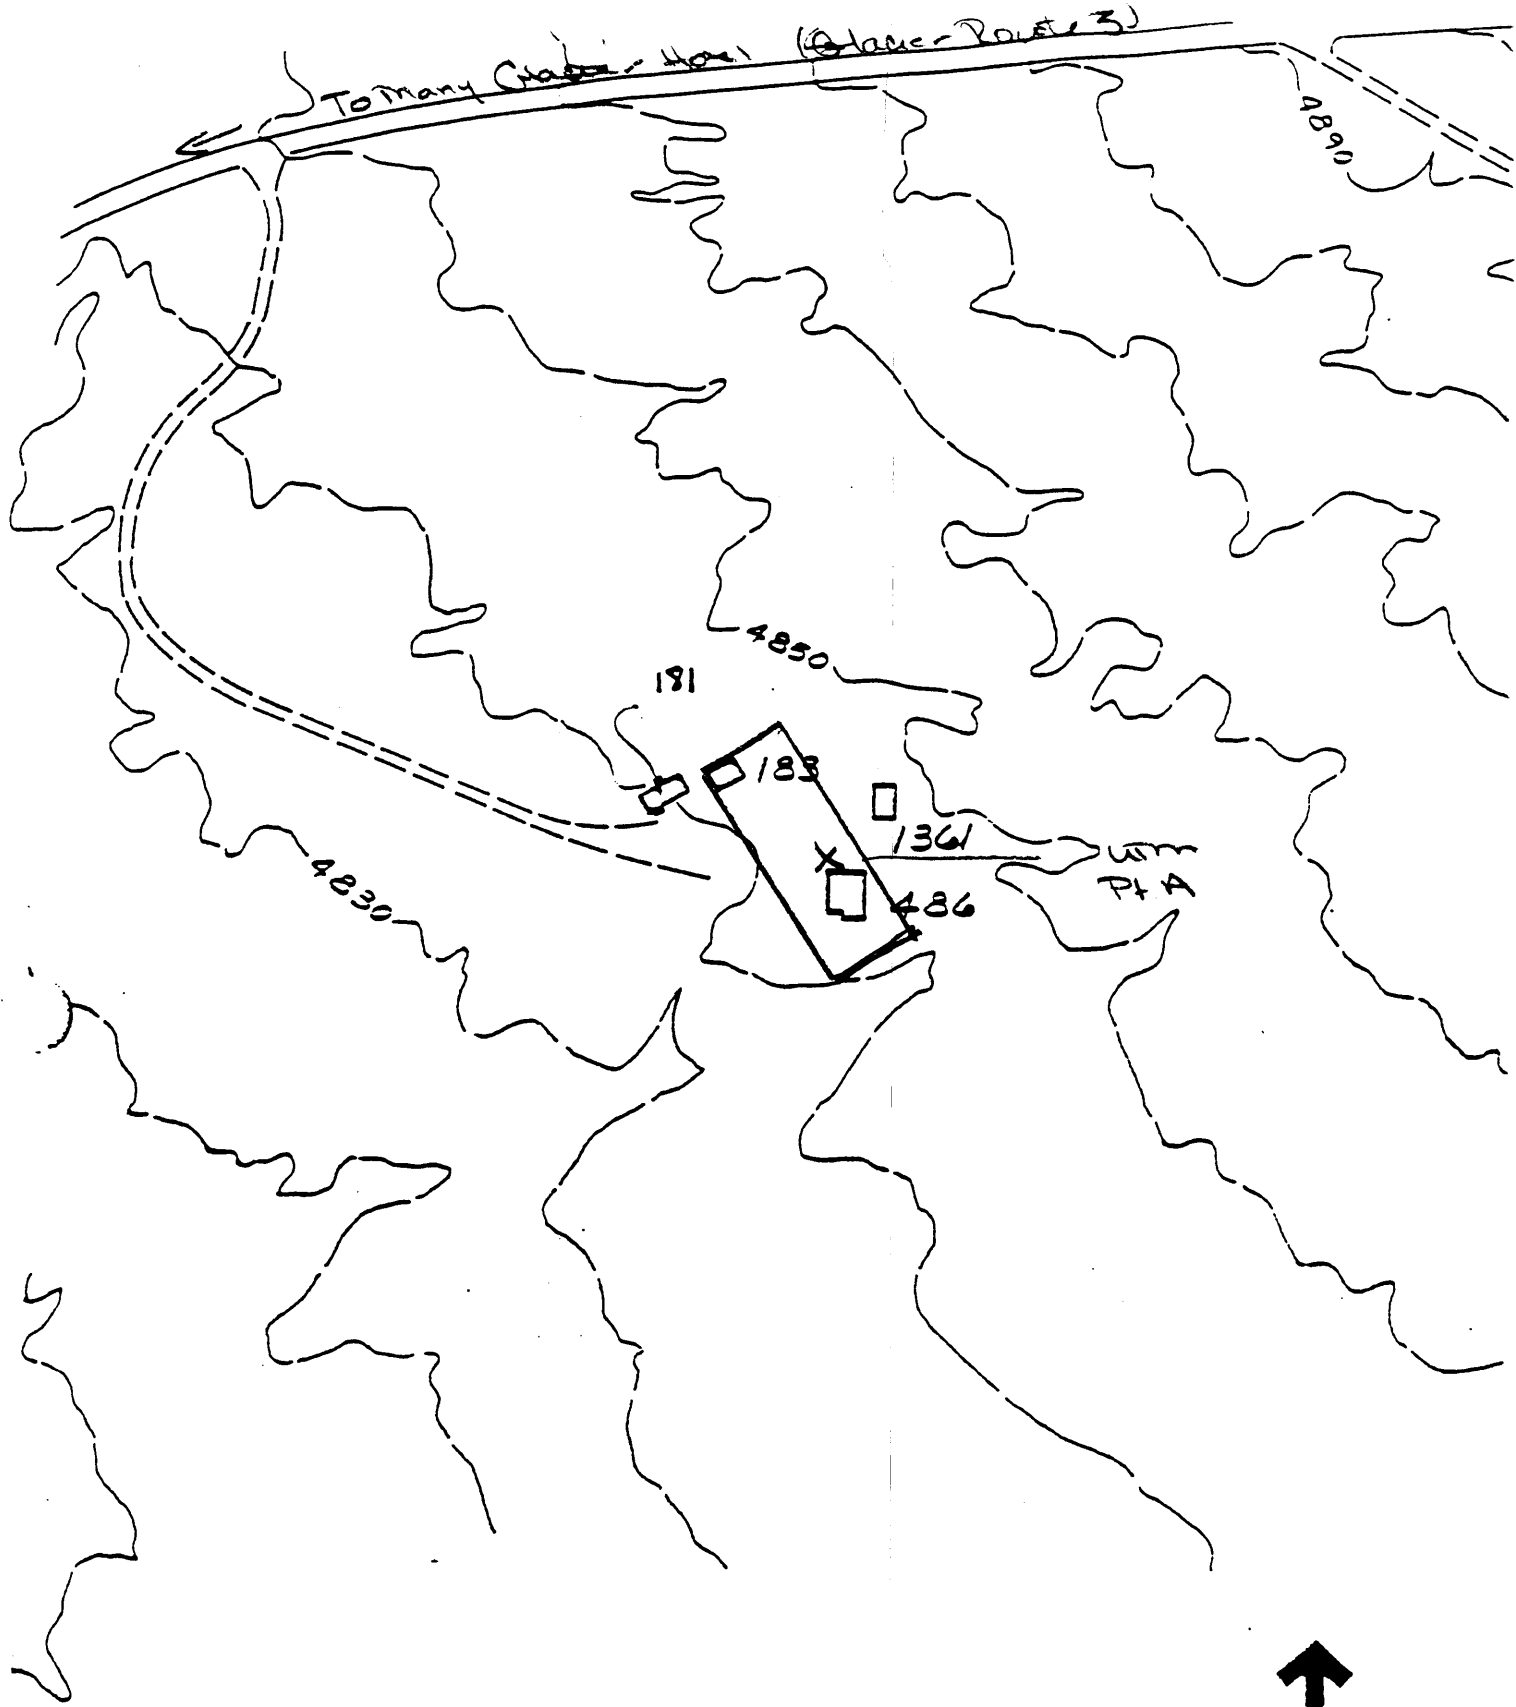
Many Glacier Barn and Bunkhouse

HRA map 1994 based on  
Cultural Resources Management Plan  
Many Glacier Hotel Horse Concession Area  
1984  
Glacier National Park  
National Park Service—U.S. Dept. Interior

The boundaries have been drawn to incorporate the barn, the bunkhouse and the corral system while excluding the unevaluated concession-owned bunkhouse.
