Town Marblehead 009

Address 3 Manataug Trail

Historic Name Harris Farm

Community: MARBLEHEAD	Form No: 33
Property Name: Harris Farm

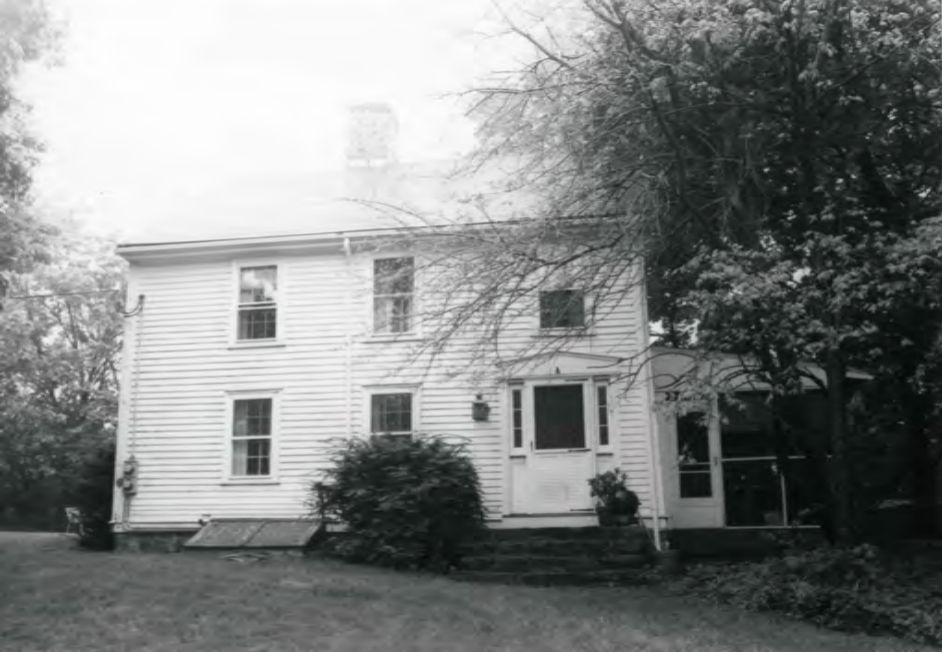
Harris Farm: 13

- 36:4 detail, attic: original rafter cut off, new portion of tie beam added
- 36:5 detail, summer beam and prick post, southwest room
- 36:6 southwest room
- 36:12 west facade
- 36:13 south facade
