ARIZONA STATE HISTORIC PROPERTY INVENTORY

SURVEY AREA NAME: Kingman Historic Resources Survey

HISTORIC NAME: George R. Kayser House

ADDRESS/LOCATION: 604 E. Oak

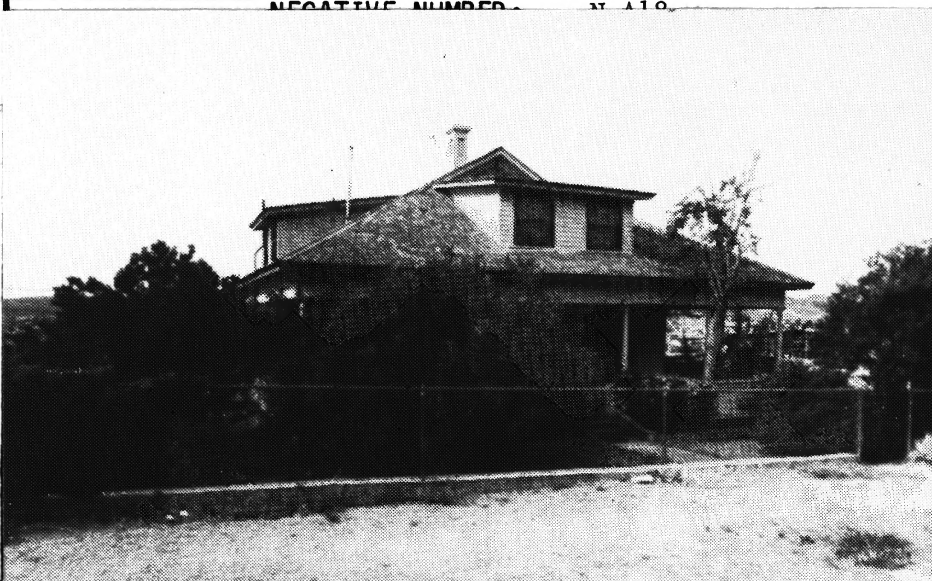
PHOTOGRAPH

CONDITION: good/maintained

ALTERATIONS: unaltered

DATE: 4/84 **VIEW:** South

Vertical boards enclose lower half of porch, columns rest on enclosure; dormers on each roof slope; Gablets at front and rear of house over dormers; concrete chimney.
