Historic name: Dyer, Samuel Residence

### **National Register of Historic Places Registration Form**

3. State/Federal Agency Certification	5
5	2. Location  Street & number: 208 North Cantril Street  City or town: Castle Rock State: Colorado County: Douglas  Not For Publication: N/A Vicinity: N/A	
(	Name of related multiple property listing: N//A  (Enter "N/A" if property is not part of a multiple property listing  Natl. Reg. of H National Pa	listoric Plac ark Service
	Other names/site number: <u>5DA.653</u>	0 2010

#### House, 1875, additions 1893, 1901; Building (Photographs 1-4); Floor Plan

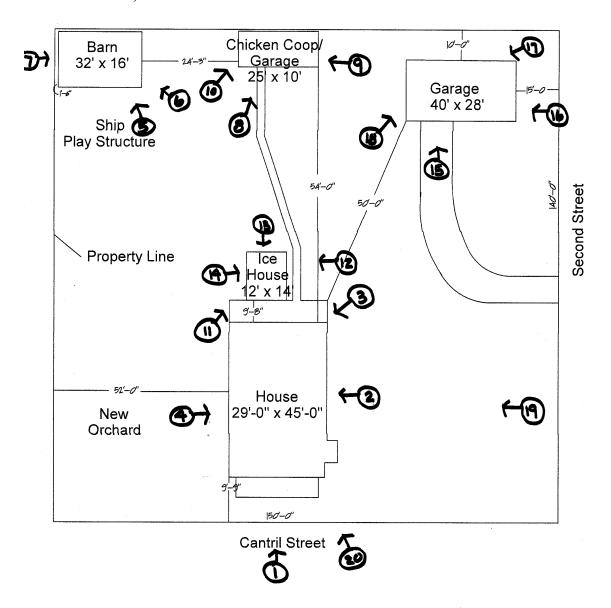
#### Sketch Site Plan, with Photo Locations Indicated

DYER RESIDENCE Castle Rock, Douglas County, Colorado June 3, 2016

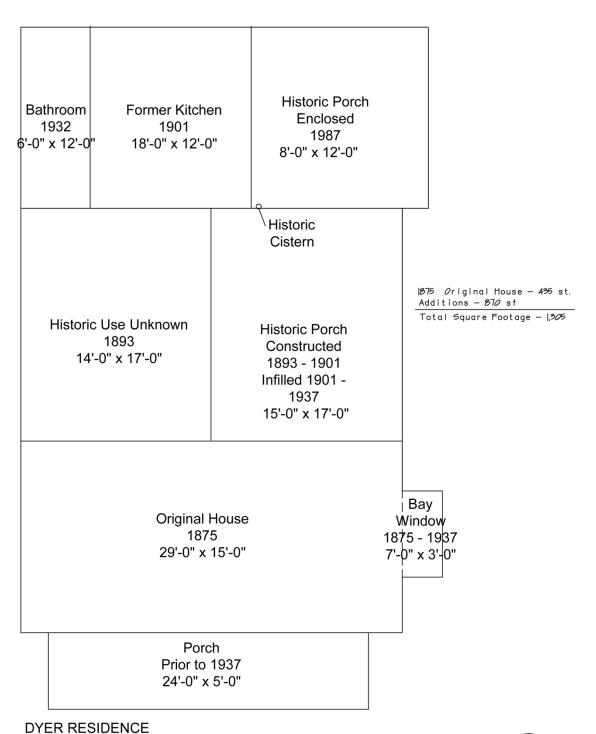
#### **Sketch Floor Plan of House**

Castle Rock, Douglas County, Colorado June 3, 2016

The Dyer house (approximately 29' x 45') faces west and sits atop a rhyolite stone foundation with a cornerstone with the date 1875 carved in the face. The west porch, which was constructed after the original house, covers the cornerstone, which is only seen by climbing under the porch. The walls with wood corner boards are clad with weatherboard siding. The cross-gabled roof has composition roofing and overhanging eaves. The original 1875 building is believed to have been the side-gabled, one-and-one-half story west portion of the house due to the dated cornerstone. The west-facing porch is not original, but was constructed sometime prior to 1937 (see Historic Photo 1). In 1893, the cross-gabled addition, located on the northeast portion of the house just behind the side-gabled original building, was constructed.<sup>2</sup> A kitchen addition, attached to the east of 1893 addition, was constructed in 1901.<sup>3</sup> Although no written evidence has been found, a 1932 bathroom (date found inscribed on the back of the original baseboard trim) shed-roof addition, was constructed onto the 1901 addition.<sup>4</sup> The south side of the house historically featured porches along the successive additions, dating from ca. 1893 – 1901. Based on field investigations, the porch attached to the south side of the 1893 addition is believed to have been infilled ca. 1901 – 1937. The other south-facing porch, attached to the 1901 kitchen addition, was infilled in 1987, when a bathroom addition was constructed by the previous owners, John and Fleta Knockels.<sup>5</sup> A bay window was also added to the south side of the

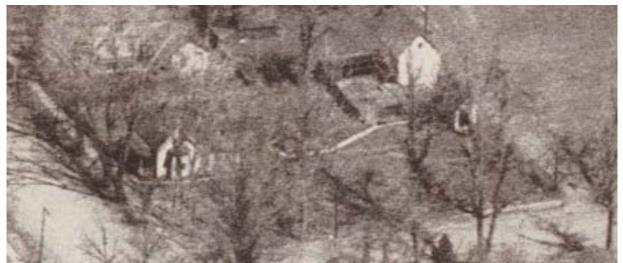
1. 1937 Aerial of the Property – Looking Northeast at the South Side of the Property. Courtesy of the Douglas County History Research Center

original 1875 house, ca. 1875 – 1937 (see Historic Photo 1). Finally, in 1985, the attic of the 1875 portion was rehabilitated, making an additional bedroom and adding a window at either end of the gables.<sup>6</sup>

The period of significance is from 1875, the date when the house was first built, to ca. 1937, the date by which the historic additions and features were constructed as shown in a historic aerial photograph.

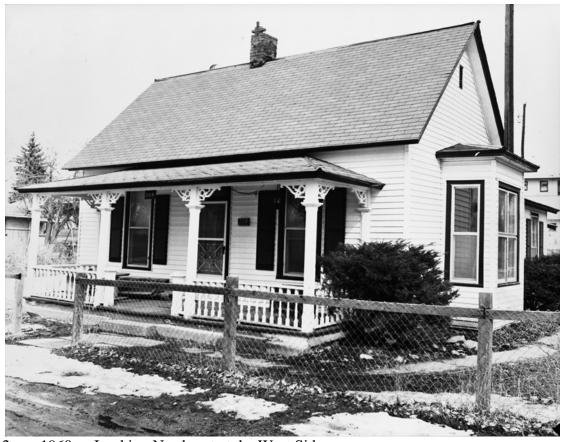
2. ca. 1960s – Looking Northeast at the West Side
