National Register of Historic Places Registration Form

historic name Rochester Hotel

street & number 726 E. Second Avenue [N/A] not for publication

city or town Durango [N/A] vicinity

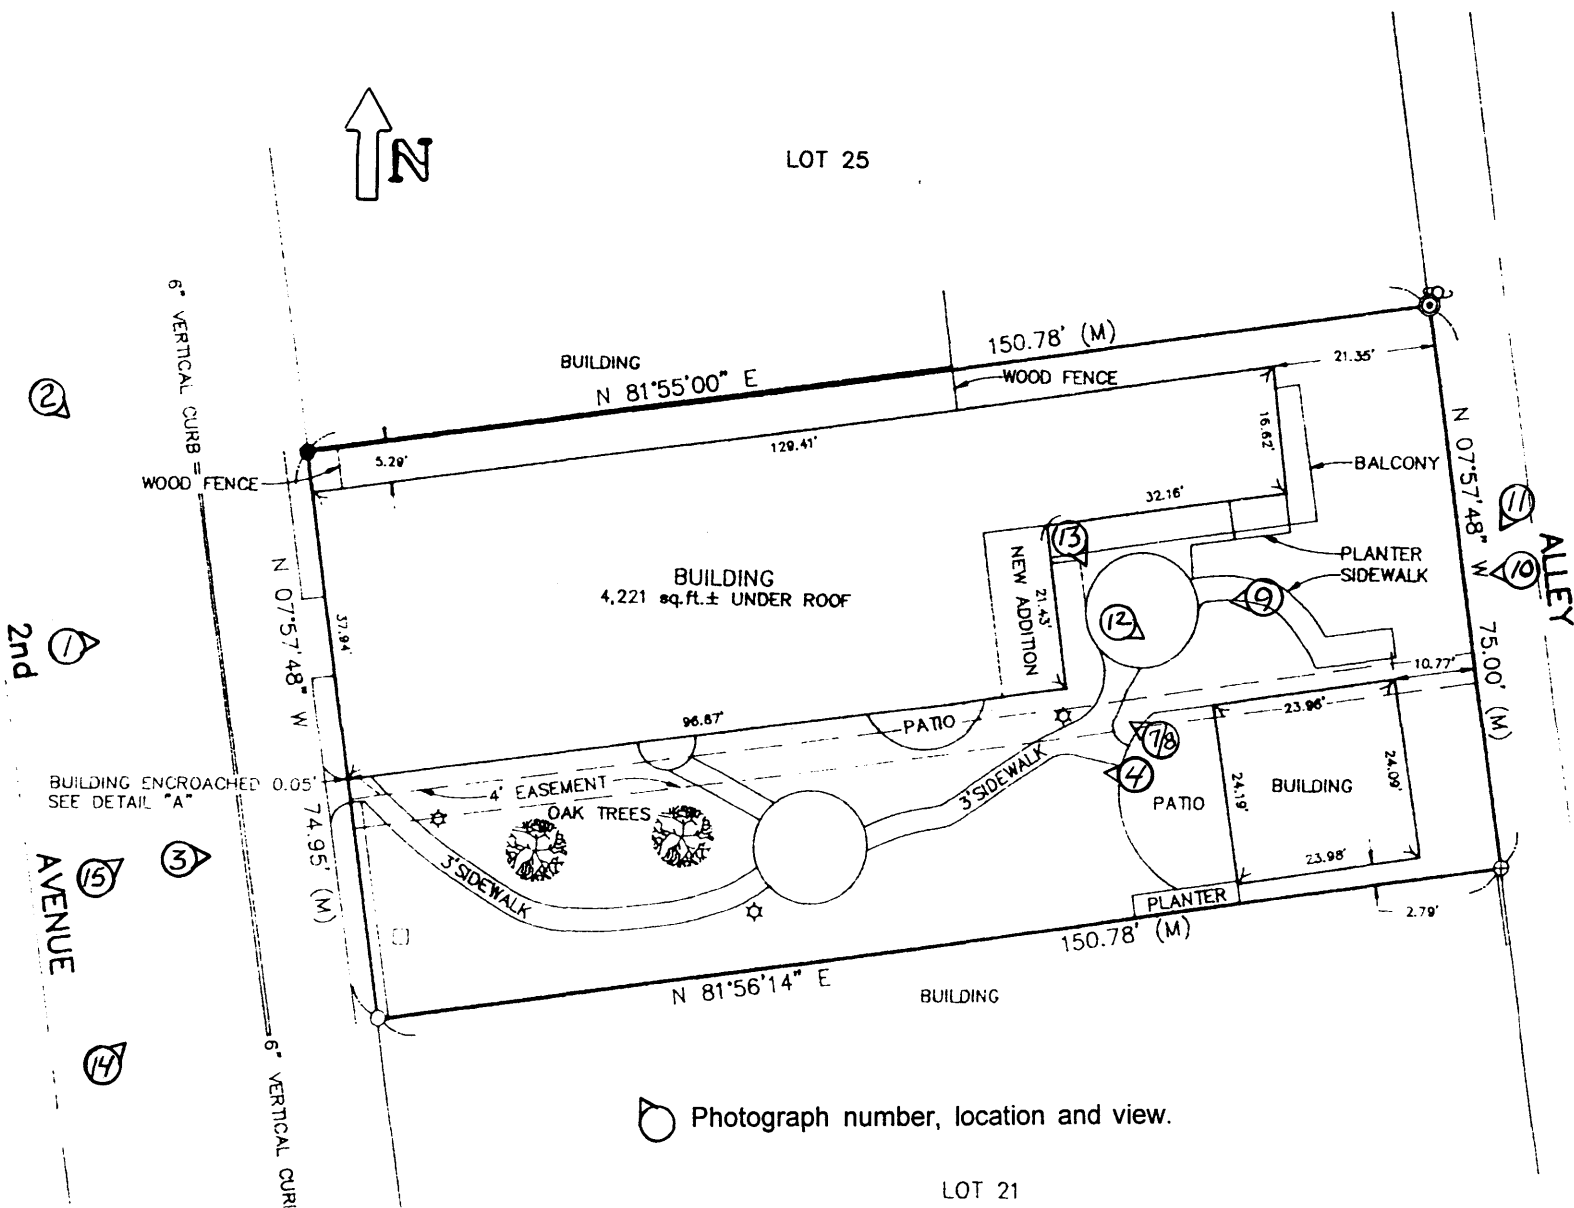
SKETCH MAP

Lots 22, 23 and 24 of Block 42 in the City of Durango

The nomination includes all of the land historically associated with the hotel.
