**NATIONAL REGISTER OF HISTORIC PLACES  
INVENTORY -- NOMINATION FORM**

DEPRESSION-ERA BUILDINGS

NAME: Verlot Ranger Station (Public Service Center)

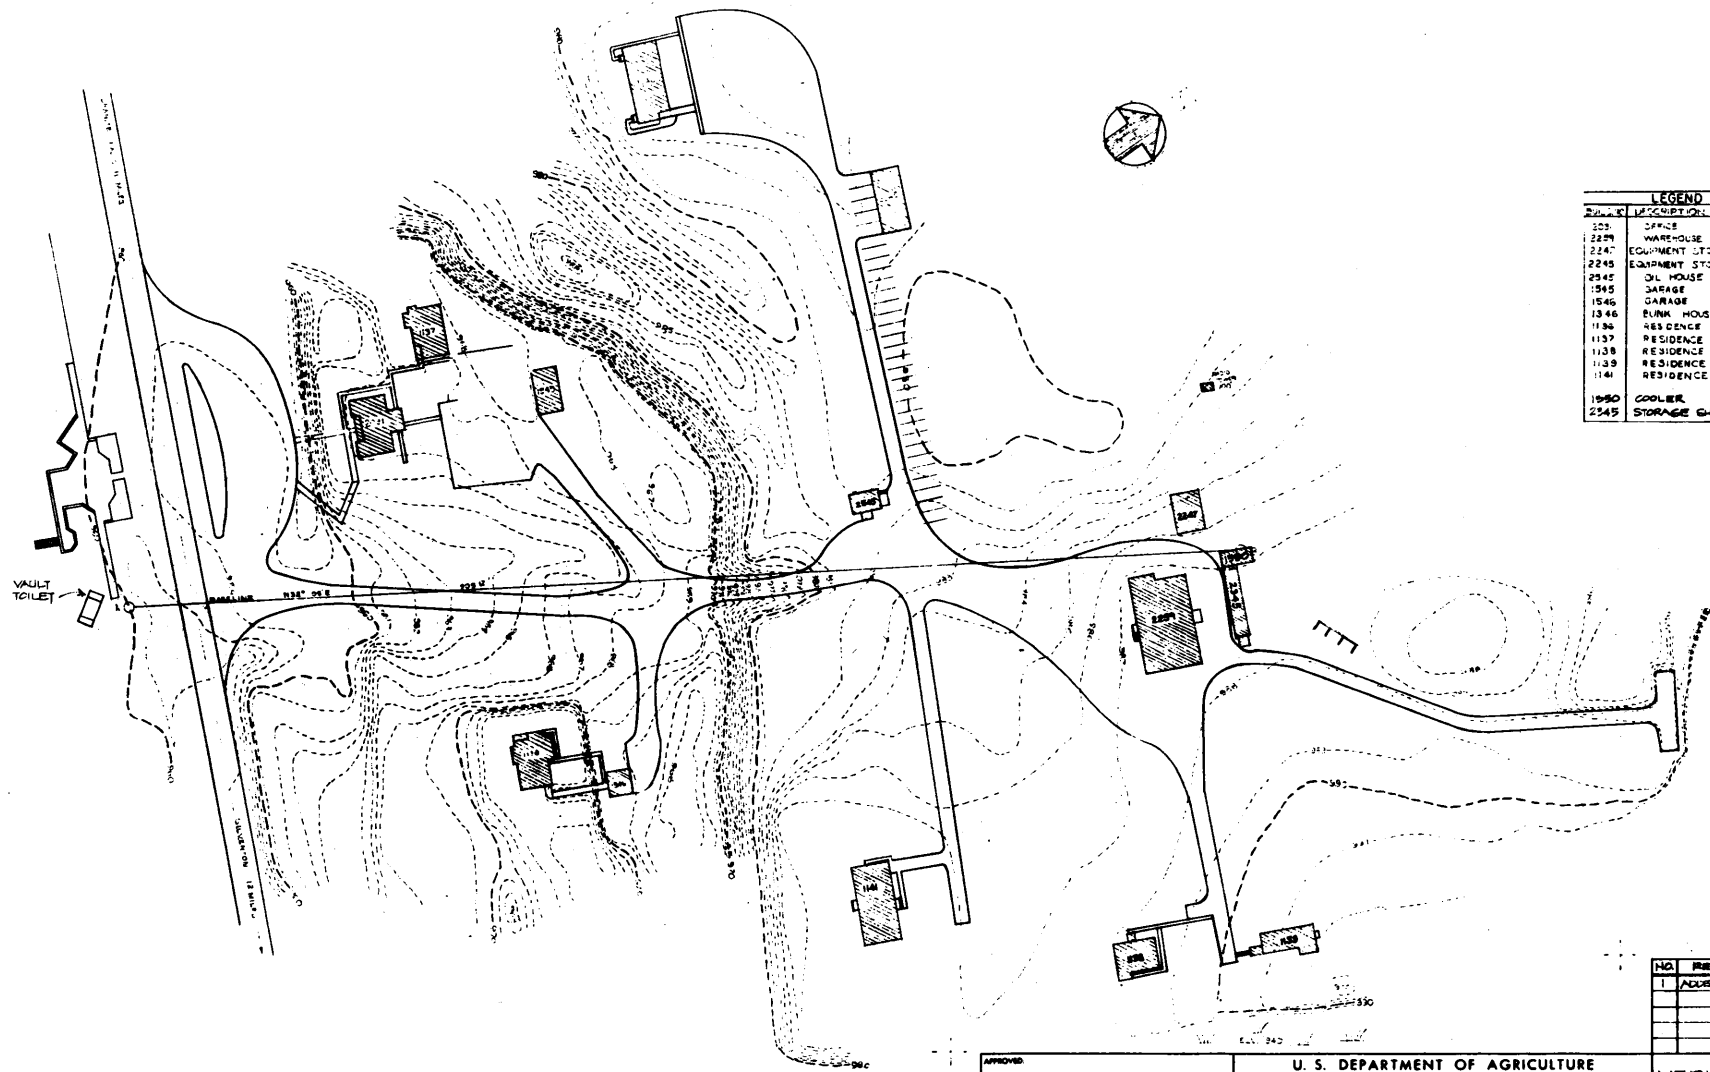
The Verlot Administrative Site (the former Monte Cristo Ranger Station) is comprised of the buildings and features within a 59 acre tract in the NE 1/4 of Section 16, T30N, R8E, WM in Snohomish County, State of Washington.

The boundaries are delineated as follows: Beginning at the NE corner of Section 16, thence south to the north side of Forest Highway 7, thence following the north side of the highway in a northwesterly direction to the north section line of Section 16, thence east along the section line to the beginning point. This description is subject to any easements for public road right-of-way along Forest Highway 7.
