National Register of Historic Places
Inventory—Nomination Form

historic St. Mark Methodist Church

street & number 781 Peachtree Street N/A not for publication

city, town Atlanta N/A vicinity of

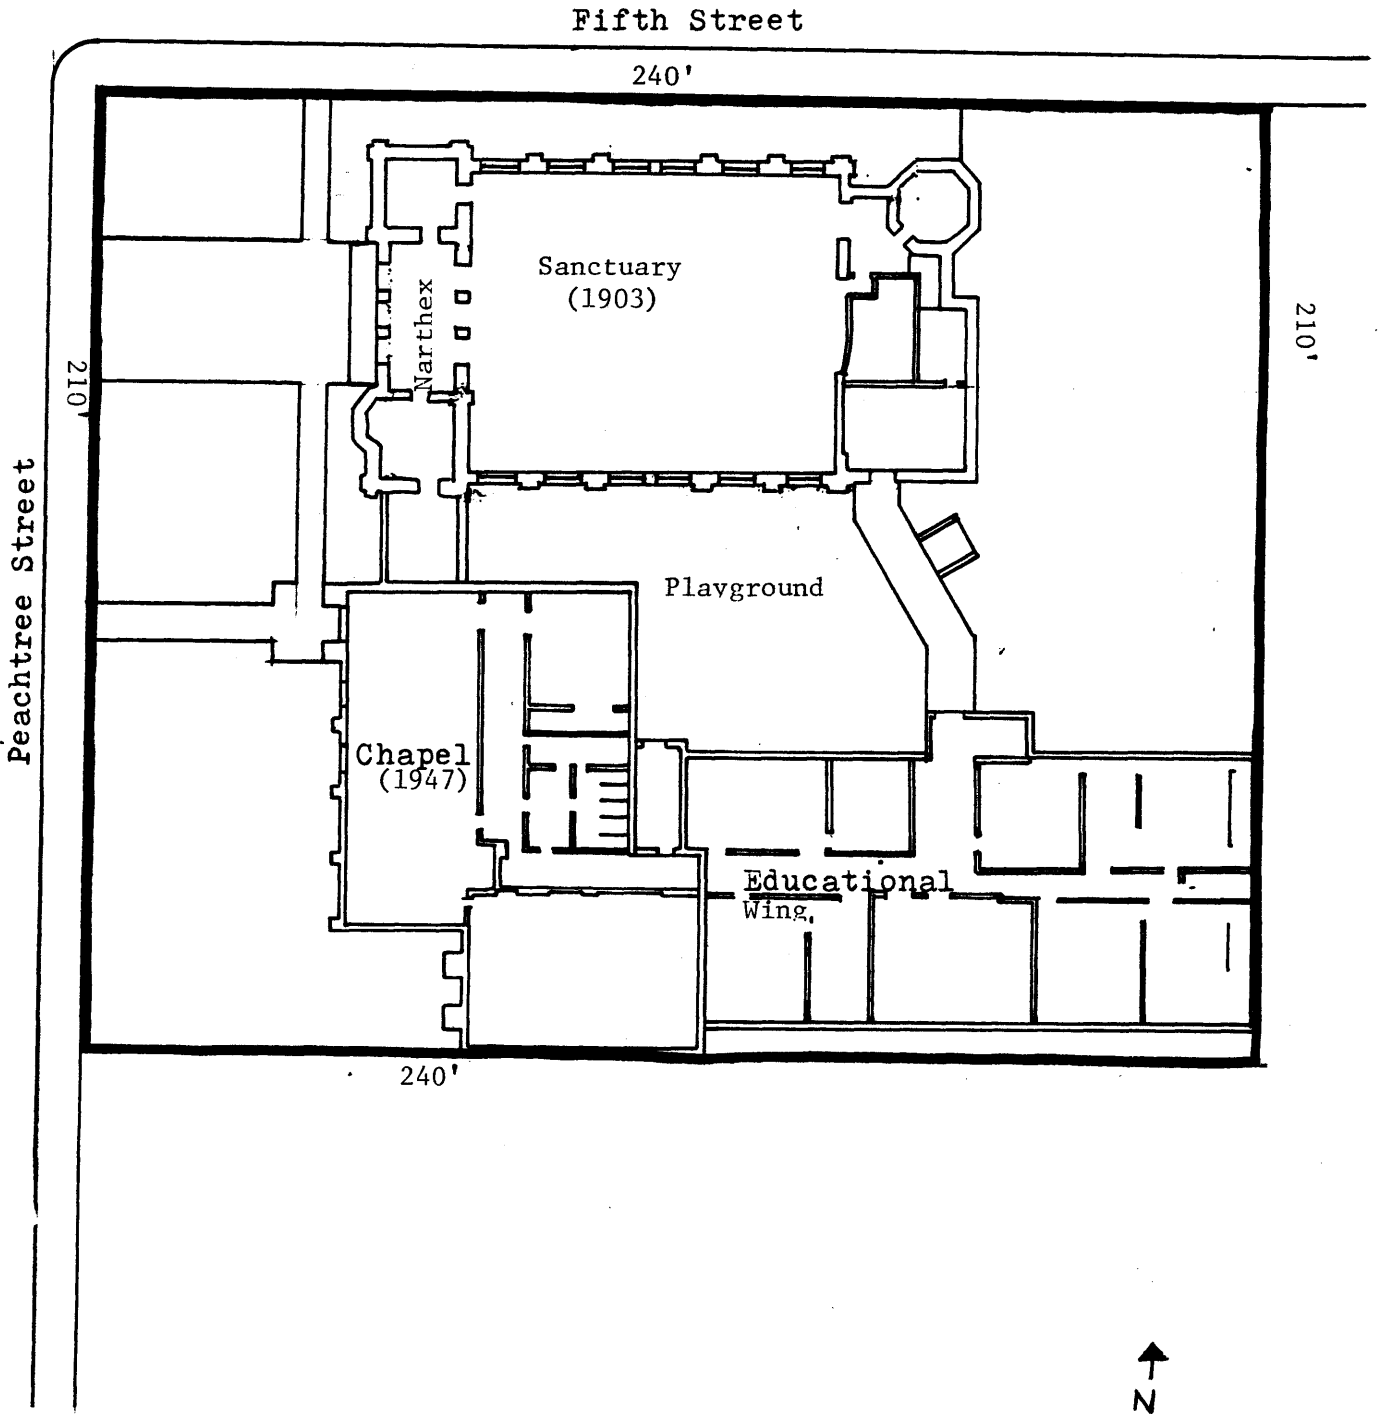
SKETCH MAP/SITE PLAN
St. Mark Methodist Church
Atlanta, Fulton County, Georgia.
Scale: 1" = 40'
Source: Based on church files and the
map.
Date: 1985.
Key: The nominated property is marked
by a heavy black line. The buildings
are identified on the map.

The boundary of the property is based on the current legal boundary description. It includes the historic church and the non-historic additions. See attached sketch map.
