NATIONAL REGISTER OF HISTORIC PLACES PROPERTY PHOTOGRAPH FORM

Church of the Messiah (First Unitarian Church)

First Unitarian Church

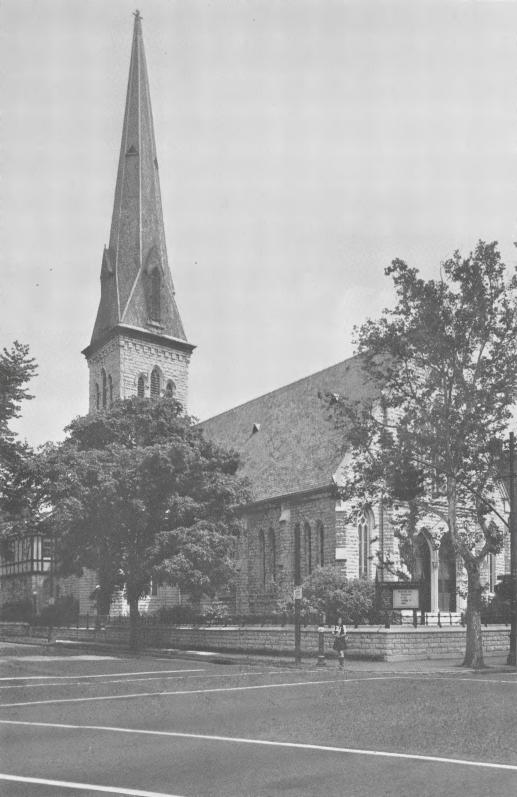
PHOTO NO. 1 0 10

View of the church from the northwest (York Street at left; 4th Street down on right) showing the asymmetric composition and spire (apparently the crocket at the tip has sunk a few feet from its original position.)

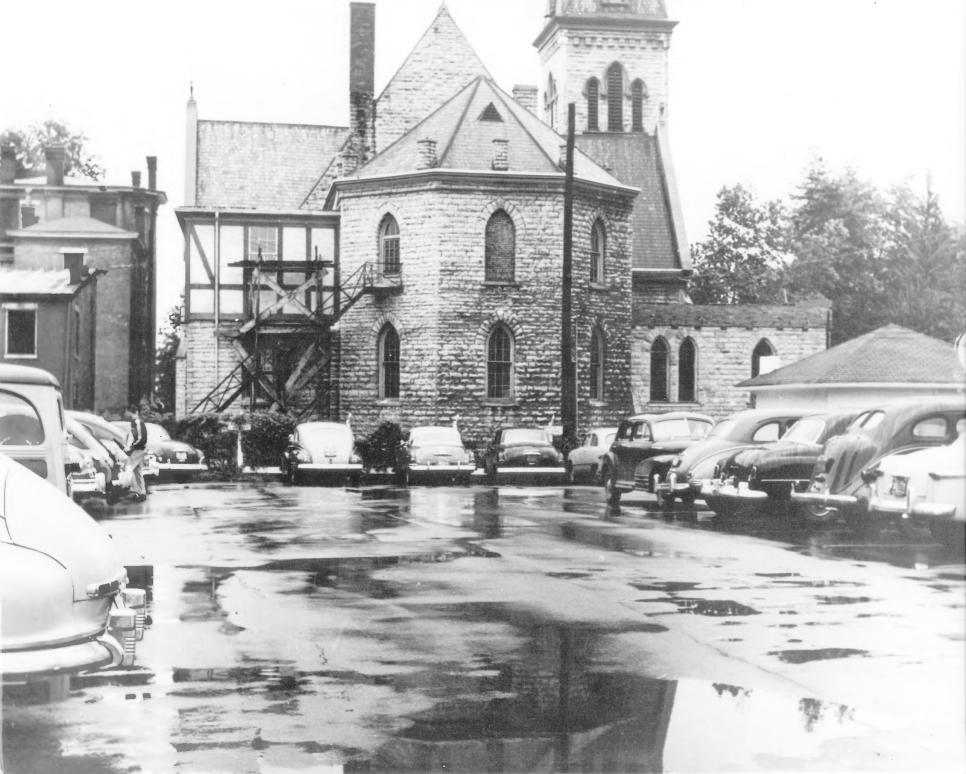
North side of the church, with nave at right, base of tower, north transept, and link to Sunday School wing at left. Note original stone and castiron fence at left and right, although the more delicate iron fence in front of the transept is probably not original.

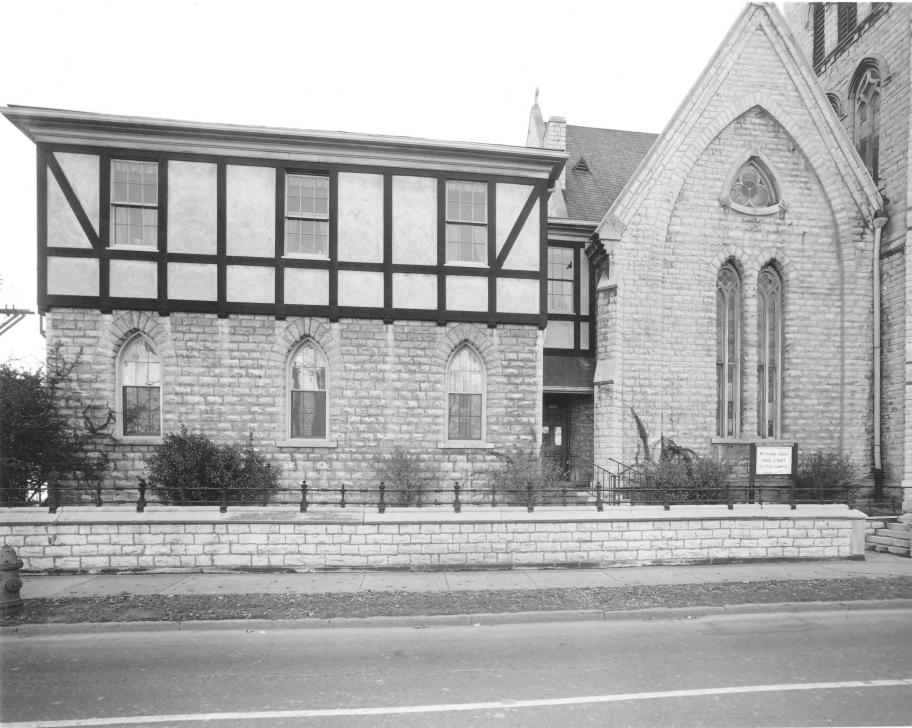
рното No. 4000 neeting

East end of church during the 1951 construction program showing meeting hall-apse in center, completed second-story addition at left and partially completed addition at right. Note blank eastern gable of actual auditorium above "apse" roof. (Note also brick rear of adjacent house at left.)

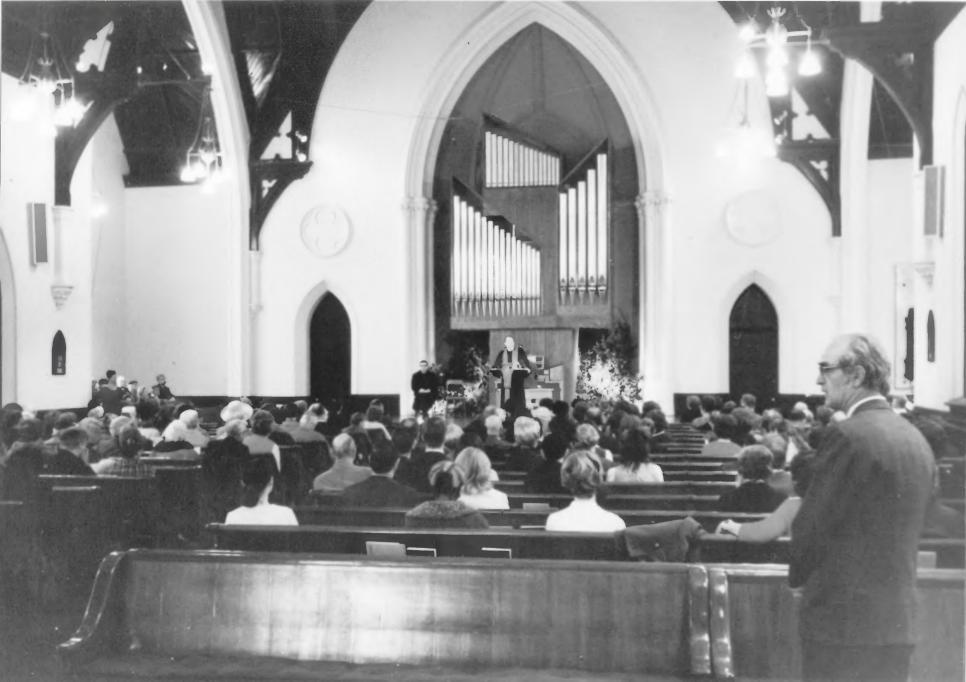
East end of auditorium prior to the 1970 alterations. Note original location of organ in north transept at left and treatment of altar niche.
