KENTUCKY HISTORIC RESOURCES
Individual Inventory Form

Resource # Be-47
Boone County

1. Name of Resource:
Farmers Bank of Petersburg

5. Location:
3010 First Street
Petersburg, KY

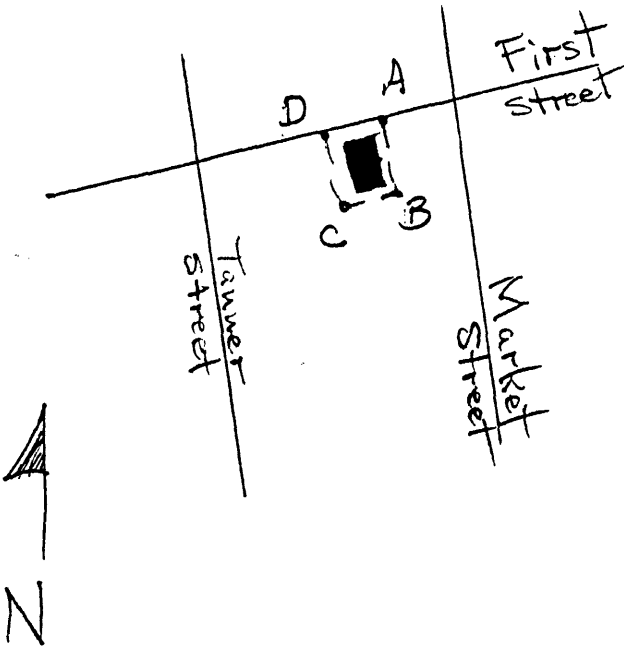
44. Site Plan (and boundary description and justification for N.R. sites):

The property is a rectangular parcel measuring 30' x 70', whose northeast corner is 5 feet directly northeast of the northeast corner of the bank's foundation and whose southeast corner is 5 feet directly southeast of the southeast corner of the bank's foundation. The boundary includes the building and the entire parcel that has historically been associated with the property. Line D-A is on the south side of First Street.

Contributing: 1 building

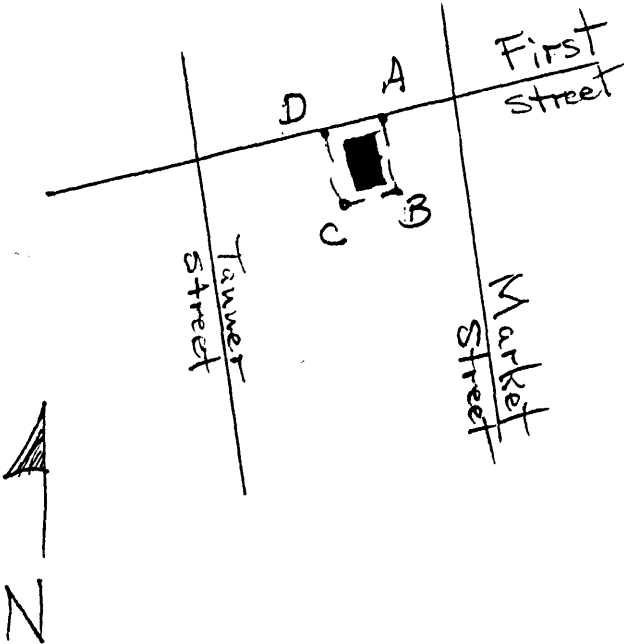
44. Site Plan (and boundary description and justification for N.R. sites):

The property is a rectangular parcel measuring 30' x 70', whose northeast corner is 5 feet directly northeast of the northeast corner of the bank's foundation and whose southeast corner is 5 feet directly southeast of the southeast corner of the bank's foundation. The boundary includes the building and the entire parcel that has historically been associated with the property. Line D-A is on the south side of First Street.

Contributing: 1 building
