NATIONAL REGISTER OF HISTORIC PLACES  
REGISTRATION FORM

FIRST NATIONAL BANK-GRAHAM BUILDING

street & number 100 North Chester Street  
city or town New Cumberland  
state WV code 029 county Hancock zip code 26047

First National Bank -Graham Building  
Hancock County, West Virginia

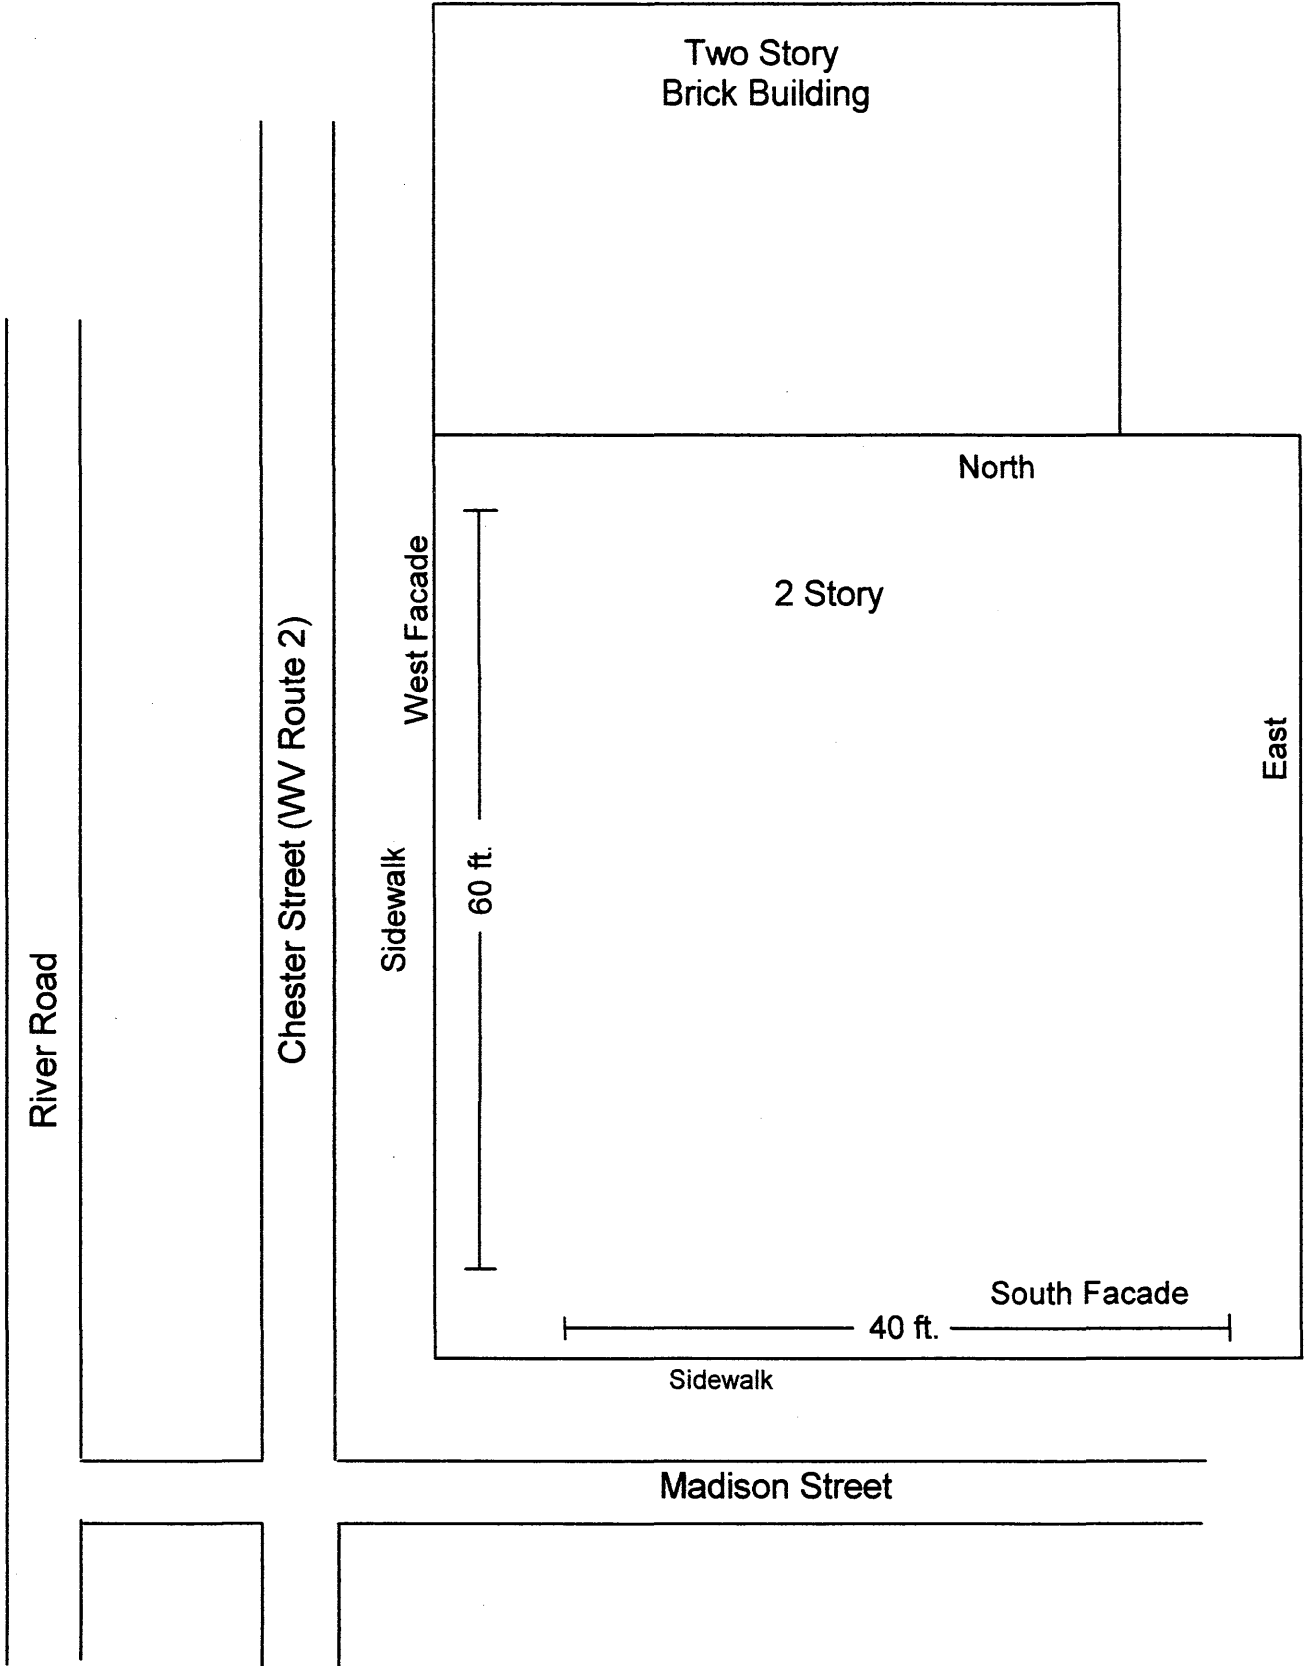
Sketch Map  
First National Bank of New Cumberland  
New Cumberland, WV

**Verbal Boundary Description**

The building is situated on the southwest corner of lot 32. "Part of Lot Number 32 in Campbell's Addition in the Town of New Cumberland, Hancock County, West Virginia, Bounded and described as follows: On the North by Lot No. 31, on the East by part of Lot No. 32, on the south by Madison Street; and on the West by part of said lot 32 belonging to E. G. Richardson. The Part of the said Lot 32 hereby conveyed being forty feet by sixty feet; fronting on Chester Street sixty feet, fronting on Madison Street forty feet." Hancock County Deed Book Q, page 450.

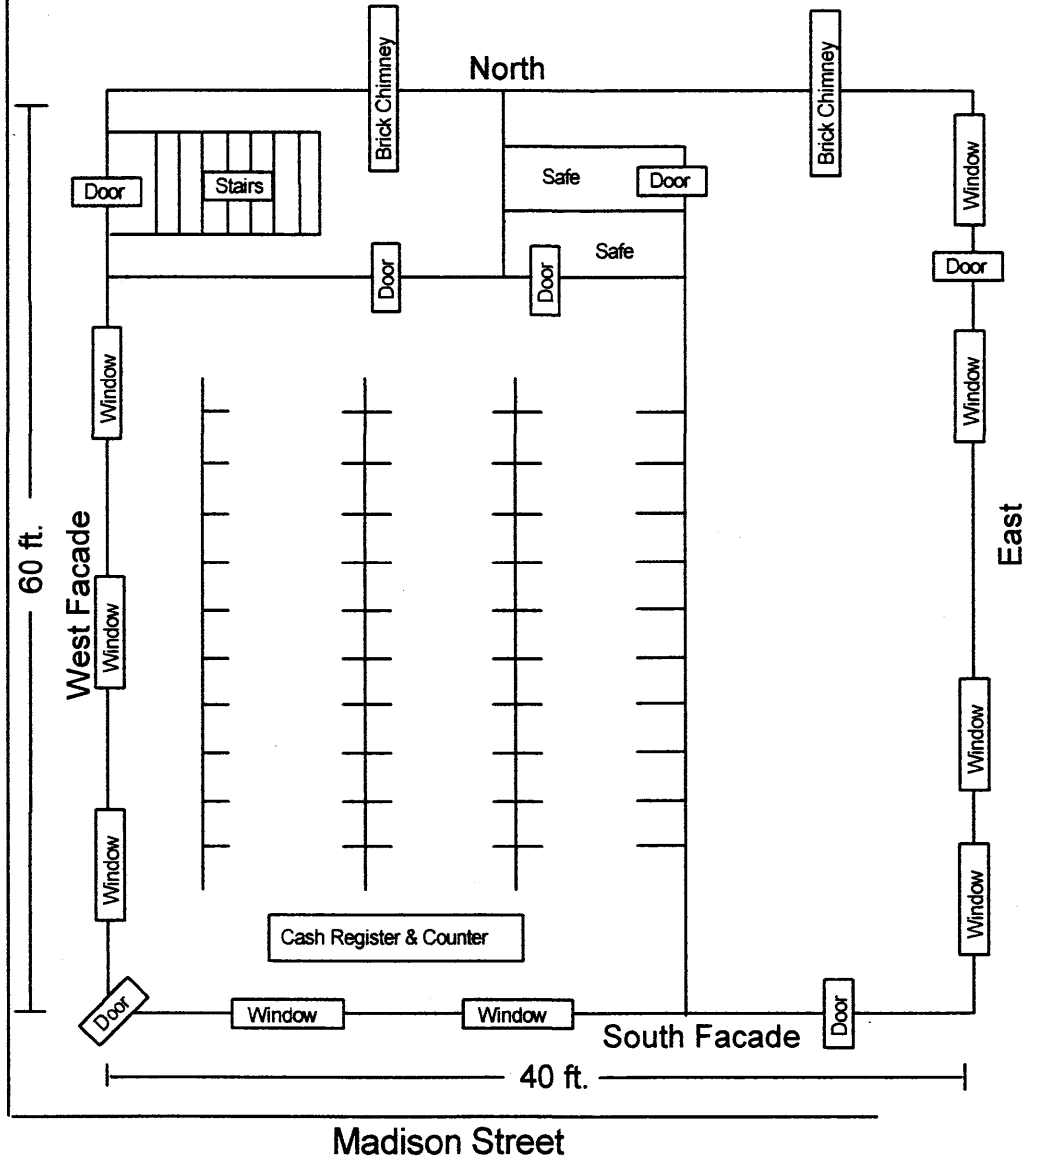
# First Floor First National Bank of New Cumberland New Cumberland, WV

Access to the main interior space on the 1st floor is through the corner-recessed entry in the west facade. The 1st floor interior is divided into three spaces. The space inside the door, the largest of the three, is used for a building supply business. Freestanding shelving creates three aisles running parallel to the west, or front, facade. Shelving also extends across the windows on the front facade and along an interior wall parallel to the free standing shelves and the front facade. The wall creates a second space on the 1st floor that extends to the south facade and to the east, or rear, exterior wall of the building and is parallel with the building's south facade. This space is used for storage and contains a large, built-in safe containing shelves and drawers.

At the rear of the main floor space, a wall parallel to the east, or rear, facade intersects with the previously mentioned interior wall. This rear interior wall contains a door into an office and storage area, the third space on the 1st floor. In the rear interior wall in the main floor room, near the intersection of the two interior walls is a large floor to ceiling walk-in steel safe now used for storage. The safe is flanked by fluted steel Ionic pilasters headed by a decorative triangular pediment. The safe door has decorative stenciling and says "The National Safe Company, Cleveland USA."
