National Register of Historic Places
Registration Form

1. Name of property:
historic name: Smith-Giltinan House
other names/site number: N/A

2. Location:
street & number : 1223 Virginia Street, East
city or town: Charleston
state: WV code: WV county: Kanawha code: 039

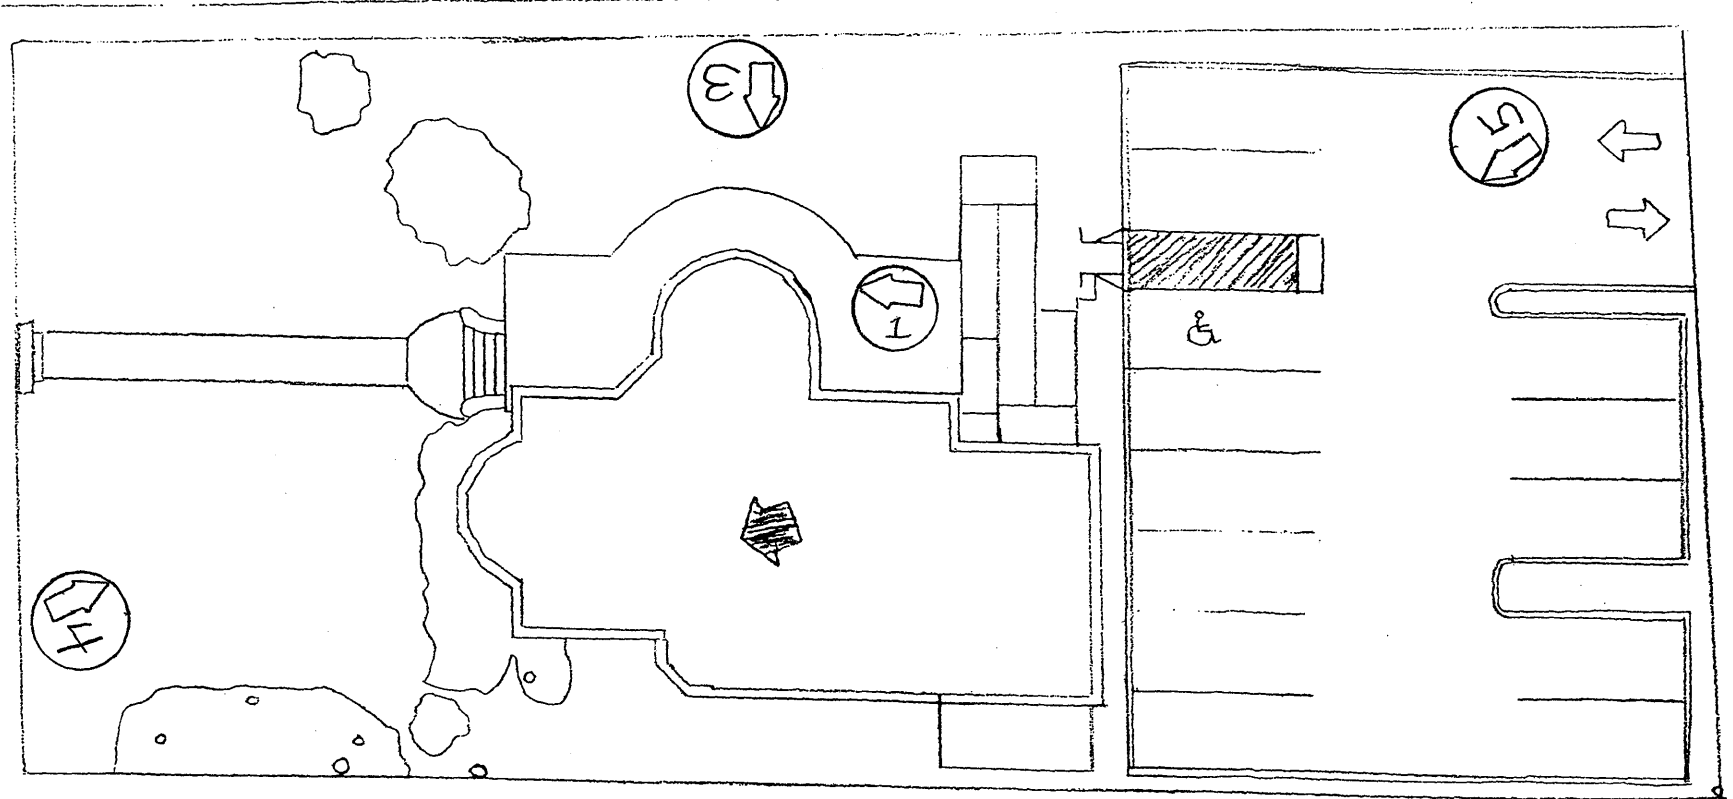
SITE PLAN

The boundary of the Smith-Giltinan House National Register nomination is shown as the entire lot on the accompanying Site Plan titled "Verbal Boundary Description Smith Giltinan House Kanawha County, WV". The map is dated Oct. 2001. The site plan is used as the verbal boundary description.

The area encompasses the city lot on which the buildings are located.

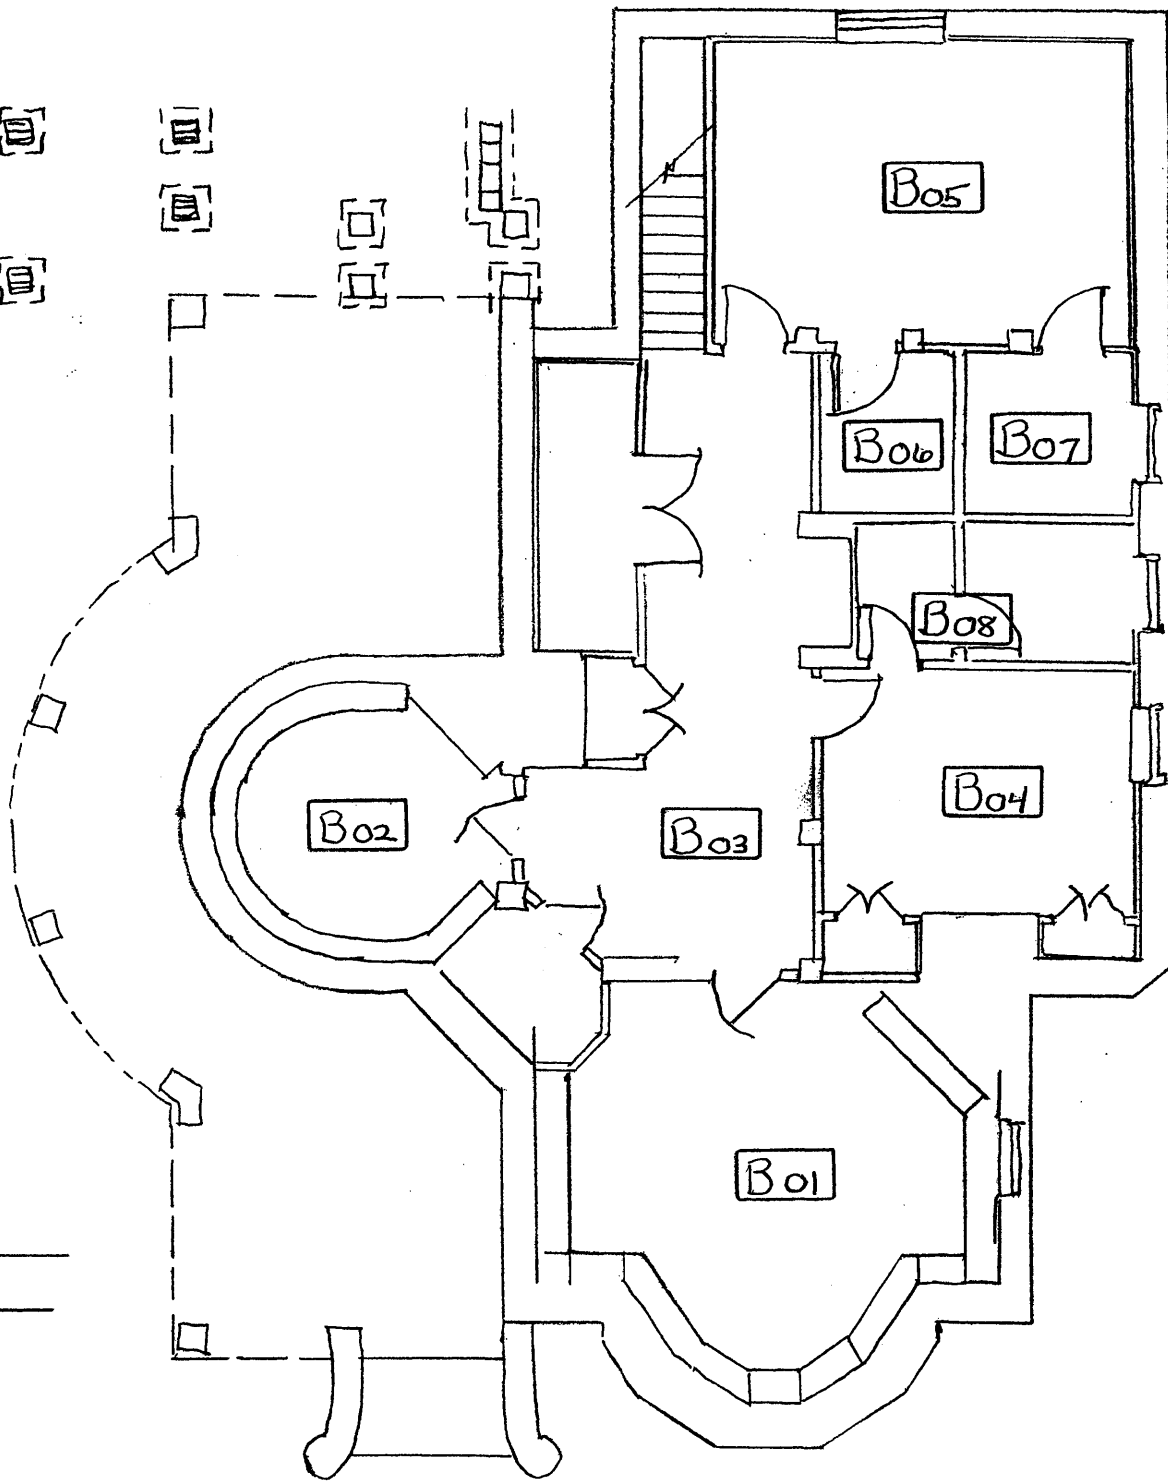
LOWER LEVEL PLAN

The basement has also been rehabilitated to suit its current use. Most likely, originally it was used as a very utilitarian space. The plan has been divided into rooms that match the plan of the upper floors although the finishes here are much simpler. On the south side there is a large office room, Room BO5, that has painted walls and ceiling, simple oak trim and a carpeted floor. There is a small workroom off of this room, Room BO6, which is used for the copy machine, etc. and it has the same finishes. The center corridor, Room BO3, also has the same finishes. There are five horizontal paneled doors but they are also probably not original. On the north end, which would be underneath the tower, BO1, is a library with the same finishes. The octagonal shape and plan is maintained and there is a center brick pier that is a structural support. There are built-in bookcases in this room.

The most interesting aspect of the basement is the wine cellar, Room BO2, which is underneath the west tower so it is almost a round, barrel shaped room with stone walls, painted concrete floor and a drywall ceiling. None of the decorative finishes are original. Some of the soffits have been painted to match the walls where the ductwork is hidden. The door to this room has a single pane of glass with a wrought iron grapevine trellis on it. The west room, Room 304, has mirrors on the walls and is used as an exercise room with the appropriate equipment. The floor is carpeted here. To the south of the exercise room is a bathroom, Room BO8, with the same fixtures and finishes as the other bathrooms. This bathroom is not original.

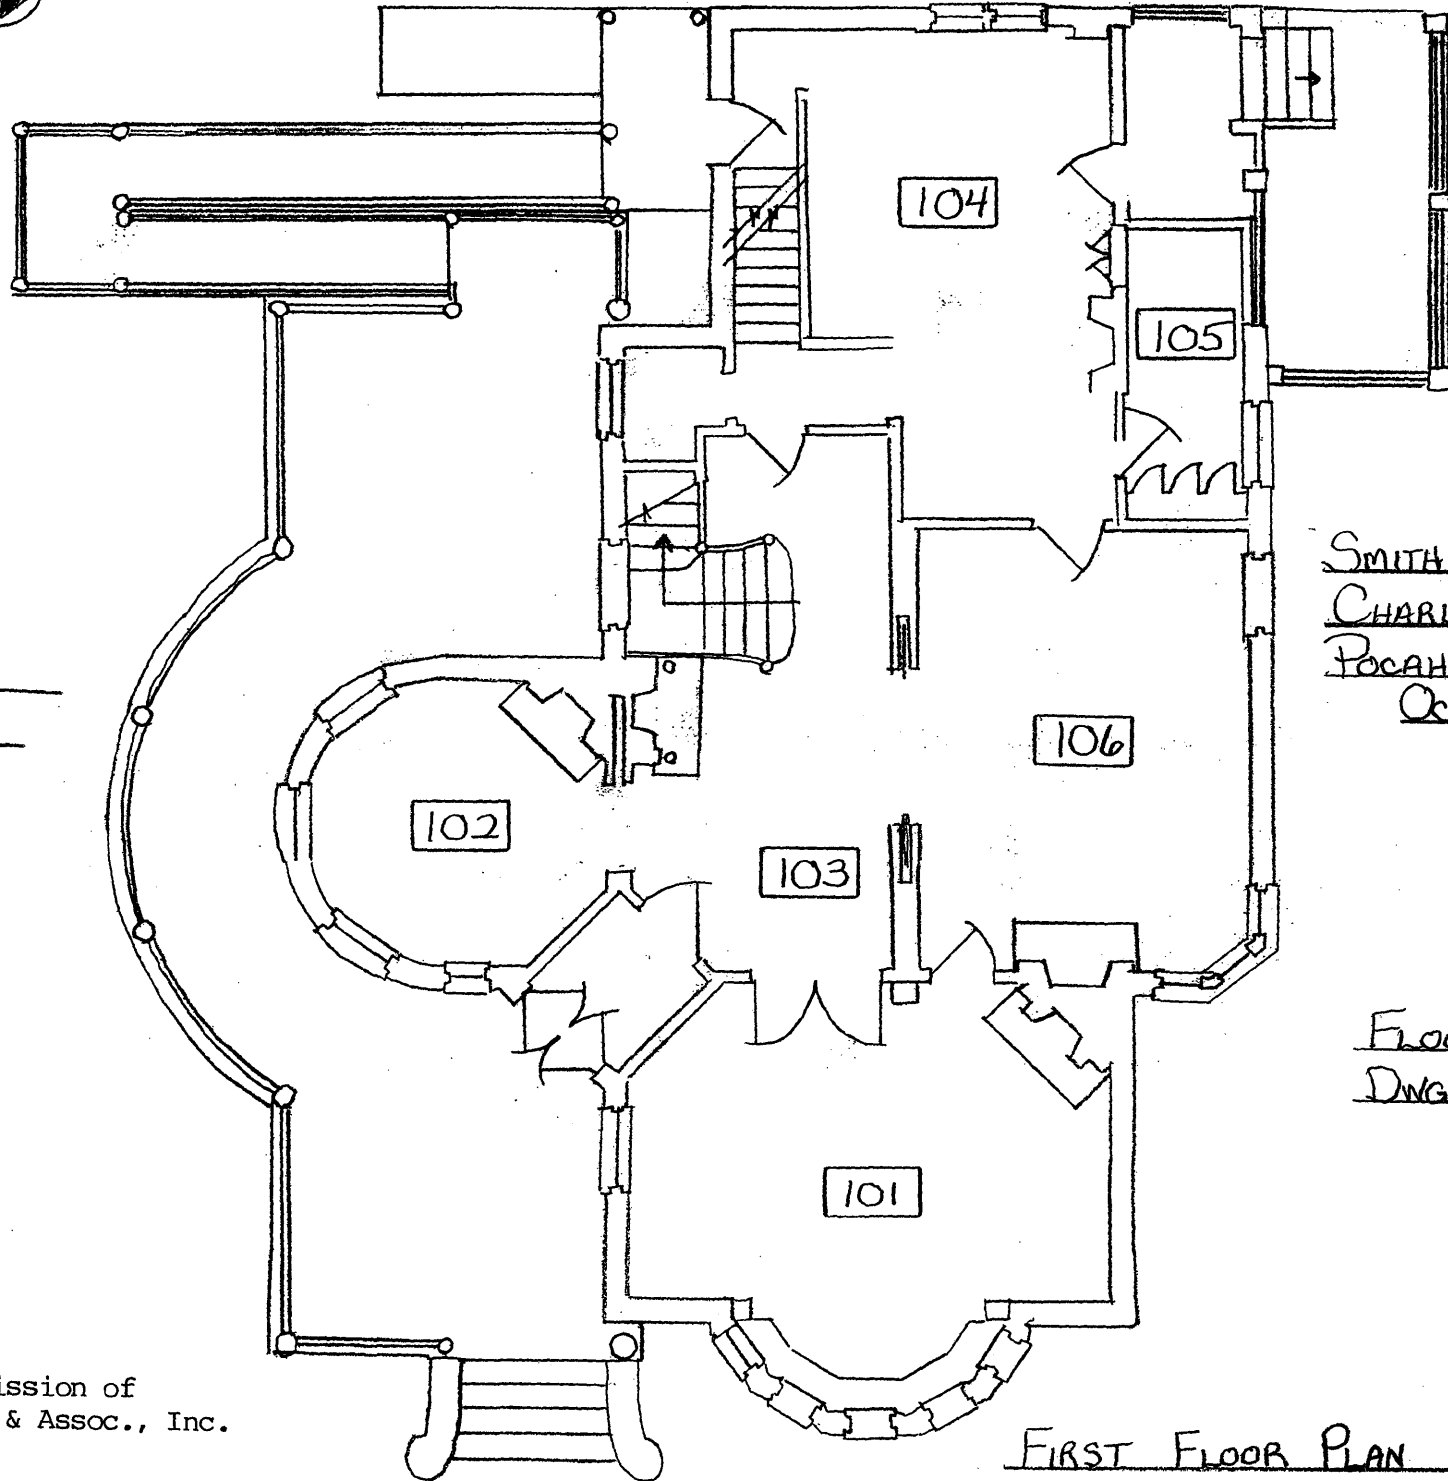
FIRST FLOOR PLAN

The current reception area, Room 103 on the plans, was originally the entrance foyer and the focal point for this room is the fireplace. It is very large and it goes from the floor to the ceiling with a battered, pyramidal-shaped breast. The breast is wood and divided into horizontal panels with a decorative egg and dart molding. The tall mantle piece is supported by fluted columns with Ionic capitals and there are decorative garlands and urns on the mantle piece. The terra cotta tile surround is approximately the size of brick and has a wrought iron fire screen.

The original small parlor, Room 102 in the semi-circular tower, is to the east of the entrance foyer. It has birds eye maple wood trim. The fireplace surround is also birds eye maple and it has a green tile surround. The flooring is maple but it is not original. The ceiling has a non-original mural.

The original formal parlor, Room 101, is to the north of the entrance foyer and is currently being used as an office. It has reproduction wallpaper on the walls and ceiling and an original crown mold. The flooring is tongue and groove oak with a wide surrounding band on the edges. There is a pair of French doors and a bay window to the north. The front of the window seat has the same basketweave detail as the main stair and allows for the modern HVAC system. There is a fireplace on the western wall and it has the same Craftsman style tile as the other tile in Room 103. The wood mantel of the

The historic dining room, Room 106, is currently used as a conference room and is to the west of the entrance foyer. It has reproduction wallpaper on the ceiling. The walls are painted and have the same five-foot tall wainscoting as the foyer. There are tongue and groove oak floors. The doors and trim in this room are the same as in the other rooms. It has a very large fireplace along the north wall with large blue glazed ceramic tile.

Room 104 is currently used as an employee lounge/kitchen and it has all modern finishes and fixtures. This was probably the location of the original kitchen, but this portion of the house has been modified in its plan and finishes to accommodate its current use. The same is true of Room 105. It is currently being used as a bathroom and it also has all modern finishes and fixtures.

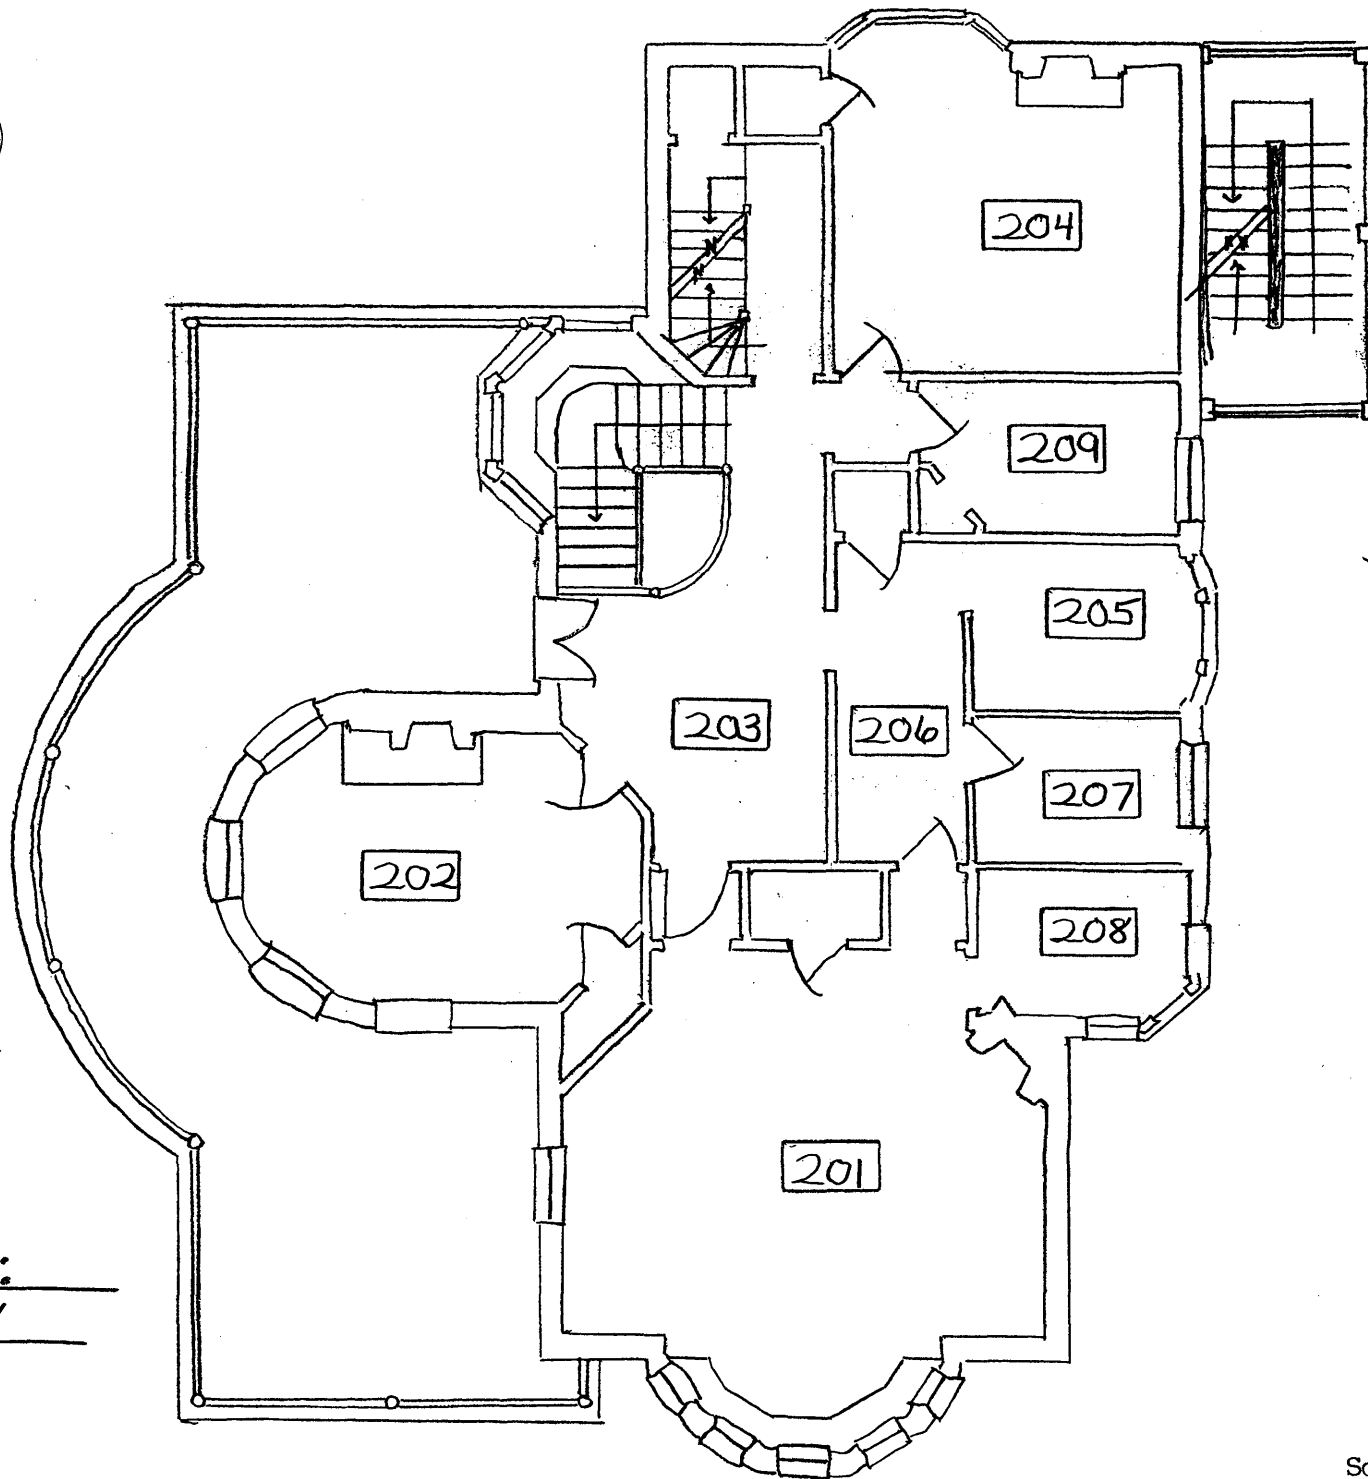
SECOND FLOOR PLAN

The major element of the second floor is the center stair hall, Room 203, or landing, that has half of an octagonal tower at the landing. The tower has beautiful leaded glass windows in a vertical pattern. The stepped trim is original on the surrounds and the heads are a simple frieze with a cove crown above. There is a French door on the landing with lattice-applied molding and a transom with the same molding. All the doors here are original and have horizontal four panels. The trim is the same as elsewhere. The flooring is oak tongue and groove.

The space within the semi-circular tower on the second floor is being used as a secondary dining room and is labeled Room 202 on the plans. It has the same details as other locations in the house, but the woodwork is birds eye maple. There is a fireplace on the south wall with birdseye maple mantle. To the side of the mantle is a beveled mirror with a birdseye maple frame. This mantelpiece and surround is a bit simpler than the ones on the first floor. There is a decorative molding around all the openings and recessed panels. The ceramic tile surround is a horizontal patterned cream yellow.

The north room, Room 201, is the largest room on the second floor. It is the bay under the turret and it has French doors leading out onto the porch. The French doors have the same decorative lattice as the French doors in the stair hall. There is a crown molding but it is not original. The ceiling and walls are plaster. The trim and the doors match the other rooms. The door hardware is very simple brass. The fireplace in this room is located on the west wall and it has a blue ceramic tile with a wood surround with a butternut mantle. The flooring in this room is covered with carpet.

There is a bathroom off of Room 201, noted as Room 208 on the plans, that has a free standing tub, sink and commode. These are non-original reproductions. There is vertical beaded board wainscot with wallpaper above. It has a painted plaster ceiling and small

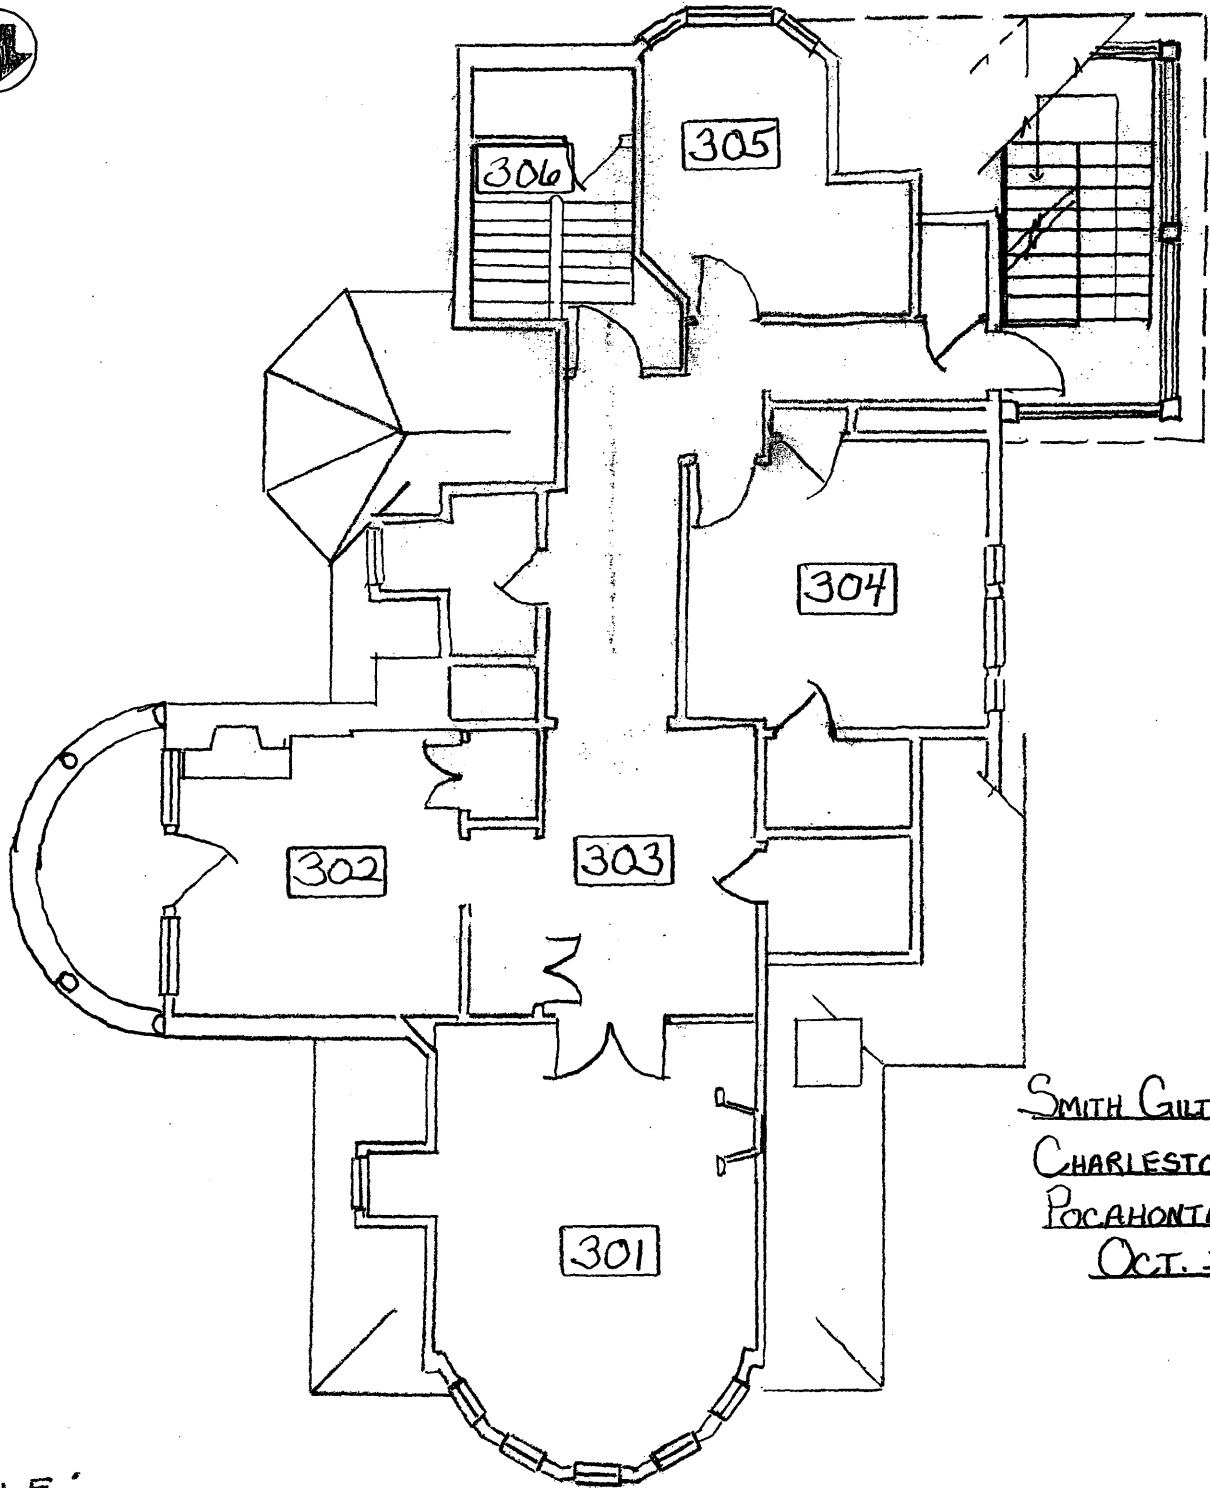
THIRD FLOOR PLAN

The north room in the attic, Room 301, is currently used as an office and has a hexagonal bay. The original elements to note are the fluted trim around the windows and a plain flat-headed crown above the windows. The sashes are diagonal panes over a single pane and are single hung. The diagonal panes above are in a diamond shaped pattern. Above that, there are transoms on the three primary windows in the bay and the transoms have arched, leaded, stained glass windows. There is a fireplace on the west wall but it does not appear to be original. The original doors are five horizontal panels and they have flat-headed trim. The walls and ceiling are plaster. There is a non-original mural painted on the turret wall that goes to the turret ceiling and there are mirrors in the squinches of the turret. The floor is carpeted.

The east room, Room 302, has an antechamber to the small, east, eyebrow dormer balcony on the east elevation in the bay that has wallpaper, the same wood trim and flat-headed arches. There is a central door with flanking windows that have the same diamond pattern, although larger, than the windows in Room 301. This entrance system leads out onto the balcony.

The center room, Room 303, has predominantly non-original, non-historic elements installed. There is a wet bar. There is a bathroom on the east side of this room that has non-original, ca. 1950, shower stall, sink, etc. This bathroom also has vertical beaded board wainscoting with wallpaper above it, as do the other bathrooms. There is also a hexagonal white and black 1" ceramic tile floor; these elements are also non-original.

The room on the rear west elevation, Room 304, is a workroom. It has stepped door trim and five horizontal paneled doors. There is a plaster rosette in the ceiling that is decoratively painted. The floor is carpeted. None of these elements are original although they are appropriate to the time period and style of the house.

Room 305, the southernmost room, has a small, three-sided bay with the same trim as is in Room 304 above and below the bay. The windows in the bay are one over one, double-hung sash. The walls and ceiling are painted plaster and the floor is carpeted.
