National Register of Historic Places Registration Form

FIEUCIVEDIZZOU
1. Name of Property	
Historic name: Morrison Main Street Historic District Other names/site number:	JUL - 9 2014
Name of related multiple property listing: N/A	ANT REGISTER OF HISTORIC PLACES
(Enter "N/A" if property is not part of a multiple property listing

2. Location Street & number: Roughly located between Orange Street, Lincolnway, Mathe Union Pacific Railroad City or town: Morrison State: Illinois County: Whiteside Not For Publication: Vicinity:	adison Street and

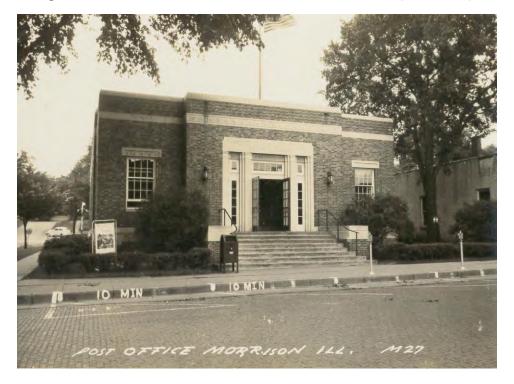
Figure 10. Morrison, Illinois, United States Post Office, 226 West Main Street (1947).

1. 226 West Main Street United States Post Office **Contributing**

Description: Tall one-story freestanding corner brick and stone building. The red brick is laid in Flemish bond on all elevations. The symmetrical main elevation (south) presents a raised projecting central block with wings. Wide concrete steps with center and side metal railings and brick sides with limestone caps, lead to a double door entrance (glass and aluminum transom) with very narrow sidelights, each opening with stepped limestone architrave trim. The words: "Unites States Post Office, Morrison Illinois" is incised in plain limestone frieze above. The parapet has a continuous limestone band with incised and relieved decoration, alternating courses of recessed bricks and a reeded limestone coping at the top. The side wings are similar with a brick and limestone water table and one window

opening per wing (non-historic aluminum). The window architrave trim has limestone at the top and stepped brick sides. A modern concrete ramp with metal railings (1998) is at the east corner while the west corner has an incised cornerstone that reads: "Henry Morgenthau, Jr., Secretary of the Treasury; James A. Farley, Postmaster General; Louis A. Simon, Supervising Architect; George O. Von Nerta, Supervising Engineer; 1934". The side elevation (west) is detailed similarly, with a large central block, slightly recessed wings of unequal width, and six window openings. To the north and setback from the side elevation is a two-story block (brick without limestone detailing) with a recessed entrance, loading dock along the rear elevation (north), tie suspended metal canopy and double-hung windows above (three on rear elevation and two on side). The other side elevation (east) faces 222 West Main Street and lacks detail present elsewhere.

History: Building construction started in 1934-1935 under the New Deal by the U. S. Treasury Department. It was constructed on the corner of West Main and North Orange Streets at 226 West Main Street at the cost of \$35,000.1 Joe Wilson was the postmaster at that time and remained postmaster until 1946.2 A copper box with local information was placed behind the cornerstone by Postmaster Joe Wilson on May 2, 1935.3 The government appropriated \$52,754 for the new post office, of which \$32,754 was for the building and \$20,000 for the lots, furnishings and administrative cost. 4 The contract was let in the early winter of 1934 to the Weitz Company, Inc., of Des Moines, Iowa, and the post office was to be completed and ready for occupancy by October 8, 1935. J. J. Neil of Orono, Maine was the superintendant in charge of construction for the contractor, and S. Wormolts of Pittsburgh, Pennsylvania, was construction superintendent for the government.5 Work on the building was officially started on February 11, 1935. The excavation was sub-let to Carl C. Stephens of Ashton, Illinois, who began that part of the job on February 14 and finished on March 14, 1935. Winter frost delayed work on the building's footings, which was completed between March 1 and March 10 when actual building construction proper was started. 6
