# National Register of Historic Places Registration Form

historic name Staff Row and Old Post Area [Boundary Increase; Additional Documentation]  
other names/site number Original Fort McPherson (Northeast Corner of Post)

street & number 1777 Hardee Avenue SW  not for publication  
city or town Atlanta  vicinity  
state Georgia code GA county Fulton code 121 zip code 30330

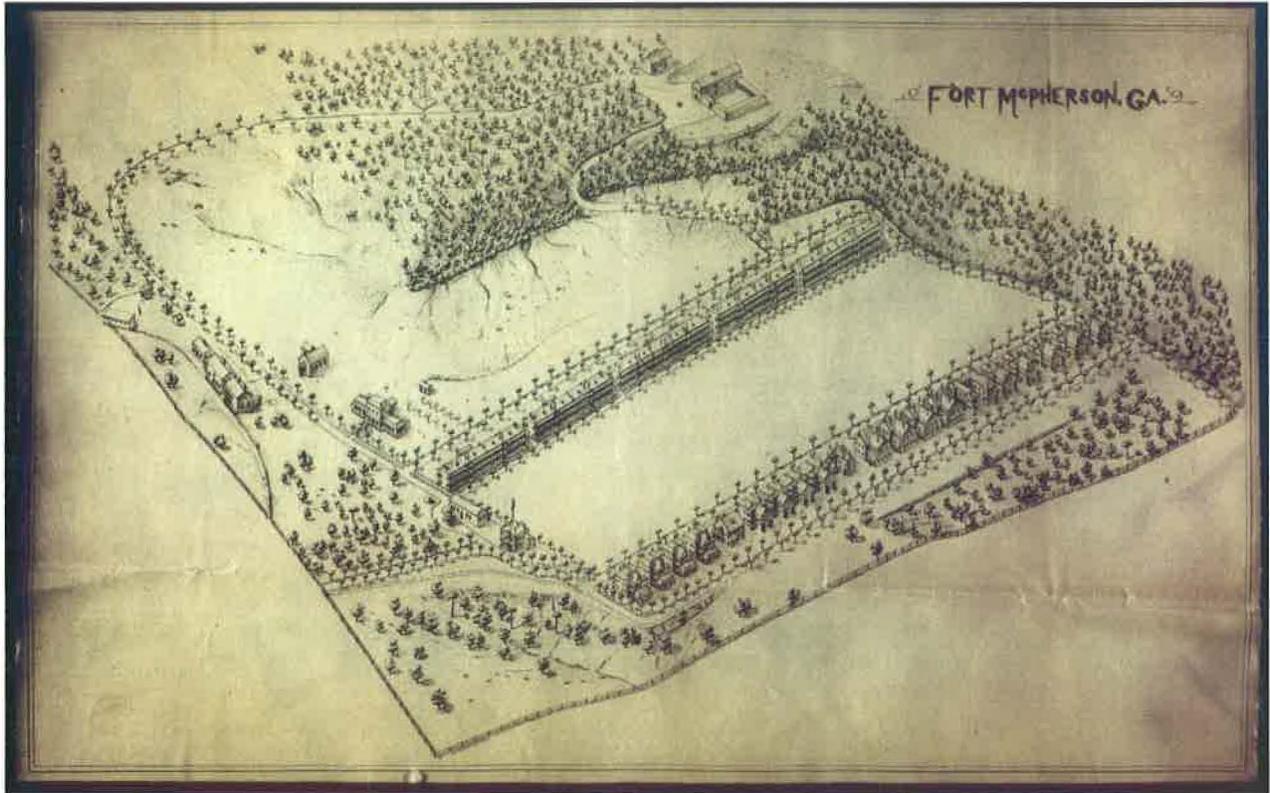
Figure 2. 1890 layout of Fort McPherson. Drawing from the US Department of the Army, Fort McPherson.

In a letter to the Quartermaster General on May 22, 1890, Captain Jacobs recalls his selection of appropriate building sites. Jacobs reports, "For this duty I associate with me a most capable civil engineer, a resident of Georgia, I found the topography of the land much broken, and cut by ravines, about two-thirds covered with timber and dense under brush, the latter I had cleared out that I might gain a clear and correct idea of its characteristics. But after careful and deliberate survey of the whole tract nothing was found more suitable for building sites than two ridges near the north east corner, about 1500 feet long nearly parallel and running almost due east and west."<sup>32</sup>This large-scale grading at the post became one of the first construction projects initiated at Fort McPherson and was accomplished in stages from 1886 to 1888. Performed by local civilian workers, the grading of the land provided level building sites for the new post. According to Fort McPherson's Master Plan of 1890, the original layout of the post centered around the man-made plateau and the surrounding areas and included officer and troop housing separated by a large, central parade field.<sup>33</sup> Two rows of housing lined the northern and southern sides of the field along the 1,500 foot parallel ridges; officer dwellings faced south and troops barracks faced north. This arrangement followed the basic idea that the soldier should have a house with a convenient location and a relaxing natural setting. The intervening parade ground also allowed for adequate ventilation and natural light for the garrison. Captain Jacobs left the west end of the parade ground open, allowing the prevailing winds from the west and northwest to provide cool air during the hot Atlanta summers. The post headquarters and a guardhouse stood at the eastern edge of the field, while a bakery, magazine, oil house, coal shed, quartermaster's office, and commissary, stood southeast of the residential buildings and the parade field. Non-commissioned officers' quarters were located on the southern border of the post, while a stable and a workshop stood west of the parade field. A combination mess hall and kitchen, not yet completed in 1890, was located behind the row of troop barracks.<sup>34</sup> The location of the quadrangle 500 feet from the railroad depot on what is now Lee Street, providing peace and quiet to the residential area.<sup>35</sup> Figure 2 shows an artist's rendering of the post in 1890.

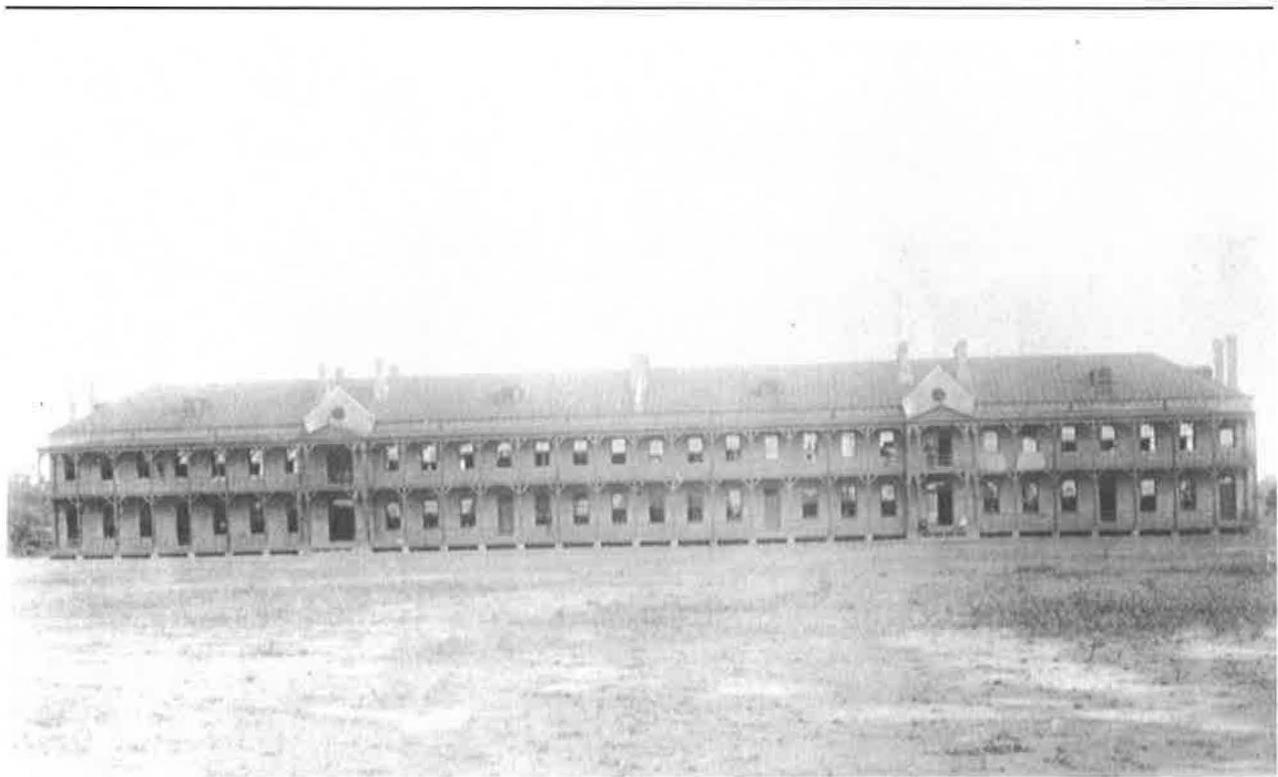
Figure 3. 1892 photograph of Troop Row, Building 58. Photograph from the US Department of the Army, Fort McPherson.

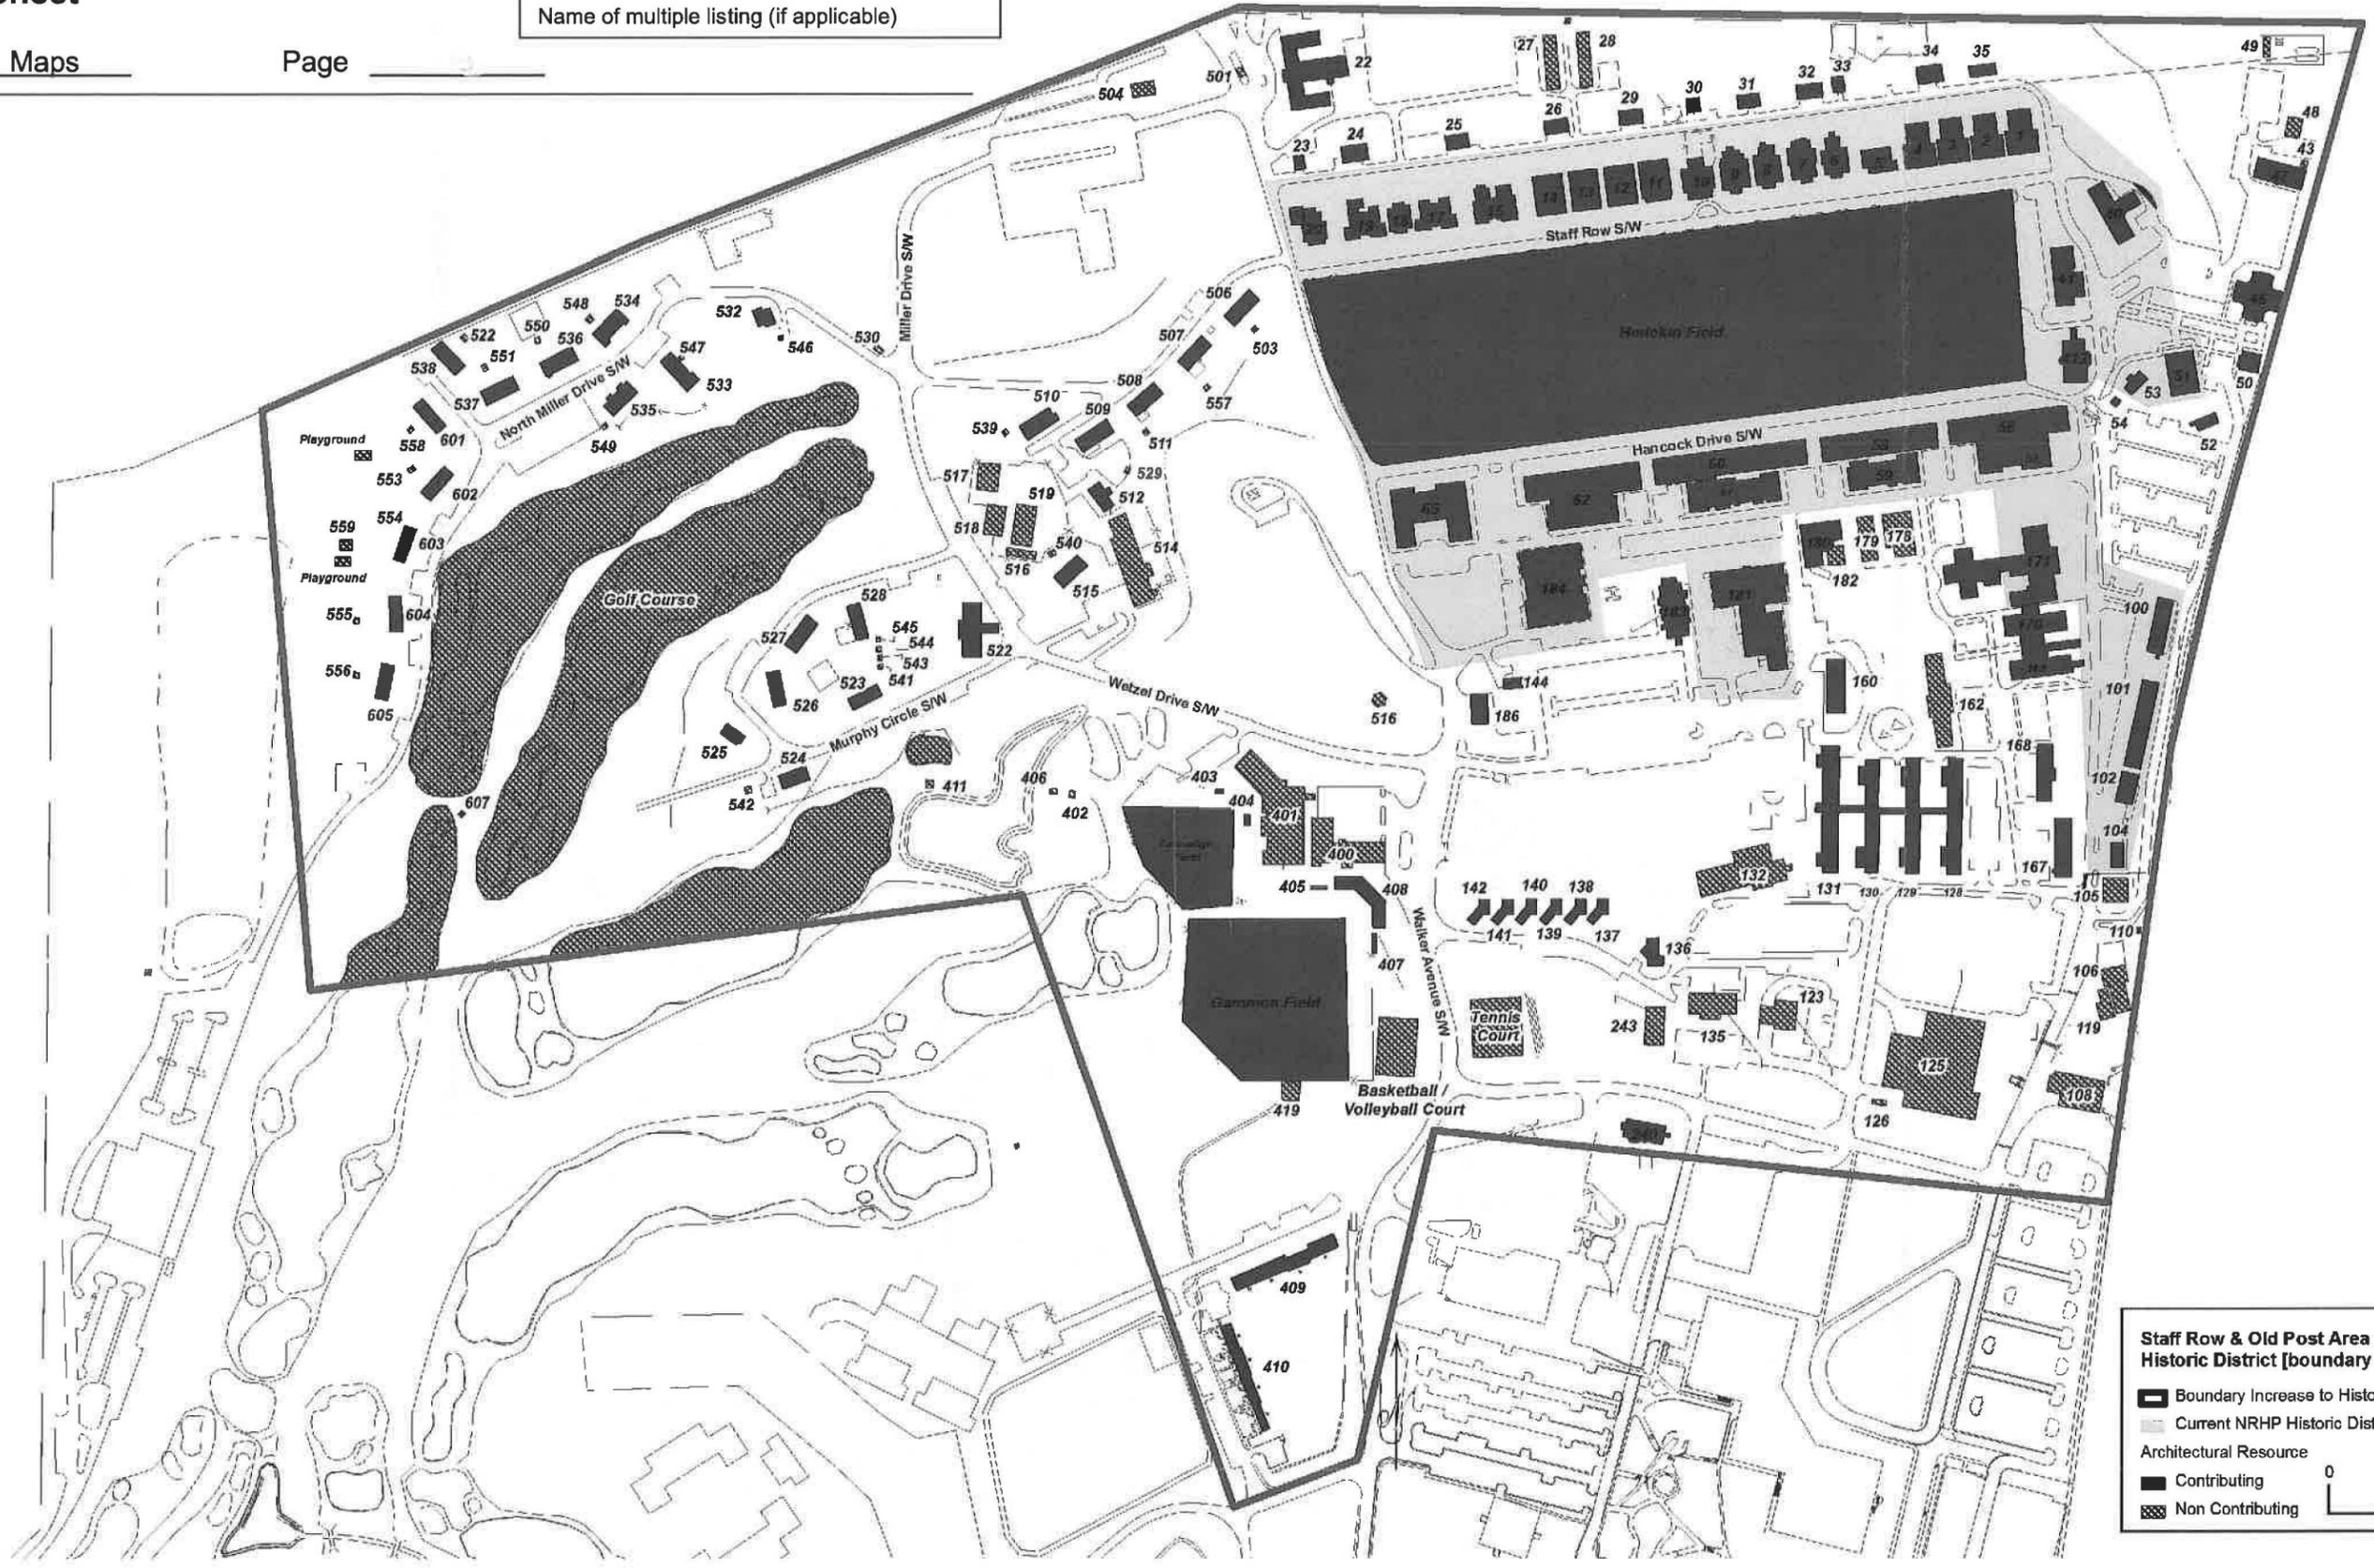
**Staff Row & Old Post Area  
Historic District [boundary increase]**

- Boundary Increase to Historic District
- Current NRHP Historic District
- Architectural Resource
  - Contributing
  - Non Contributing
