# Iowa Site Inventory

- Site Name Plagmann Round barn
- Village/Town/City Conroy vic. Township Hilton County Iowa
- Street Address Off IA 209
- Legal Location 80 N 10 W 19 SE 1/4 of NW 1/4  
Urban: subdivision block range parcel section Rural: township 1/4 section of 1/4 section
- UTM Location: zone 15 easting 578,760 northing 4,619,470; Acreage less than one acre
- Owner(s) Name Carl Schnebke
- Owner(s) Address R. R. #1 Box 138 Marengo Iowa 52301  
(Street address) (City) (State) (Zip)
- Use: Present \_\_\_\_\_ Original \_\_\_\_\_

## Continuation Sheet

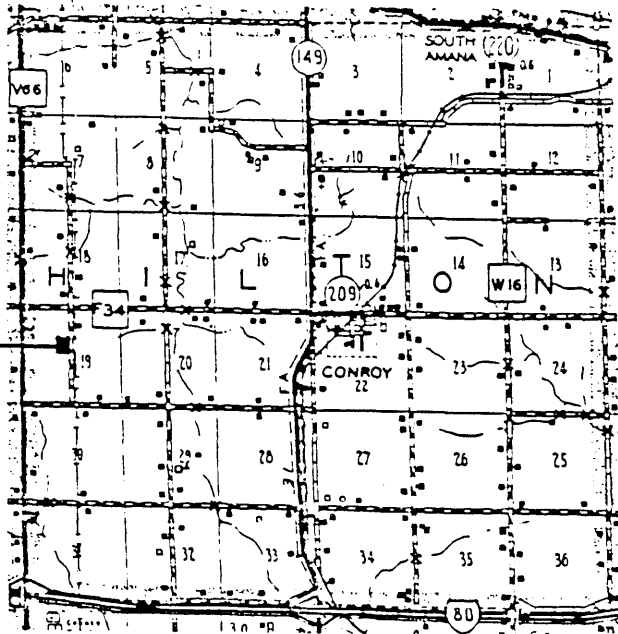
18. Map

VBD: A circle 120' in diameter, based on center point of barn, including barn only. Excludes adjacent modern silo.
