NORTH DAKOTA CULTURAL RESOURCES SURVEY

Base Data Form

1. County Grand Forks, North Dakota 2. Site Number CK 11
3. Site Name (s) First National Bank
4. Type of Resource: A. Archaeological  Historical  Architectural  Paleontological

Continuation form: Historic Sites

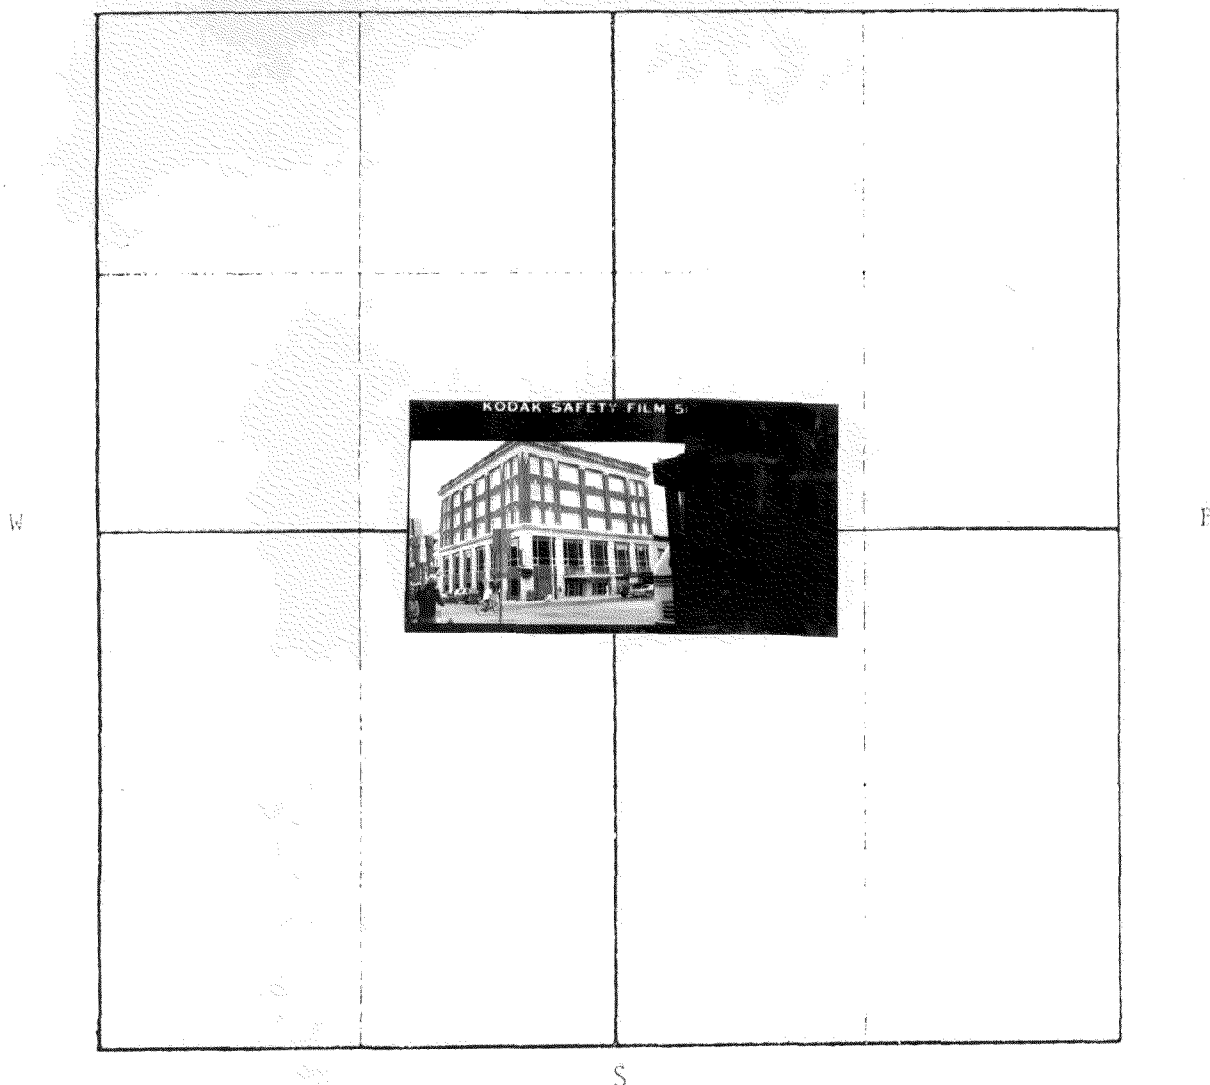
20. Sketch Map of Site: Scale: \_\_\_\_\_

C. \_\_\_\_\_ D. \_\_\_\_\_
7. Access: visible  
 Location: northeast corner of DeMers Avenue and North Fourth Street  
 Acreage: less than one acre  
 Verbal boundary: city lots roughly 90 X 100 feet
