# National Register of Historic Places Registration Form

Historic name: Mount San Jacinto State Park Historic District

Street & number: 25905 Highway 243

City or town: Idyllwild State: CA County: Riverside

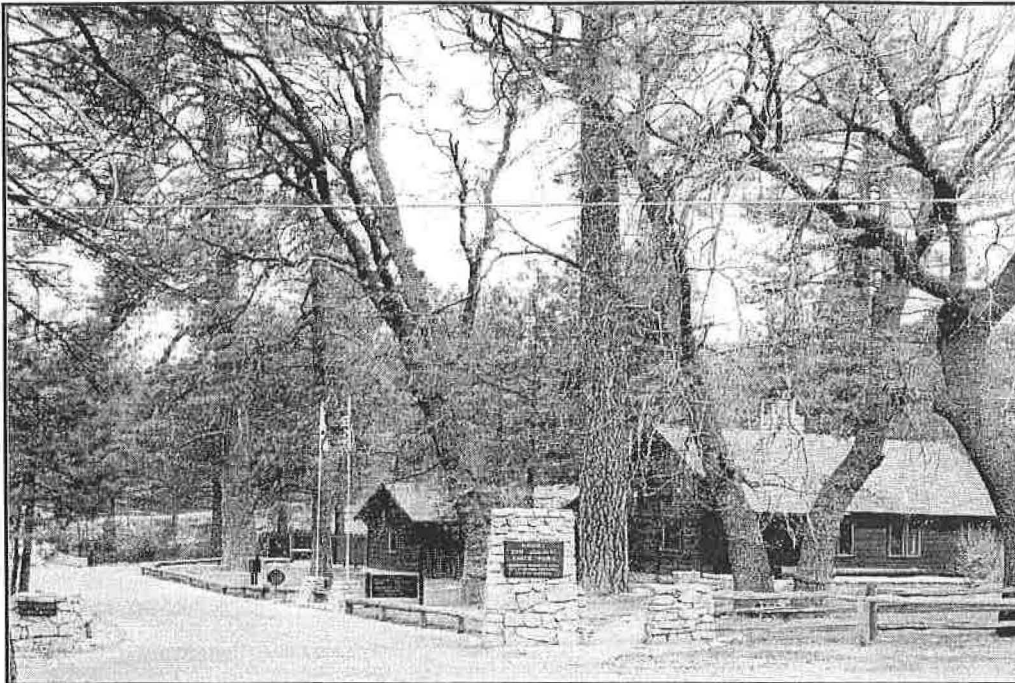
Photograph # HP1  
Looking North at Park  
Entrance and  
Headquarters Area off  
Hwy 243  
Date: 1956 Apr 19  
Source:  
CA State Museum  
Accession # 090-23431

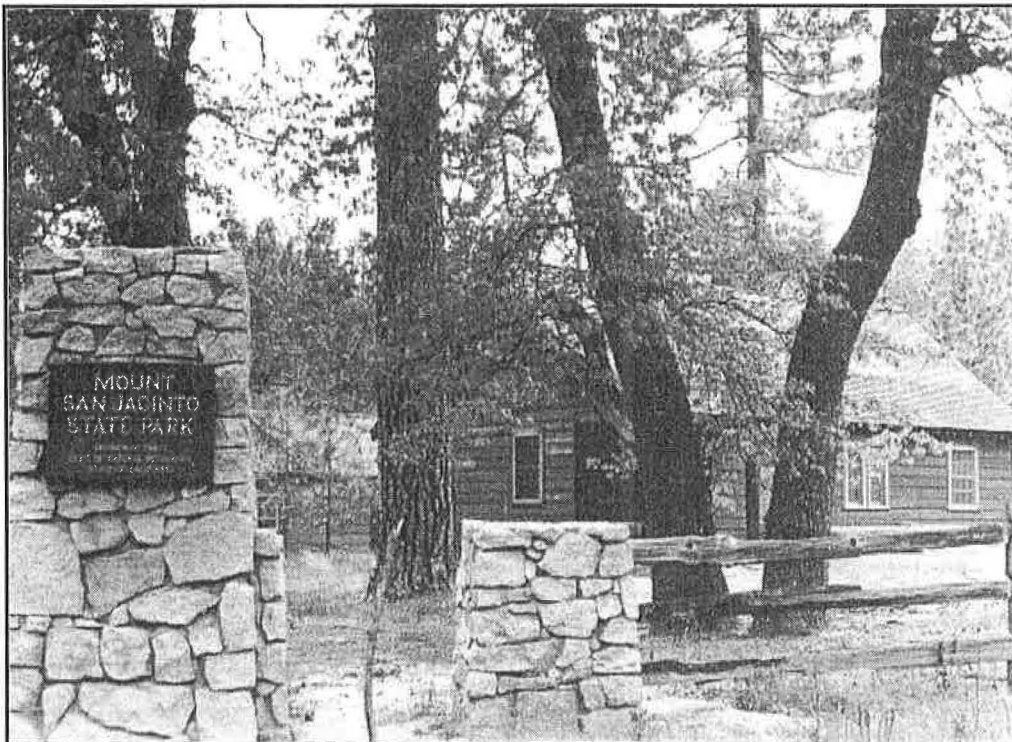
Photograph # HP2  
Looking North at Stone  
Masonry Column, Pier,  
and Residence #1 (right)  
Date: 1936 May  
Source:  
CA State Museum  
Accession # 090-23396

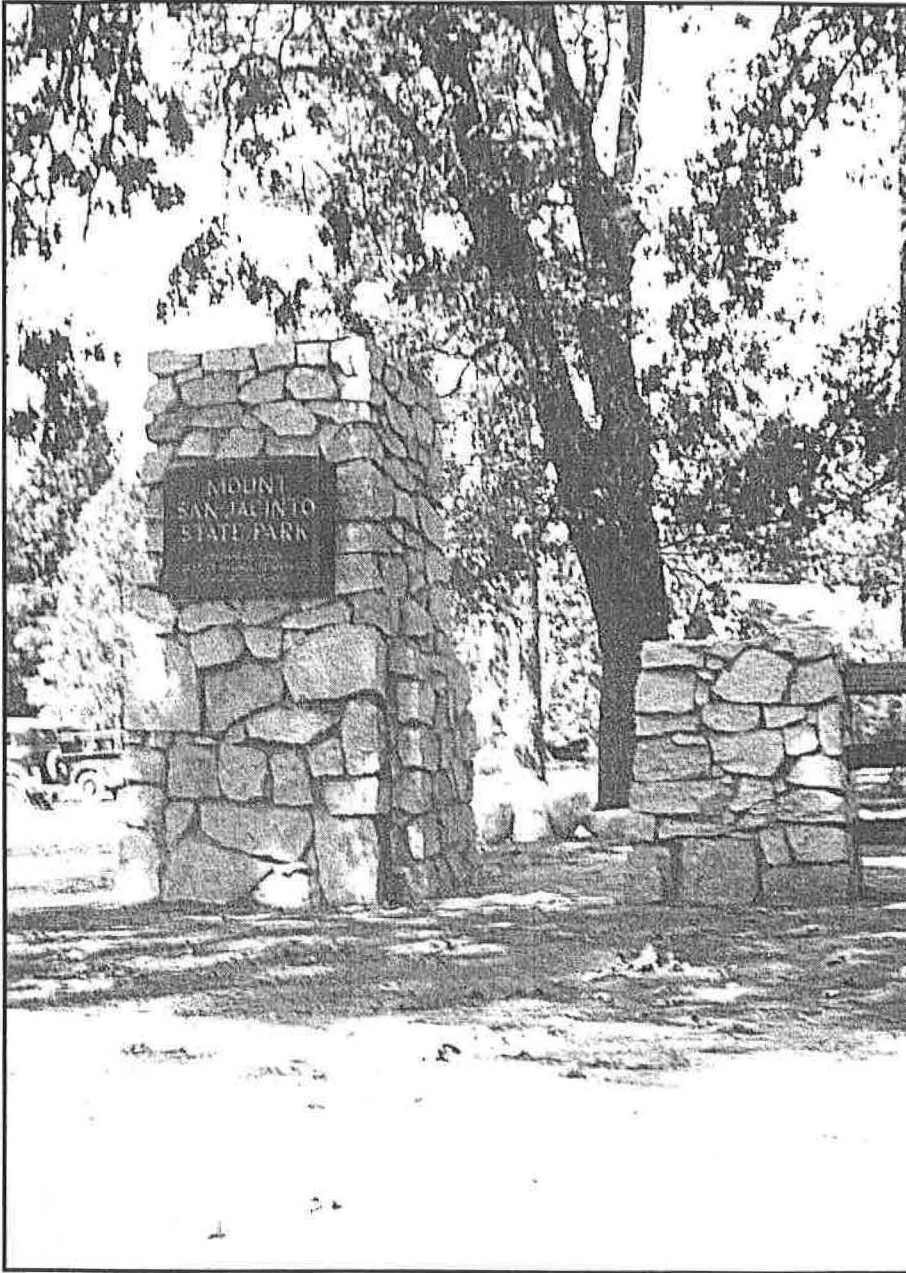
Photograph # HP3

Looking Northwest at  
Stone Masonry Column,  
Pier, and Visitor Parking  
Area (left)

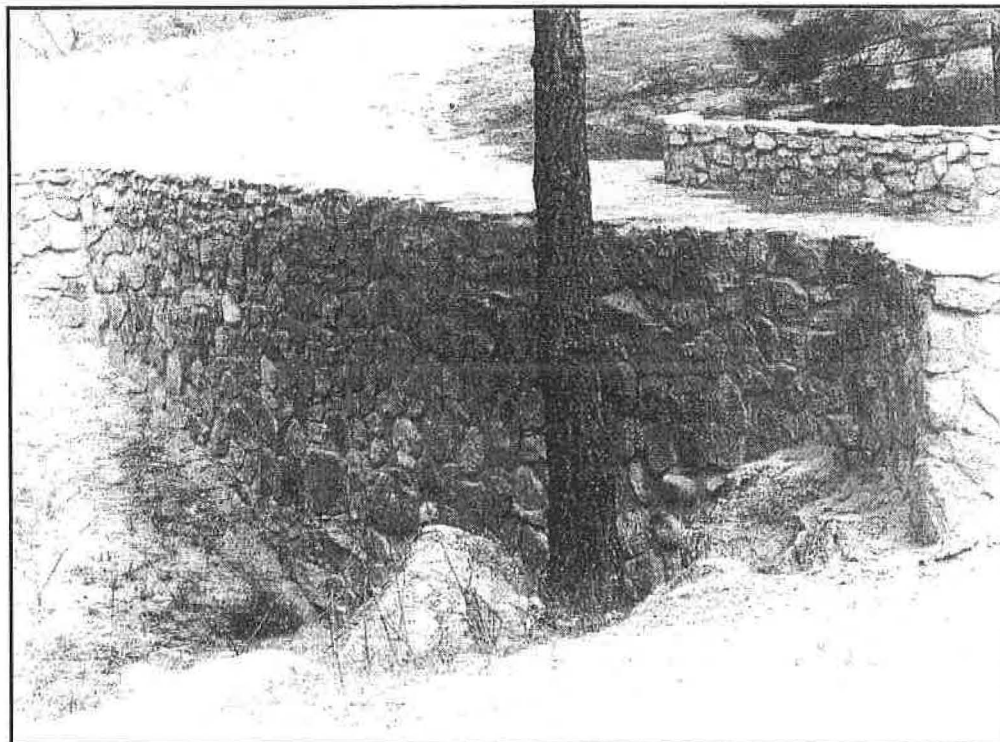
Photograph # HP5

Looking North at Stone  
Masonry Bridge

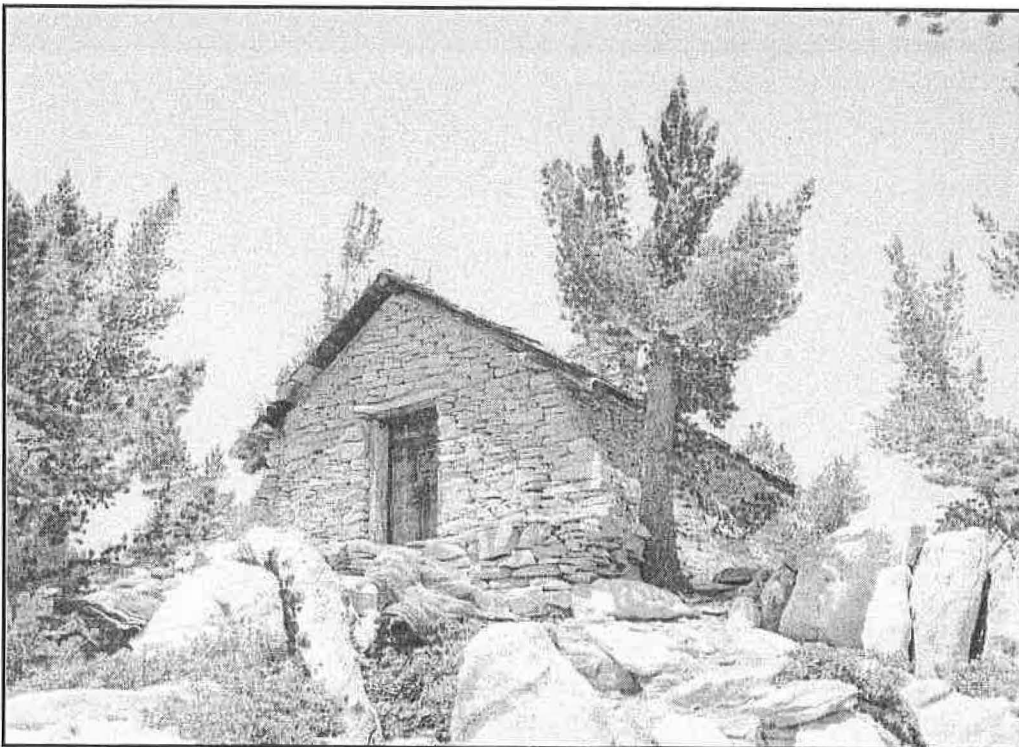
Photograph # HP8  
Looking Northwest at  
San Jacinto Peak Shelter  
Date: 1952 August  
Source:  
CA State Museum  
Accession # 090-23415

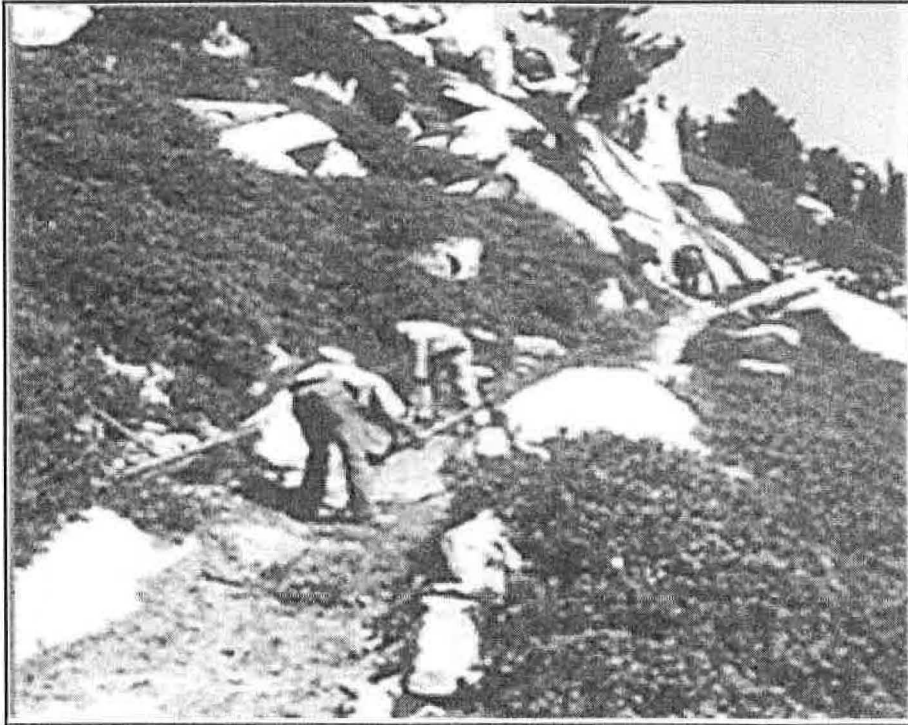
Photograph # HP9  
Looking Northeast at Trail  
Repair Work  
Date: 1957 August 8  
Source:  
CA State Museum  
Accession # 090-23933

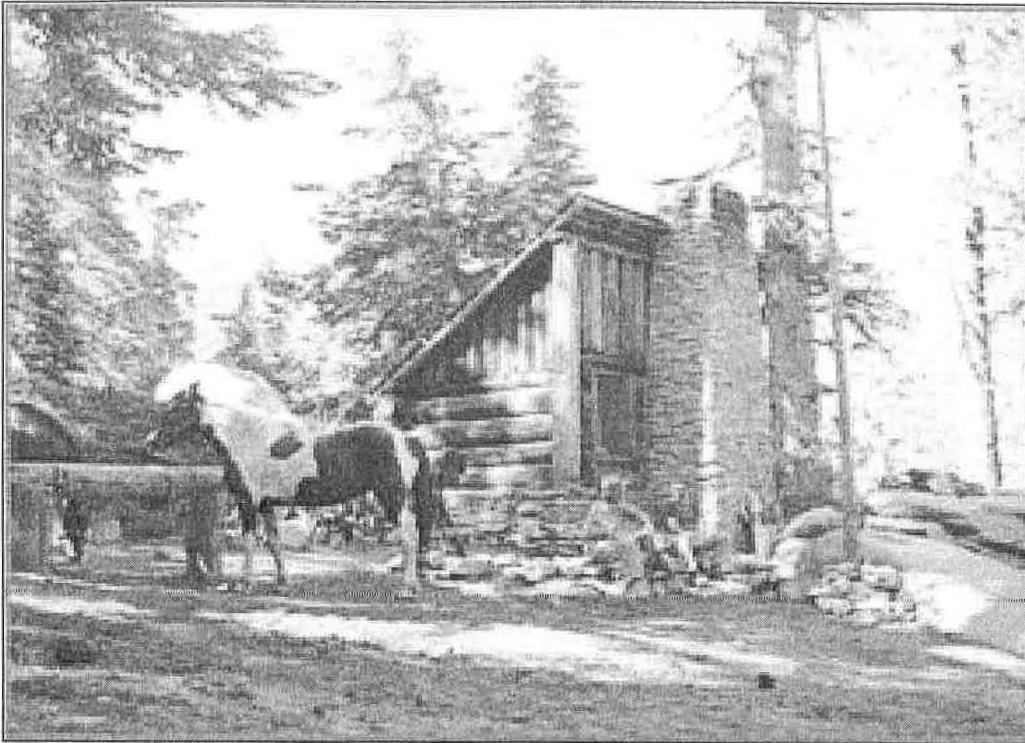
Photograph # HP11  
Looking North at Round  
Valley Shelter  
Date: 1952 August  
Source:  
CA State Museum  
Accession # 090-23420

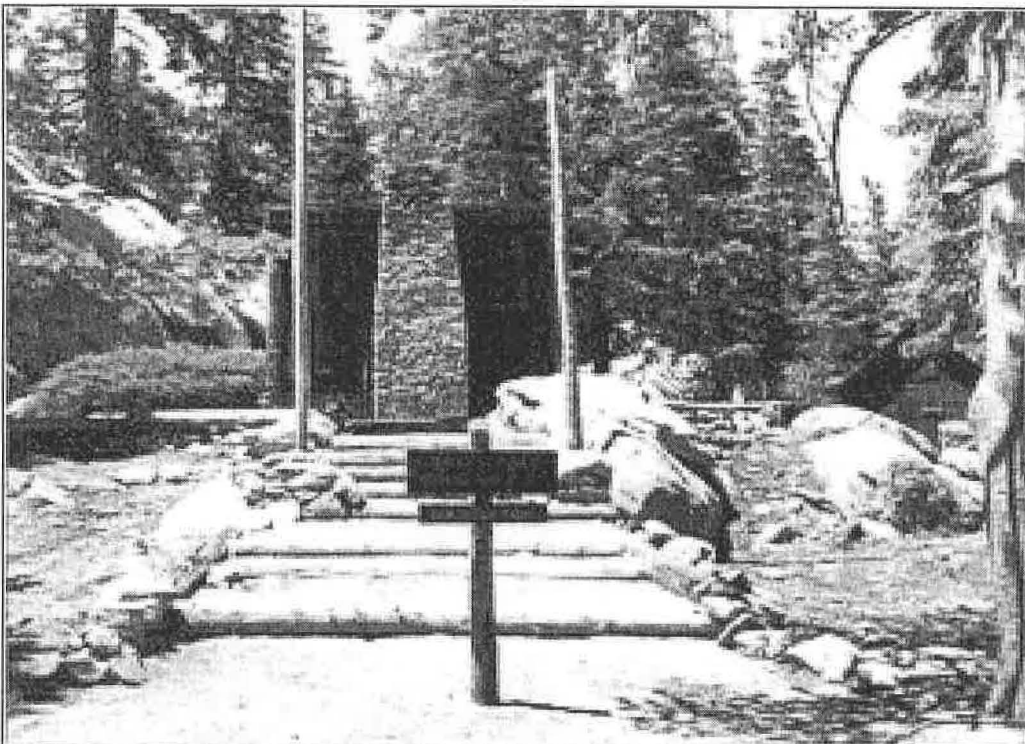
Photograph # HP12  
Looking Northwest at  
Round Valley Shelter  
(Middle) and Tool Shed  
(Right)  
Date: 1963 August 5  
Source:  
CA State Museum  
Accession # 090-24241

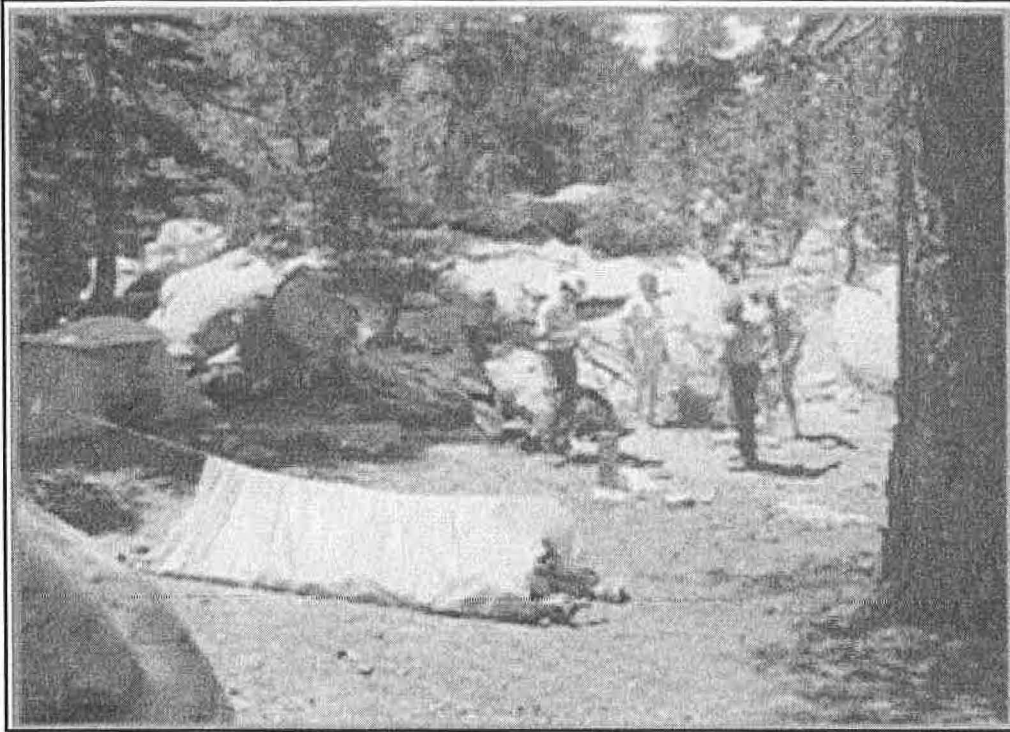
Photograph # HP13  
Looking North at Round  
Valley Primitive  
Campground Campsite;  
Site of CCC Spike  
Camp  
Date: 1977  
Source:  
CA State Museum

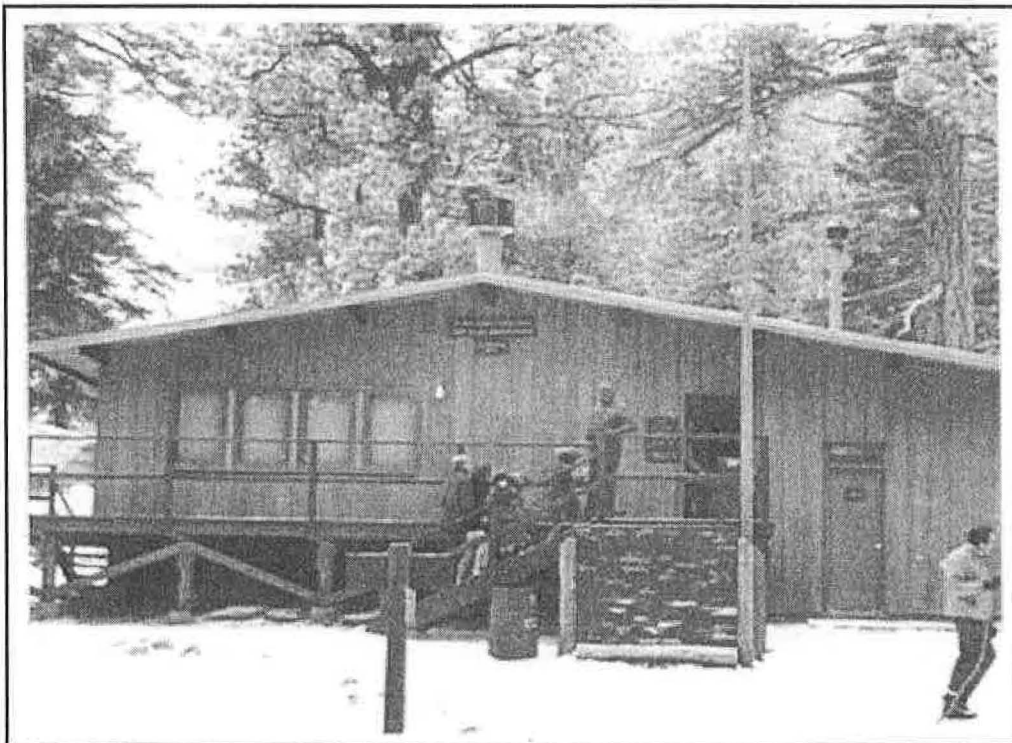
Photograph # HP14  
Looking North at Long  
Valley Ranger Station  
Date: Winter 1964  
Source:  
Mount San Jacinto State  
Park  
Accession # N/A

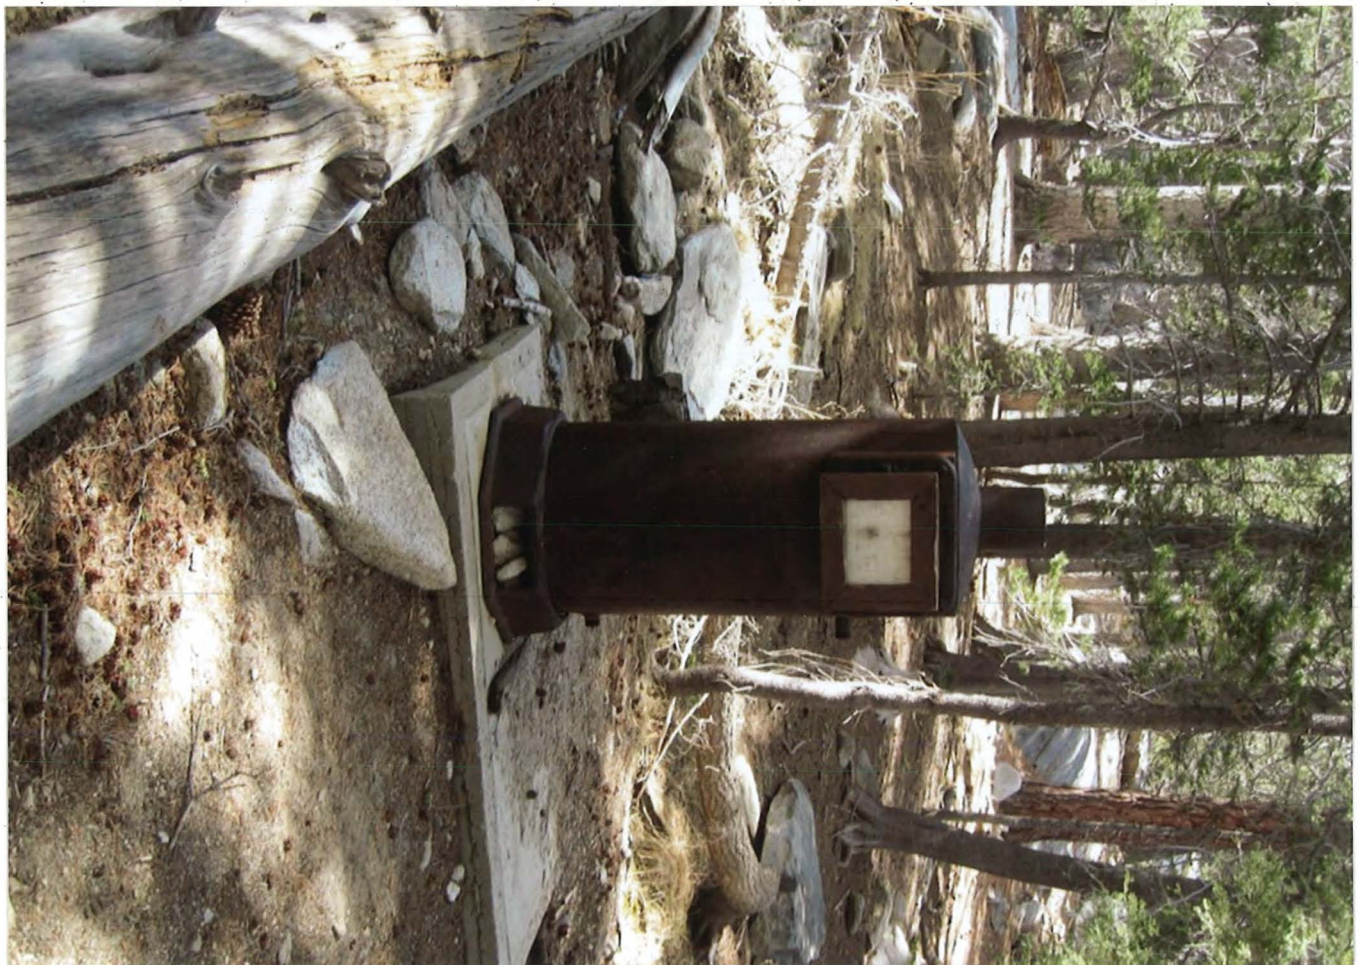
PHOTOGRAPH #17

City or Vicinity: Idyllwild  
County: Riverside  
State: California  
Name of Photographer: John McCall  
Date of Photographs: April 2007  
Location of Original Digital Files: Southern Service Center, California State Parks  
Photograph #17: CA\_Riverside County\_Mt San Jacinto SP\_Historic District\_0017  
East-Facing Façade of Abandoned Metal Boiler at CCC Spike Camp Site at Round Valley; Camera Facing West.

Photograph # 17

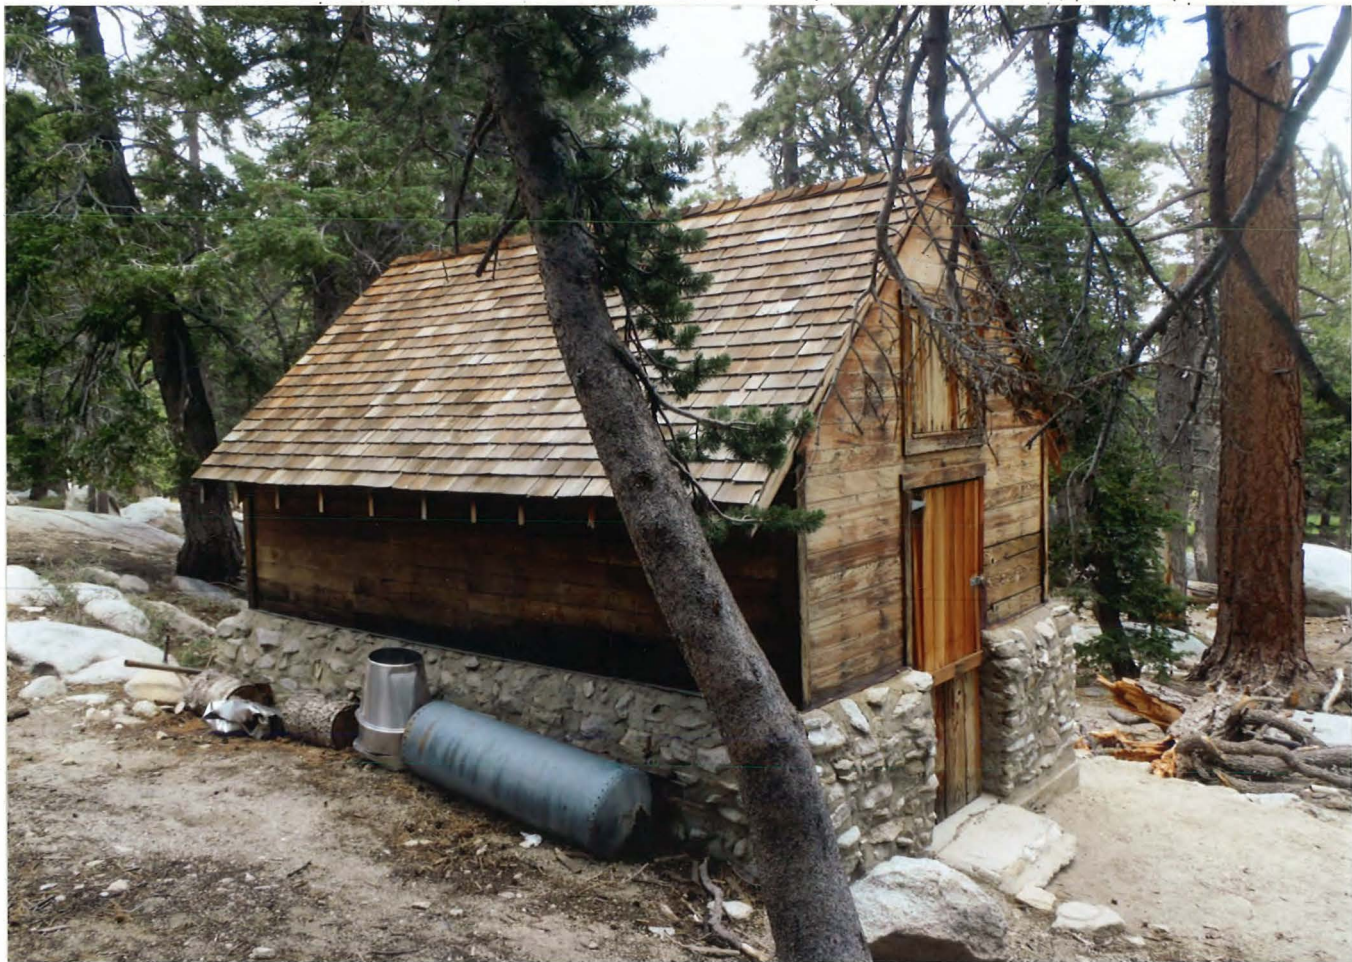
PHOTOGRAPH #19

Photograph #19: CA\_Riverside County\_Mt San Jacinto SP\_Historic District\_0019  
Southwest and Southeast-Facing Facades of Tool House at Round Valley; Camera Facing Northeast.

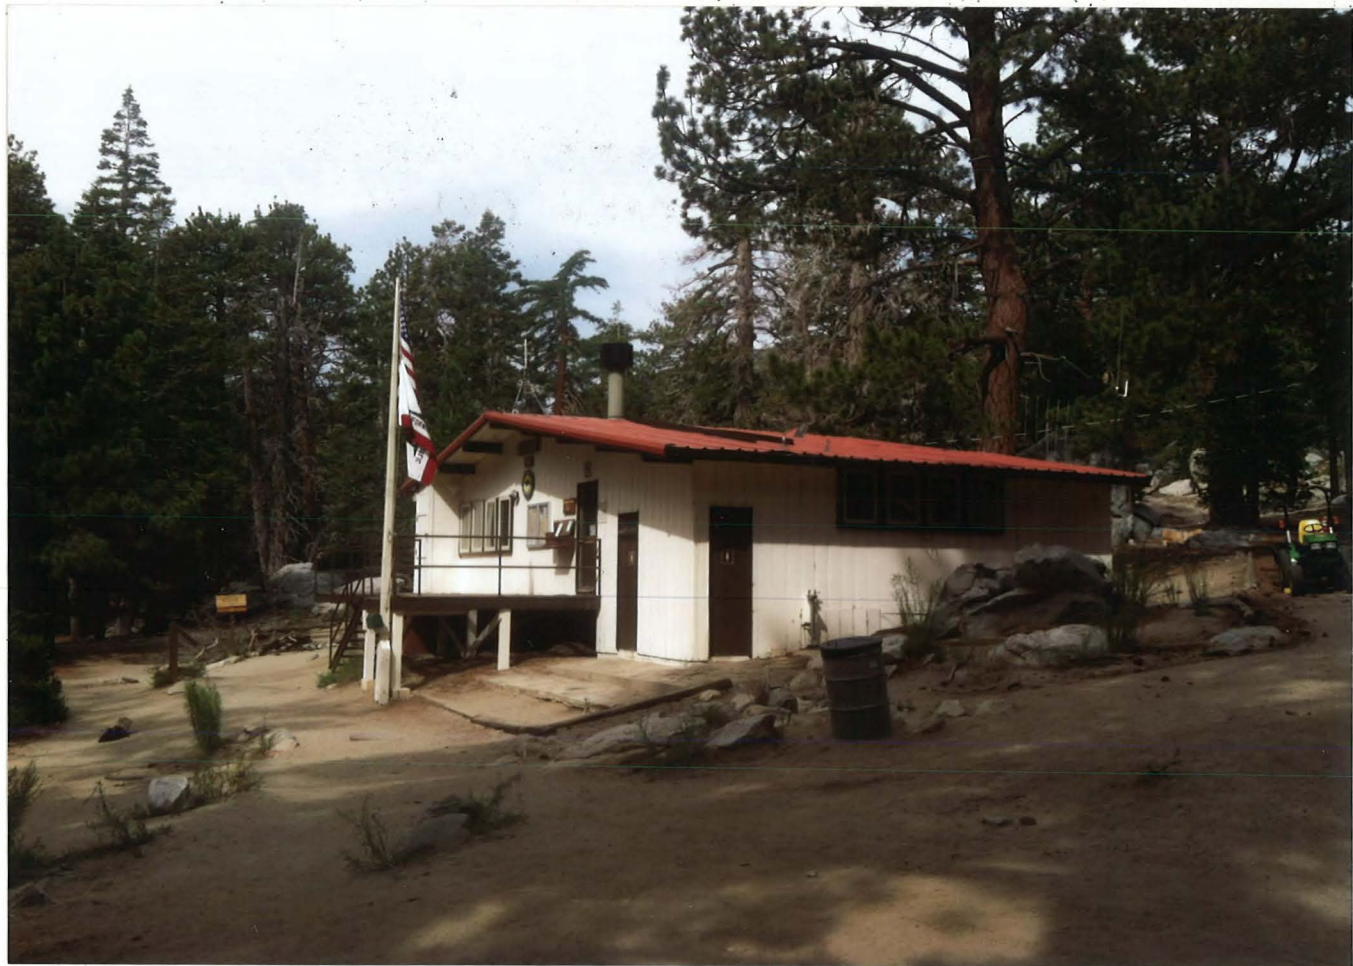
MOUNT SAN JACINTO STATE PARK  
HISTORIC DISTRICT  
IDYLLWILD, CA  
PHOTOGRAPH #21

Photograph #21: CA\_Riverside County\_Mt San Jacinto SP\_Historic District\_0021  
South and East-Facing Facades of Ranger Station at Long Valley; Camera Facing Northwest

Photograph # 21

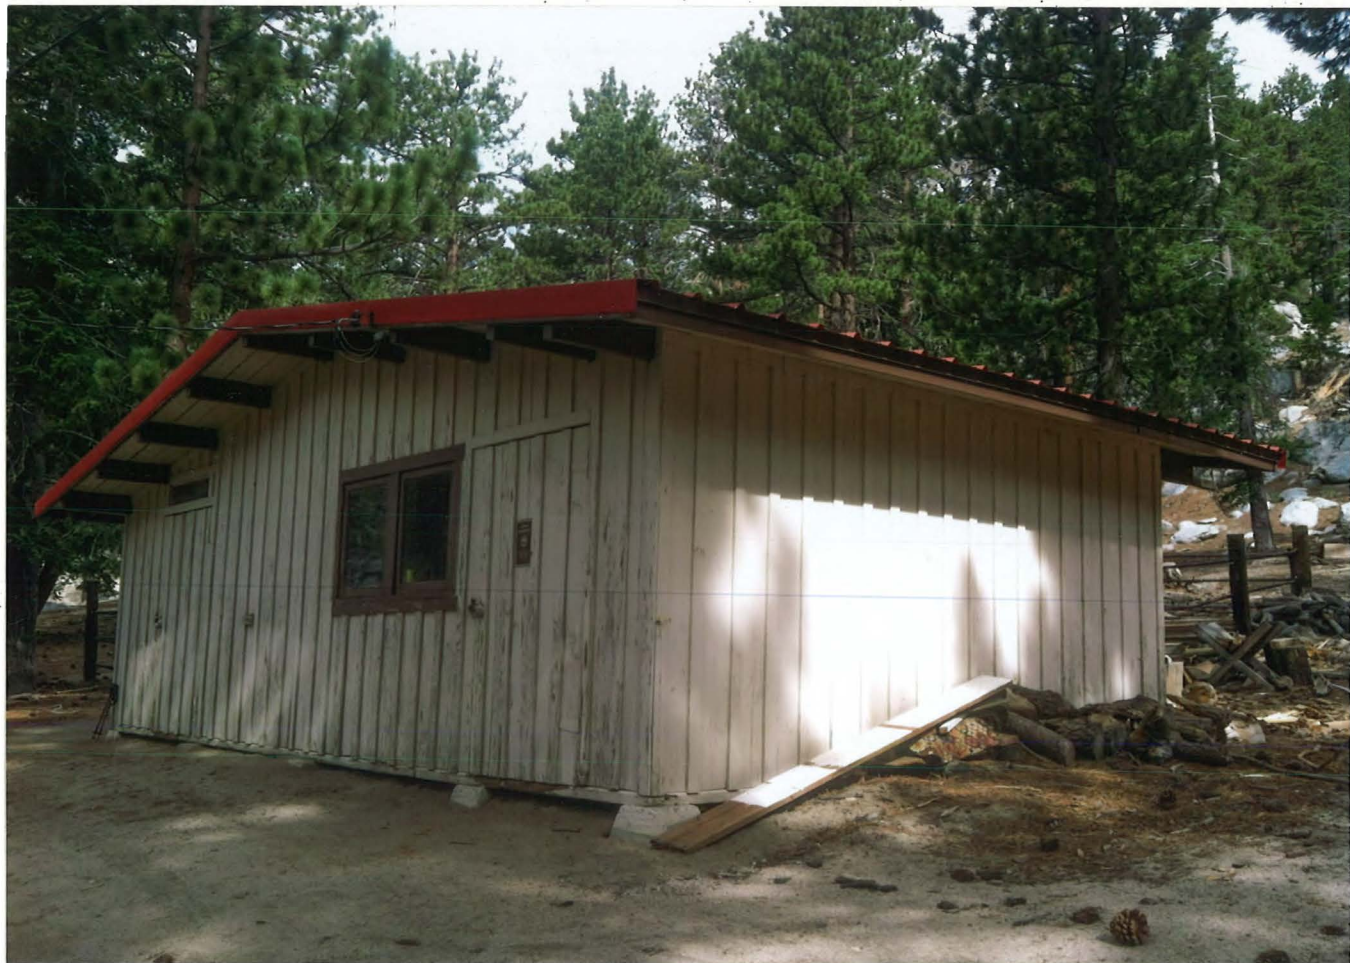
IDYLLWILD, CA  
PHOTOGRAPH #22

Photograph #22: CA\_Riverside County\_Mt San Jacinto SP\_Historic District\_0022  
Southeast and Northeast-Facing Facades of Wood Shop and Stables at Long Valley;  
Camera Facing Northwest

Photograph # 22
