KENTUCKY HISTORIC RESOURCES
Individual Inventory Form

Resource # Be-210
Boone County

1. Name of Resource: Hudson house

5. Location: 12328 Gaines Way
Walton, KY

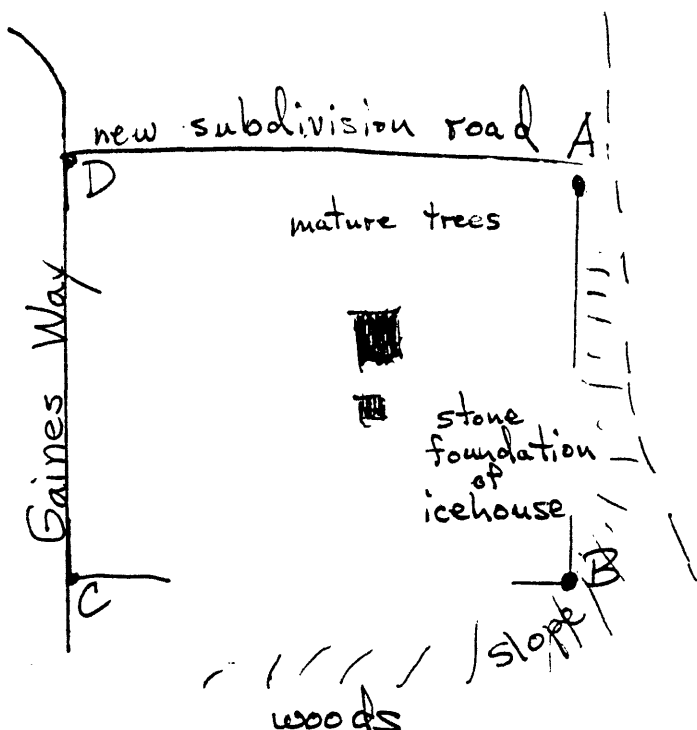
44. Site Plan (and boundary description and justification for N.R. sites):

The boundary occupies lot 27 in Bedinger's Landing subdivision and is roughly 350' x 230' in size.

The boundary includes the house, the remains of the icehouse, and acreage sufficient to provide a setting.

Contributing: 1 building
 1 structure (icehouse)

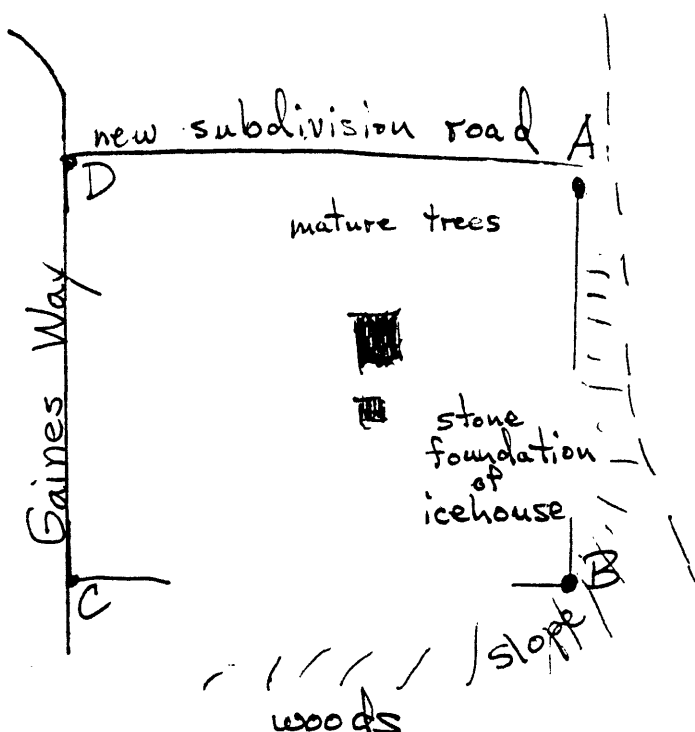
44. Site Plan (and boundary description and justification for N.R. sites):

The boundary occupies lot 27 in Bedinger's Landing subdivision and is roughly 350' x 230' in size.

The boundary includes the house, the remains of the icehouse, and acreage sufficient to provide a setting.

Contributing: 1 building
 1 structure (icehouse)
