National Register of Historic Places  
Registration Form

Historic name Rooks County Record Building  
Other name/site number F.E. Young Building

Street & number 501 Main ☐ not for publication  
City or town Stockton ☐ vicinity  
State Kansas Code KS County Rooks Code 163 Zip code 67659

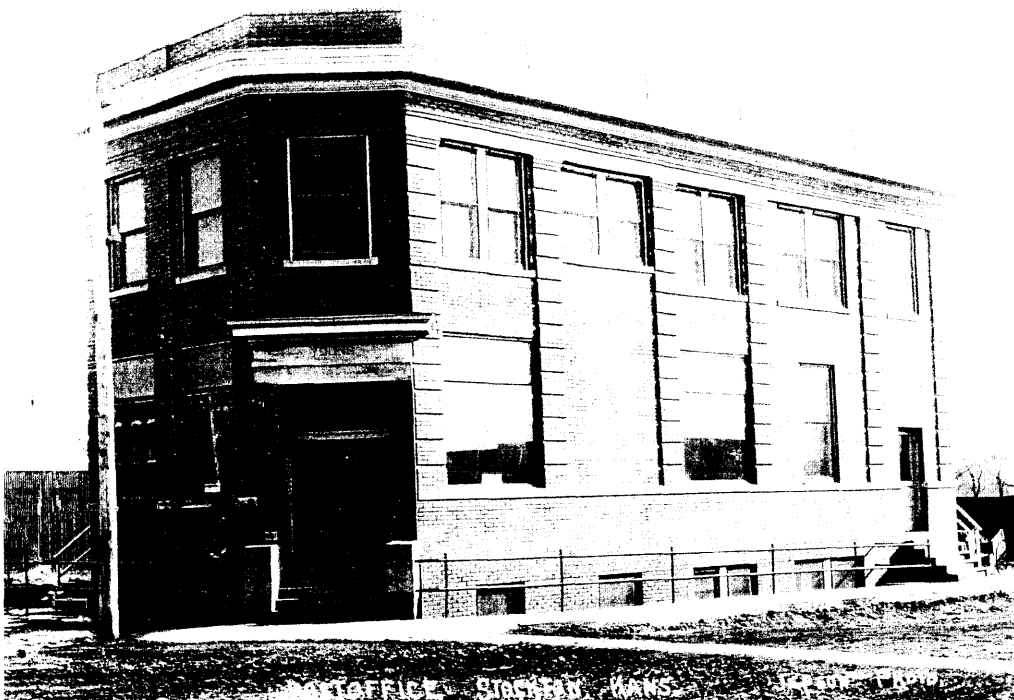
Rooks County Record Building, constructed 1911 as Post Office

Source: City of Stockton (c.1912)

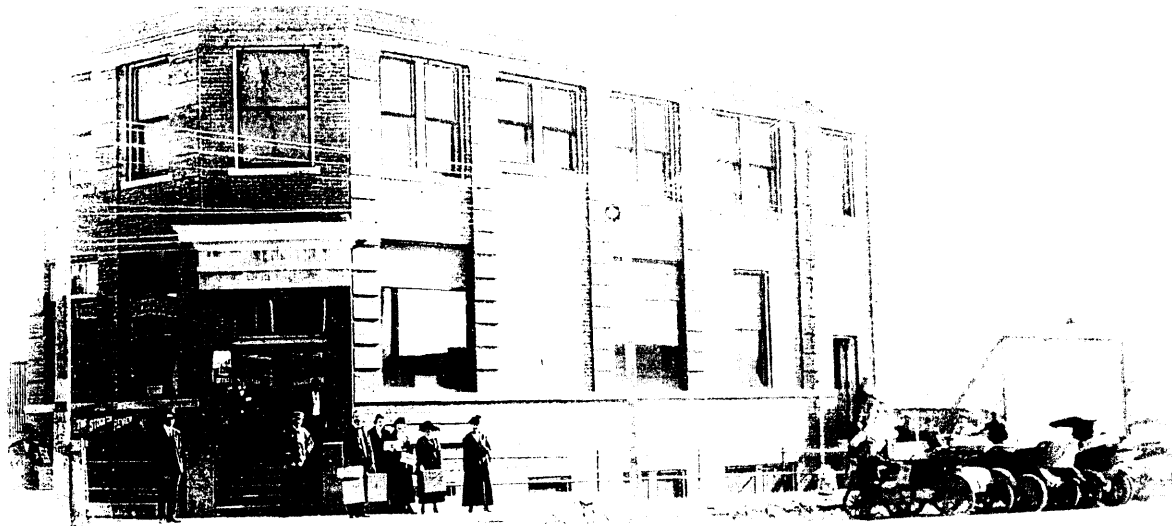
Early Views of Rooks County Record Building illustrating Post Office on ground floor, Telephone Company on 2<sup>nd</sup> Floor and The Stockton Review in basement. Also building is freestanding with vacant lot on the east (no date on photos, c. 1915-early 20s)

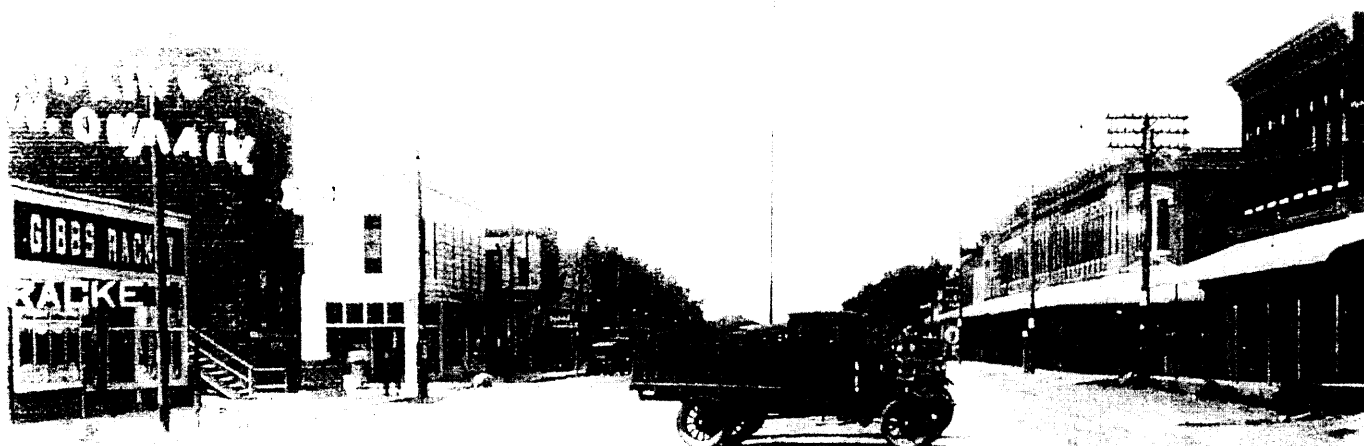
**FIGURE 4 – Historic Views of Record Building**

Looking West on Main Street, Stockton, 1925 – Record Building on left with Telephone Company sign on 2<sup>nd</sup> floor. Source: City of Stockton

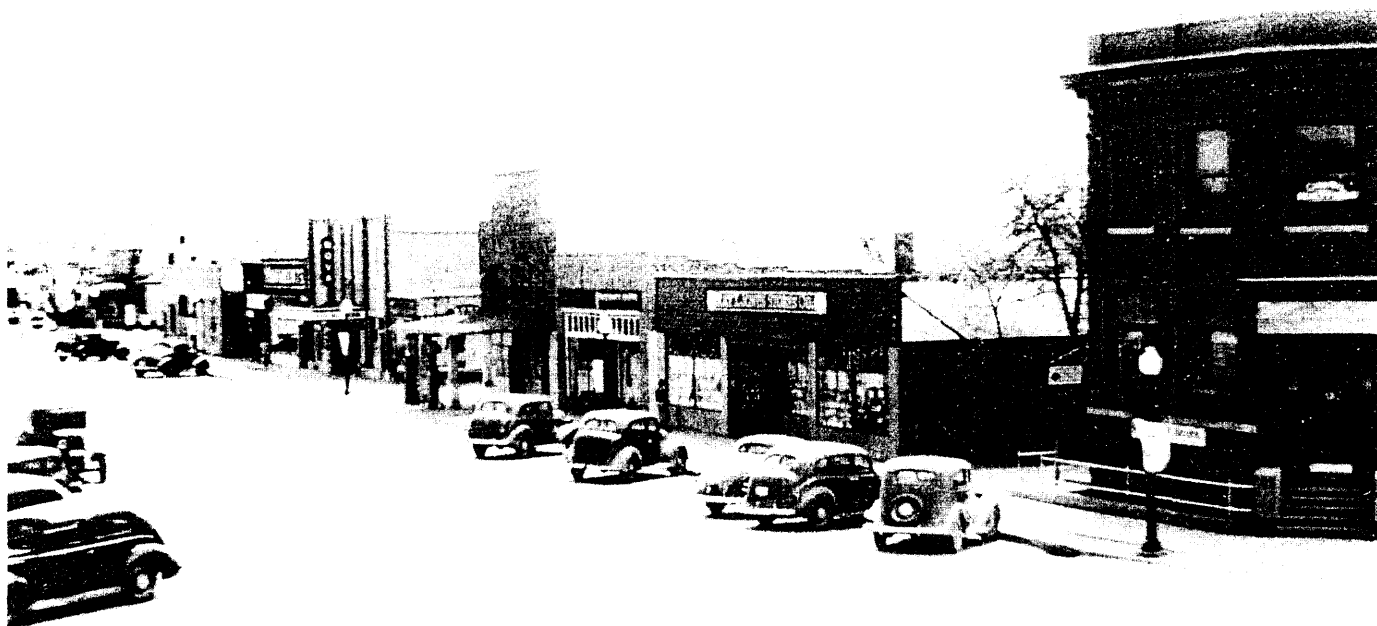
Looking East on Main Street, Record Building on right. Telephone Company has moved to ground floor, beauty shop on 2<sup>nd</sup> floor, and The Record in the basement. (no date on photo, c.mid-1930s) Source: Jean Lindsey, Rooks County Historical Society
