National Register of Historic Places Registration Form

Historic name Lexington Veterans Administration Hospital

Other names/site number Veterans Affairs Medical Center, Leestown Division, Lexington, Kentucky / FA-400

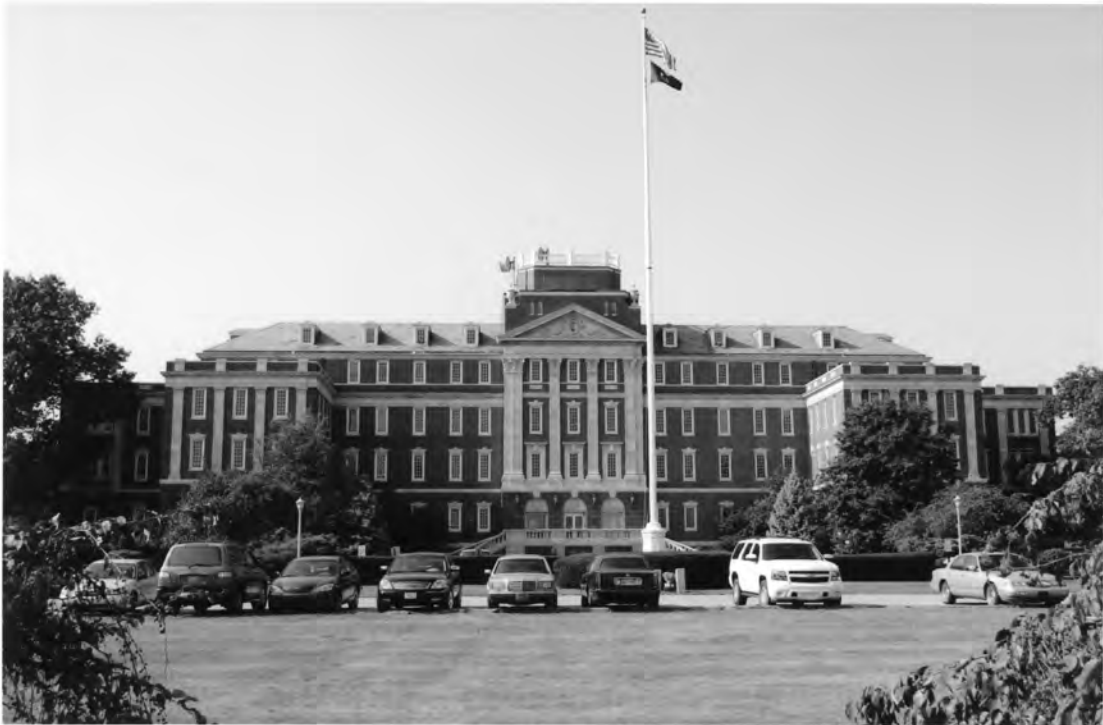
KY-Fayette Co-2nd Generation Veterans Hospitals ~~MPS~~-Lexington VA Hospital-0001

1. Resource 15 and facade of Resource 1. View looking southwest.
2. Facade of Resource 4. View looking west.
3. Facade and southwest elevations of Resource 7. View looking northeast.
4. Resource C looking northeast to courtyard of H-buildings.
5. Facade of Resource 29. View looking southeast.
6. Southwest and facade elevations of Resource 39. View looking north.
7. View to south-southeast from near Resource 20 looking to Resources 67, 39, and 41.
8. View looking north-northwest to Resources 28, C, and 29.
9. View looking northeast in courtyard to Resources 17, 16, and 29.
10. View looking southeast to Resources 1, J, and 2.
11. View looking northwest from Resources 38 and 9.
12. View looking northwest to Resource 4 from the southeast entry drive.

The flag pole is a common object found at many Second Generation Veterans Hospitals, usually located to the front of the main building. The flag pole (Resource 15, circa 1930s) is located northeast of the main building (Resource 1, 1930) and is aligned with the center of the building. The octagon-shaped base, similar
