National Register of Historic Places Registration Form

I. Name of Property					
nistoric name	Puritan Apartment Hotel				
other names/site number	JFCO-2260				
Related Multiple Property	NA				
2. Location	1023				
street & number 1244 South	Faurth Street			NA	not for nublication
Treet & number 1244 South	Fourth Street				not for publication
city or town Louisville				NA	vicinity
state Kentucky	code KY county	Jefferson cod	le 111	zip coo	le 40203

The Puritan Apartment Hotel (JFCO-2260), hereafter referenced as the Puritan, is a six story apartment hotel constructed in the Colonial Revival Style. The building was constructed in four main building campaigns, most of which utilize the Colonial Revival architectural vocabulary, beginning in 1914 and concluding in 1958. The Puritan is situated at the northwest corner of West Ormsby and South Fourth Street, within the Old Louisville Residential National Register District (75000772), at the southern edge of the downtown core. The Puritan campus includes the main building complex, along with a one-story maintenance building connected by an underground tunnel to the main building. A small elevator tower was appended to the building's south

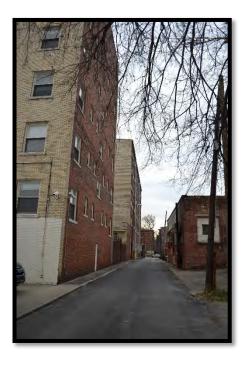
Figure 3. Setting photographs. Left: View of low stone wall and cast iron/modern metal fencing, at corner of west alley and West Ormsby Avenue. (Photo 0001). Right: View of west alleyway, looking south toward maintenance facility. (Photo 0002).

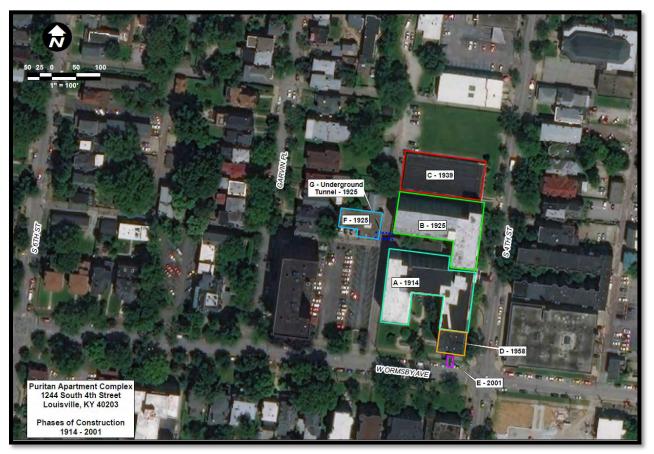
Figure 4. The Puritan Apartments Evolution from 1914 – 2001.

The Puritan Apartment Hotel is a six-story building constructed in four major building campaigns (**Figure 4**). A six-story elevator tower addition (E), which measures approximately 19 x 28 feet, was also appended to the building in 2001 and is included in the description below. In spite of what may seem like a number of additions, the building's owners made every effort to tastefully match each new addition with existing fabric, using similar decorative details and fenestration patterns. The need for additional space did not eclipse the desire to keep the building's architectural status throughout all the main building campaigns.

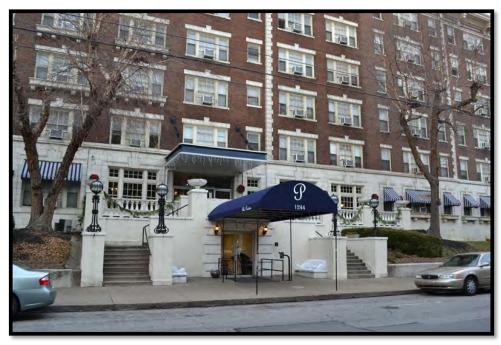
Figure 8. Puritan Apartment Hotel, Front Entrance on primary façade. Photo taken looking northwest from South Fourth Street. (Photo 0005).

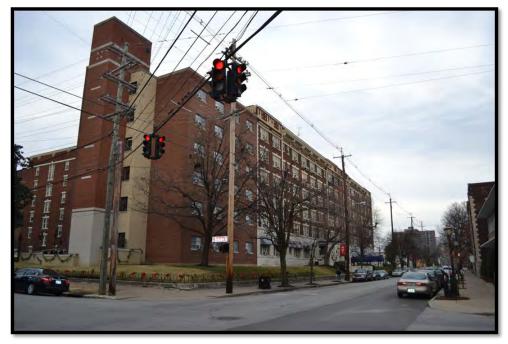
Figure 9. Primary façade, looking northwest from corner of West Ormsby Street. (Photo 0006).

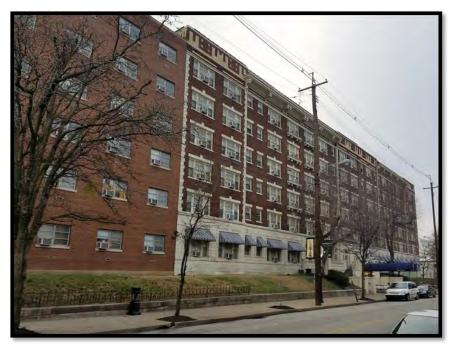
Figure 10. Closer view of 1914 and 1925 portions of the building's primary façade, looking northwest. The 1958 addition is in the foreground. (Photo 0007).

The next ten bays, divided into three parts, in a subtle nod to the Colonial Revival style, were part of the original 1914 building. The first two bays, if looking south to north, are framed by terra cotta quoins and project slightly from the main body of the building. The first story of this two-bay section is faced entirely in glazed terra cotta, as is the first level of the entire primary façade, and features tripartite 8/2 wood windows with 1/1 sidelights. The first-floor windows are encased in architectural terra cotta and are characterized by a centrally located terra cotta keystone arch. Blue and white fabric awnings provide shade from intense sunlight for the first floor windows of this entire elevation. Windows on the remaining floors are 8/2 tripartite wood windows with 1/1 sidelights and a terra cotta keystone arch. The top of the six-story windows are capped by a continuous terra cotta lintel and the second floor windows are set into a continuous terra cotta sill course. The cornice line of this two-bay section is distinguished by patterned bands of buff-colored vertically-oriented brickwork on the parapet and horizontal blonde brick banding at the cornice, which matches that found between cornice brackets on the middle six bays.

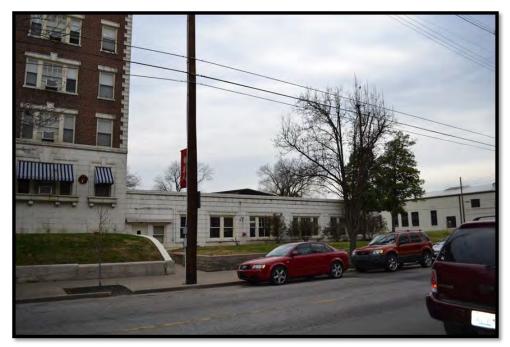
Figure 13. Garage façade, looking northwest from South Fourth Street. (Photo 0012).

architectural terra cotta as its wall cladding material. Continuing the treatment from the apartment building's façade, the window and door openings are set into the terra cotta facing and utilize terra cotta surrounds. If looking south to north, there is a single leaf door opening, for pedestrian access and a 1/1 window with a terra cotta pent roof shielding entry from the elements. The garage is lighted by the following windows on the primary facade: a 1/1 double hung window, paired 1/1 windows, three tripartite 8/2 windows with 1/1 sidelights, and a 1/1 double hung window. A modern rusticated low concrete wall forms the property boundary between this building and the sidewalk along Fourth Street.

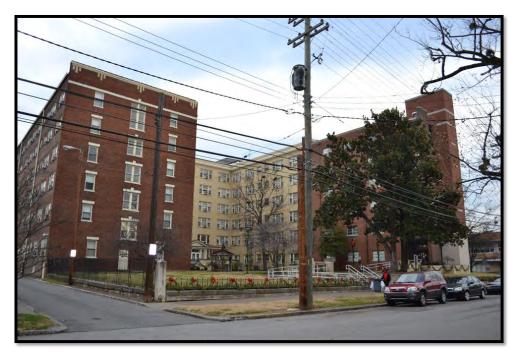
Figure 14. South elevation of Puritan Apartment Hotel, looking northeast. (Photo 0013).

The south elevation is defined by an early twentieth century low stone wall atop which sits an early twentieth century cast iron fence. This wall directly abuts the sidewalk along West Ormsby Avenue. A set of more modern concrete stairs, perhaps installed in the 1950s, provide entry to this secondary façade from West Ormsby; these stairs are flanked by recently installed metal handrails, located along the ADA-accessible concrete ramp that ties into a landing near the end of the main stair. Defining this entry is a low buff-colored, U-shaped brick veneered landscaping wall, topped with a concrete cap. A large magnolia tree is planted directly east of the stair ensemble. Four circa 1980s pathway lamps line the poured concrete sidewalk that leads into the building. Surrounding the one-story entry sun porch is a low buff-colored brick veneer wall, topped with concrete coping. A railing with a Colonial Revival style balustrade is situated to the west (left) of the entry. A curved buff-colored brick veneer wall curves around an accessible ramp that is located to the east (right) of the main stair. This east wall likely resembled the west wall, with a decorative balustrade, but was reworked to serve as an accessible entry.

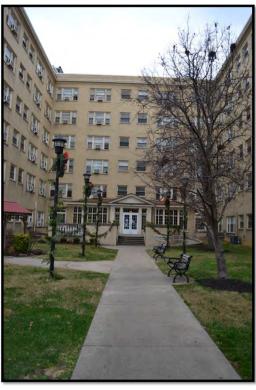
Figure 15. Secondary entrance into a one-story sun porch on the south elevation courtyard. Photo taken looking north. (Photo 0014).

A one-story sun porch characterizes the first floor of the south courtyard wall. Entrance into the sun porch can be obtained through a centrally-located Colonial Revival style pediment with fluted pilasters, framing the entry doors. Paired five-light sidelights can be found between the outer set of fluted pilasters, creating a tripartite entryway. The original entry doors have been replaced by modern ADA-compliant multi-light French doors and are topped with a multi-paned transom. Directly east and west of the entryway, a set of three casement windows light the sunporch space. Each window is topped by a multi-paned transom of casement windows. The roof of this sun porch is covered with asphalt shingles.

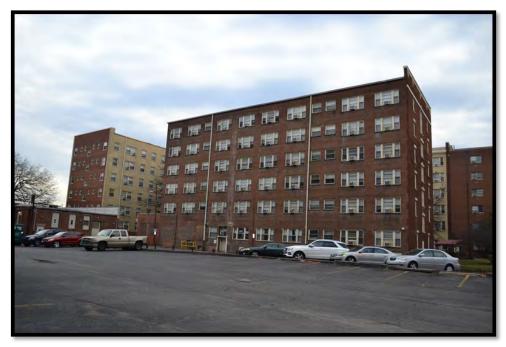
Figure 16. Rear (west) elevation, looking northeast. (Photo 0015).

The west elevation of the 1914 building is characterized by eleven bays of symmetrically-placed wood windows on all six floors, excluding the first three bays of the northwest corner of this building on the first and basement floors, which will be described separately. All windows on this elevation have brick header lintels and sills and all tripartite windows are characterized by 1/1 sash on both the main window and the sidelights. If looking north to south, the 1914 wing has two tripartite wood windows, a small single 1/1 wood window, four sets of tripartite wood windows, two small 1/1 wood windows, and two tripartite wood windows. The first floor of the 1914 wing has experienced some changes. If looking from north to south, the first three bays of windows have been enclosed with brick veneer. The fourth bay features what was likely an original service entry that has been modified with an HVAC unit where there may once have been a transom window. The remainder of the first floor fenestration pattern follows that established on the floors above. If looking north to south, the basement floor, while keeping the symmetry above, has three bricked-in window openings, one window enclosed with plywood, three wood windows with a grille covering, and one small metal utility door. The side of the one-story brick veneer porch area is appended north of this wing. According to Sanborn maps, this area was used as a dining room with access to the open courtyard between the 1914 building and the 1925 addition. Two windows were encased in brick on this onestory west elevation. Attached to this is a brick courtyard wall that appears to have been rebuilt in the recent past. An entryway into the area is secured by a screened metal door.

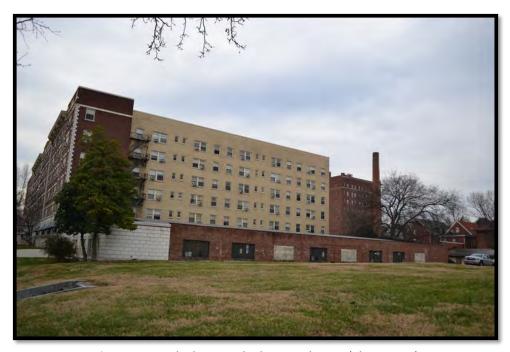
Figure 18. North elevation, looking southwest. (Photo 0018).

The north elevation of the 1925 building addition is encased in buff-colored brick and features six stories of windows arranged in a symmetrical pattern. A small portion of the primary façade's treatment is continued onto the north elevation. This area is situated at the addition's northeast corner and is characterized by red tapestry brick veneer, glazed terra cotta quoins at the façade/side wall juncture, and a glazed terra cotta cornice line. Decorative glazed terra cotta coping highlights the wall's peak, which continues along the entire north elevation of the addition.

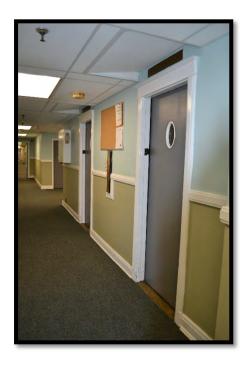
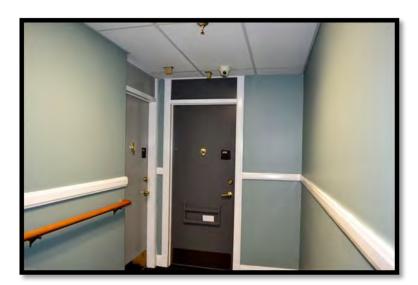
Figure 24. Apartment corridor views, second through six floors. Left: Main elevators on the third floor, looking southwest. (Photo 0027). Right: Typical apartment door for 1914 and 1925 addition has a transom window. Looking north from 1914 corridor on the second floor. (Photo 0028).

Floors two through six maintain a similar floor plan with few deviations. (See **Figure 25**). None of the upper floors have public spaces, outside the circulation hubs near the elevators and the stairs. As such, floors two through six have limited ornamentation. The main corridors feature carpeted floors, painted wall surfaces with chair rails and picture moldings, and dropped acoustic tile ceilings with fluorescent lighting. The elevators on the upper floors have a simple capped trim surround. Doors that lead into the apartment spaces are wood single-leaf door topped with transom windows that have been enclosed with plywood. The 1958 portion of the building does not have transom windows over the apartment doors; typically this later addition also does not feature chair rails and picture moldings.

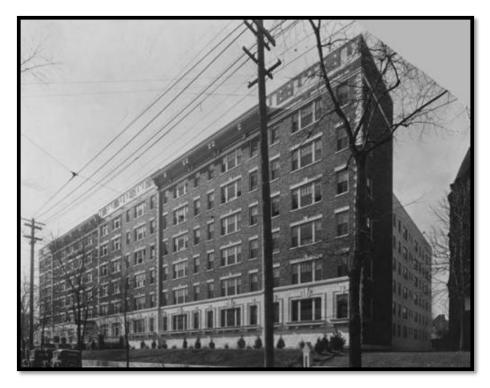
Figure 36. The Puritan Apartments in 1931, photo taken to show the recent annex addition to the building's north elevation and primary façade. 75

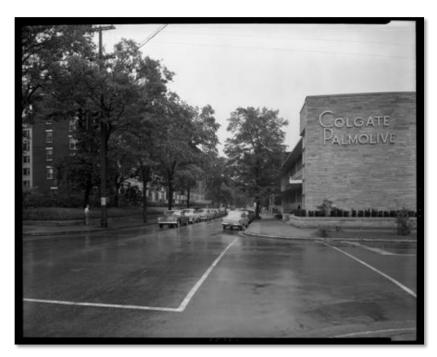
Figure 40. Looking down Fourth Street, toward the Puritan Apartments in 1955, prior to the 1958-1959 addition to the building's southeast corner. Note the original appearance of the southeast wing that faced onto Ormsby Avenue. 85

If looking from west to east, the west end of the 1914 wing faces the street. This end wing is faced with redtapestry brick veneer and has a glazed terra cotta cornice line above which is a triglyph of decorative blonde vertically-oriented brickwork. A terra cotta lintel course with a centered terra cotta keystone defines the top of the building, just above the sixth story windows. Much like the rest of the building, the windows are symmetrically-placed and arranged one atop the other for the entire six stories. With the exception of the first-floor middle bay, this end wing is characterized by three bays of 1/1 windows, either paired or placed separately. The middle bay of windows features paired 1/1 wood windows with terra cotta lintels and sills. The sixth-floor middle bay also features paired 1/1 wood windows with a two-pane transom sash. The east and west bays of windows are 1/1 wood windows with terra cotta sill and lintels. The ground floor presents a somewhat different pattern. The middle bay contains a single-leaf entry door. The end wing on the southeast side resembled this end wing prior to the 1958 addition, as can be seen in **Figure 40** in Section 8 of this document.

Due to the cramped conditions, as well as a market ripe for high-end apartments near downtown, the Puritan appended a six-story, 37-room, \$325,000 addition to the building's southeast corner in 1958. The 1958 addition was constructed in red brick veneer and included what was believed to be Louisville's first \$700 penthouse apartment. The addition incorporated 35 hotel rooms and two penthouse apartments. The smaller penthouse was to be rented by the day or week, while the larger had already been leased to W.M. Cissell, President of the Cissell Manufacturing Company, as an in-town residence, to complement his winter retreat in Florida. The intended tenants were professionals who worked downtown or nearby. See **Figure 40** for a photo of the building just prior to the 1958 addition.
