**NATIONAL REGISTER OF HISTORIC PLACES  
REGISTRATION FORM**

historic name MARY OLSON FARM  
other names/site number OLSON-JOHNSON FARM

street & number 28728 GREEN RIVER ROAD SO. not for publication   
city or town Kent vicinity   
state WASHINGTON code WA county KING code 033  
zip code 98031

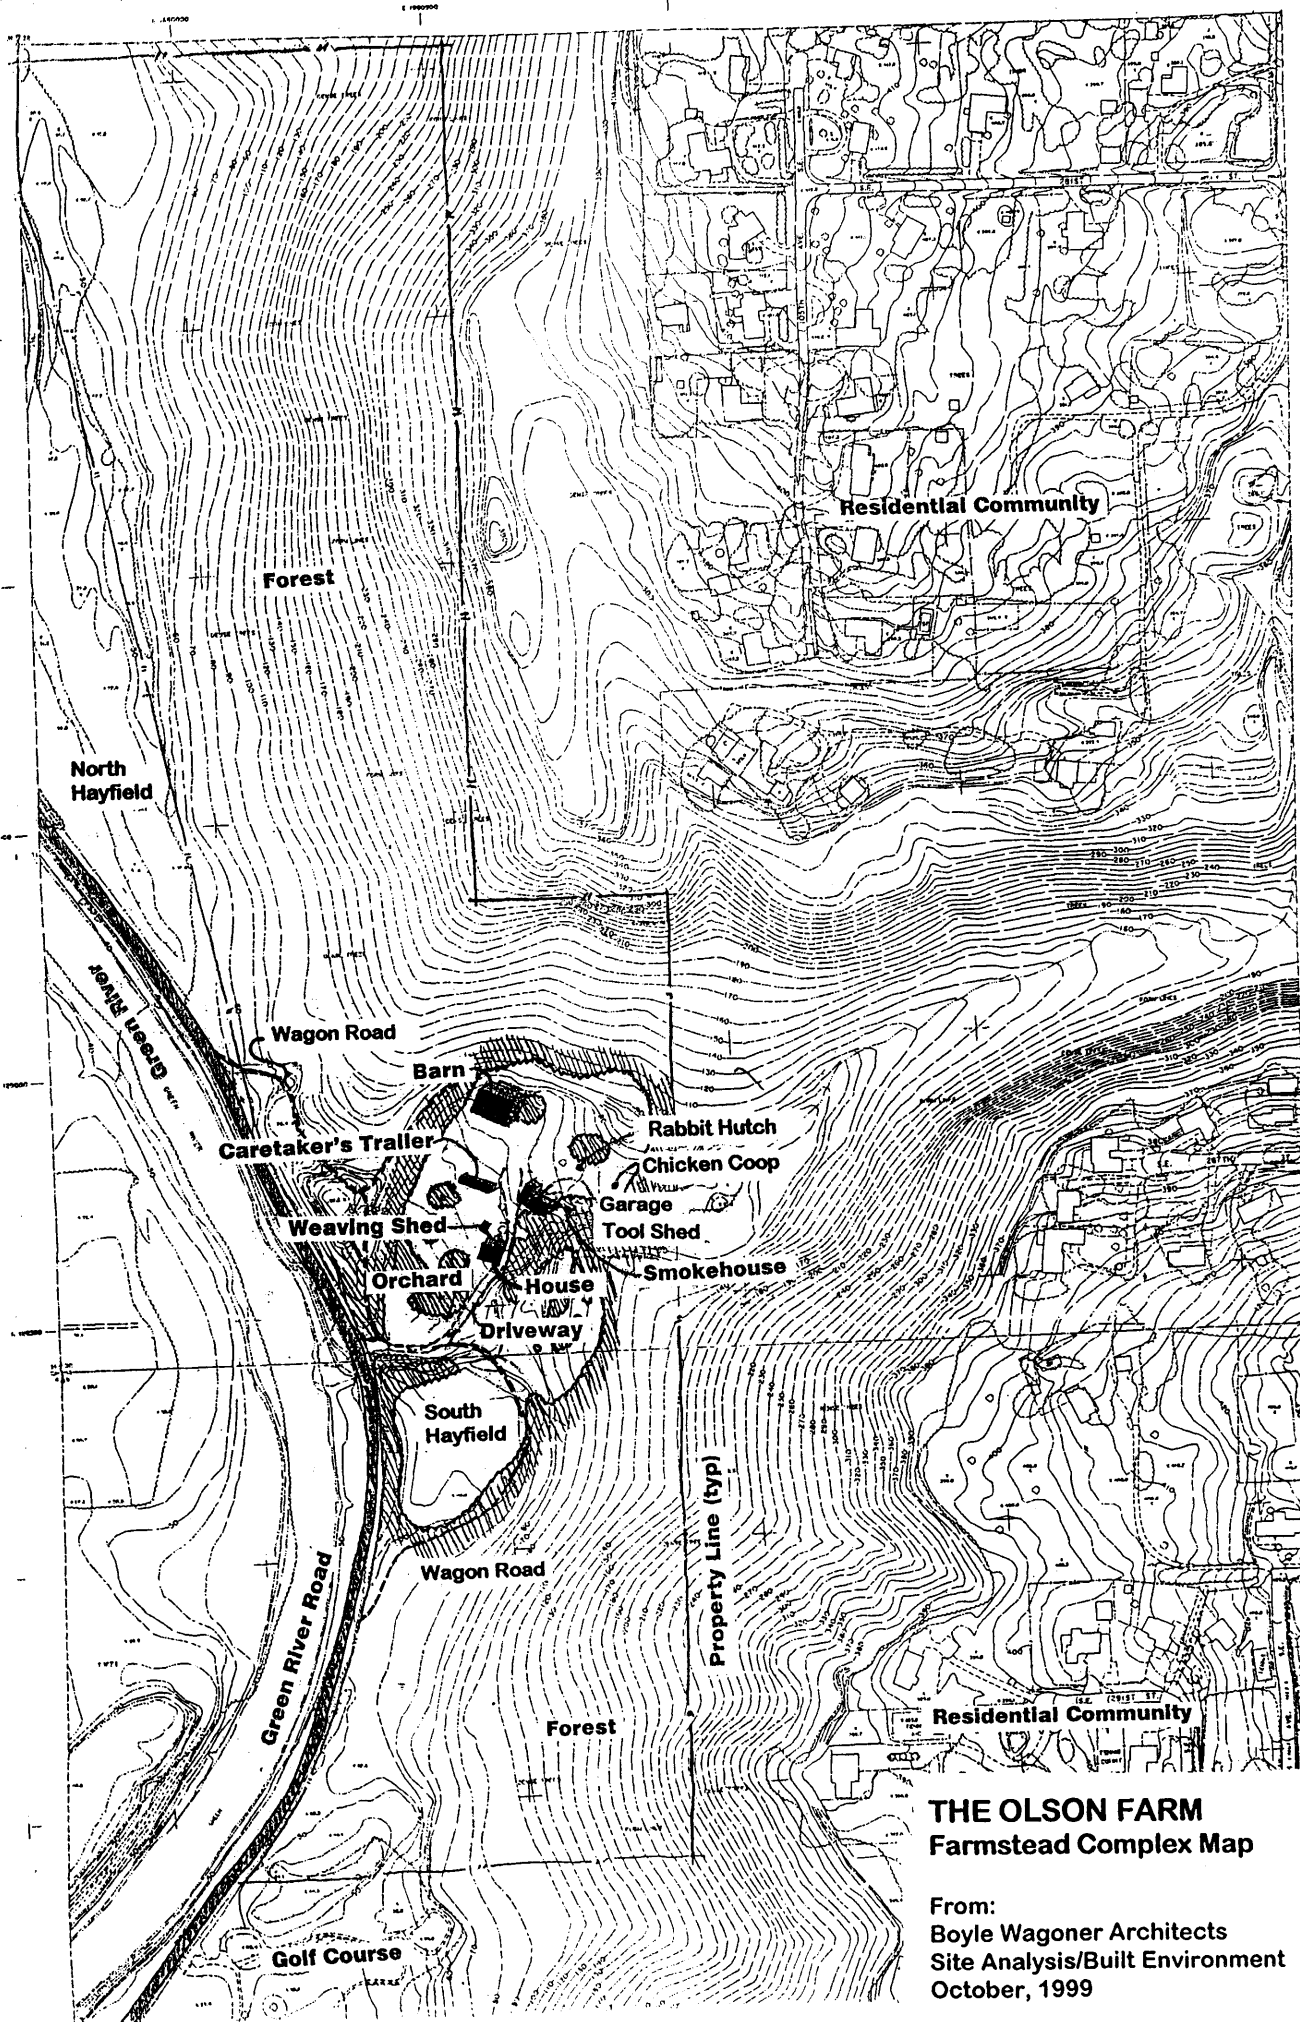
**THE OLSON FARM**  
**Farmstead Complex Map**

From:  
Boyle Wagoner Architects  
Site Analysis/Built Environment  
October, 1999

Rough-hewn posts with wire mesh fence now overgrown with blackberries defines western edge of orchard along former access lane to barn (appearing in 1937 aerial). Other fences encircle chicken coop and rabbit hutch, and border south pasture along highway. A heavy post and board fence is located at entrance on Green River Road (see attached site plan).

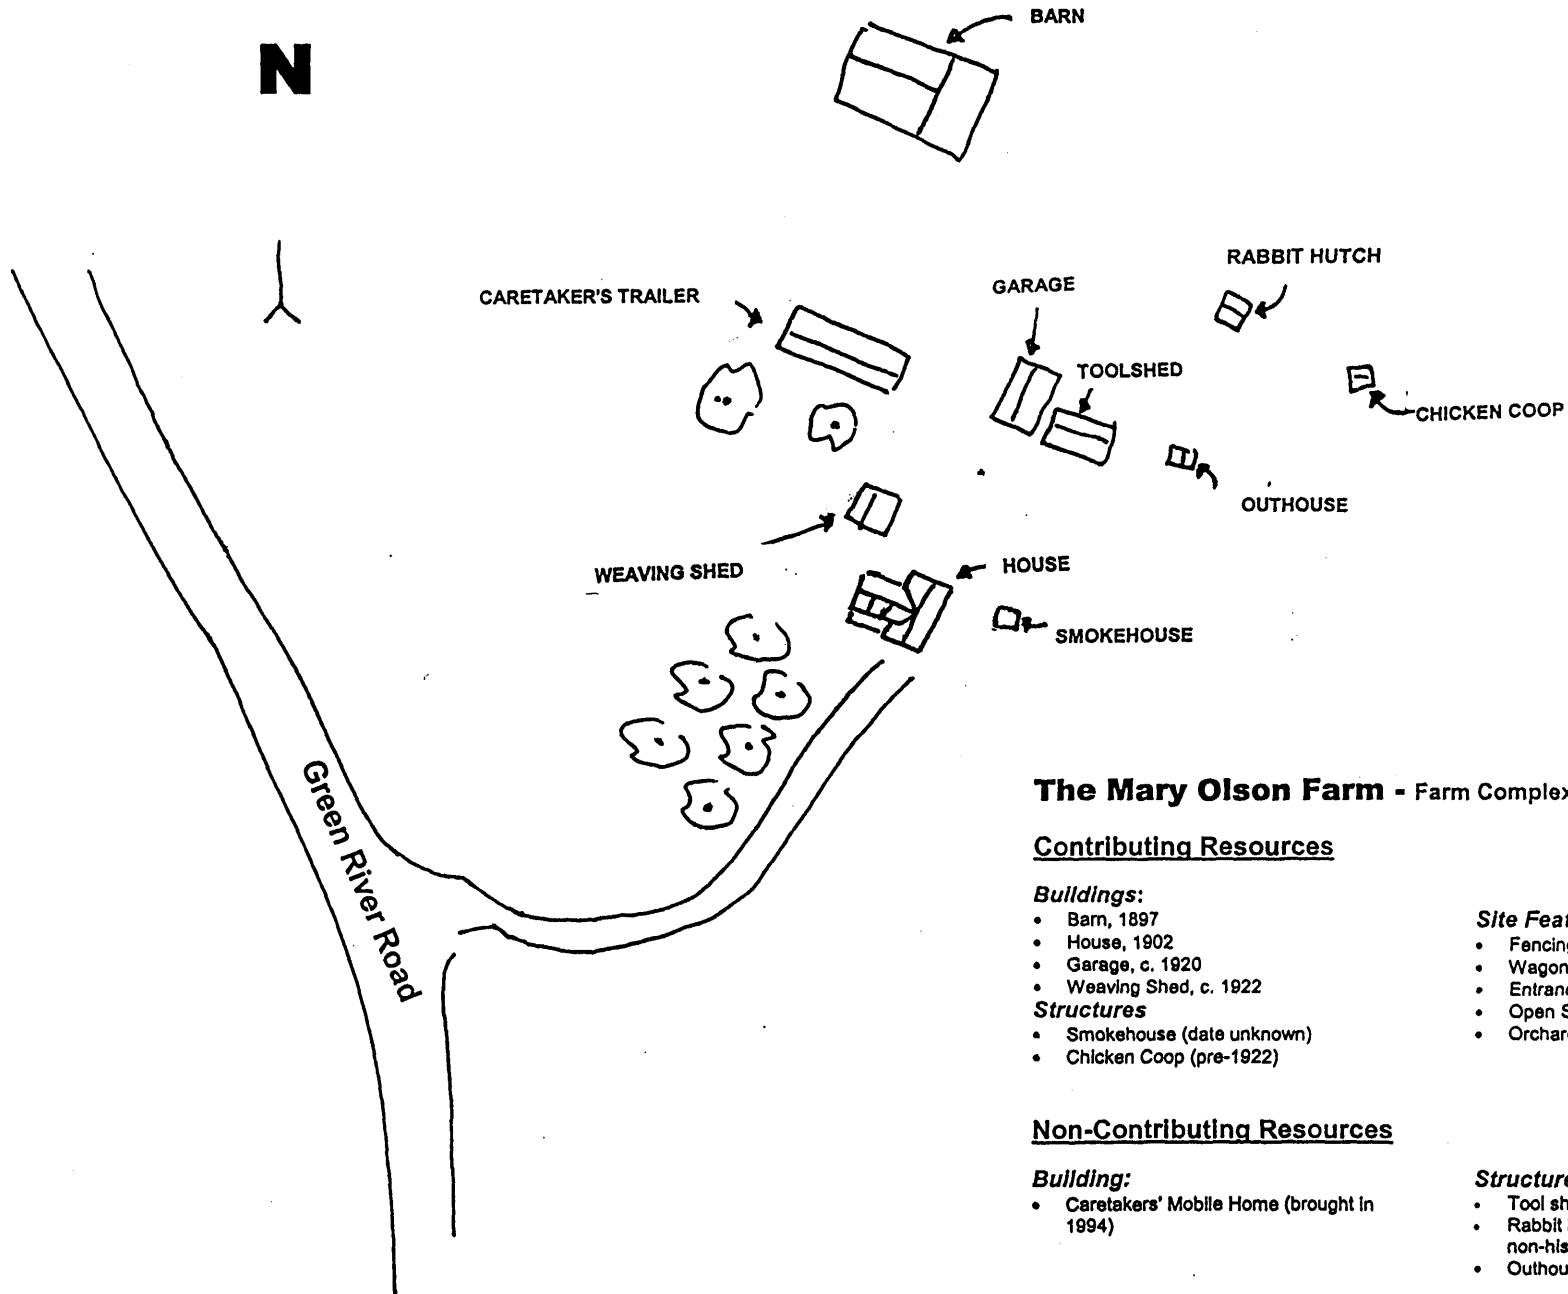
## The Mary Olson Farm - Farm Complex Map

### Contributing Resources
