# OHIO HISTORIC INVENTORY

3. No. MRW-17-15		4. Present Name(s) JARVIS HOUSE	
5. County MORROW		5. Other Name(s)	
6. Location of Negatives			
7. Specific Location East side of Route 314, the fifth building south of Route 95.		16. Thematic Category C

*Chesterville Multiple Resource Area*  
Jarvis House,  
Historic Resources of Chesterville  
Chesterville, Ohio, *Morrow County*  
Steven McQuillin  
October 1978  
Ohio State University Mansfield Campus  
Front facade, looking northeast  
HRCV-879

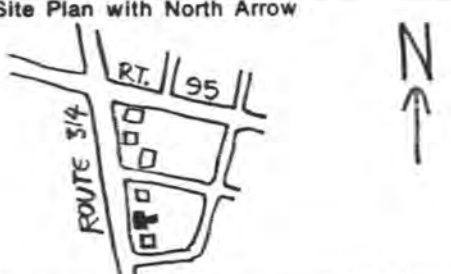
8. City or Town If Rural, Township & Vicinity Chesterville		17. Date(s) or Period c. 1850	
9. Site Plan with North Arrow

17. Description of Environment and Outbuildings This house is located on a small lot quite close to Route 314. Other houses are nearby on either side. Shade trees and shrubbery adorn the property. A new rail fence is located in front of the house.		28. No. of Stories 2

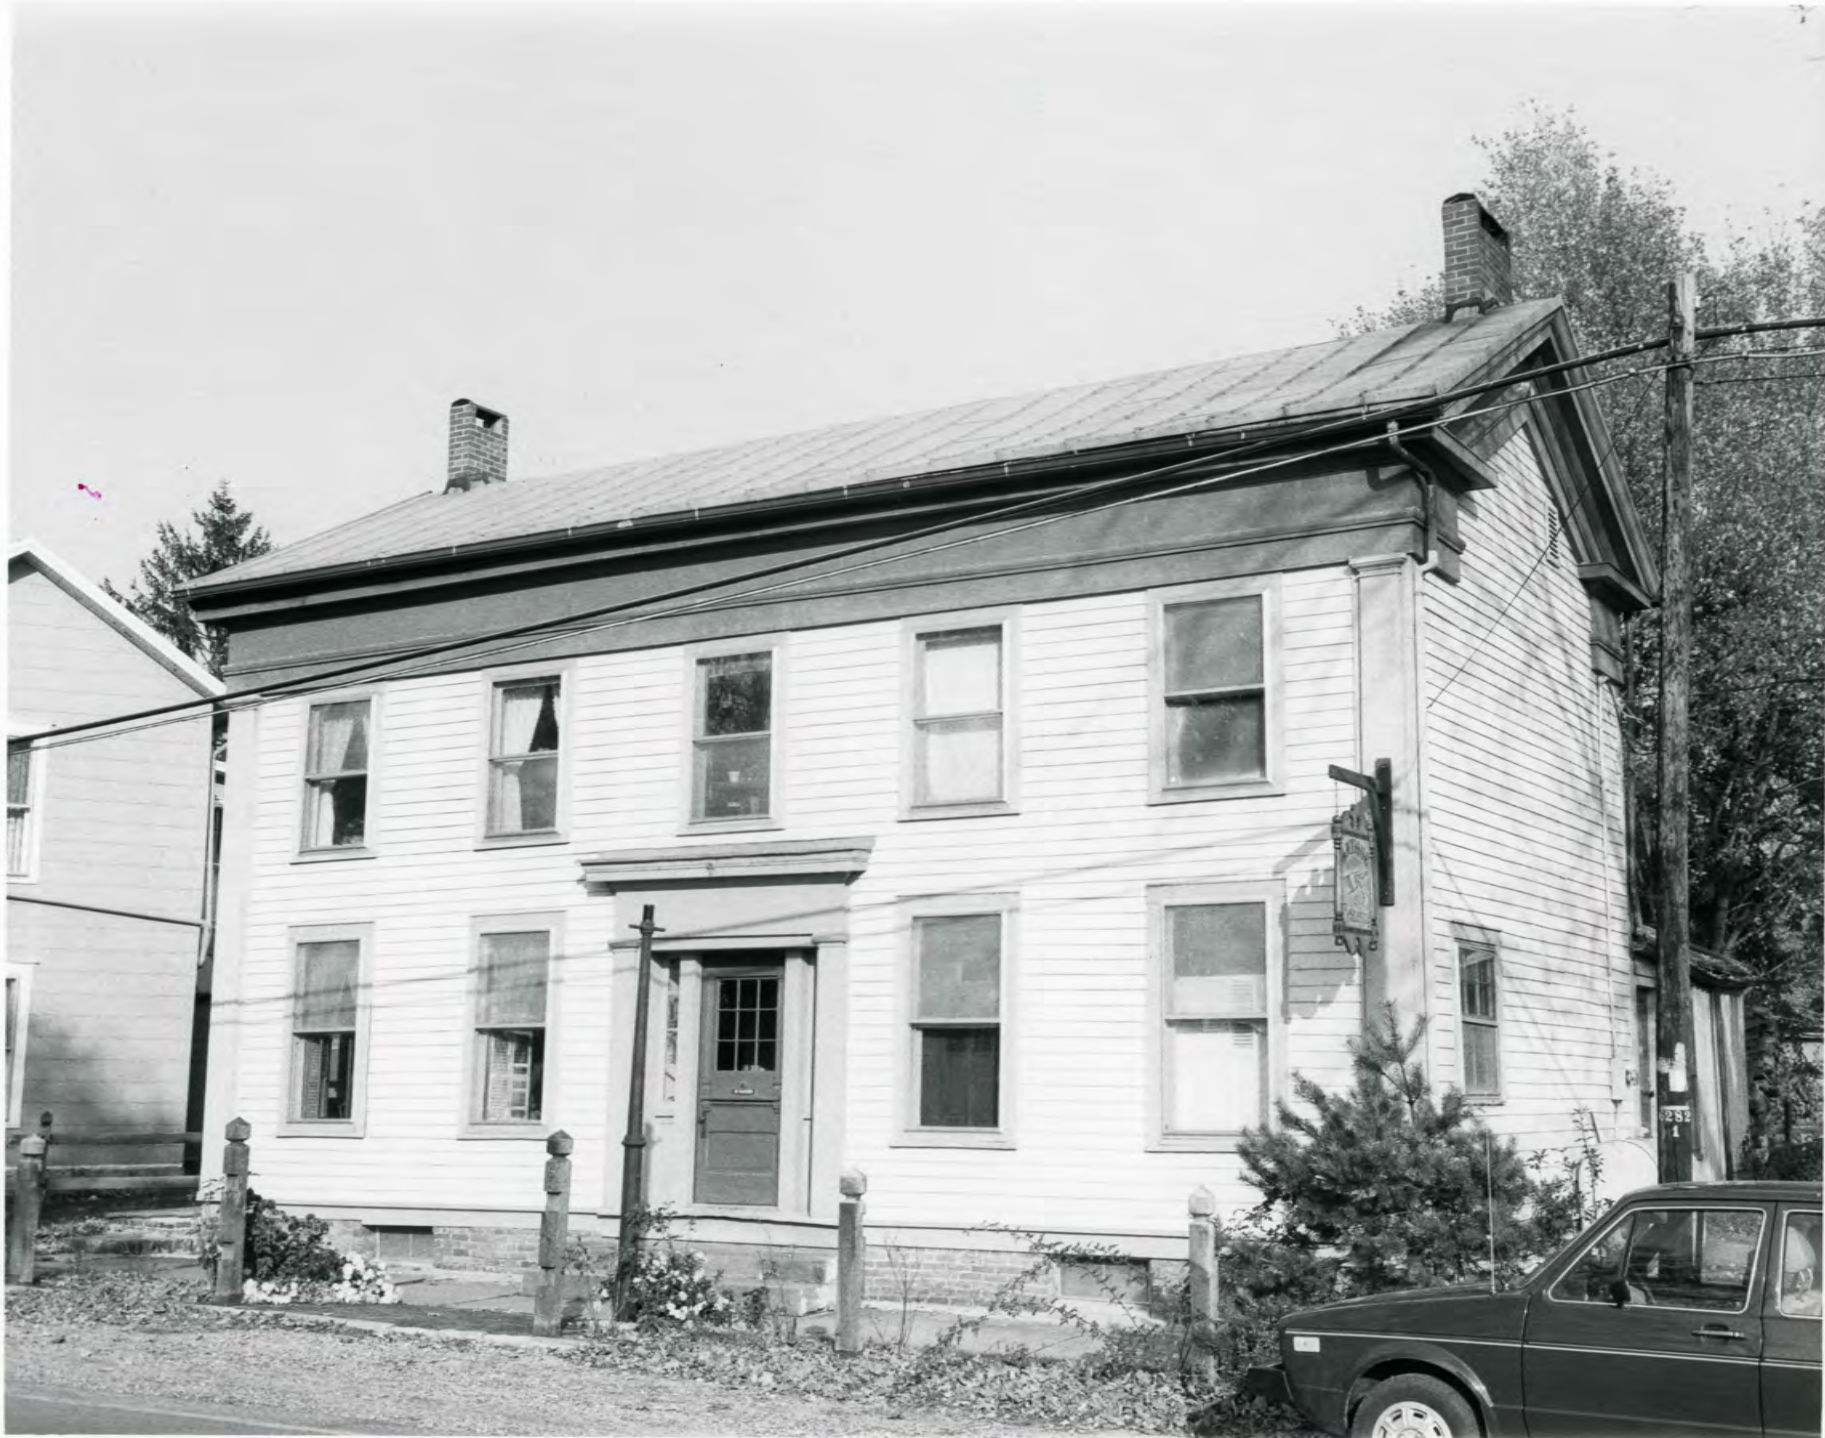
15. Further Description of Important Features This large Greek Revival house is five bays wide and a full two stories in height. Among its distinctive features is the elaborate front entranceway enframed by pilasters and a cornice, and the massive entablature at the eaves which has partial returns on both ends. The house is relatively narrow and has only one window on each side. To the rear is a long one story wing. Northern half of Lot 7 and southern half of Lot 16. Less than one acre.		26. Local Contact Person or Organization Chester Community Concerns
