KENTUCKY HISTORIC RESOURCES
Individual Inventory Form

Resource # KE-B-1
KENTON County

1. Name of Resource:
Prettyman Merry House

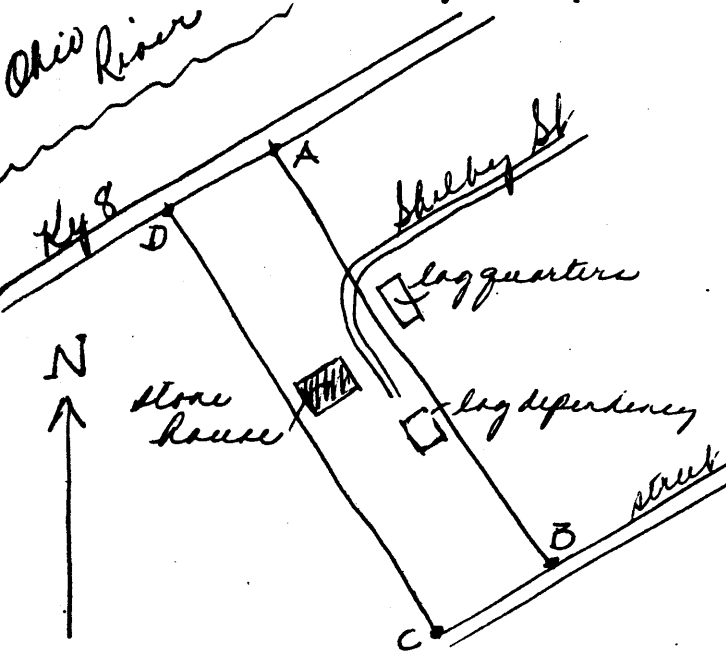
Site enclosed by A-B-C-D as shown. Includes stone house and log dependency. Quarters are altered and outside property line. A-B-C-D is present property line. B-A is on Ky. 8. The house is contributing. The log dependency is not.
