Town Burlington 017Address 12 Lexington Street  
(corner Lexington, Bedford Sts)

Historic Name Meeting House of Second  
Parish in Woburn (now United Church  
of Christ Congregational)

# INVENTORY FORM CONTINUATION SHEET

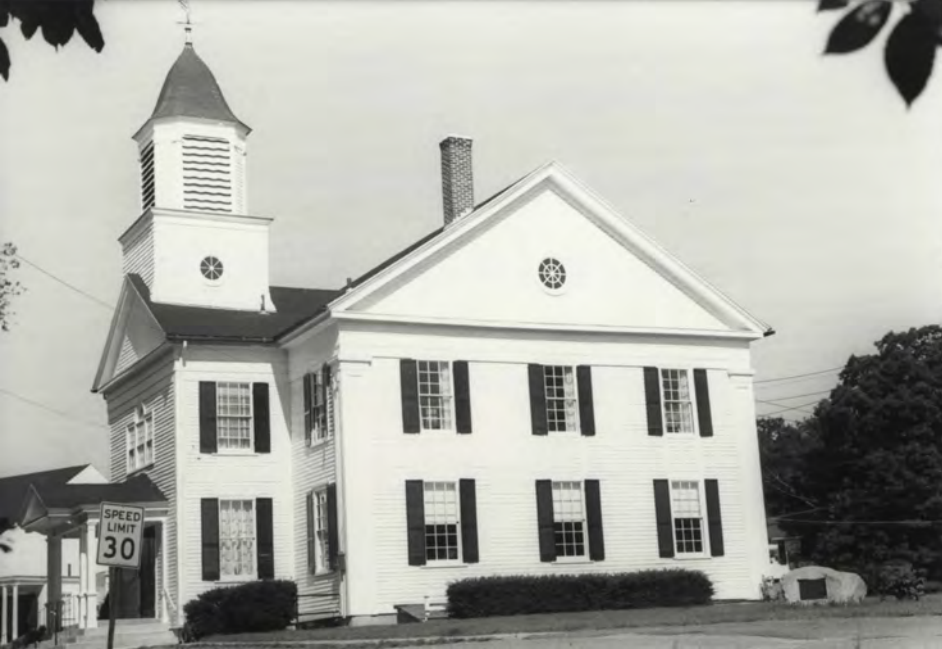
15-18

A Greek Revival remodeling in 1844 entailed the addition of a steeple and entrance on the end. The entrance featured Doric columns in antis. Further remodeling in 1885 included the removal of the steeple and construction on the south side of the present entry pavilion with shorter bell tower.

Burlington, MA  
Meeting House

(United Church of Christ)

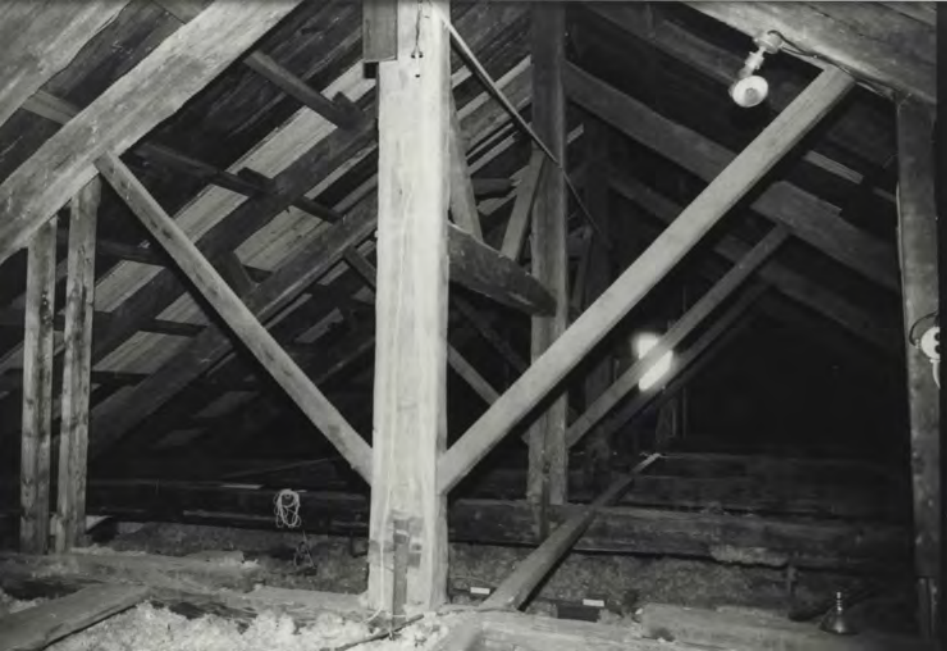
15-8

The framing of the roof visible in the attic is composed of cambered tie beams supported from the side posts by curved braces, double rafters with struts between them, king post, diagonal struts from the king posts and rafters, common purlins, and axial bracing. The axial bracing consists of horizontal beams running between king posts at the level of a collar purlin, diagonal braces rising from the horizontal beams to the king posts, and slim framing members just north of the king posts which are dovetail jointed down the center of the structure into successive tie beams.

Meetinghouse Roof  
(United Church of Christ)

The current ceiling is a dropped, coved ceiling. Evidence indicates, however, that originally the lower part of the tie beams, the side post and the curved braces were exposed. All have flat chamfers and are heavily whiter washed. Joist pockets located part way up the sides of the tie beams may indicate the level of an original plaster

ceiling, for the joists would have provided a framework upon which to nail lath. The joist pockets (joists are now removed) on the east face of the tie beams are small and rectangular; on the west face they are long slots. Apparently this arrangement allowed joists to be slipped in place after the major framing was up.

Stud mortices in the next from the westernmost tie beam indicate the location of the original west end wall. The westernmost bay, with heavy framing to support a steeple, was added in 1844.

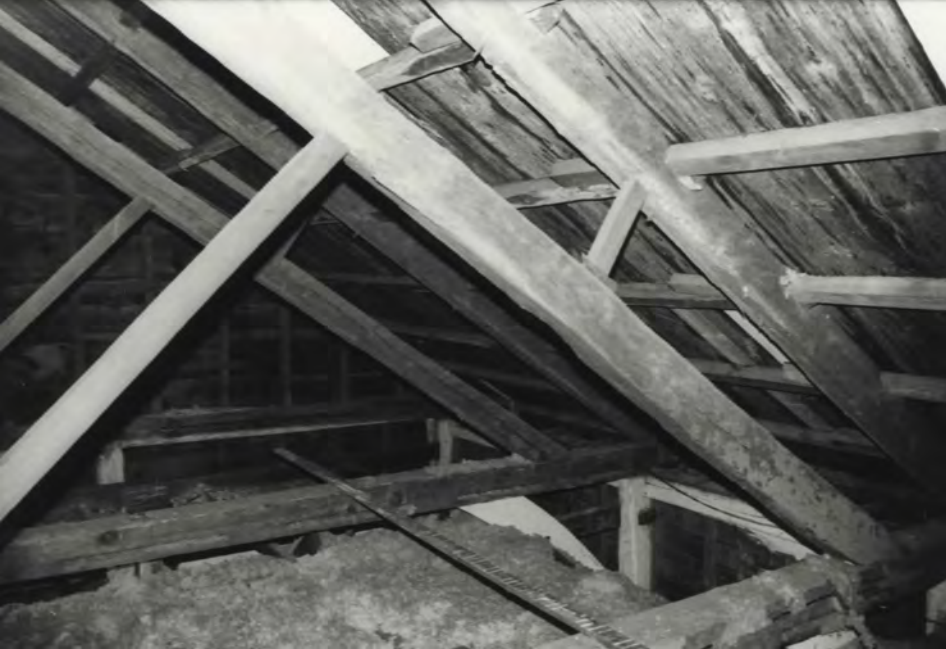
Burlington, MA 15-9

Meetinghouse roof  
(United Church of Christ)
