**NATIONAL REGISTER OF HISTORIC PLACES  
INVENTORY - NOMINATION FORM**

COMMON:  
Augustine Beach Hotel  
AND/OR HISTORIC:

Historic name: Augustine Beach Hotel AMENDED – Additional Documentation  
Other names/site number: DE CRS# N00150, Augustine Inn, The Piers - NR ID# 73000537  
Name of related multiple property listing:

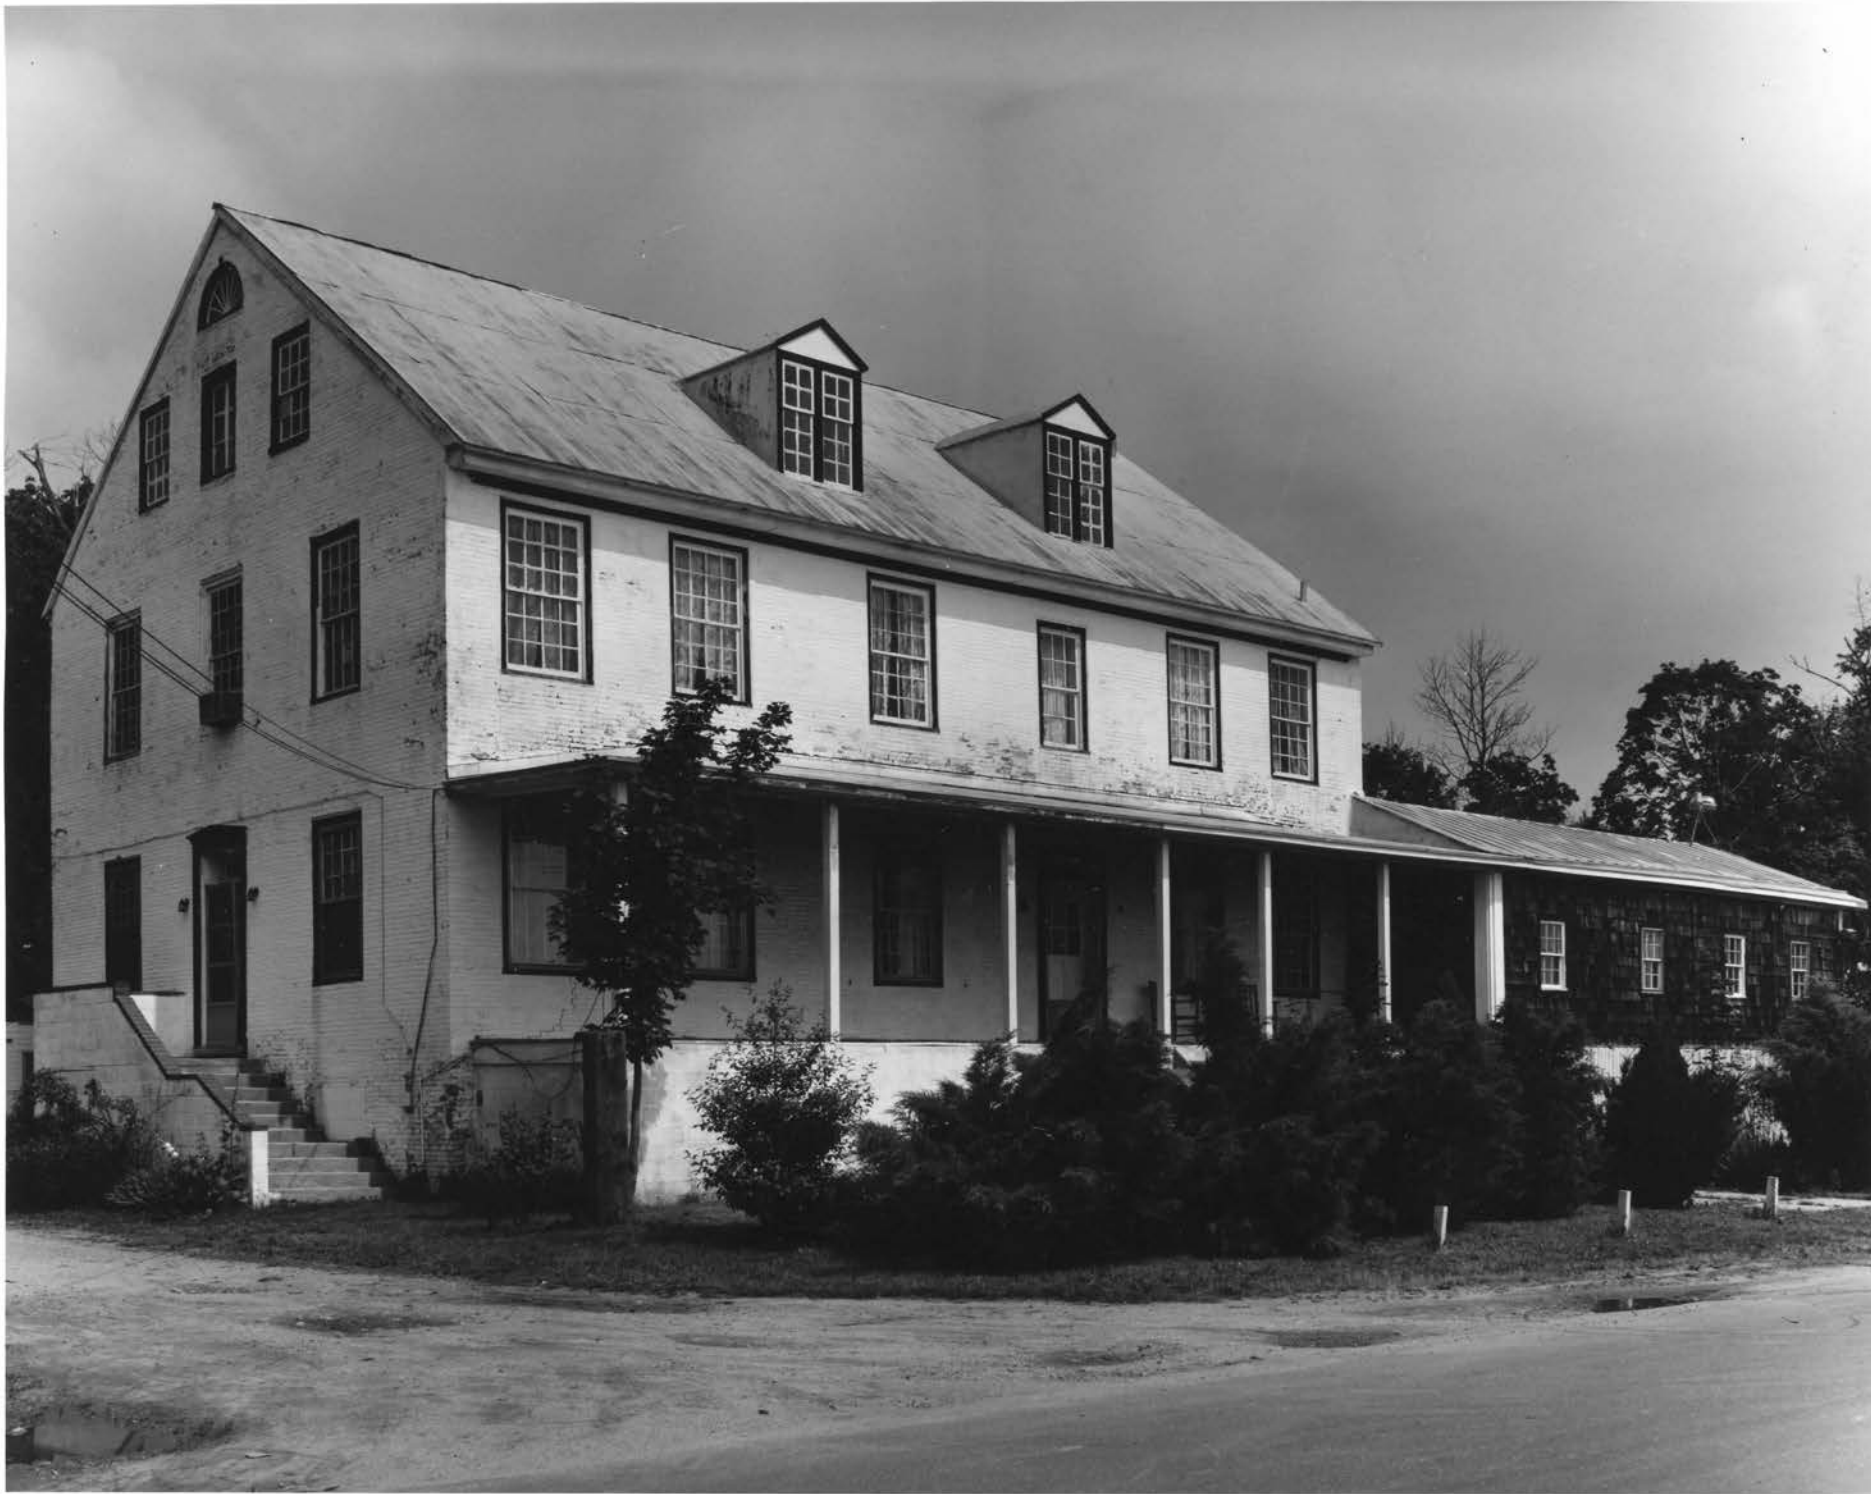
①

*Augustine Beach Hotel; front from the east.*

SIDE VIEW FROM NORTH

The east, or front, facade of the brick Augustine Beach Hotel is composed of six bays laid in Flemish bond. The entry is located in the right center bay and is covered, as is the rest of the first floor, by a hip-roofed porch extending along the front facade. Two dormers pierce the roof, and a chimney is located on the ridge line between the two south bays.

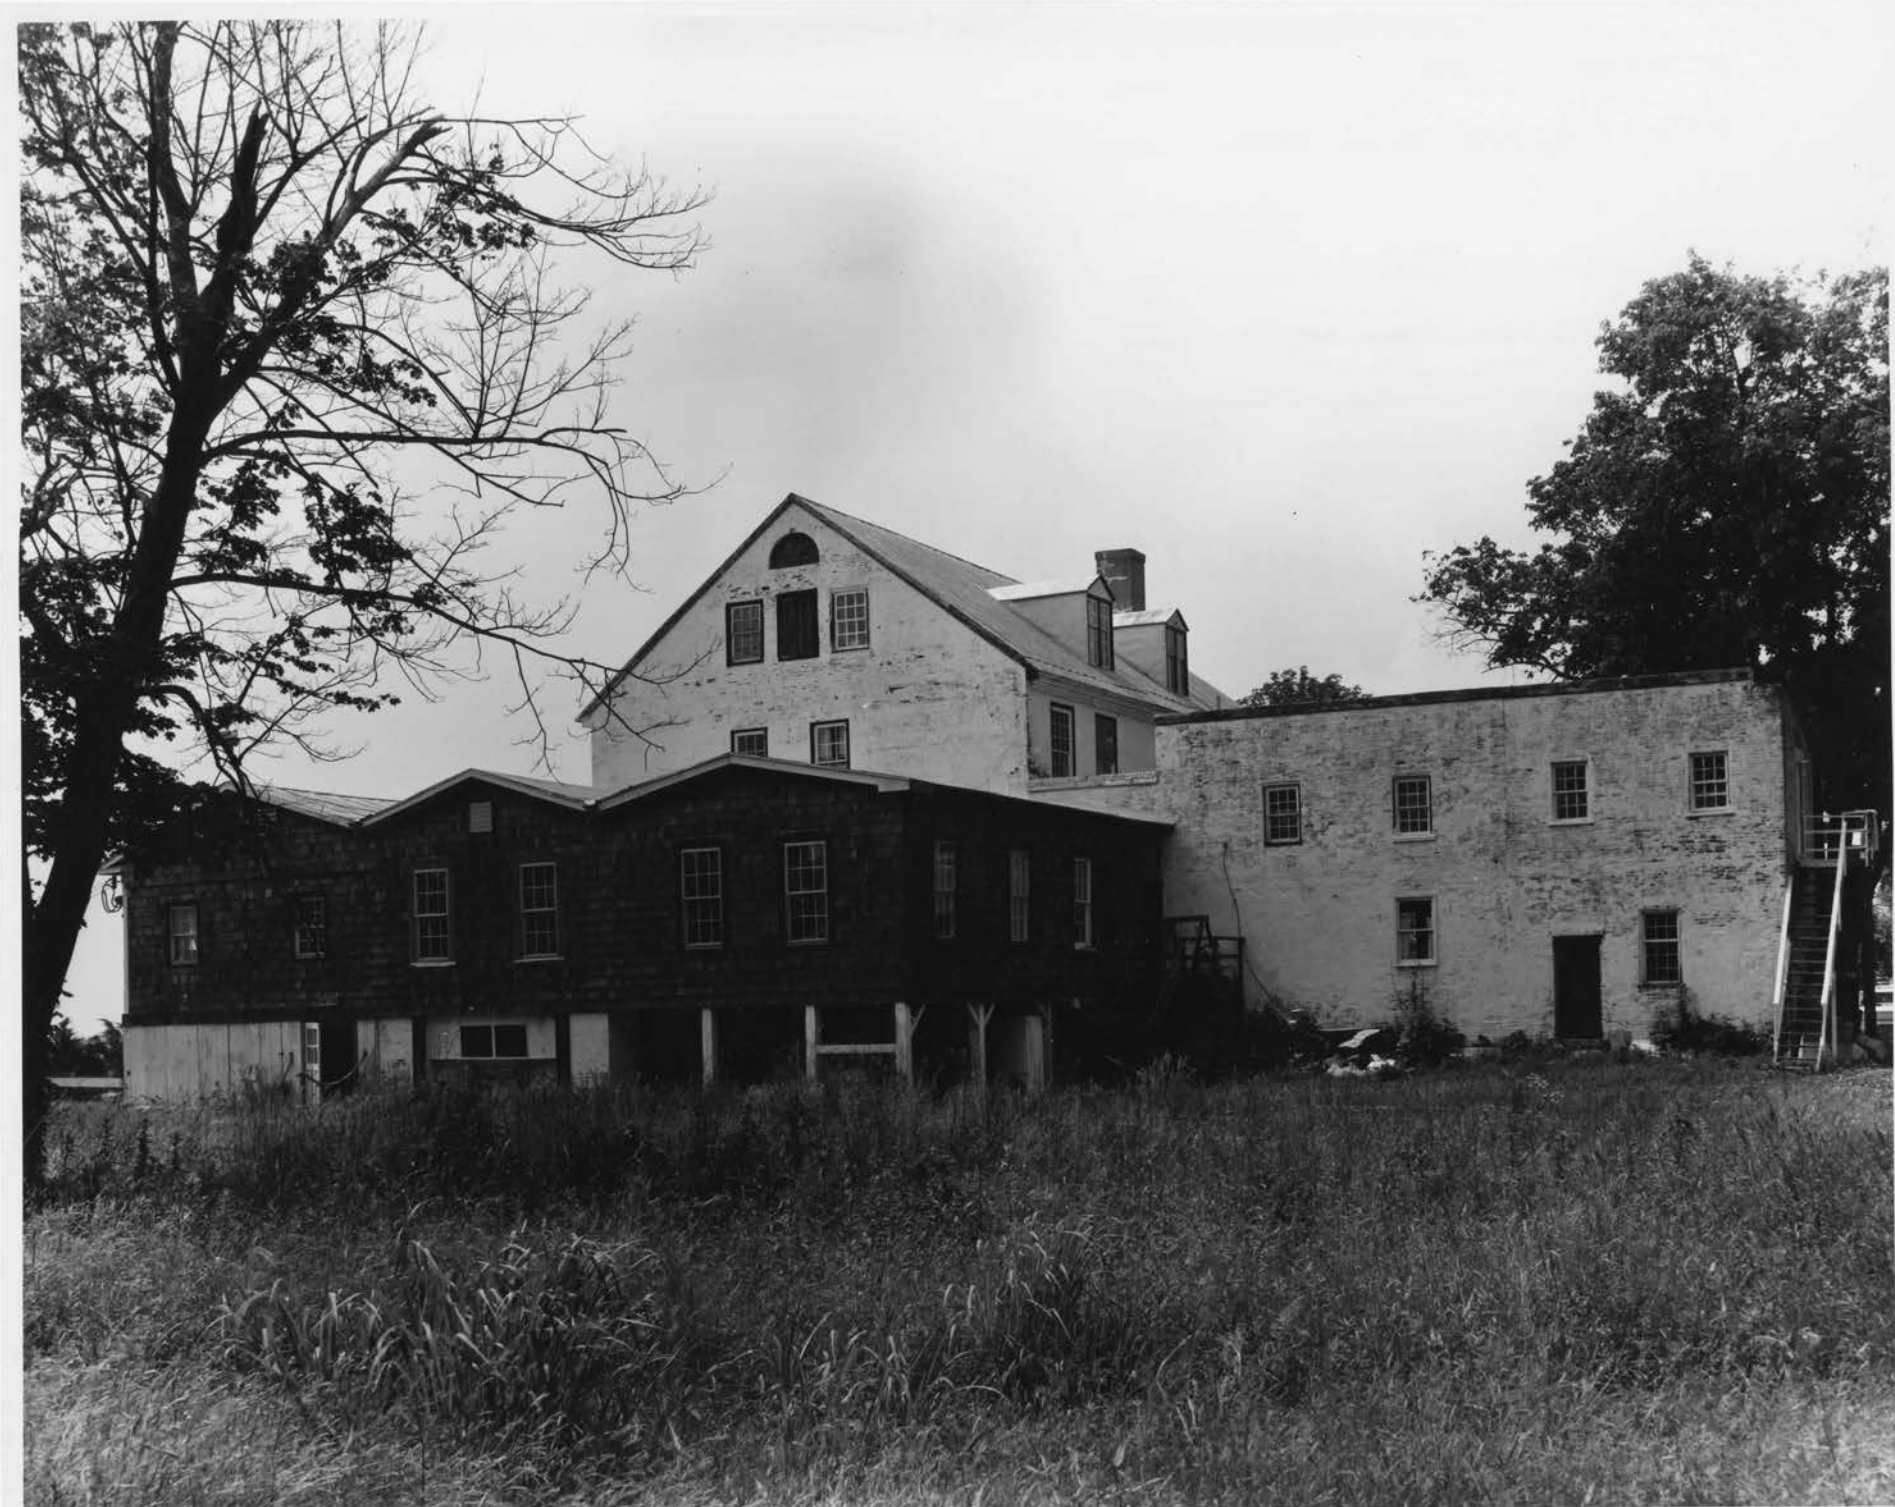
②

*Augustine Beach Hotel; side, from north.*

Side view from the north.

To the common-bond north facade a lower frame structure has been added, extending the porch line of the east facade. The north facade of the addition is composed of three low-pitch gables.

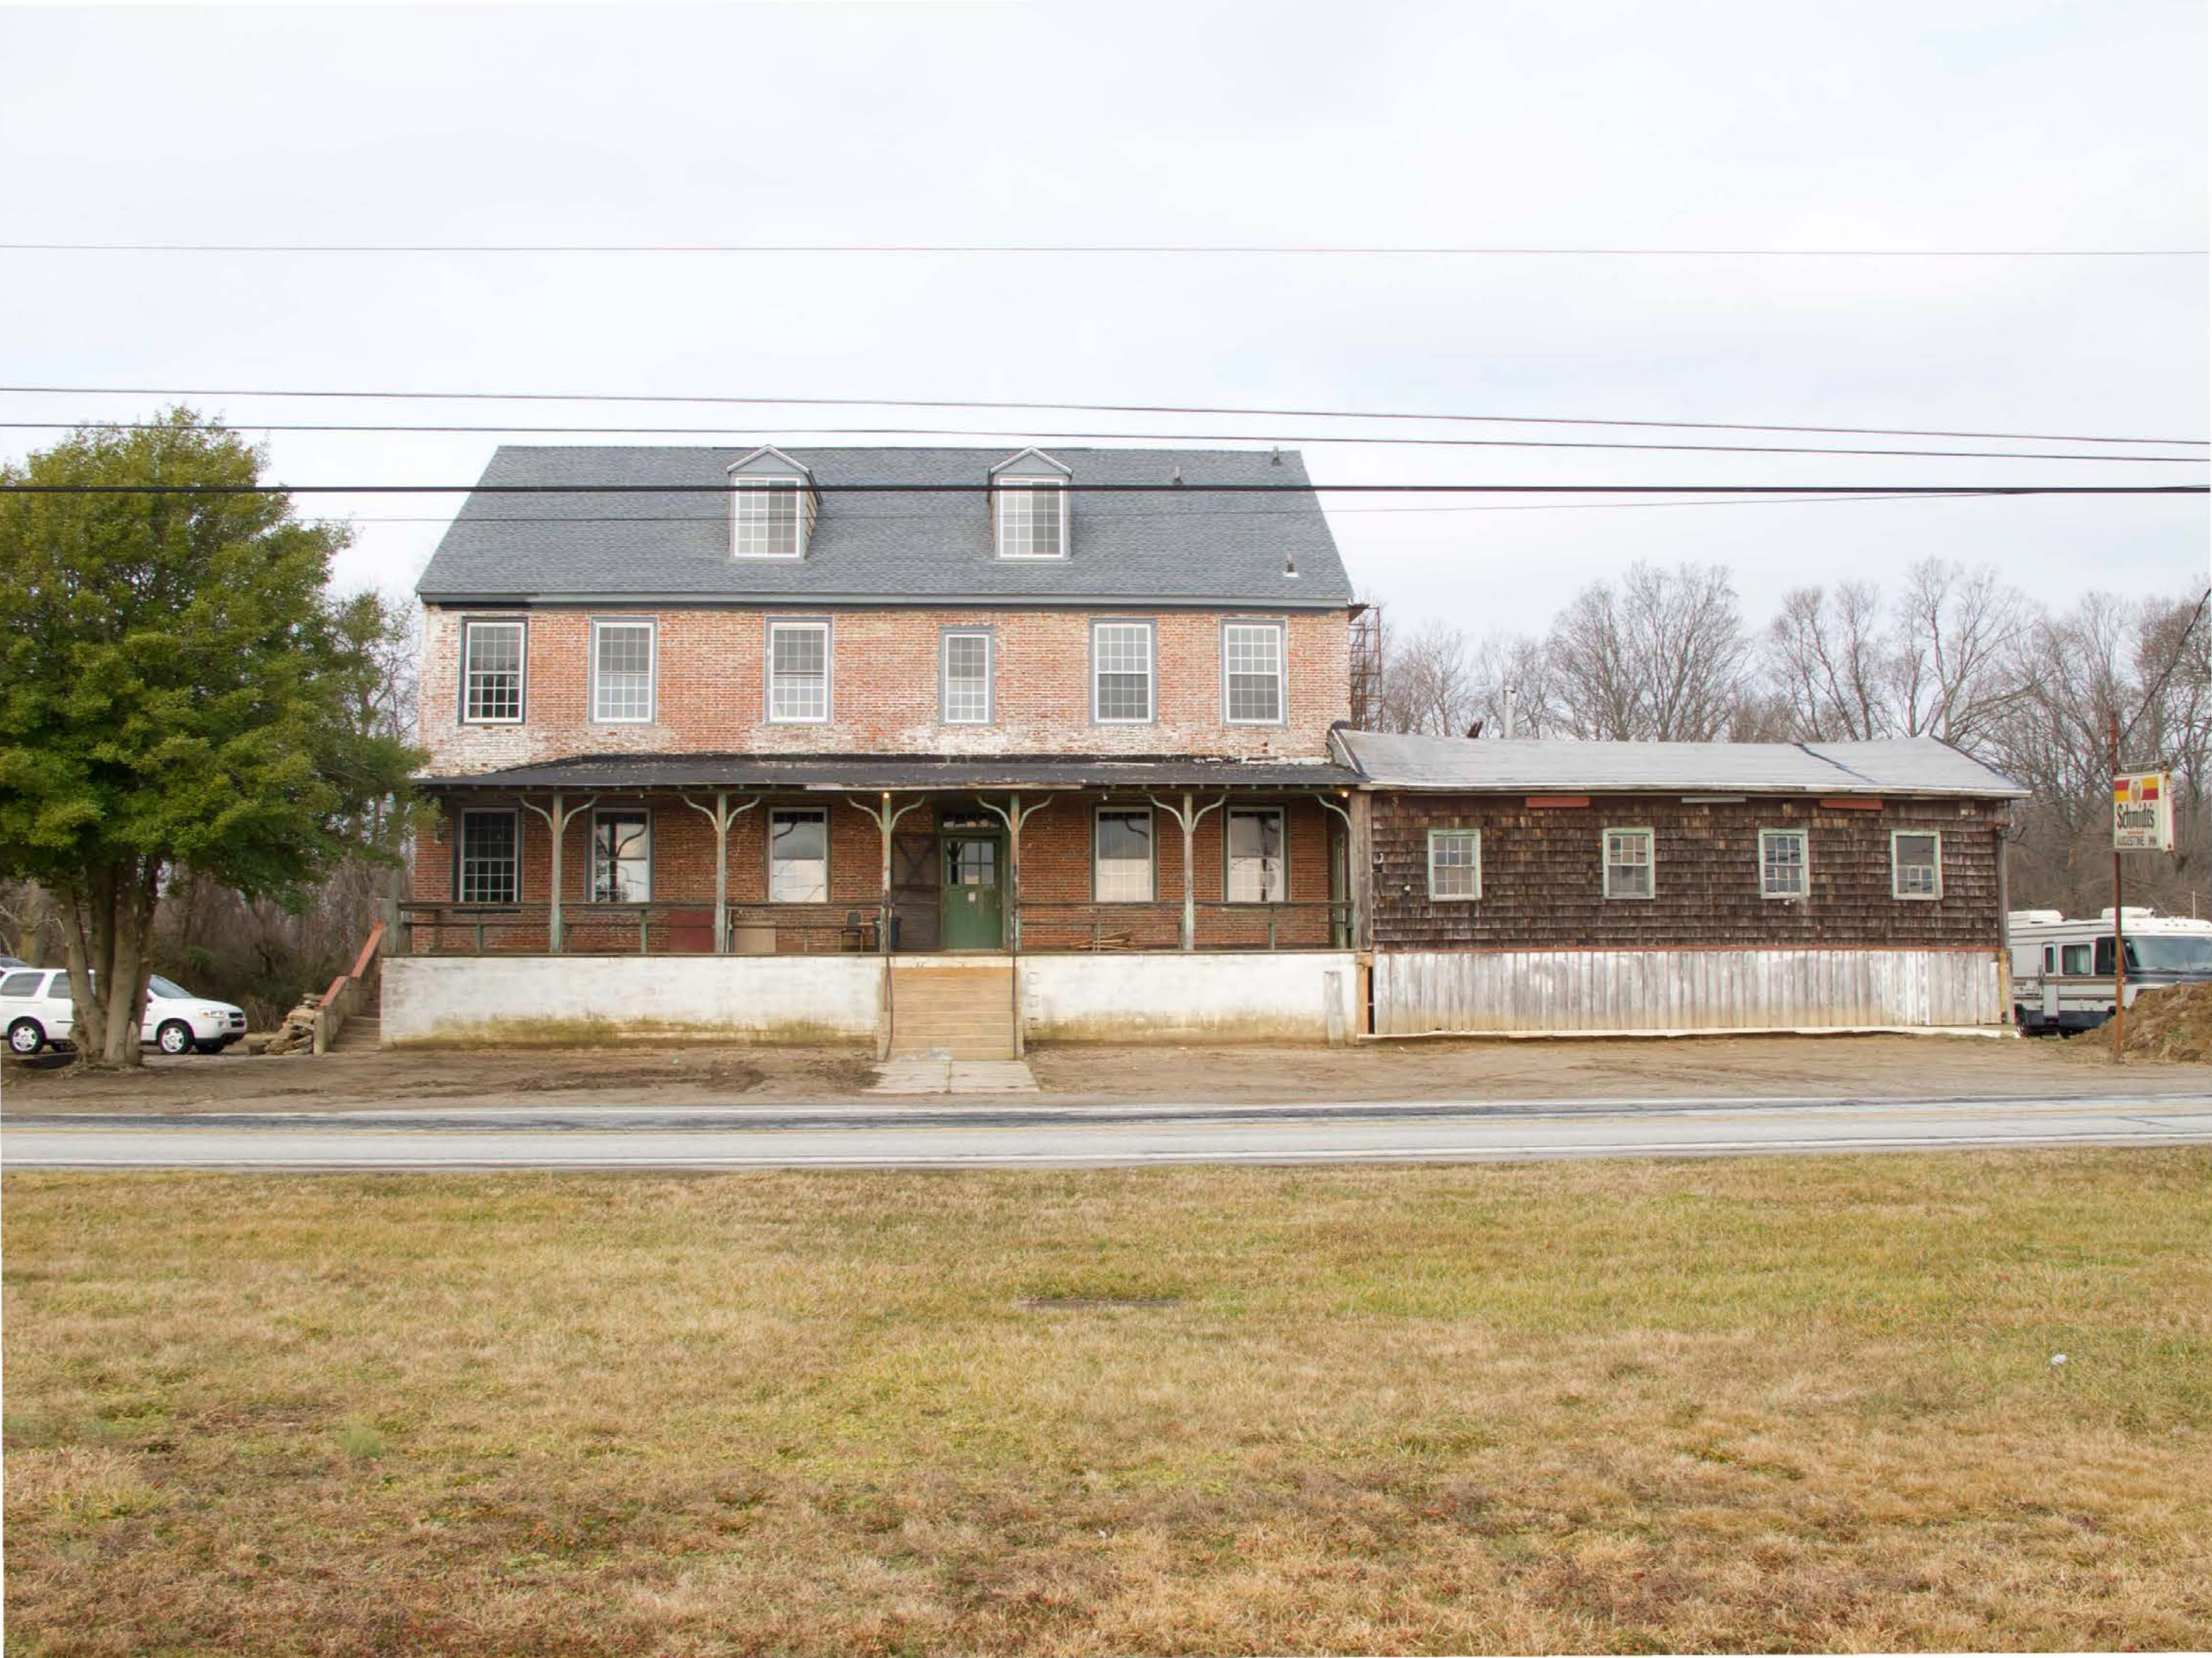
The main building is a two-story brick structure with a grey gabled roof. It features two dormer windows on the roof. The second floor has six windows, and the first floor has a porch with a white railing and a green door. To the right, a smaller wooden structure with a grey roof and a corrugated metal base is attached to the main building.
