National Register of Historic Places  
Inventory—Nomination Form

historic Old Santa Rosa Catholic Church and Cemetery

city, town Cambria N/A vicinity of

state California code 06 county San Luis Obispo code 079

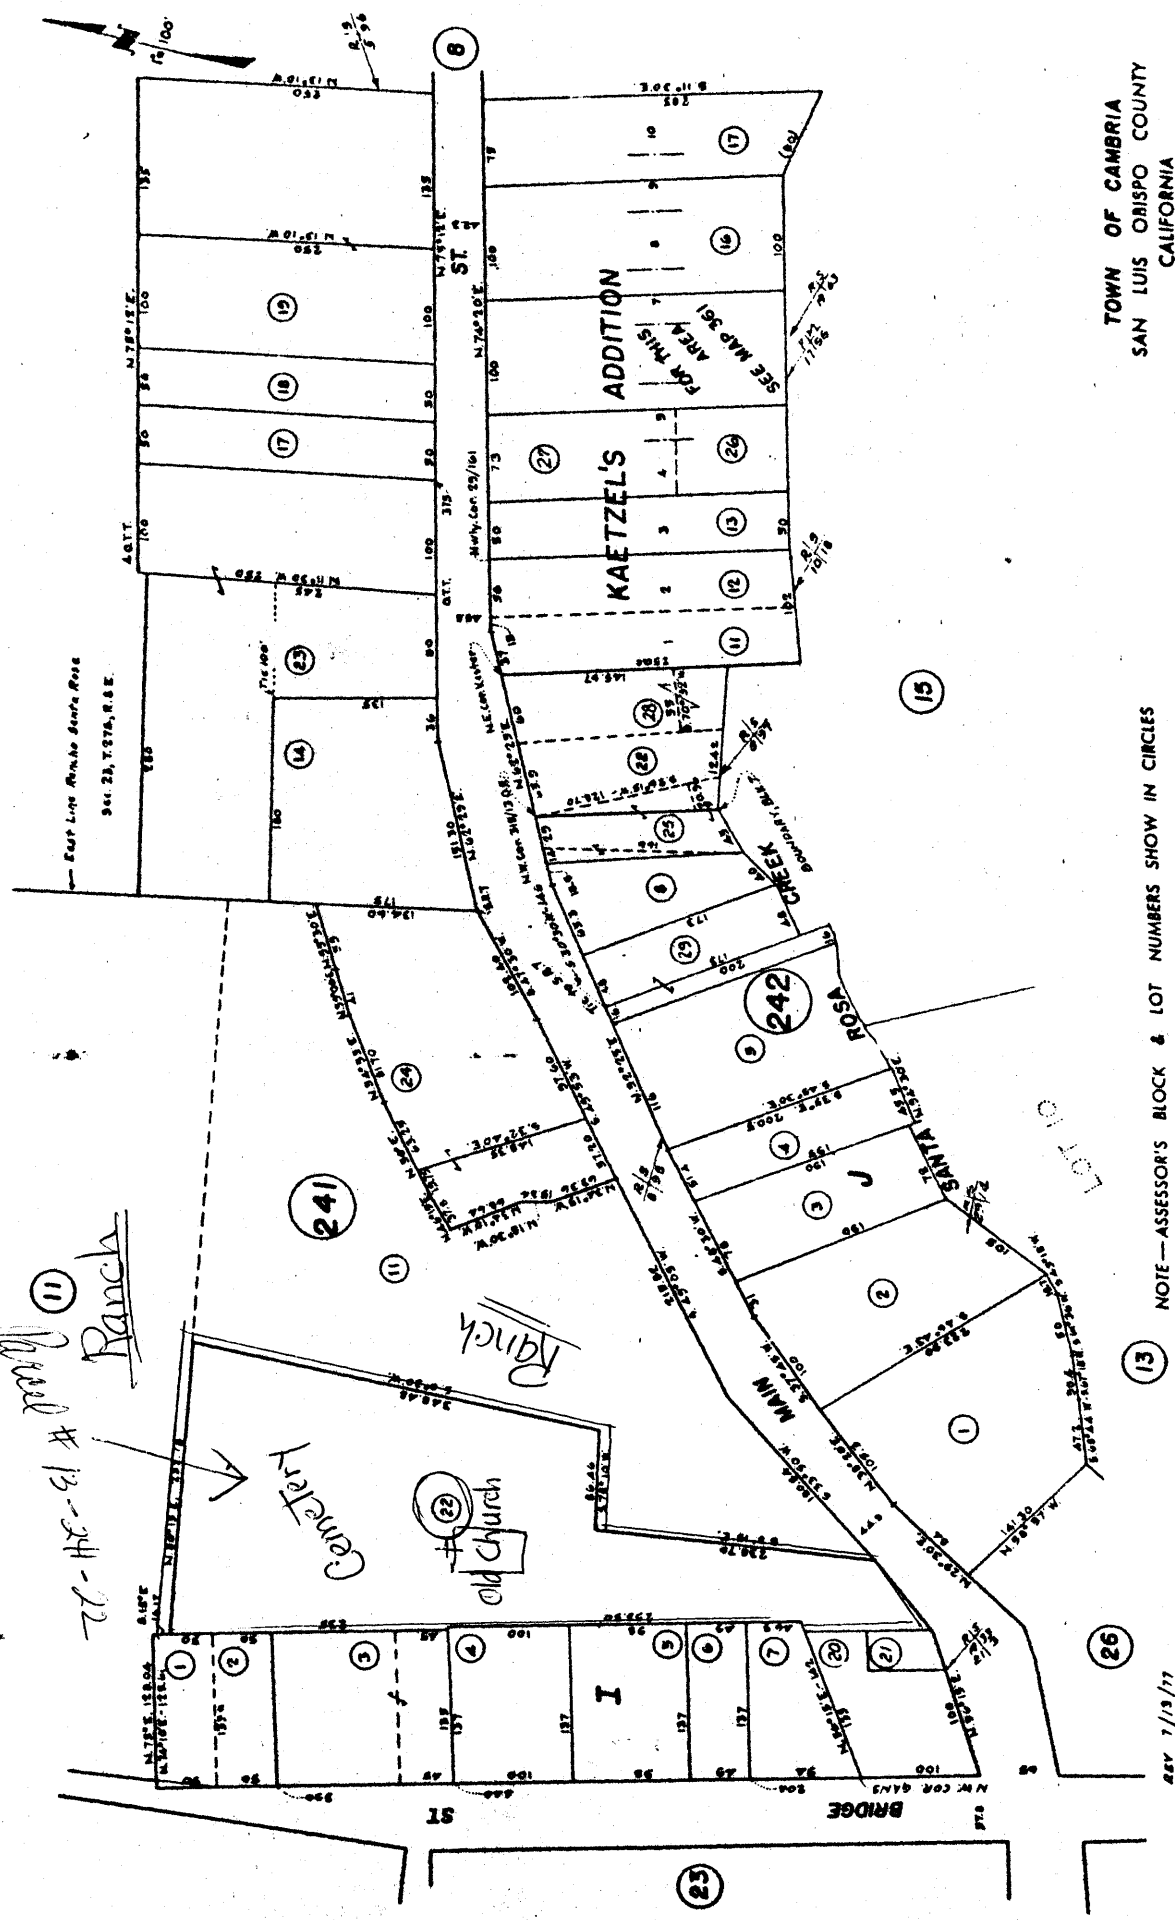
TAX AREA CODE NO. 13-24

Church building and cemetery occupy original site. North and east perimeter bounded by Phelan Ranch, west perimeter by rear lines of lots facing on Bridge St., and south by Main Street as shown on attached assessor's map.

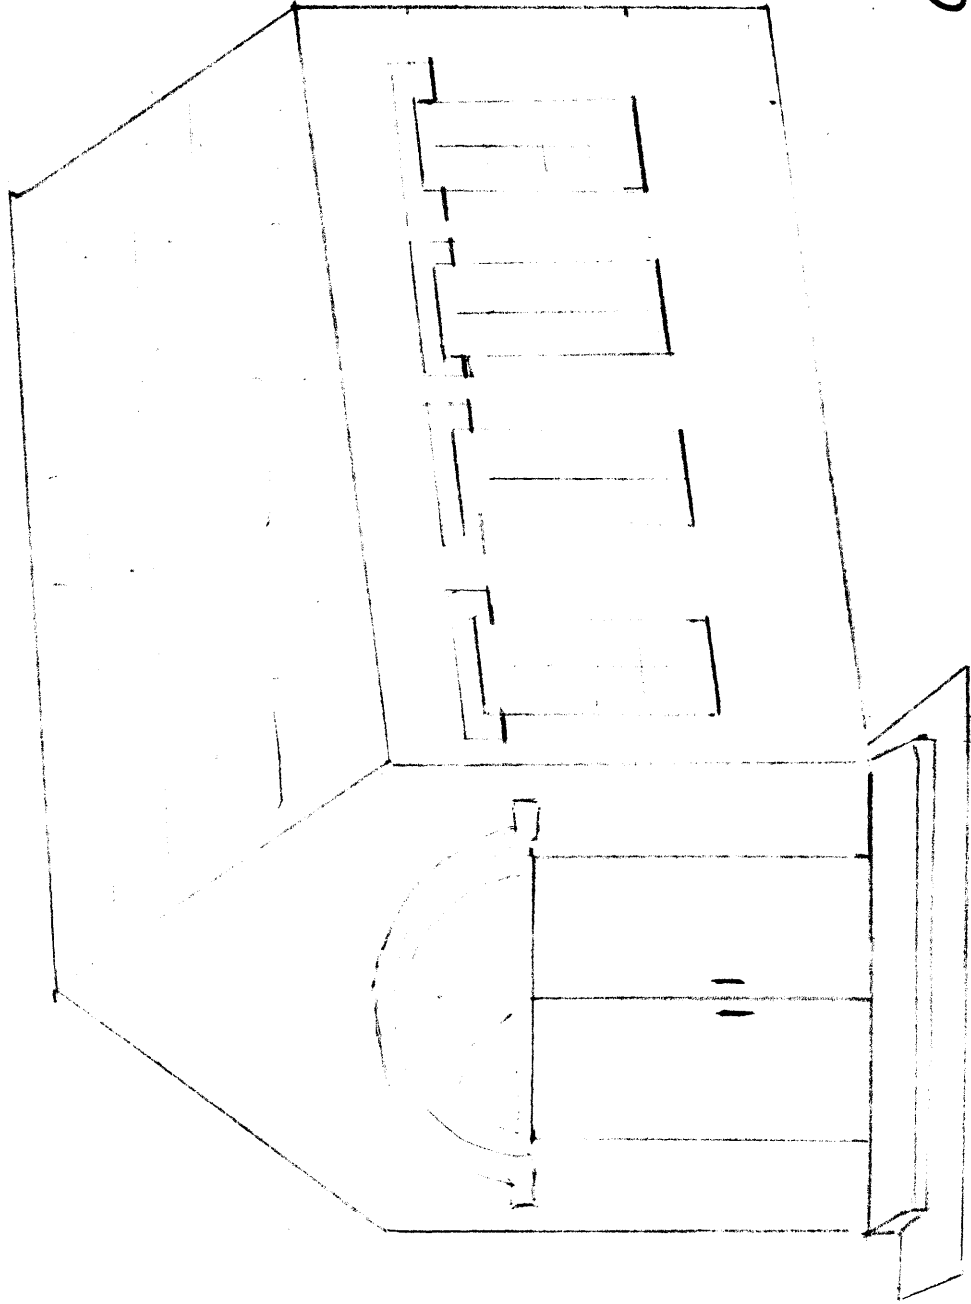
Old Santa Rosa  
Catholic Church &  
Cemetery  
San Luis Obispo Co.,  
California

$\frac{1}{4}'' = 2\frac{1}{2}'$

The church is a simple, rectangular wooden building with a medium gable roof with wooden shingles covered by composition roofing. This one-room country church is built of pine, with three-clapboard exterior siding. Detailing is based on Classical design sources popular at the time of construction. The building is symmetrical in composition. The south-facing facade is dominated by the centrally placed entrance. The entrance is a large round-headed arch which encloses two four-paneled doors with a semi-circular fanlight above. Doorway surroundings are simple, and the arch is capped by curved drip molding. Above the entrance the facade rises to its apex in a medium gable with boxed cornice and simple frieze. The corners of the building are marked by end boards. There are no windows or porch on this elevation.

The sides of the building are also symmetrical. The west elevation contains four simple rectangular windows with squared hood moldings. The simple frieze and boxed cornice are repeated at the eaves, and endboards terminate the design at each end. The east elevation is identical, with the addition of a small doorway at the right end, and an exterior metal chimney at the left.
