NATIONAL REGISTER OF HISTORIC PLACES  
REGISTRATION FORM

Historic Name: Willett House

Street & Number: 6563 Mount Holly Road

City/Town: Lisbon Not for Publication: N/A

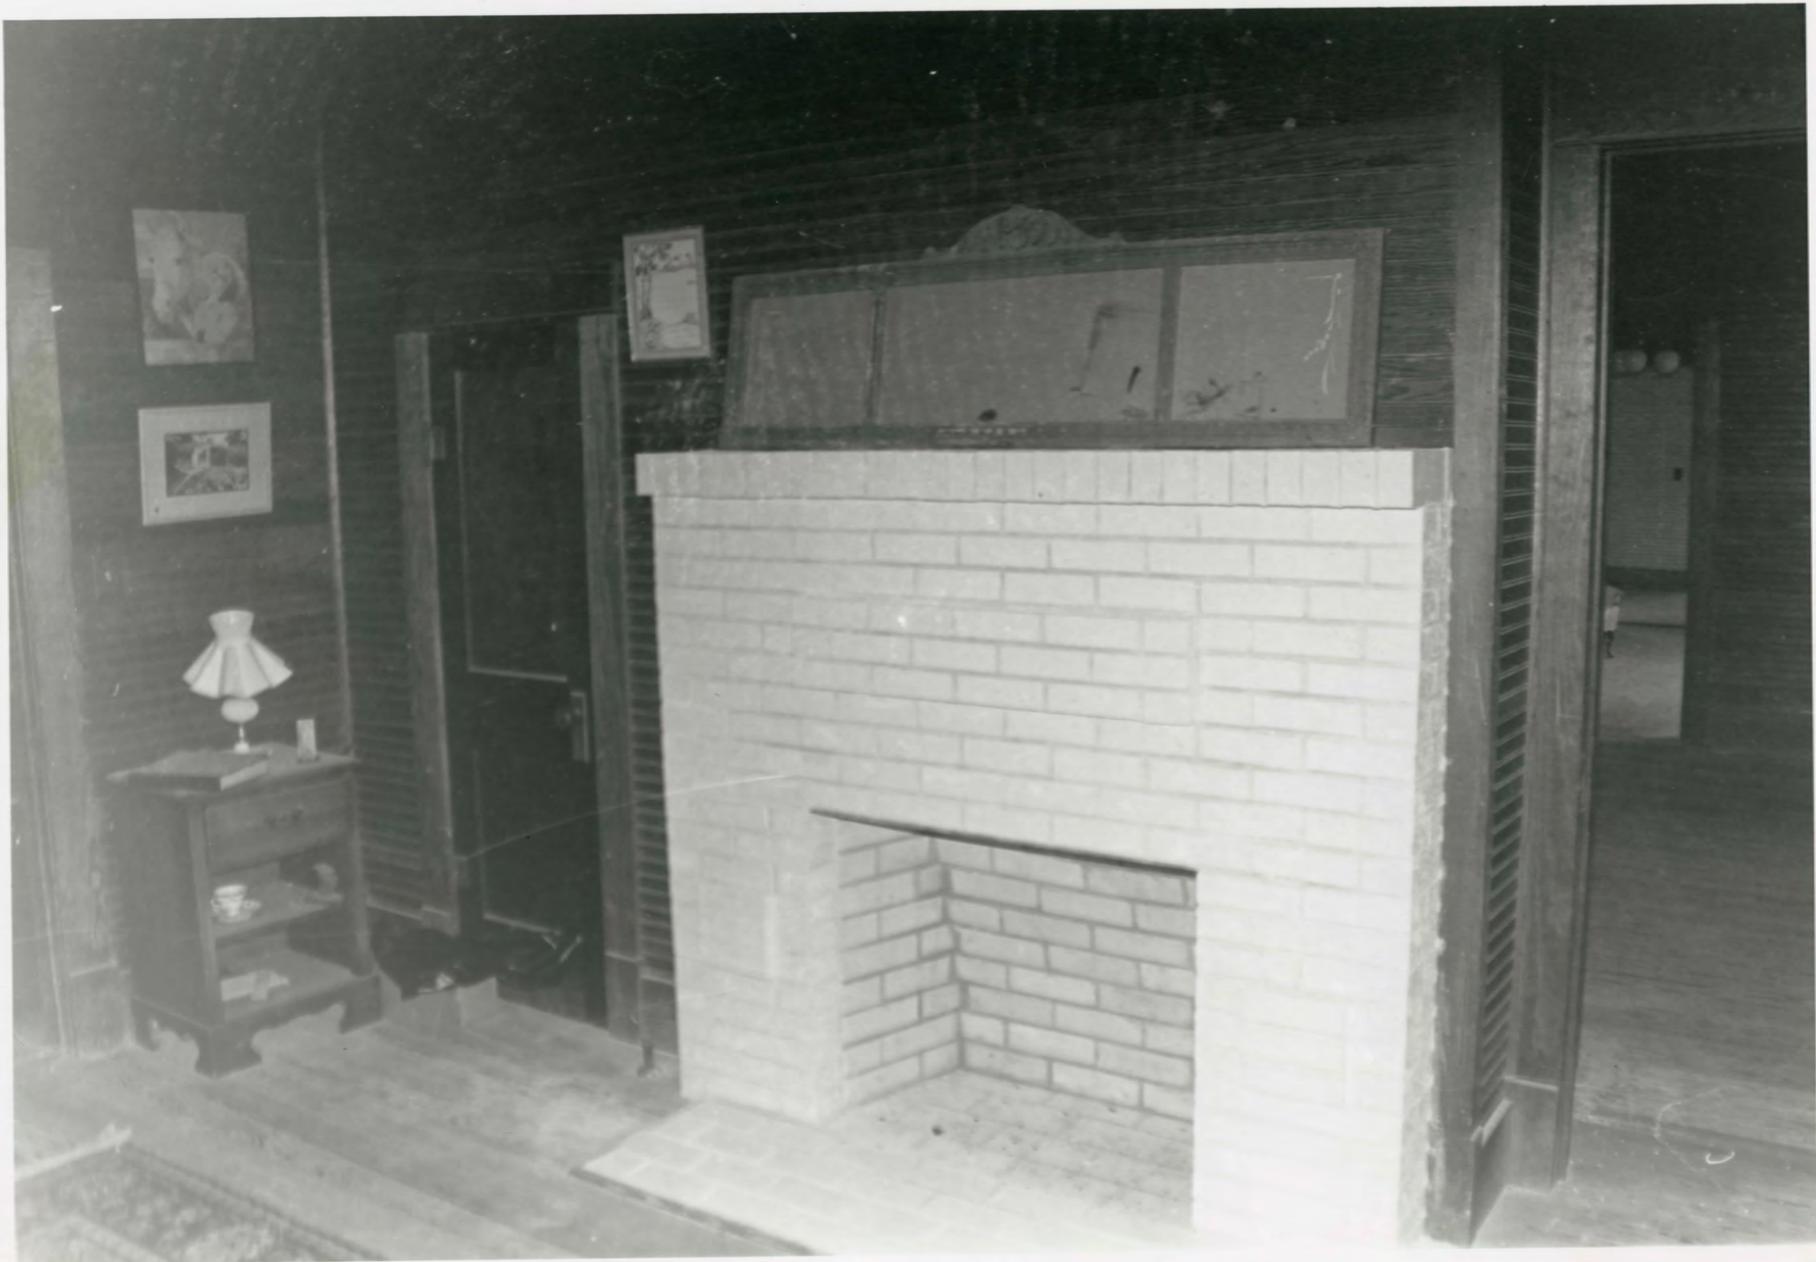
VIEW OF FIREPLACE IN NORTHWEST BEDROOM

The interior of the Willett House is largely original. The house features double beaded board paneling throughout most of the interior as well as the original wood floors. The original mantels on the west end of the interior have recently been restored. The house features fourteen foot ceilings in sections which helped to keep the house cool in the summer.

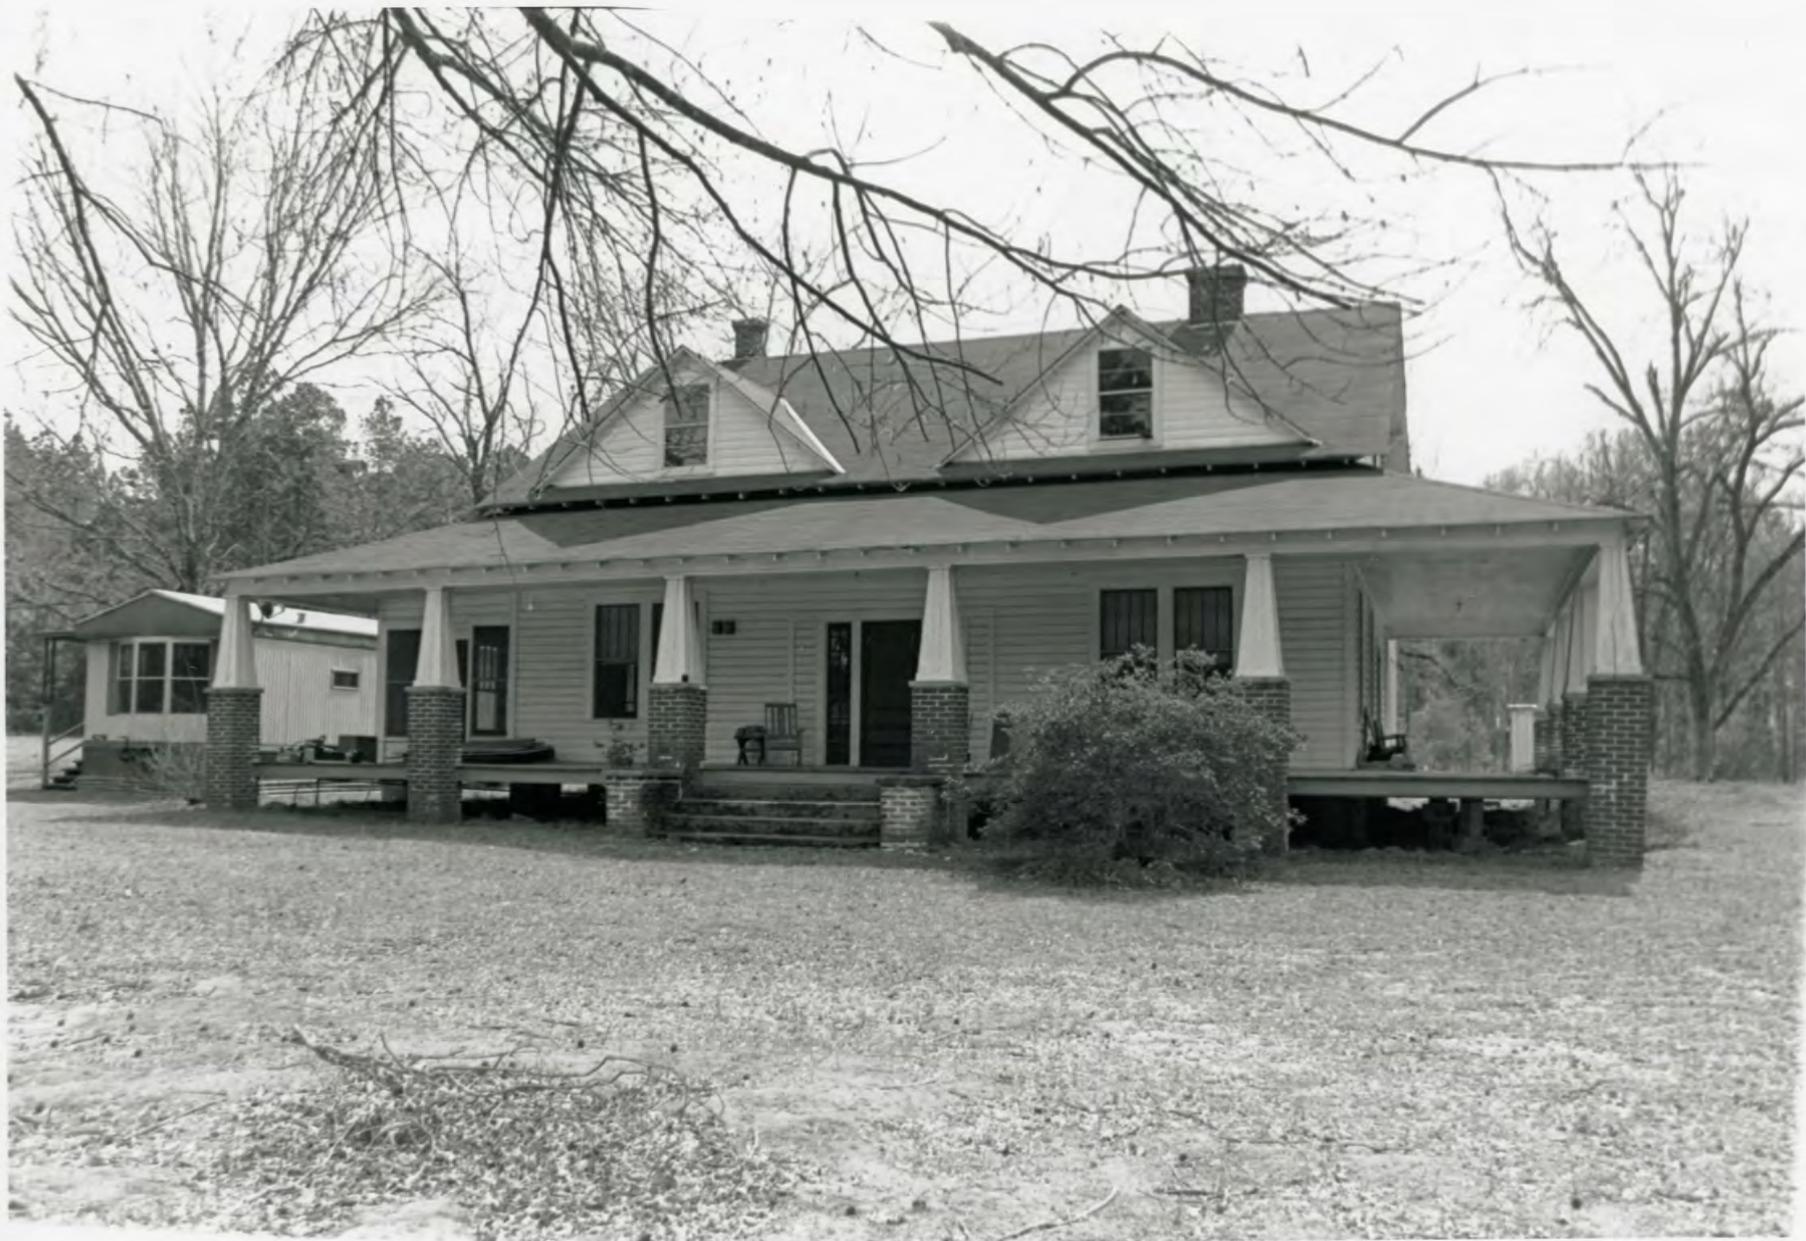
VIEW OF MAIN FACADE FROM THE NORTH.

The northern elevation is symmetrical in arrangement, with a wide hipped roof one-story porch supported by six battered wood columns on brick piers across the front, and three on each side. This porch wraps around three full sides of the structure, but was enclosed on the east elevation to create another living area for the family. The porch columns feature false decorative battens on each side which elevate this house above typical vernacular Craftsman construction. Other Craftsman elements on the house are the exposed rafter ends under the eaves, the four-over-one double-hung windows on all the elevations, and the triangular knee brackets which appear under the eaves on the three gable ends.

The northern elevation features two large gabled dormers which are symmetrically arranged on the facade and dominate the roof-line. Although the

dormers were original to the construction, the original windows were replaced with two-over-two double-hung windows. The owner plans to replace these windows with double-hung four-over-one windows as restoration on the property continues. On the first level of this elevation, a single-leaf, fully glazed multi-light door with sidelights is located at the center of the northern elevation. A stoop with five steps flanked by a low brick balustrade leads one up to this central entrance. A pair of windows are located on either side of the first floor of this elevation, and another single-leaf door with a single window on either side provides access to the porch enclosure on the east end of this elevation. All of the windows described here are double-hung four-over-one windows, and the windows are of the same configuration elsewhere on the Willett house unless stated otherwise.

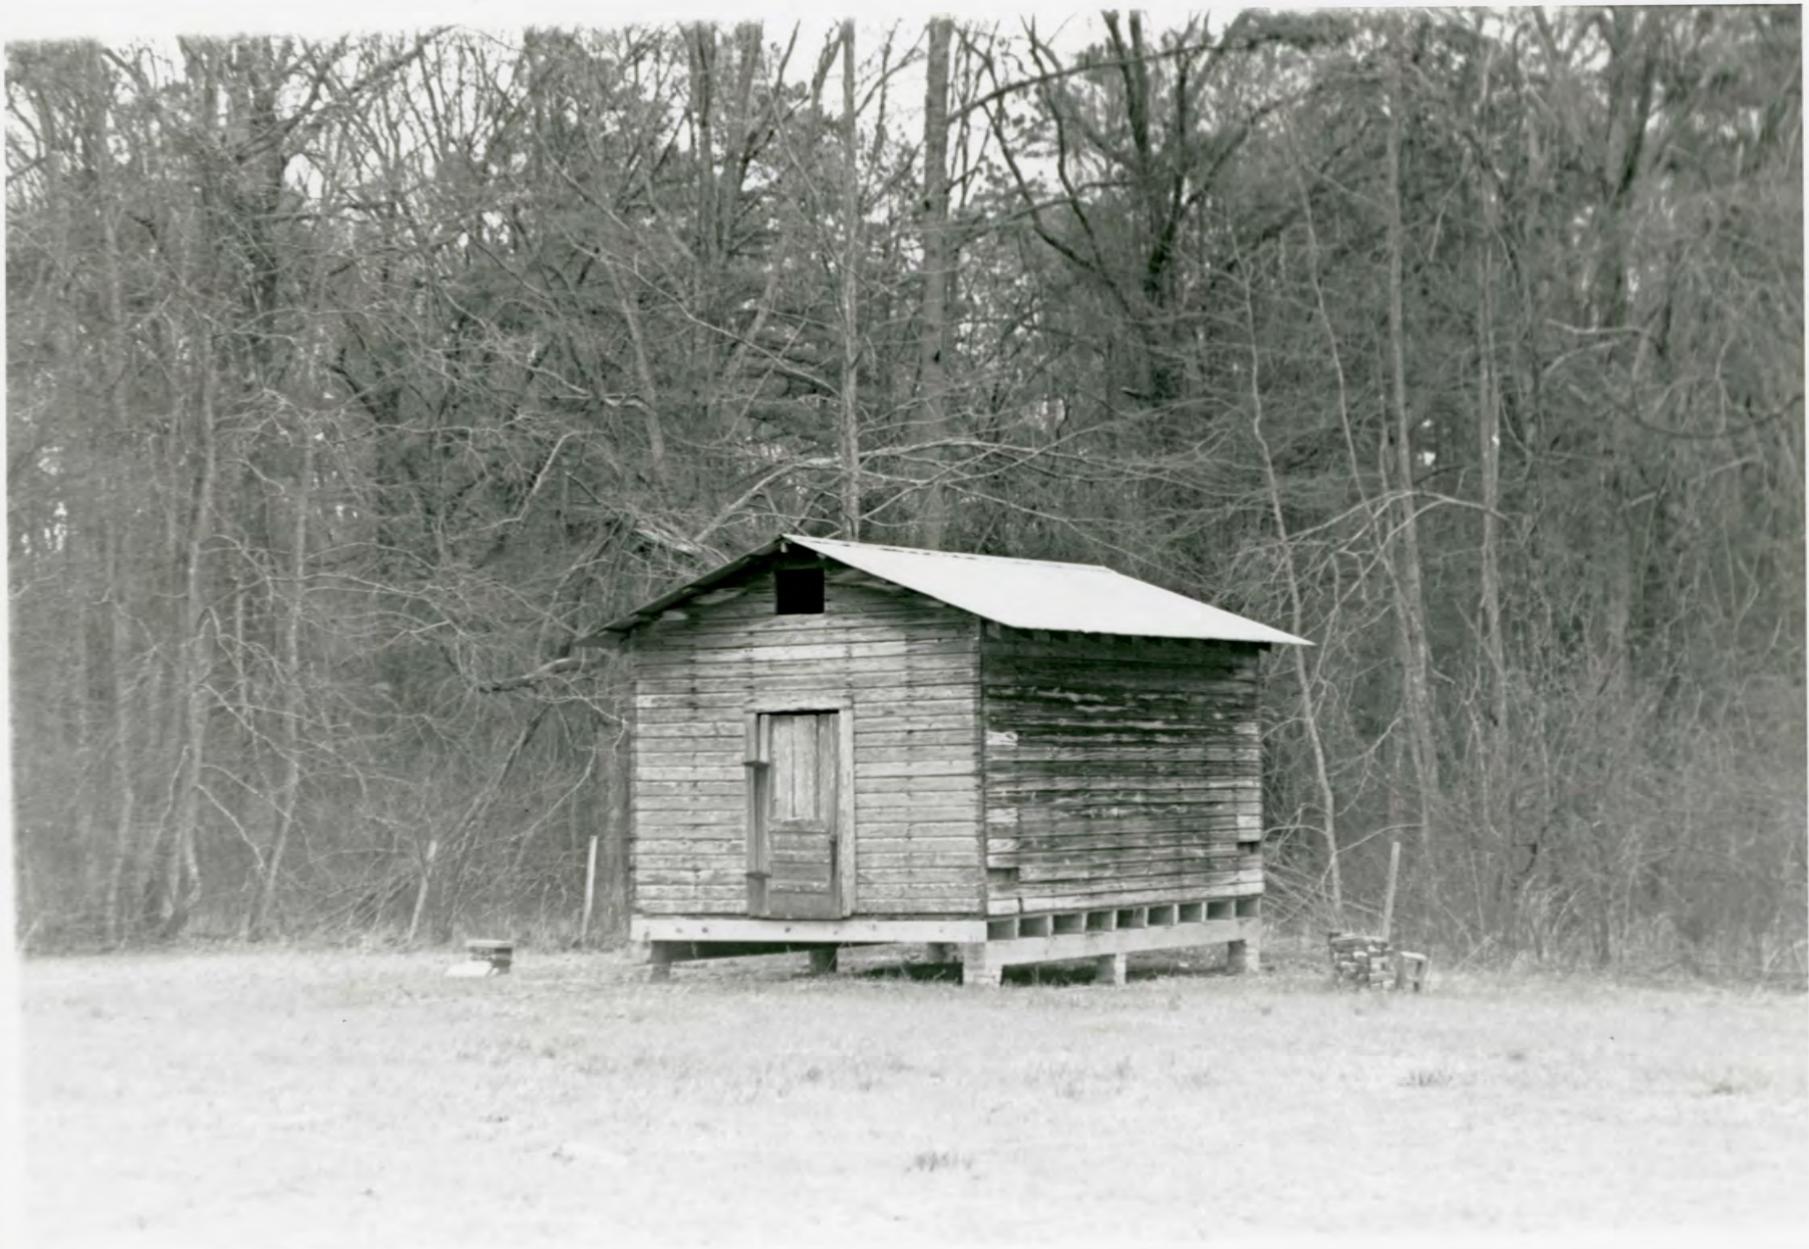
WILLET HOUSE (POTATO HOUSE)

PHOTO TAKEN FROM NORTHWEST

There are three other outbuildings which are located closer to the house. They are the potato house, the smokehouse, and a small utility building. Of these three structures, the potato house is sited the furthest south. This building has a gable roof and is covered in simple-drop novelty siding. The potato house was used for the storage of the sweet potato crop which was one of the main crops grown on the farm. The other main crops on the farm were corn and cotton. The smokehouse is also a simple gabled box-constructed structure which also has studs which were added later. As with all the other outbuildings with the exception of the utility shed, the smokehouse has a corrugated metal roof. The smokehouse is sheathed in flush wide vertical board. Closest to the house, the utility building has a gable roof with composition shingle roofing material. It is newer than the other outbuildings, and is covered in a flush horizontal wood siding.

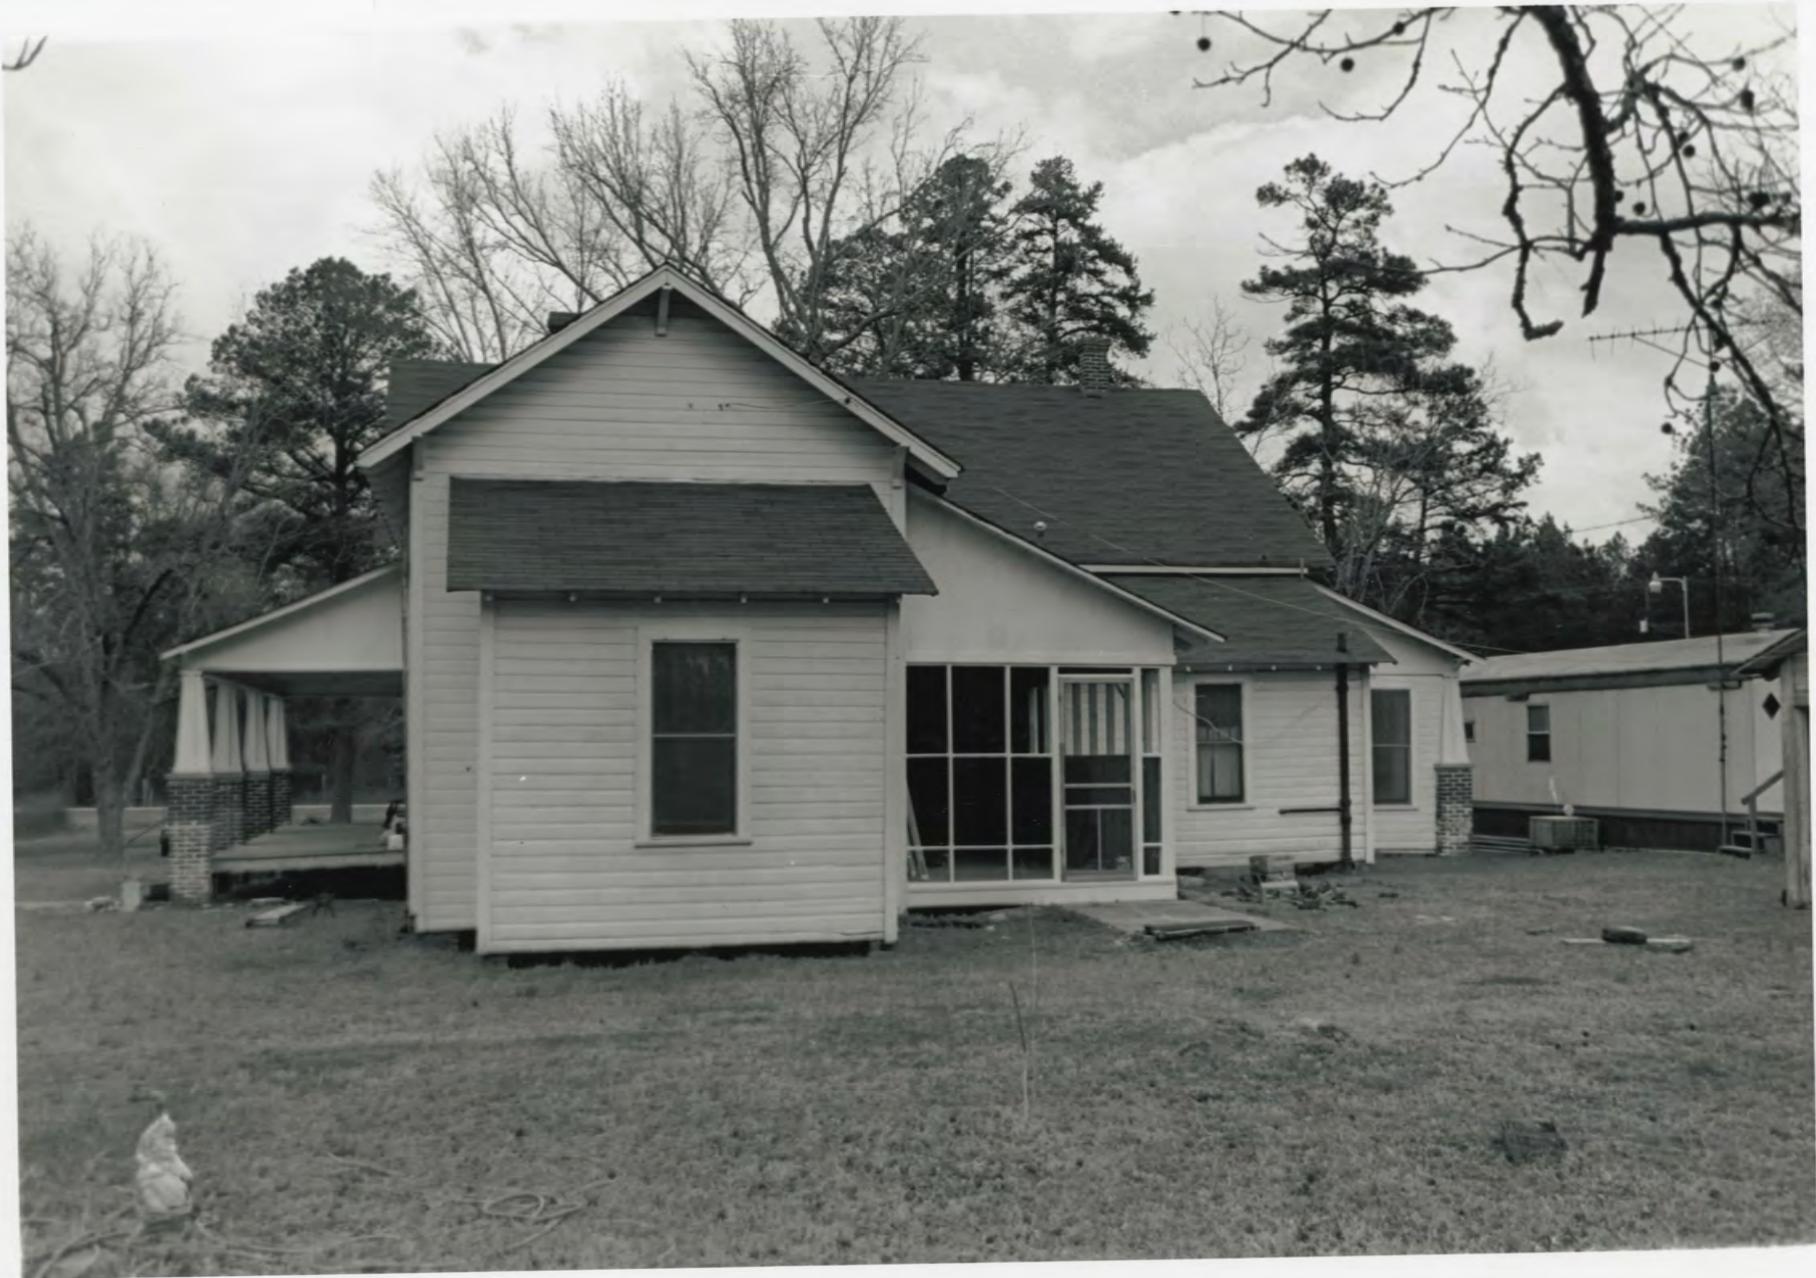
VIEW FROM SOUTH

The southern elevation is dominated by the protruding gable end of the ell, which contains a small enclosed shed addition with a single center window which protrudes out from this portion of the house. This elevation also features an enclosed shed roof addition with two windows on the south side of the main section of the house, which is connected to a recently restored screened sleeping porch off of the east side of the ell.

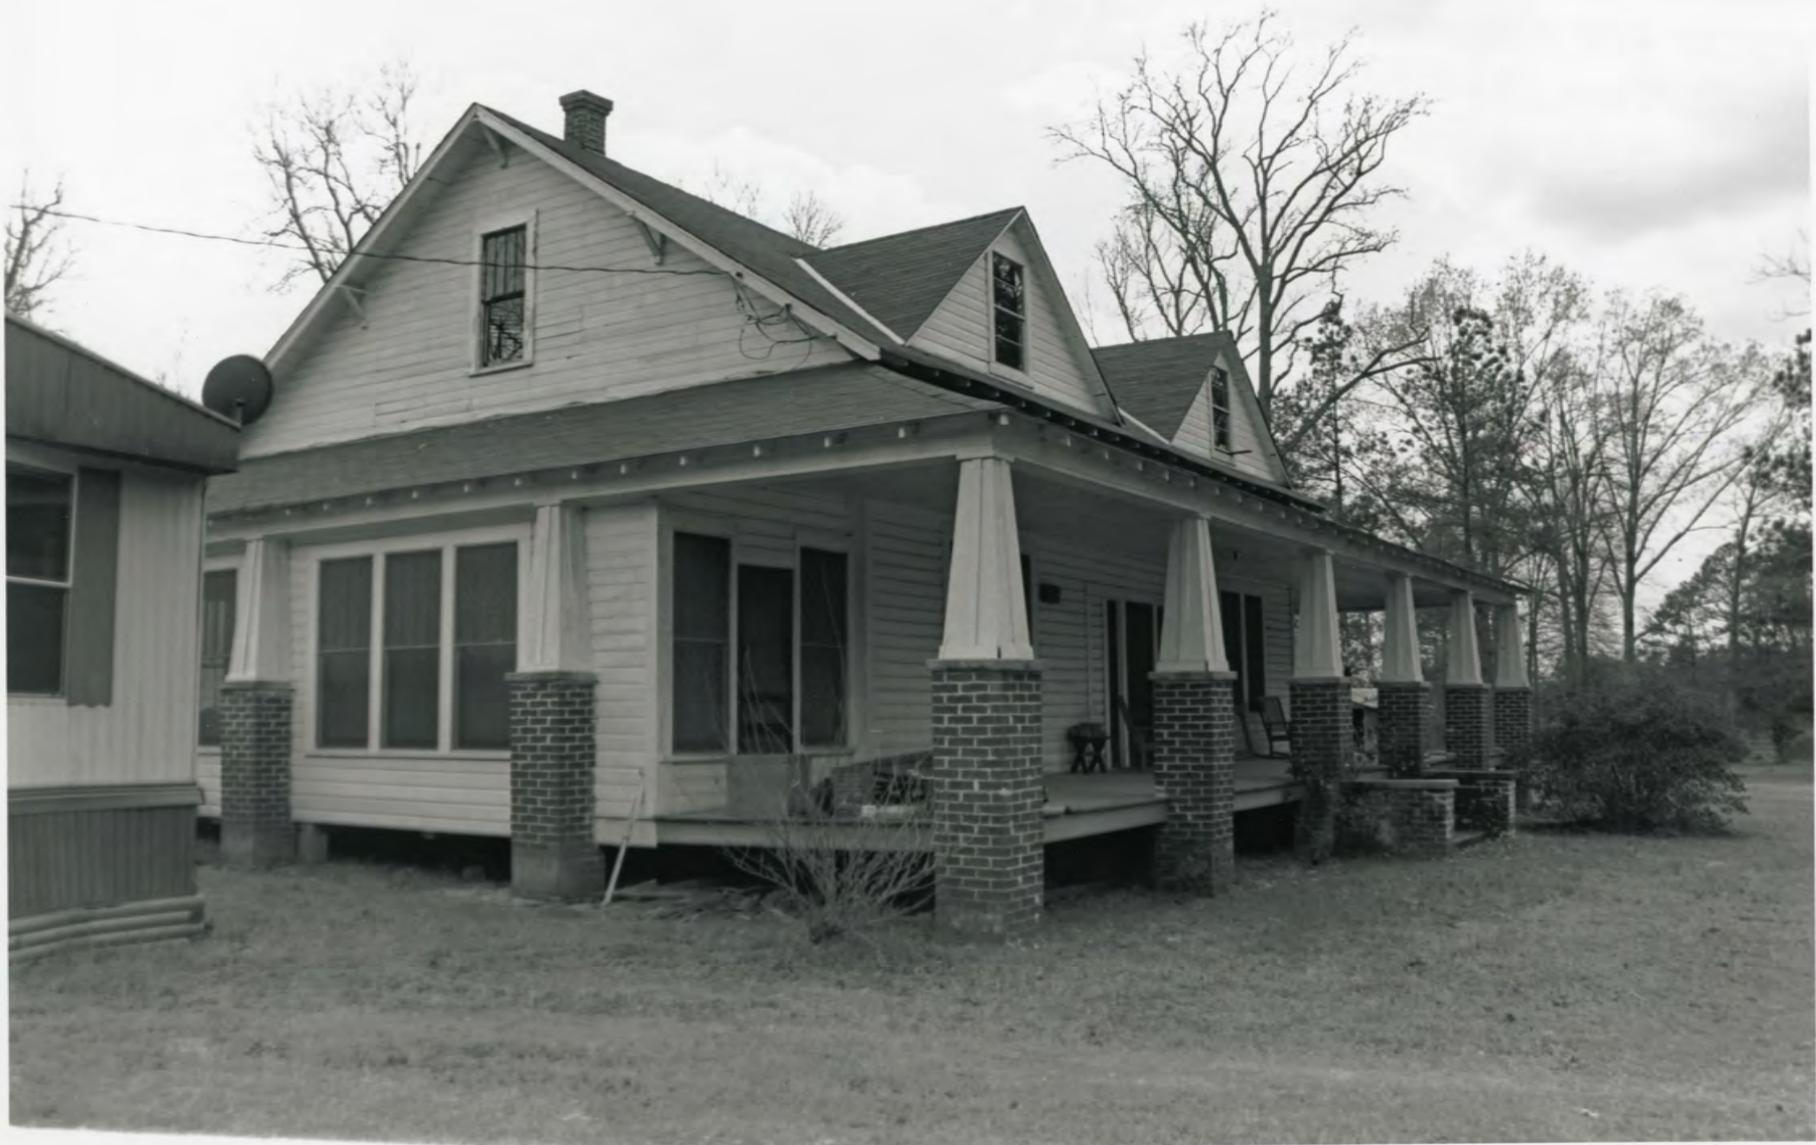
WILLET HOUSE  
6563 MT. HOLLY ROAD  
WISBON, UNION COUNTY, ARKANSAS  
PHOTO BY: R. BALDWIN  
PHOTO TAKEN: 3/17/95  
NEG. LOCATED AT AHPP  
VIEW FROM NORTHEAST

The eastern elevation is dominated by the enclosed porch which is covered in novelty siding to match the remainder of the house. The walls of this enclosure span the width between the three columns which support the southernmost portion of the porch on this elevation. The porch was enclosed in 1927 after the Willett family spent their first winter in the house. This area is lit by one group of three windows, as well as a set of windows separated by a single-leaf door. A single window is located in the center of the gable above, and lights the attic space within.

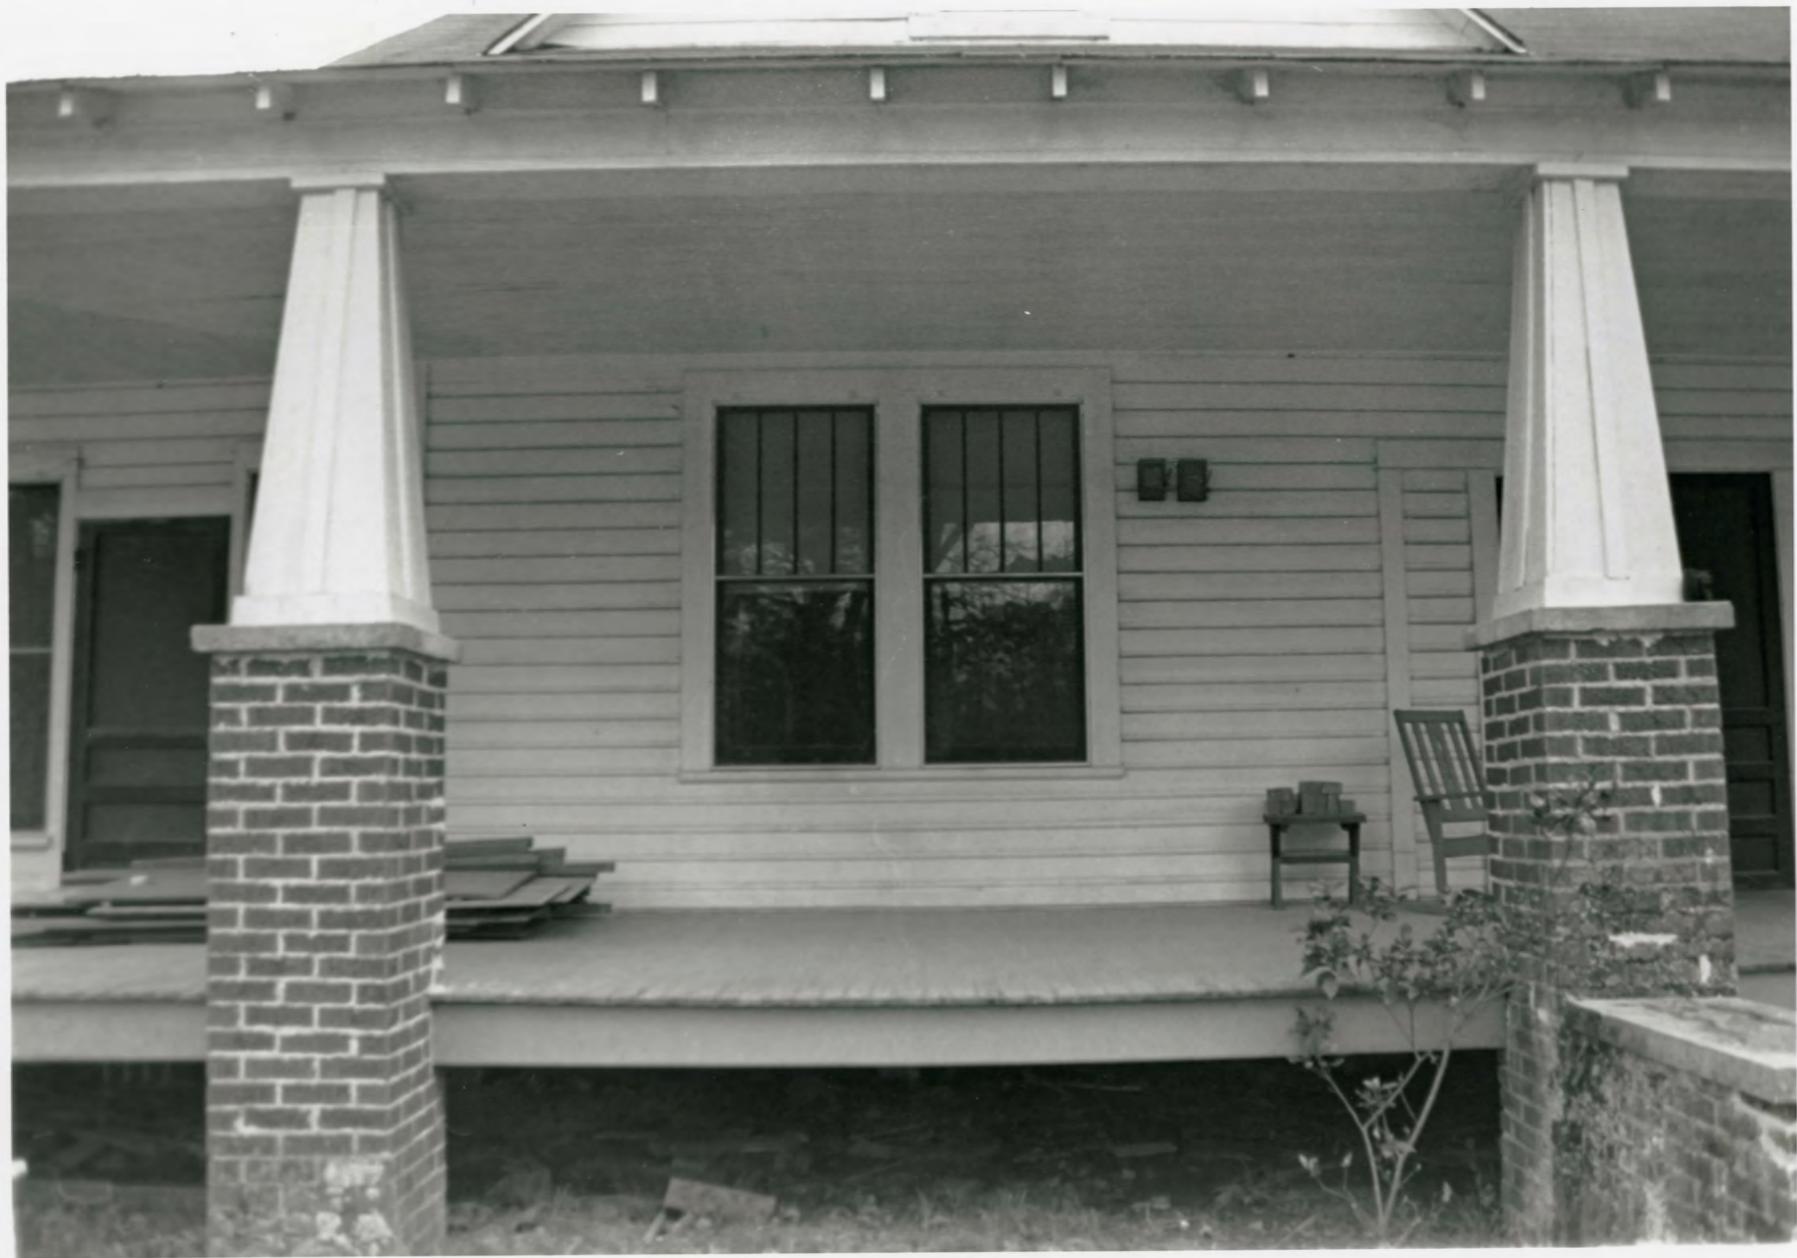
VIEW OF N. FACADE FROM NORTH

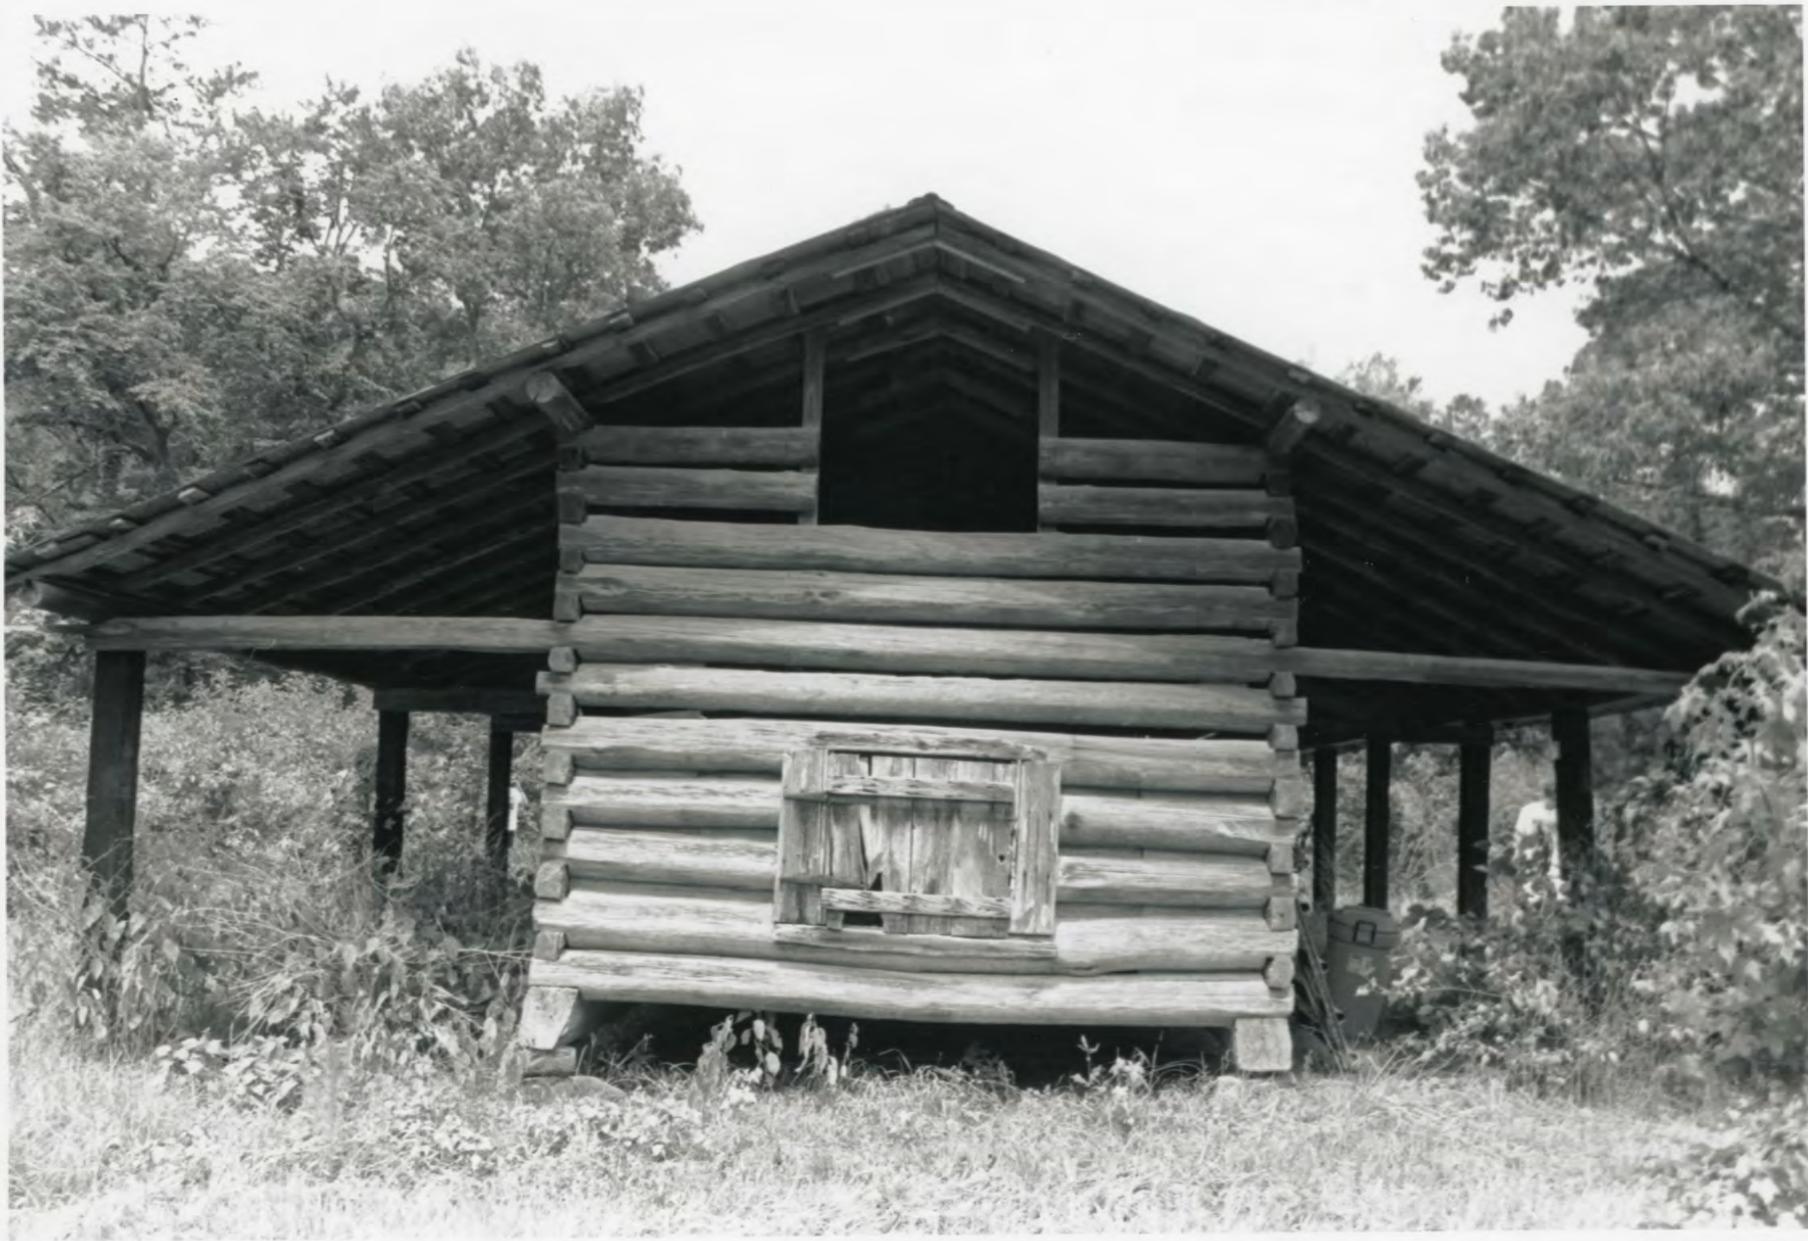
PHOTO TAKEN: 6/28/95  
NEG. LOCATED AT AHPP  
VIEW OF BARN FROM EAST

There are a total of five outbuildings on the property, at least two of which pre-date the present house. Perhaps the most significant outbuilding is the barn, which was constructed in the early 1900's. Located to the southeast of the main house, the barn is the largest of the outbuildings. It is built in the double crib form with a combination of square and half notching at the corners. The barn features an open central passage, and side sheds. The barn rests on one foot sills, and the logs are approximately nine inches in width. Each crib is approximately fourteen feet in width and twelve feet in depth, with a passage between the two pens of approximately ten feet. The sheds on either side of the cribs are supported by wood posts, as well as a single cantilever at the east and west ends. The cantilevered beam was hewn out of

a single log and expands the entire width of the east side of the structure. The cantilevered beam on the west side of the barn is missing the northernmost portion. The barn is a very remarkable remaining example of an Arkansas outbuilding from the early Twentieth Century due to the cantilevers, the high level of construction, and the present condition of the building.

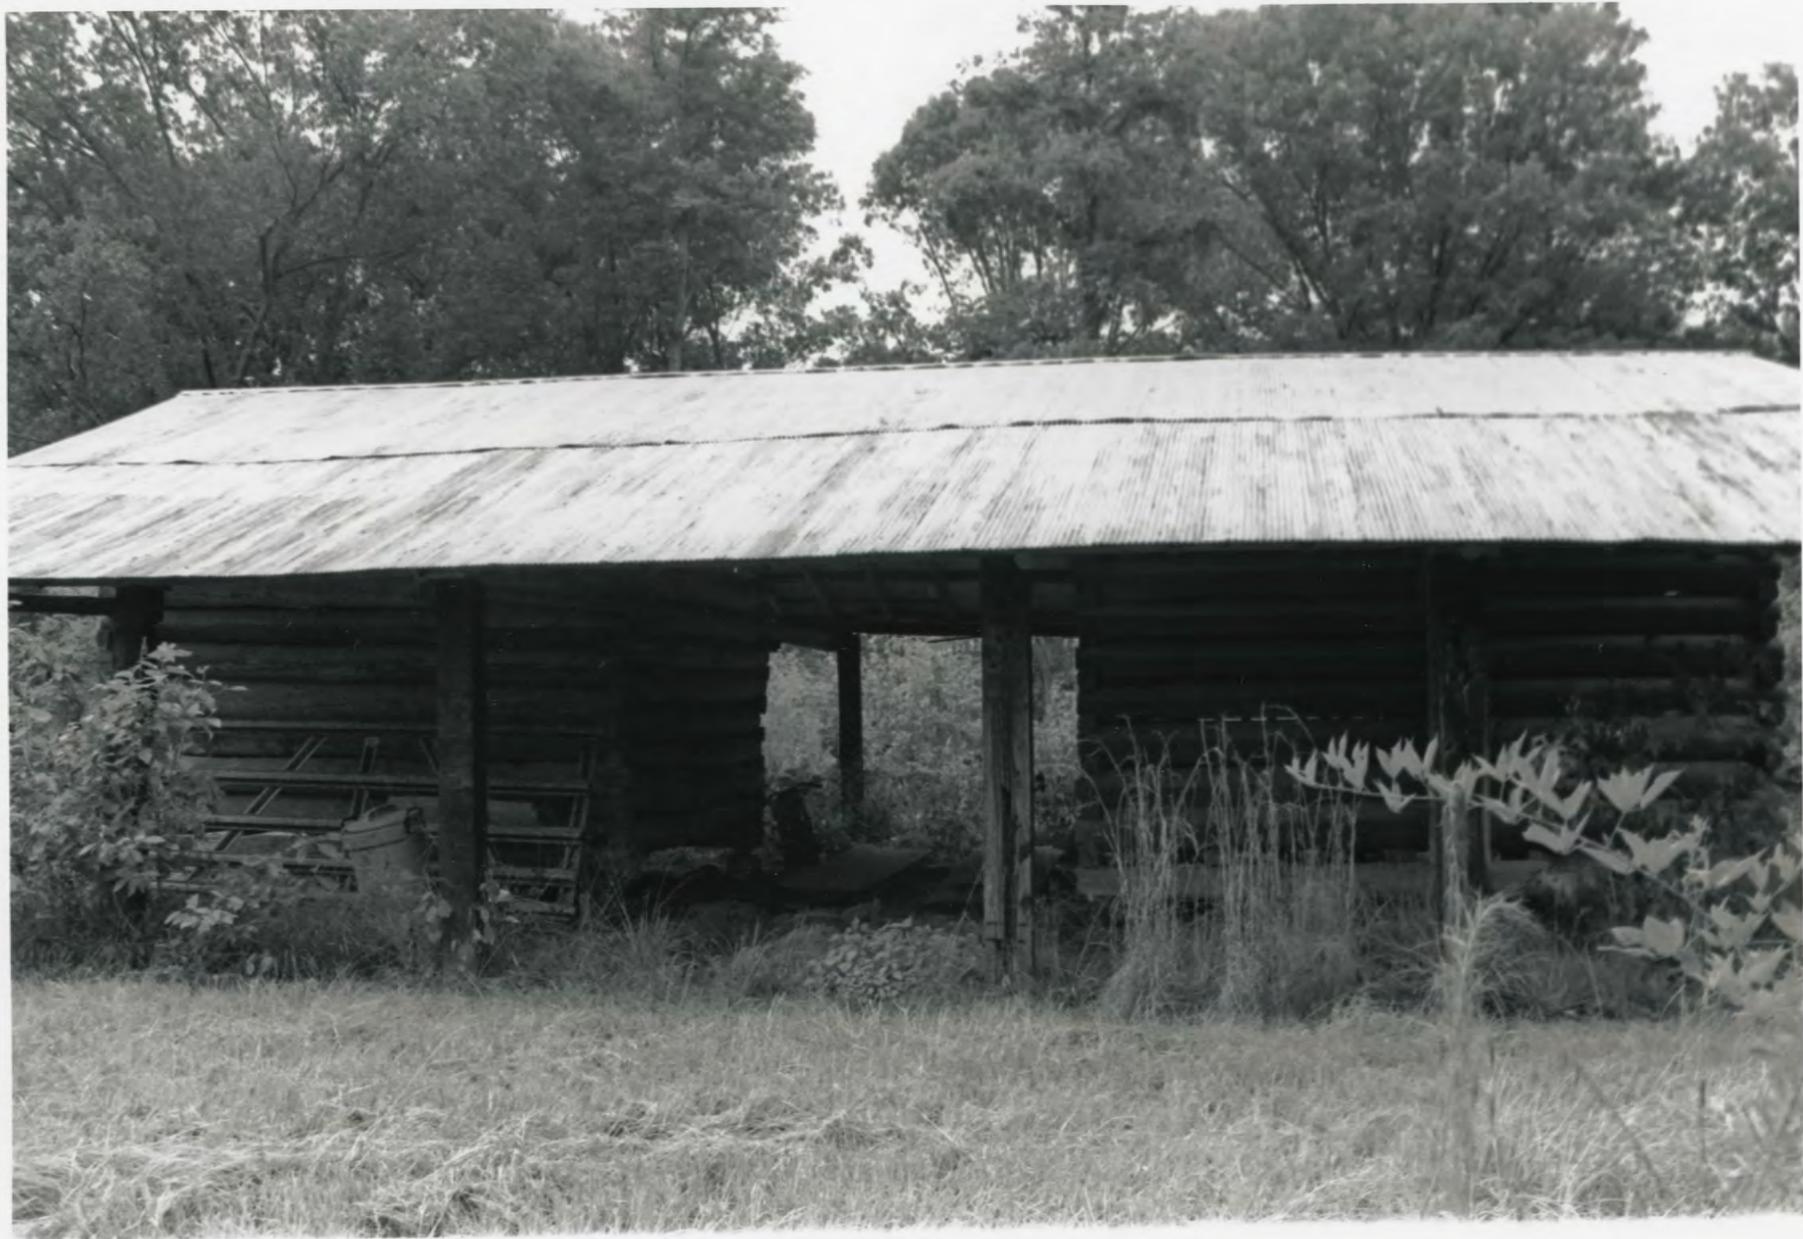
NEG: LOCATED AT AHPP  
VIEW OF BARN FROM NORTH

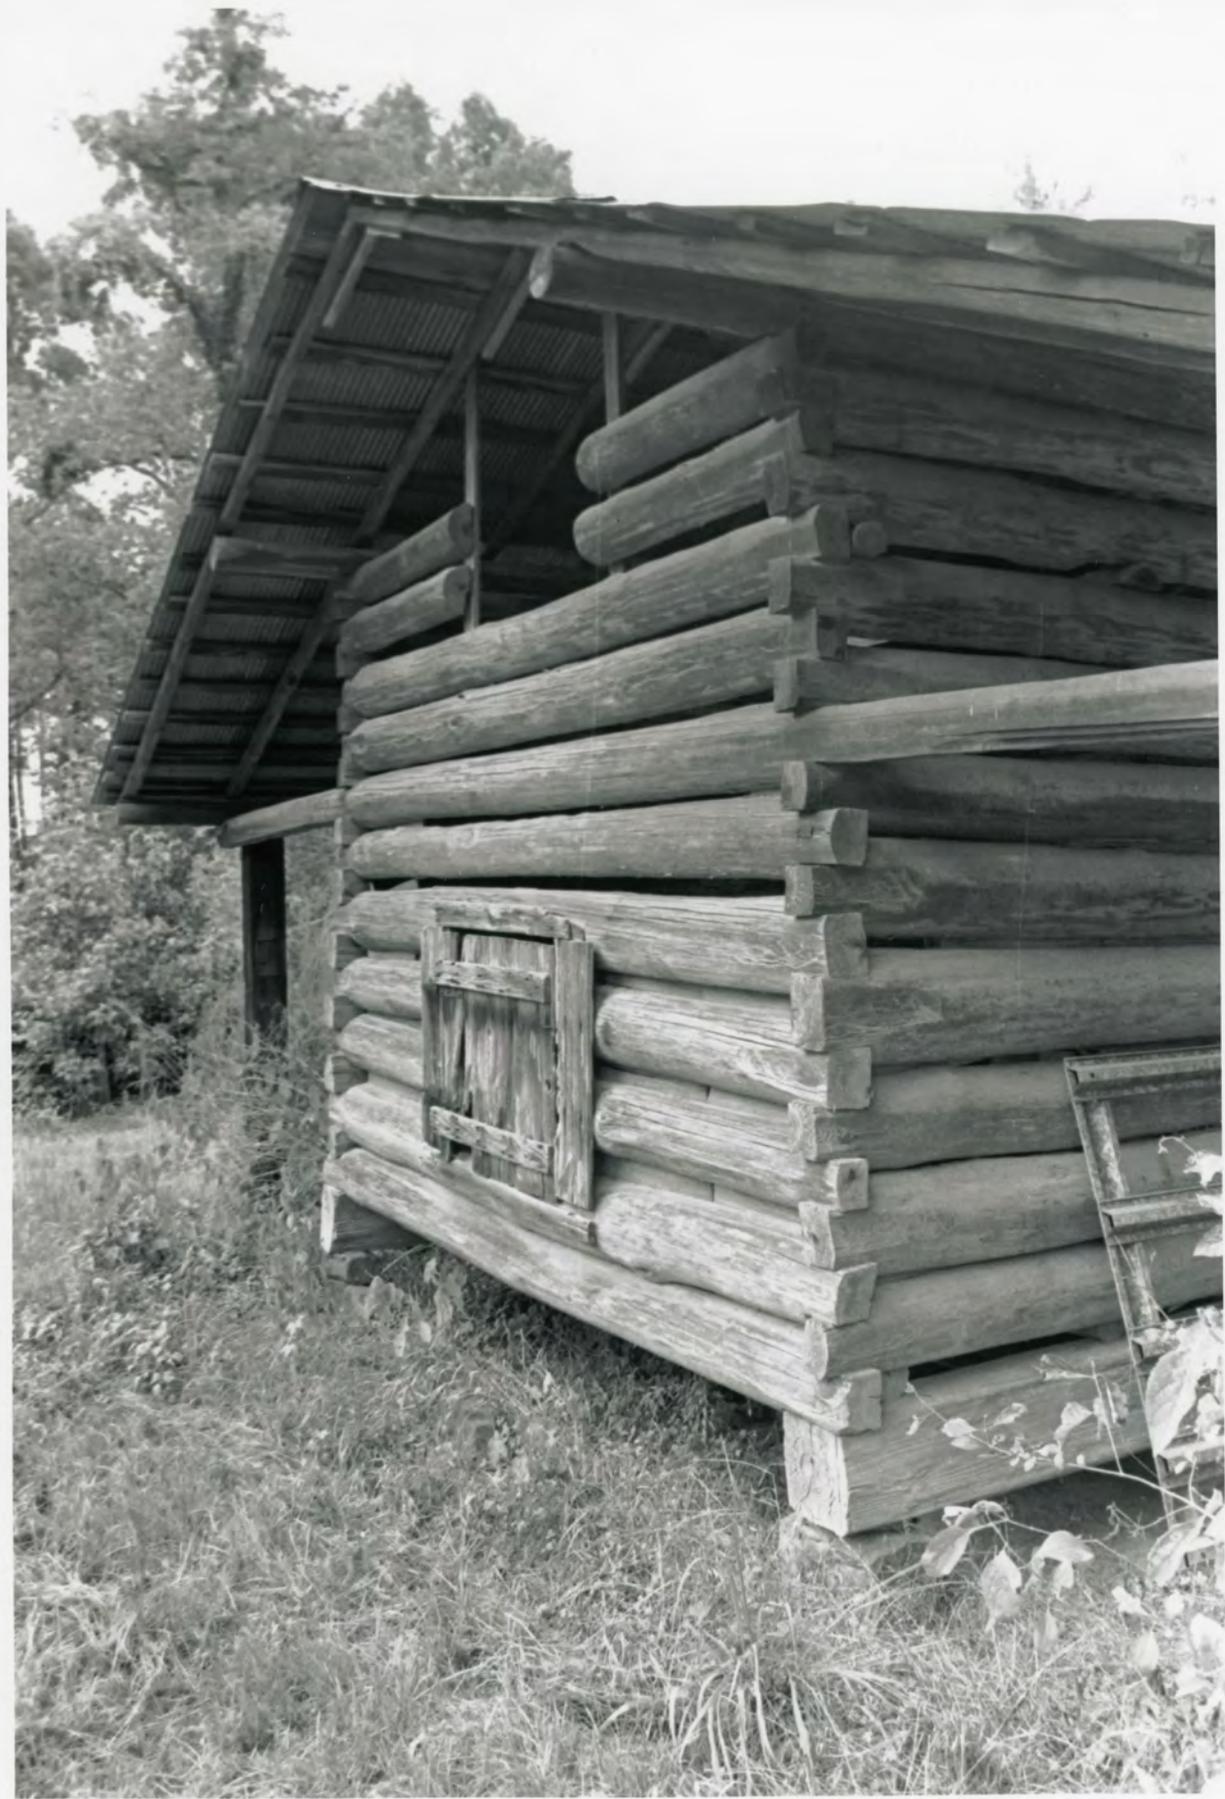
WILLETT HOUSE, LISBON  
UNION COUNTY, ARKANSAS  
PHOTO BY: HELEN BARRY  
PHOTO TAKEN: 6-28-95  
NEG. LOCATED AT AHPP  
VIEW OF BARN FROM NORTHEAST
