NATIONAL REGISTER OF HISTORIC PLACES  
REGISTRATION FORM

Historic Name: Willett House

Street & Number: 6563 Mount Holly Road

City/Town: Lisbon Not for Publication: N/A

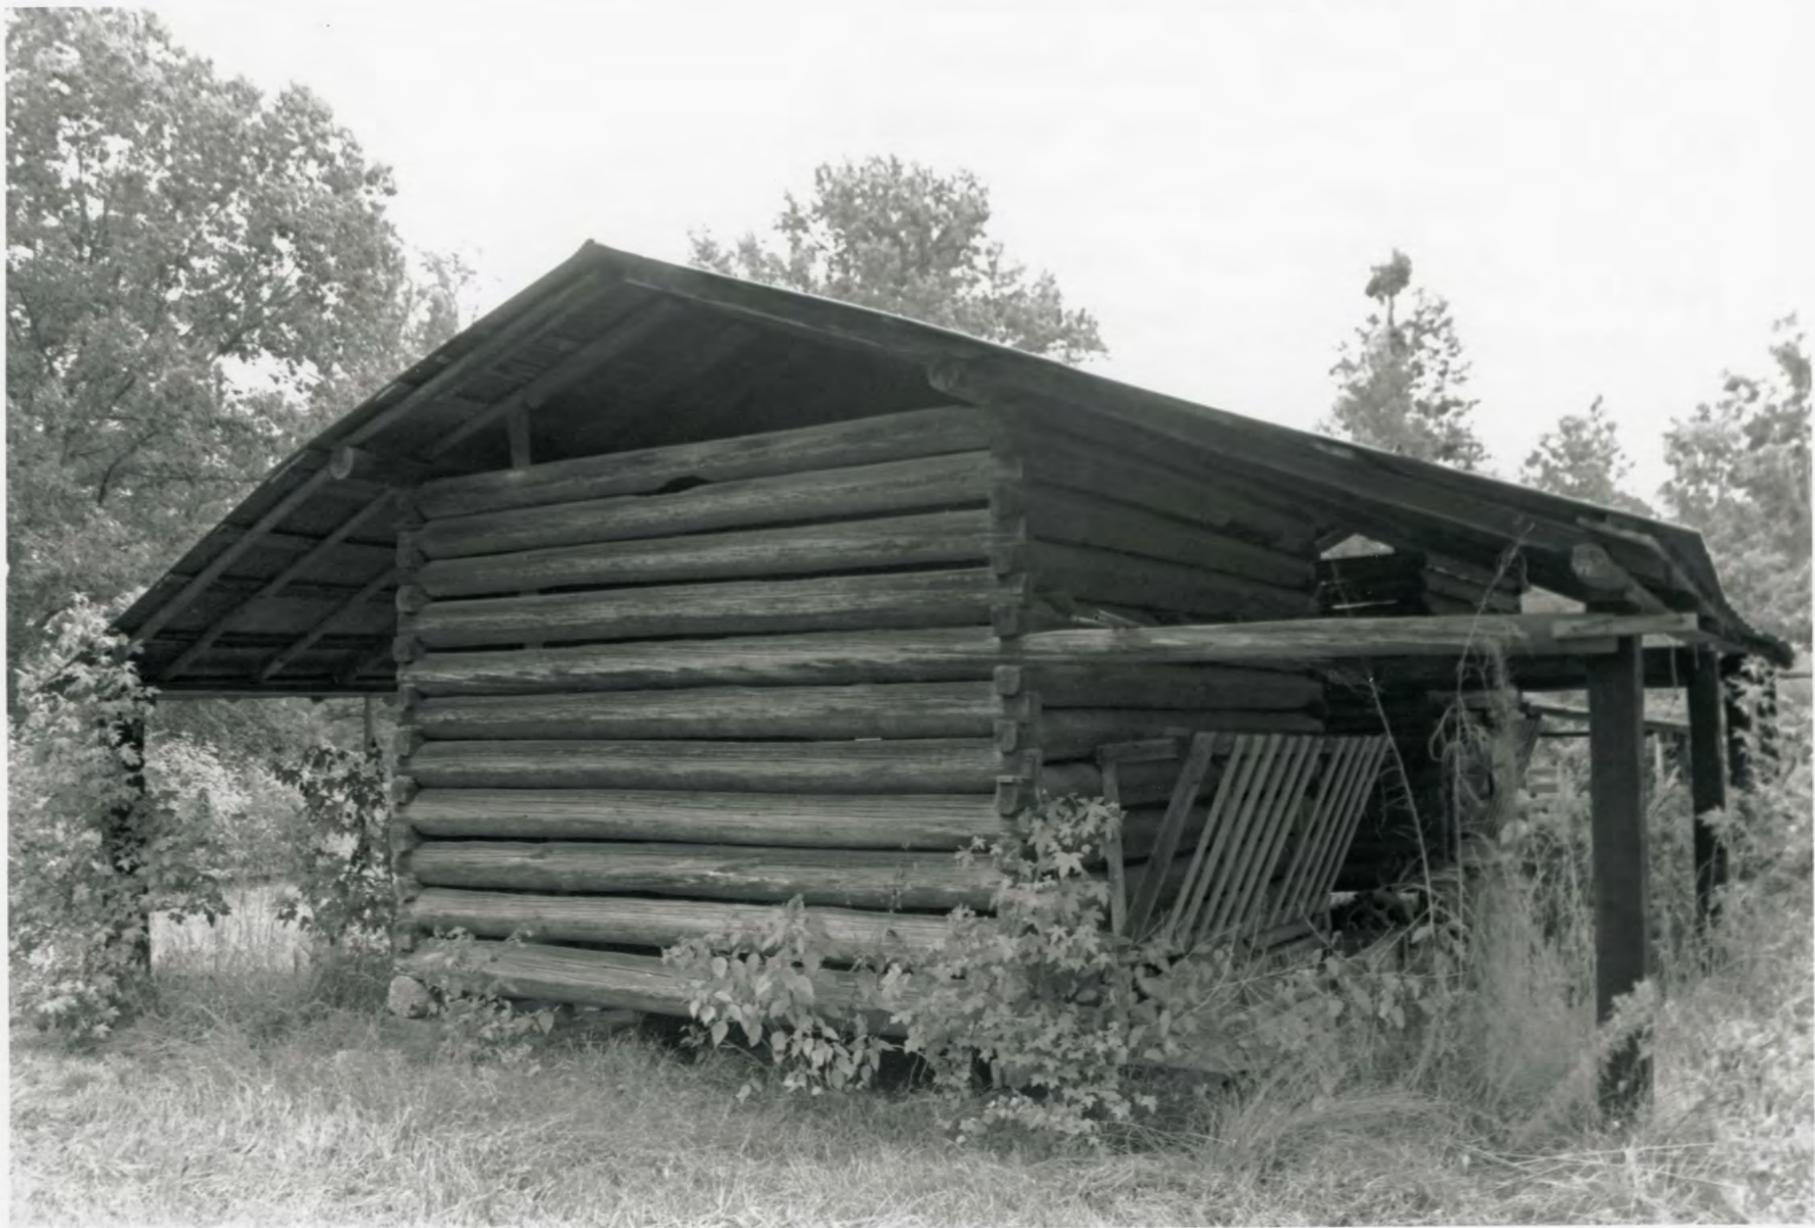
WILLET HOUSE, LISBON  
UNION COUNTY, ARKANSAS  
PHOTO BY: HELEN BARRY  
PHOTO TAKEN: 6-28-95  
NEG. LOCATED AT AHPP  
VIEW OF BARN FROM SOUTHWEST

There are a total of five outbuildings on the property, at least two of which pre-date the present house. Perhaps the most significant outbuilding is the barn, which was constructed in the early 1900's. Located to the southeast of the main house, the barn is the largest of the outbuildings. It is built in the double crib form with a combination of square and half notching at the corners. The barn features an open central passage, and side sheds. The barn rests on one foot sills, and the logs are approximately nine inches in width. Each crib is approximately fourteen feet in width and twelve feet in depth, with a passage between the two pens of approximately ten feet. The sheds on either side of the cribs are supported by wood posts, as well as a single cantilever at the east and west ends. The cantilevered beam was hewn out of

a single log and expands the entire width of the east side of the structure. The cantilevered beam on the west side of the barn is missing the northernmost portion. The barn is a very remarkable remaining example of an Arkansas outbuilding from the early Twentieth Century due to the cantilevers, the high level of construction, and the present condition of the building.

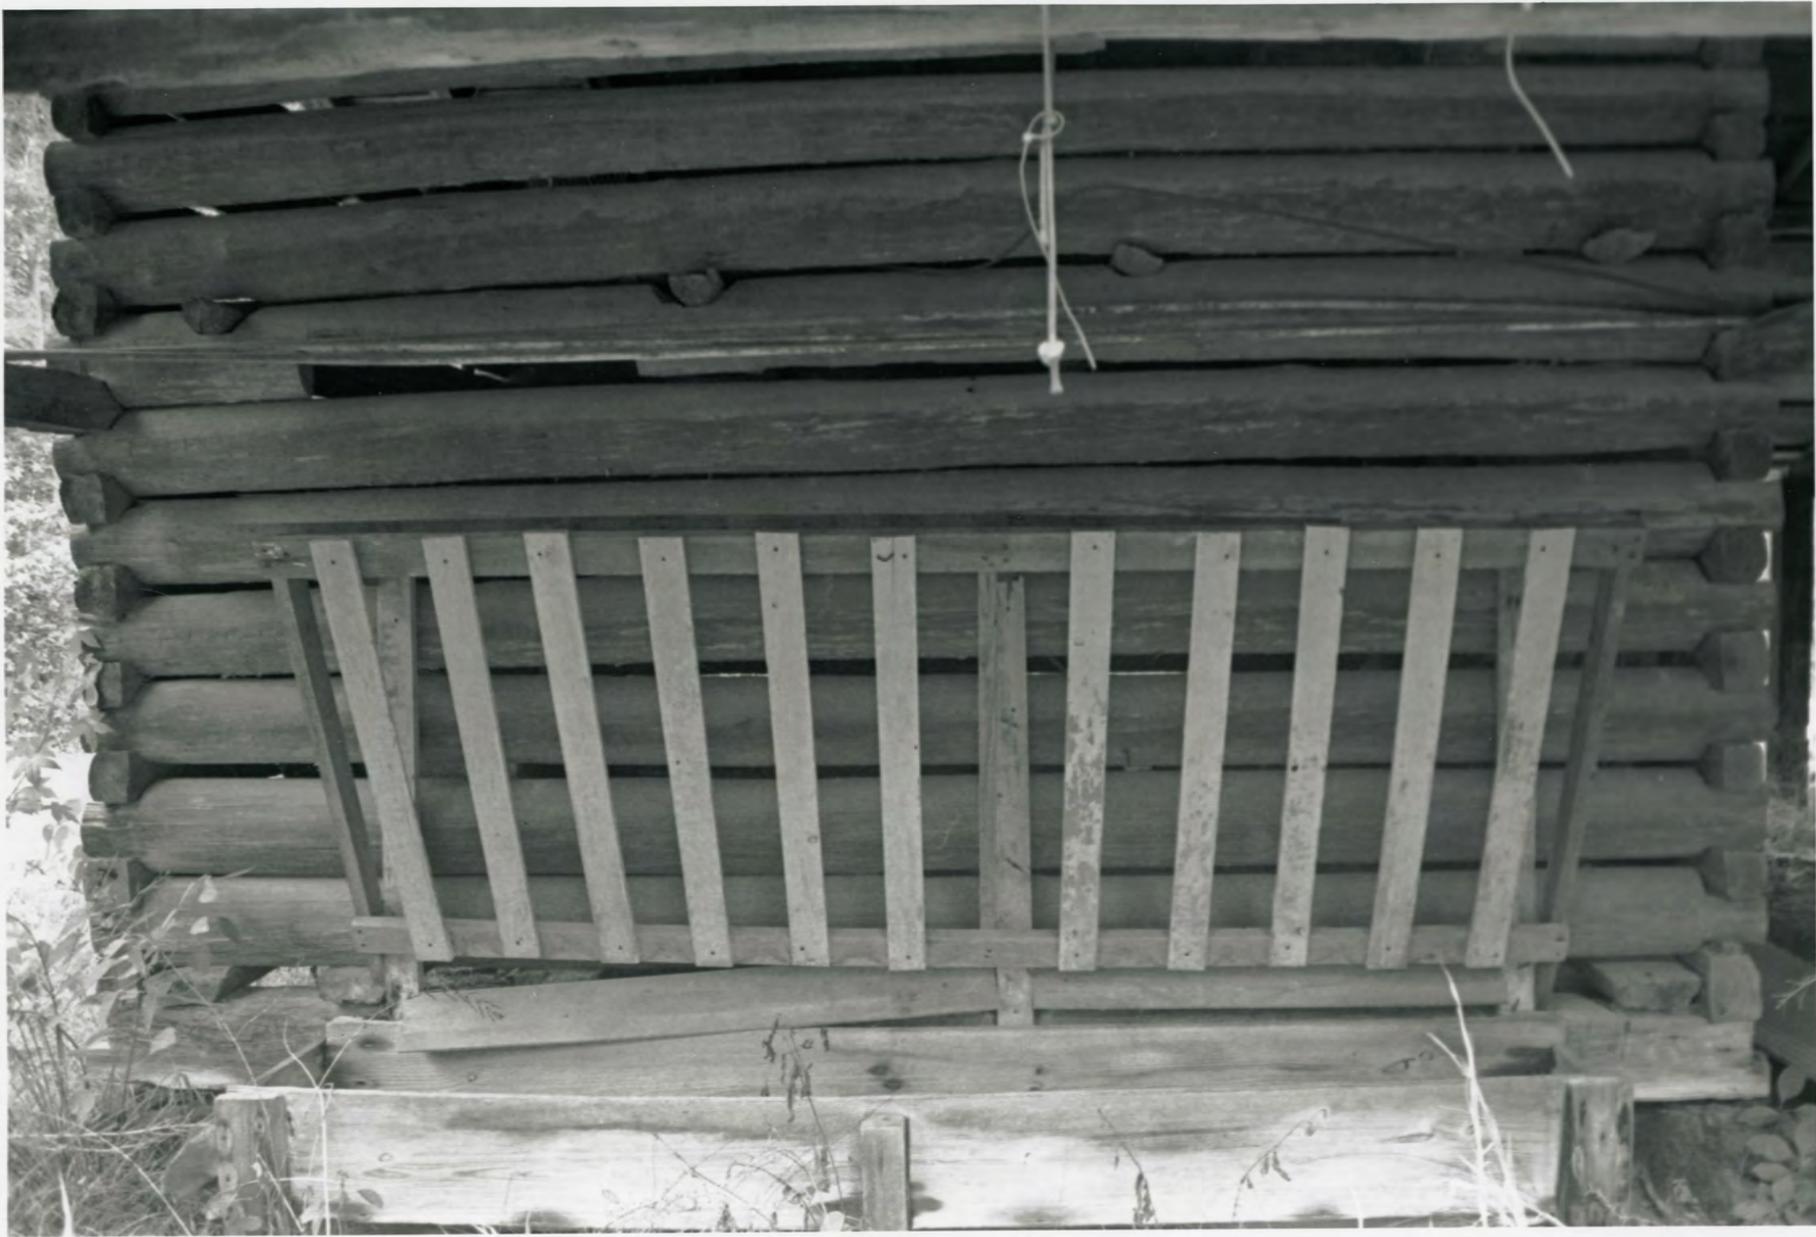
WILLETT HOUSE, LISBON  
UNION COUNTY, ARKANSAS  
PHOTO BY: HELEN BARRY  
PHOTO TAKEN: 6-28-95  
NEG. LOCATED AT AHPP  
VIEW OF SOUTH SIDE OF BARN

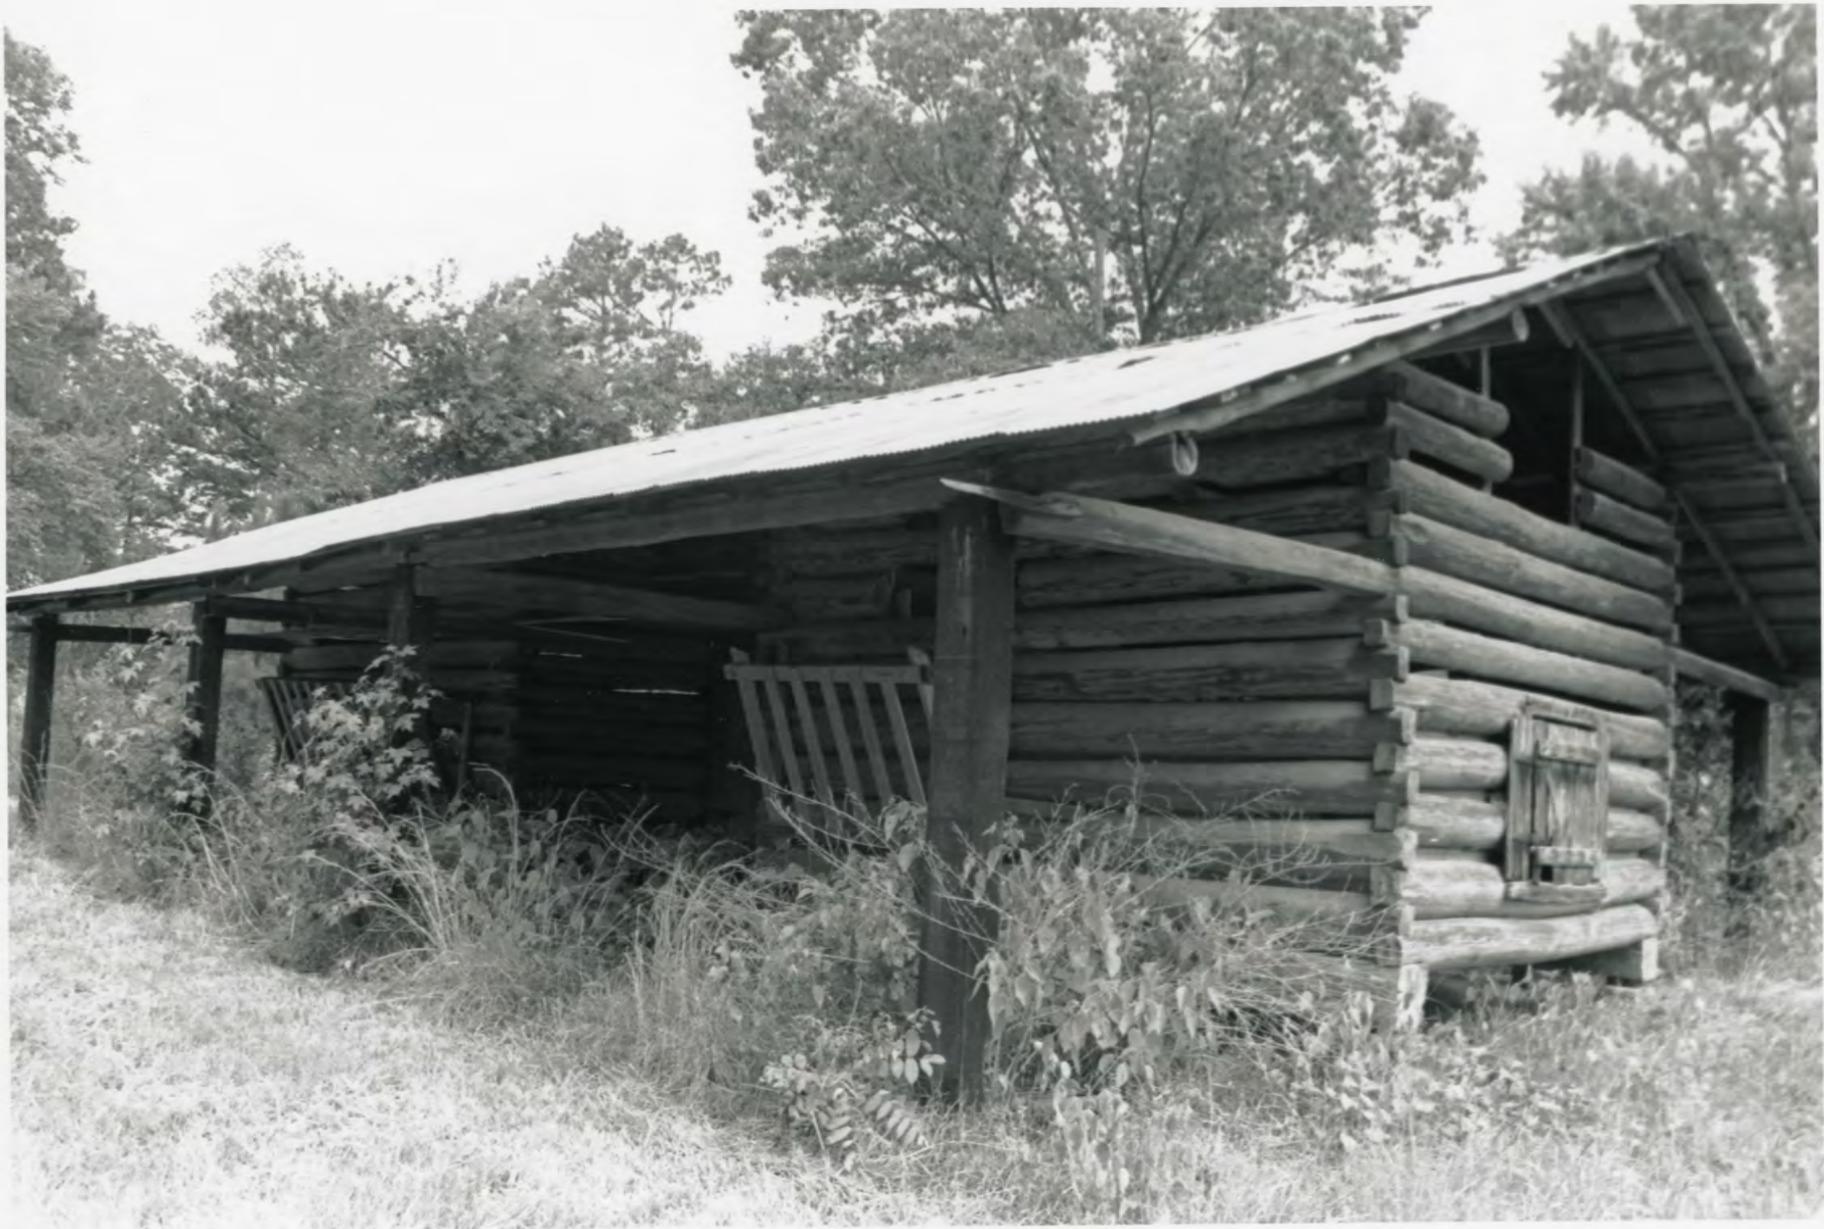
WILLETT HOUSE, LISBON  
UNION COUNTY, ARKANSAS  
PHOTO BY: HELEN BARRY  
PHOTO TAKEN: 6-28-95  
NEG. LOCATED AT AHPP  
VIEW OF BARN FROM SOUTHEAST

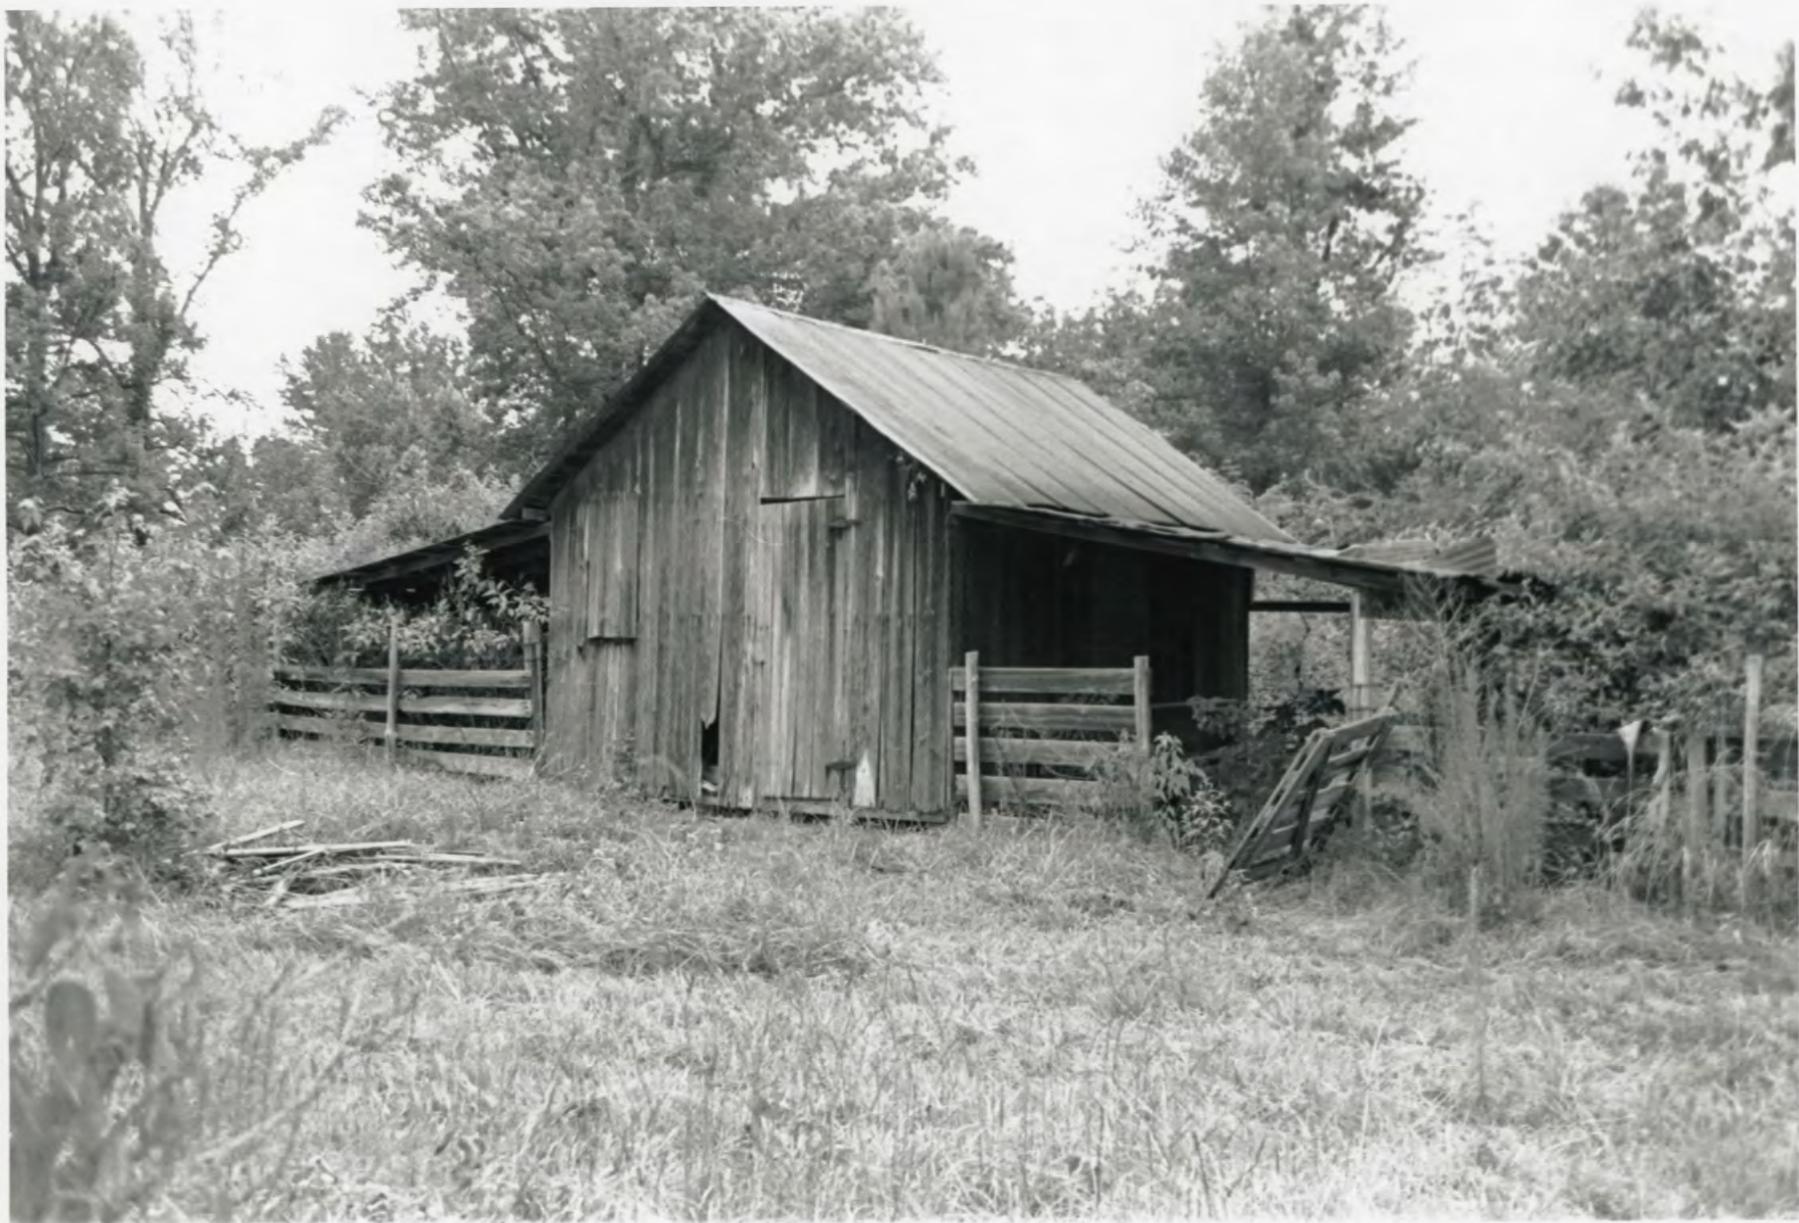
WILLETT HOUSE, LISBON  
UNION COUNTY, ARKANSAS  
PHOTO BY: HELEN BARRY  
PHOTO TAKEN: 6/28/95  
NEG. LOCATED AT AHPP  
VIEW OF FEED HOUSE FROM SOUTHWEST

The feed house is located a few hundred feet on the west side of the barn. The feed house is the only portion of the original house remaining today. The feed house is a small box-constructed rectangular structure covered in vertical flush boards with open side sheds. At one time the feed house served as the detached kitchen for the Willetts previous house. After the current house was constructed in 1926, the kitchen became a storage house for hay and feed for the cows and pigs on the farm.

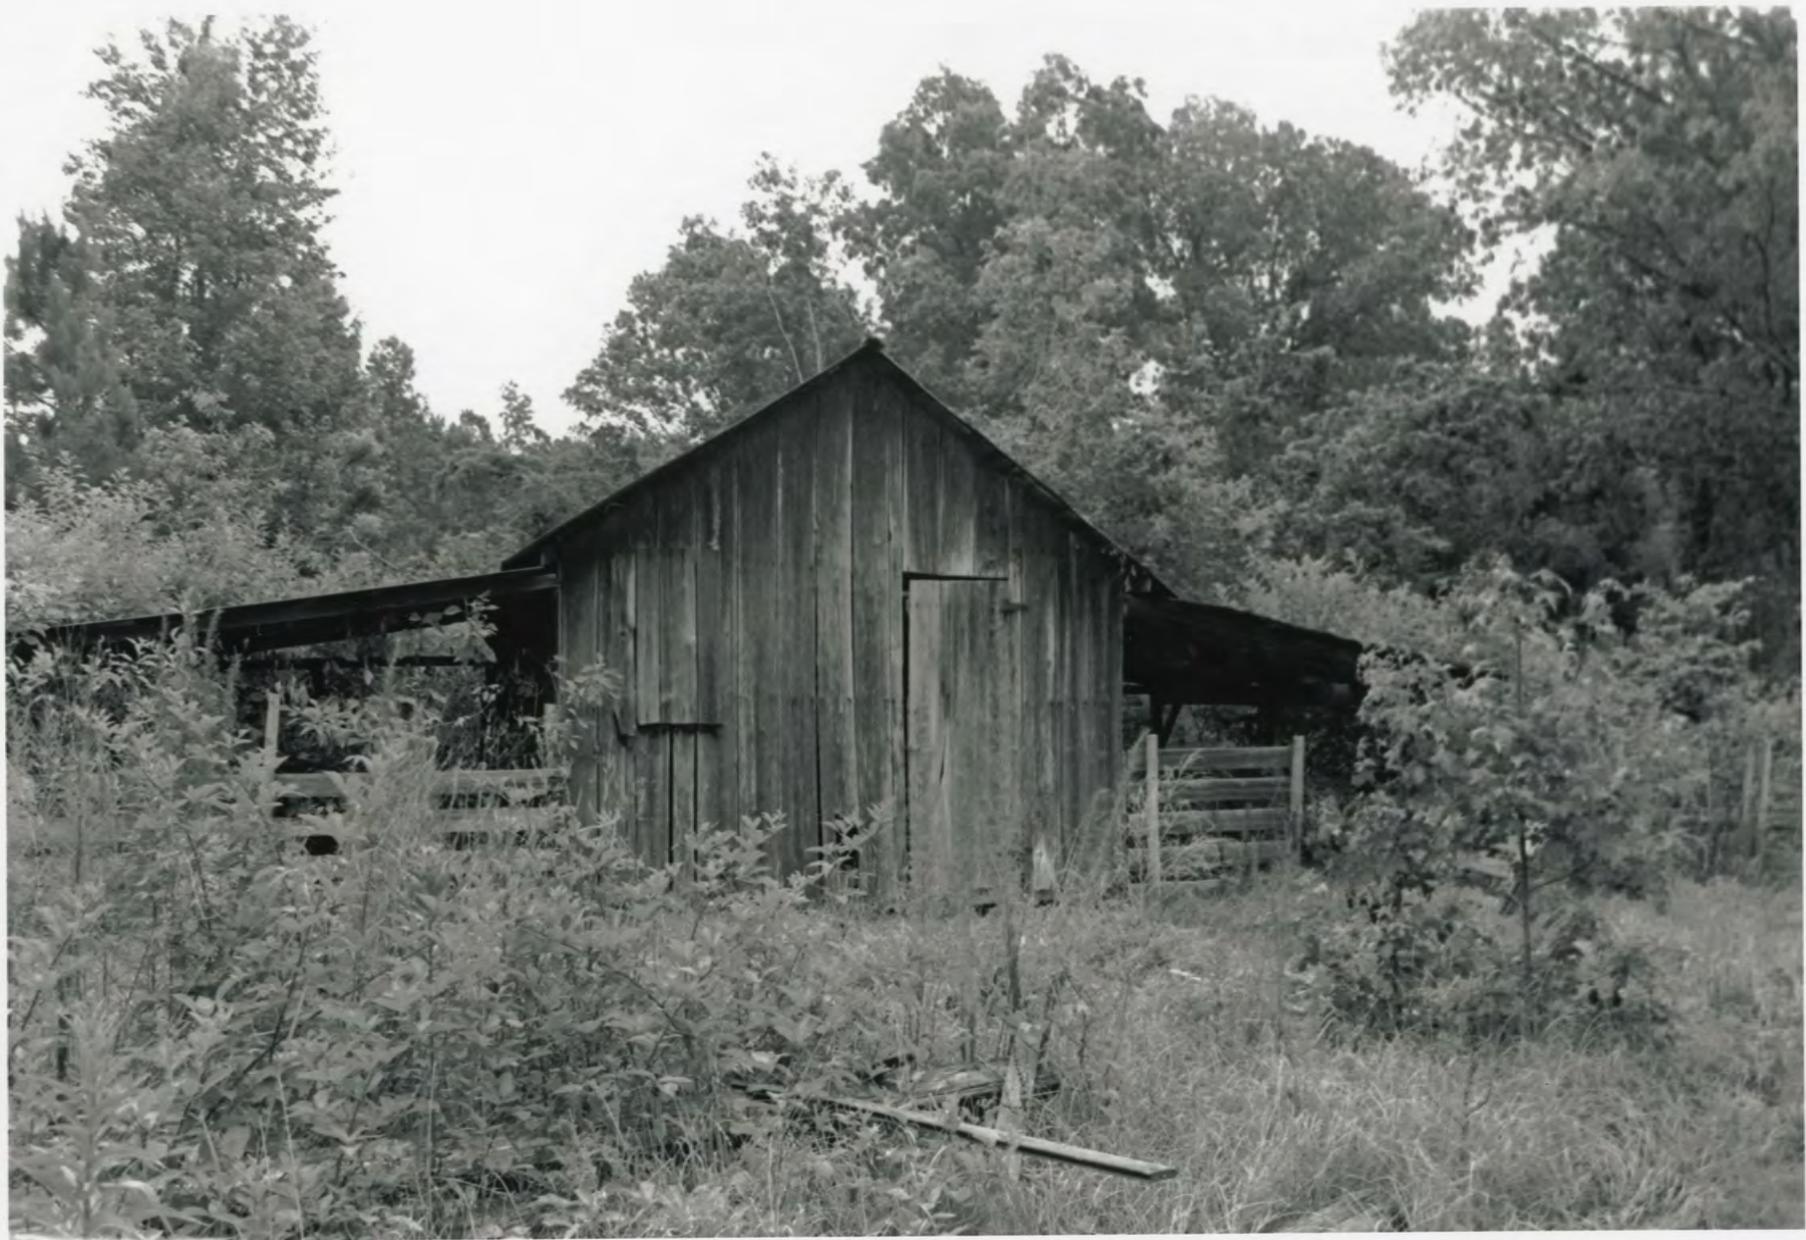
VIEW OF FEED HOUSE FROM WEST

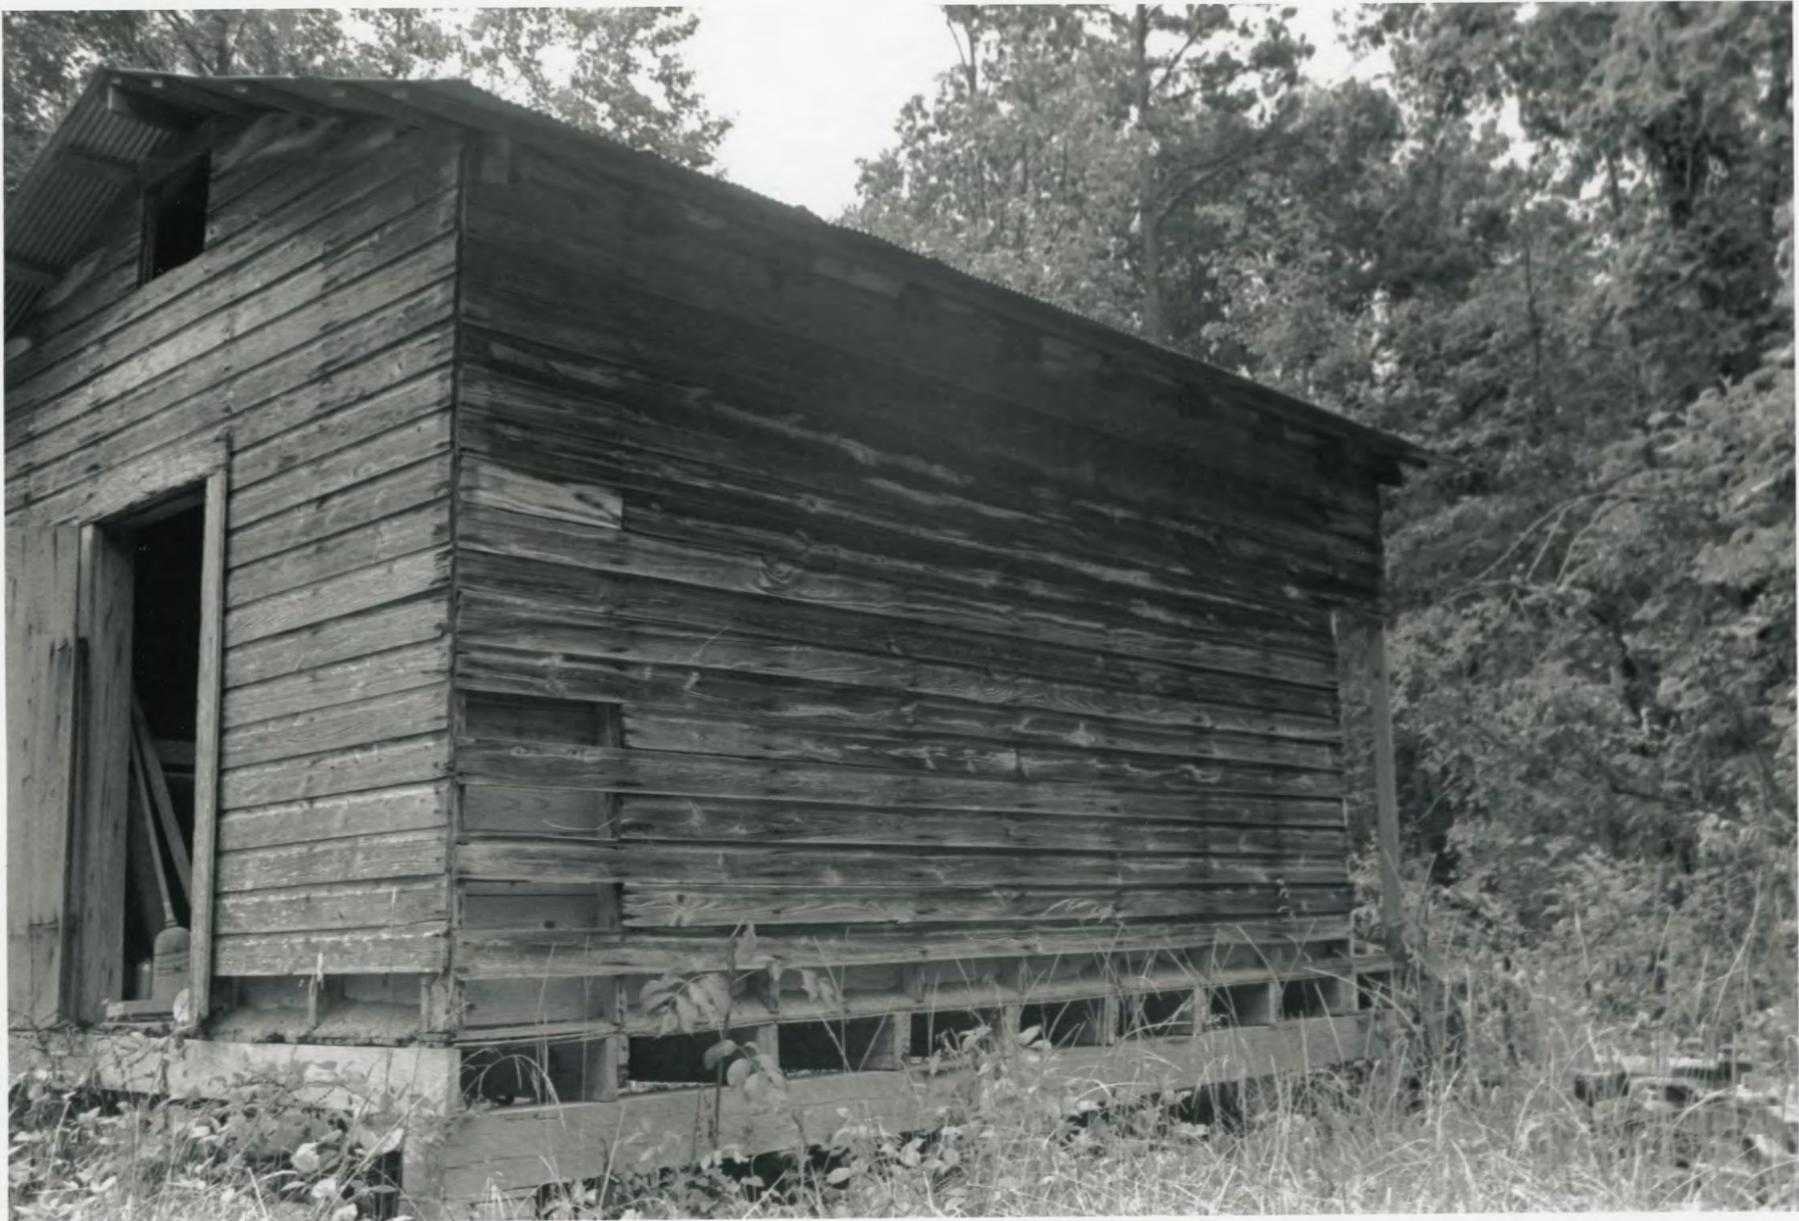
POTATO HOUSE AS VIEWED FROM NORTHWEST

There are three other outbuildings which are located closer to the house. They are the potato house, the smokehouse, and a small utility building. Of these three structures, the potato house is sited the furthest south. This building has a gable roof and is covered in simple-drop novelty siding. The potato house was used for the storage of the sweet potato crop which was one of the main crops grown on the farm. The other main crops on the farm were corn and cotton. The smokehouse is also a simple gabled box-constructed structure which also has studs which were added later. As with all the other outbuildings with the exception of the utility shed, the smokehouse has a corrugated metal roof. The smokehouse is sheathed in flush wide vertical board. Closest to the house, the utility building has a gable roof with composition shingle roofing material. It is newer than the other outbuildings, and is covered in a flush horizontal wood siding.
